Geotechnical Damage due to the 2011 Christchurch, New Zealand

Suguru Yamada, Assistant Professor, University of Tokyo
Rolando Orense, Senior Lecturer, University of Auckland
Misko Cubrinovski, Associate Professor, University of Canterbury

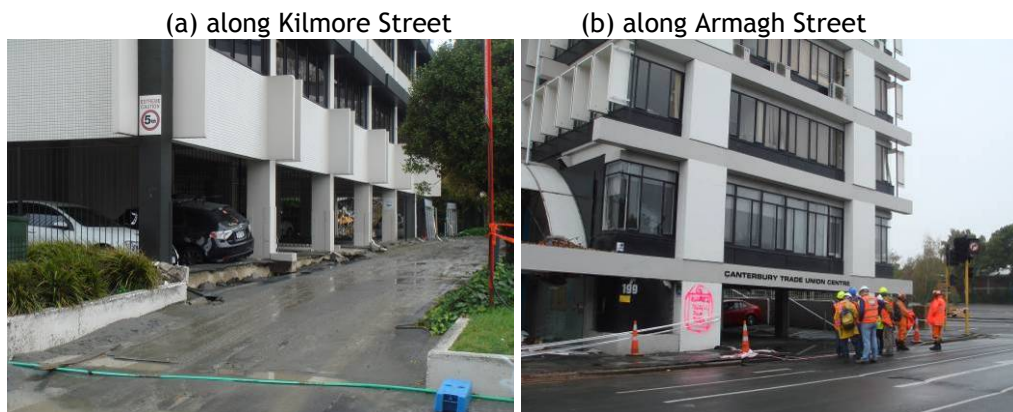
In the Central Business District (CBD), several buildings collapsed, while many of the buildings that survived suffered significant or some form of structural damage. Severe liquefaction was also observed in the CBD, such as along Kilmore Street (Figure 11a) and Armagh Street (Figure 11b). The relation between the building structural damages and liquefaction of the foundation ground is currently under investigation.

Figure 11. Liquefaction-induced damages in CBD.

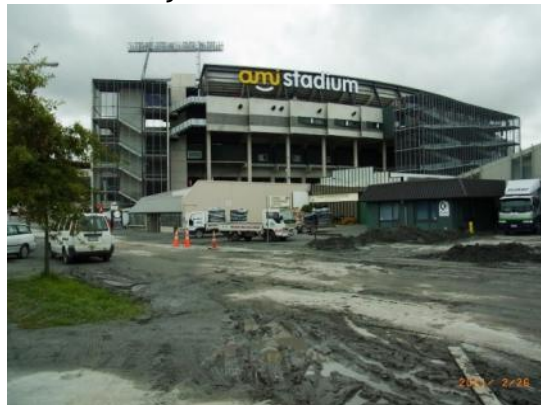
(a) Massive amount of sand ejecta in front of the west stand of AMI stadium.

Figure 12. Liquefaction adjacent to AMI stadium.

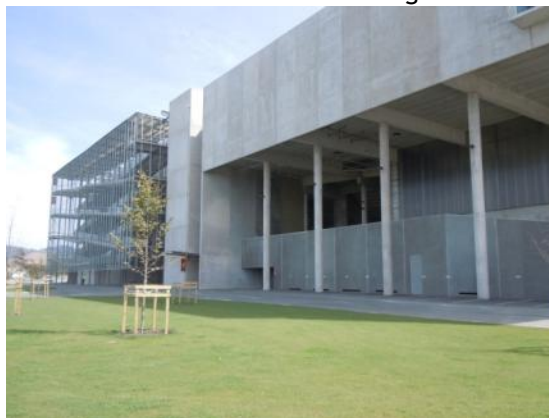
There are very few structures in the area where liquefaction countermeasures have been implemented in the foundation ground. One example is the AMI stadium located near CBD, where the ground under the east stand was stabilized with stone column. Minor liquefaction was observed near the east stand in spite of the severe liquefaction all around the stadium (Figure 12).

(b) The ground in front of the east stand of AMI stadium. The green turf was not covered by sand boils.

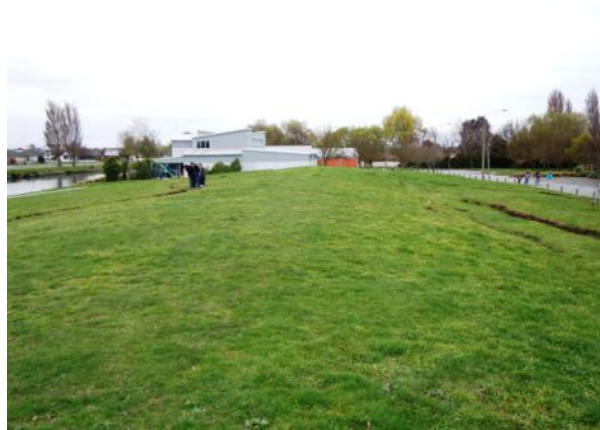
(a) Damage in Porritt Park after 2010 Darfield Earthquake (JGS, 2010)

Figure 13. Lateral spreading and the crown settlement of a stop bank near Porritt Park.

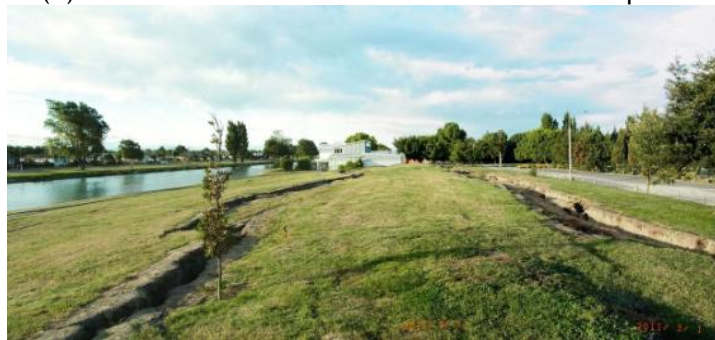
Because of short time interval between the two gigantic earthquake events, the earthquake caused additional damages to many facilities which suffered liquefaction-induced damage and had not been repaired. Figures 13 (a) and (b) are photos of a river embankment in Porritt Park (east bank of Avon River), after the 2010 earthquake and 2011 earthquake, respectively. The width of crack openings on the shoulder and settlement of the crown became larger due to repeated liquefaction of the foundation ground of the embankment. Extensive repeated liquefaction was observed in entire Porritt Park, where half of green grassy area was covered by sand boils again following the previous earthquake.

(b) Same area after the 2011 Christchurch Earthquake

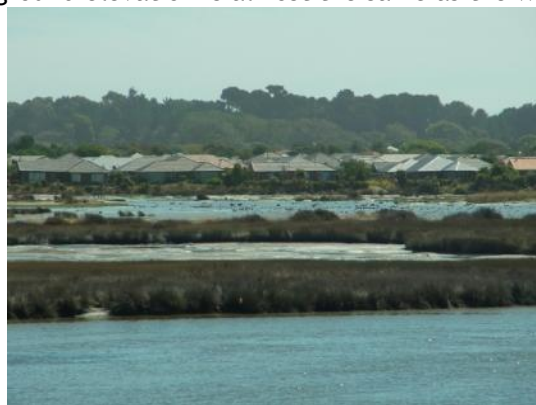
Extensive liquefaction was observed widely in residential areas along Avon River. The very shallow ground water table (1.0m to 1.5m) has been recognized in western suburb of Christchurch, particularly in areas close to the coastal line. Bexley is a newly constructed residential area developed by reclaiming the wetland near the mouth of Avon River. Figure 14 shows a broad panorama overlooking Bexley, taken from the South Brighton Bridge crossing the river mouth of Avon. It can be seen that residential houses are now located on an area where the ground elevation is almost the same as the water surface.

Figure 14. A photo overlooking the Bexley residential area.

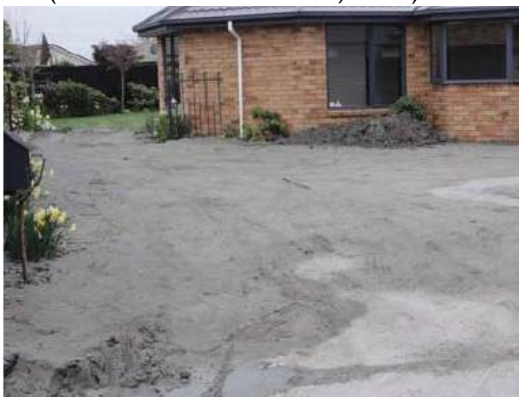
(a) After the 2010 Darfield Earthquake
(Cubrinovski and Orense, 2010)

Figure 15. Damage to residential houses due to repeated liquefaction in Seabreeze Close, Bexley.

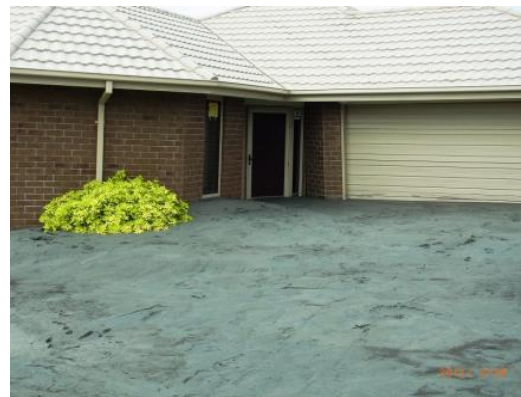
In Bexley, a large number of residential houses/properties suffered severe damage from liquefaction in September 2010 earthquake. After the 2011 earthquake, it was again one of the worst hit areas in terms of liquefaction-induced damage. Figures 15 (a) and (b) show damaged residences after the 2010 and 2011 earthquakes, at Seabreeze Close in Bexley. Massive amount of sands were ejected and deposited around the houses. Differential ground settlement was caused by severe sand boils, resulting in tilting in many houses.

(b) after the 2011 Christchurch Earthquake

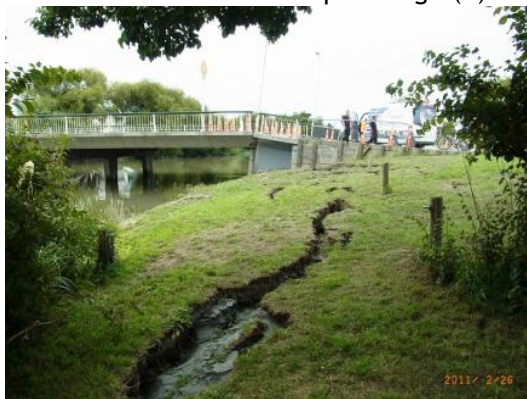
Damages in levees along Avon River were observed everywhere, spanning from inside the CBD to the river mouth. Many bridges crossing the Avon river suffered tilting in their abutments, as a result of lateral spreading and loss of bearing capacity due to liquefaction (Figure 16a). Damage to pipelines was also observed at the connections between bridge and backfill. In most cases, the settlement of the bridge abutment itself is smaller than that of the adjacent soil because the bridge is supported by pile foundations (Figure 16b).

(a) Tilt in abutment due to lateral spreading

Figure 16. Damage to bridge crossing the Avon River (Avondale Road).

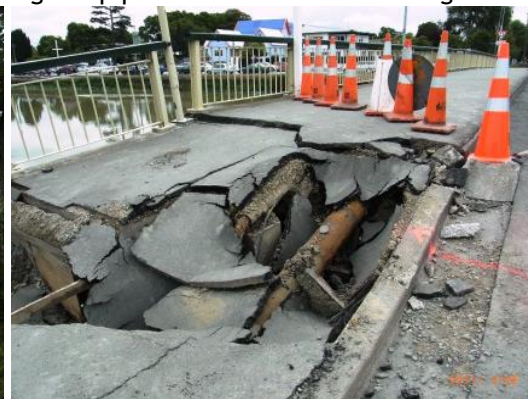
(b) Damage to pipeline installed in the bridge

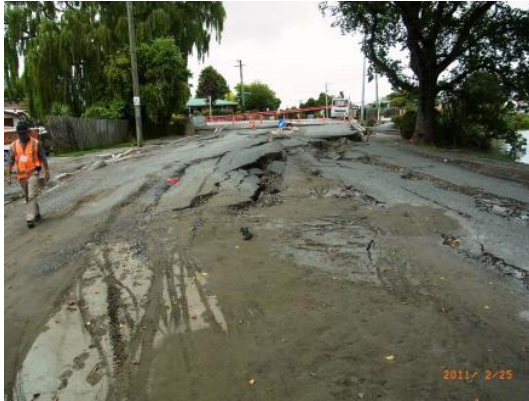
Due to lateral spreading and heaving of the river bed, the cross-sectional area of the Avon River has become smaller than before the earthquake (Figure 17). Therefore, people living in areas adjacent to the river will now have to worry about flooding during the rainy season.

(a) River dike moved laterally toward the river

Figure 17. Ground distortions due to liquefaction along Avon River.

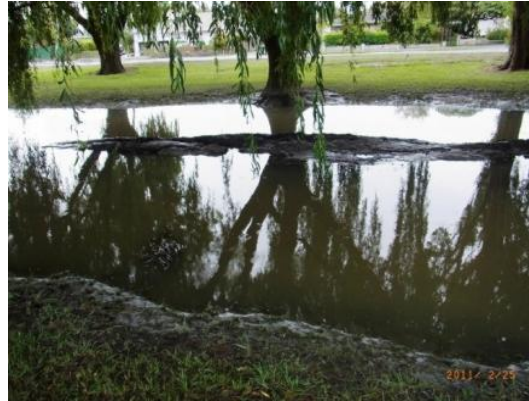
(b) River bed appeared above water surface as lateral spreading pushed up the river bed

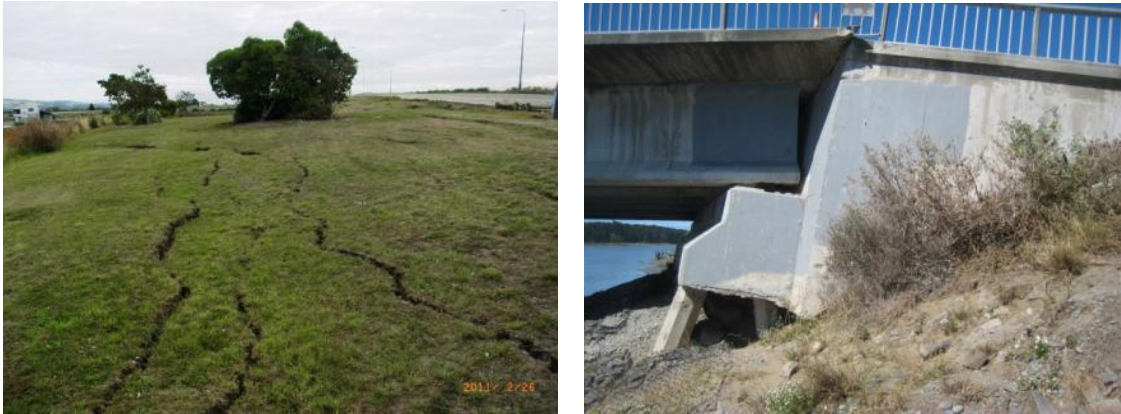
The South Brighton Bridge which crosses the mouth of Avon River was severely affected by liquefaction on ground basement. Observed damages near the bridge were lateral deformation and crown settlement in the bridge approach, large tilt of abutments, tension and compression cracks in pile foundations and failure of pipeline installed underneath bridge girder (Figure 18). The body of the embankment spread laterally, with the top settling down due to liquefaction of the ground underneath and causing large tilt of the abutments. The back side of the abutment settled down, the front side lifted up, and the pile foundation protruded to the ground surface. Tension and compression cracks were observed in the battered pile foundation; however no pile was broken. Thus, it can be considered that the loss of lateral bearing capacity of the pile foundation was induced by liquefaction below the abutment.

(a) Damage to the body of the embankment (b) Tilted abutment and protruding battered pile foundation

Figure 18. Liquefaction-induced damage to South Brighton Bridge.

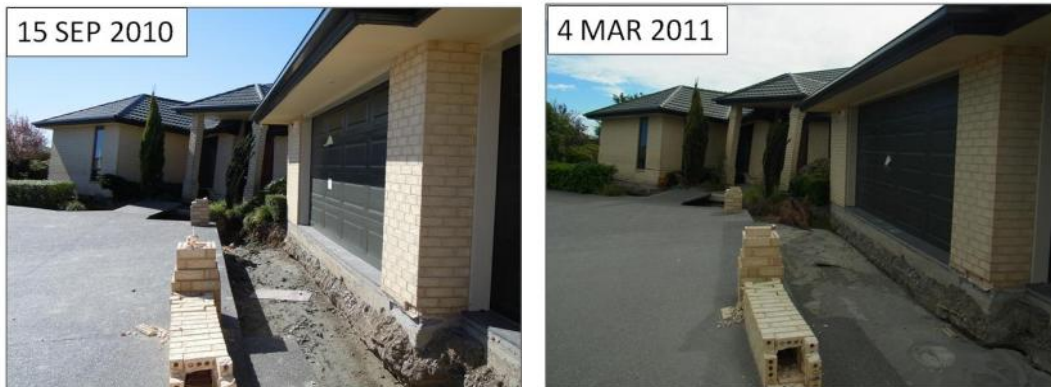
Figure 19 shows two photos of a residential house which suffered severe damage due to lateral spreading in 4 September 2010 earthquake. This residence is standing on a ground that moved toward Waimakariri River, resulting in tilting of the house and formation of 1.6 m wide crack. An investigation was carried out at the residential property shown in the figure on 4 March 2011. Sand boils were observed only in the crack, with the width of crack increasing to 1.9 m. It is unknown, however, whether the increase in crack opening was caused by this earthquake alone. Creep deformation in this area due to the aftershocks of 2010 Darfield earthquake has been reported (Cubrinovski and Orense, 2010). Therefore, there is a possibility that the width of the crack was more than 1.6 m before the February 2011 earthquake and the impact of the recent earthquake to this area was minor. No other remarkable additional damage to residential house/properties was observed in South Kaiapoi.

Figure 19. Minor additional damage to a residential house which underwent foundation failure due to lateral spreading and liquefaction in 2010 Darfield Earthquake. (South Kaiapoi)

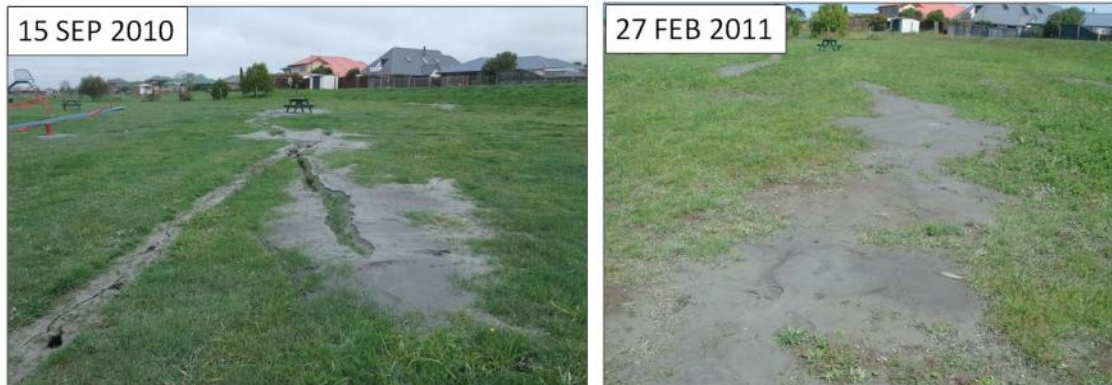
In areas close to the waterways, most of sand boils were observed at existing/repared cracks caused by the 2010 earthquake. Aside from the lower intensity of ground shaking in Kaiapoi, it is possible that the excess pore water pressure generated by the earthquake motion could have been dissipated easily through the existing cracks and therefore, significant ground distortion was not caused by this earthquake (Figure 20 and 21).

Figure 20. Repeated liquefaction at a park adjacent to Courtenay Lake (South Kaiapoi). Liquefied soil was ejected from existing cracks, but ground distortion was minor compared to the ones observed in September 2010 earthquake.

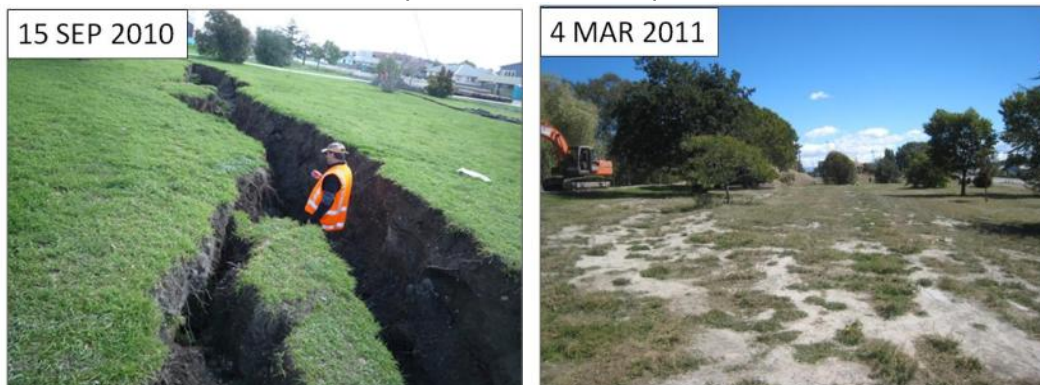
Figure 21. Damage to the stop bank along Kaiapoi river (North Kaiapoi). Sand boils were observed on restored cracks. The damage to the stop bank was minor and lots of small fissures were observed at restored cracks.

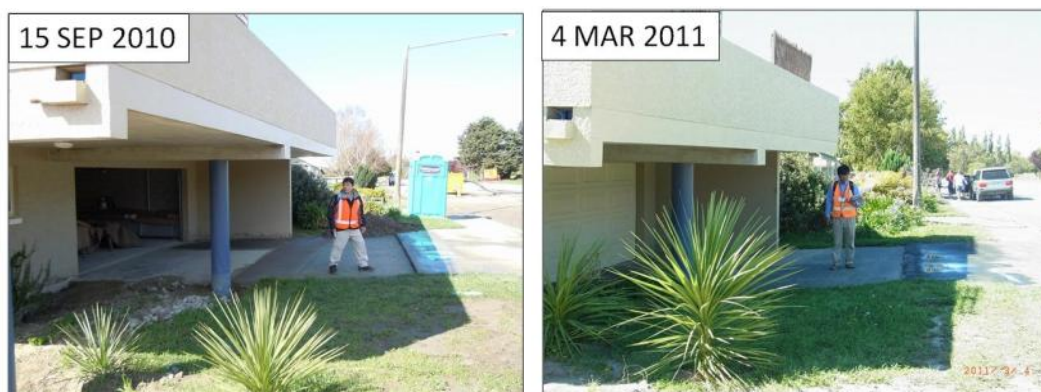
Figure 22 is comparative photos of settlement of a two-story house due to liquefaction. The slope in front of the garage was originally uphill, but it became a downhill after 2010 Darfield earthquake as a result of more than 50 cm of ground subsidence. This house suffered additional 15 cm of subsidence from the 2011 earthquake. The narrowing gap between the roof and the head of a member of the research team can be recognized from the figure. Although the investigators appearing in the photos are actually different, their heights are almost the same.

Figure 22. Further subsidence in two-story house neighboring the stop bank. (North Kaiapoi)

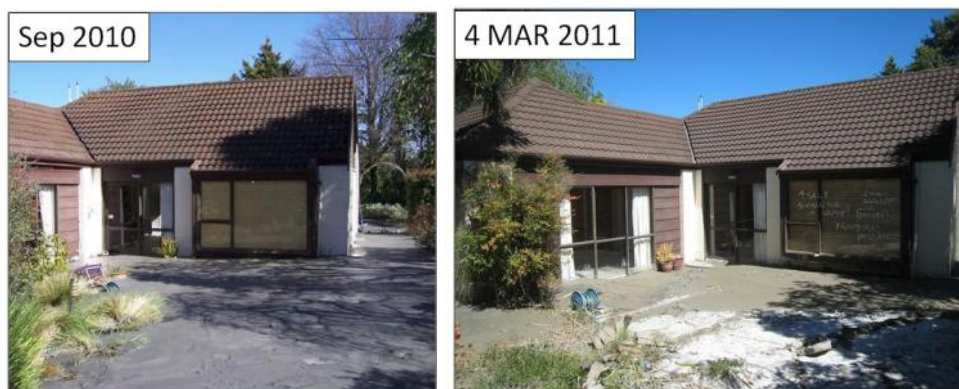
Massive amount of sand ejecta, about 400 mm in thickness, was observed in a property following the September 2010 event (Figure 23). The ejected sand covered a deck in front of the entrance, with thickness of about 10 cm. The observed thickness of sand ejecta after the 2011 earthquake was around 20 cm.

Figure 23. Repeated liquefaction in a residential property in North Kaiapoi.

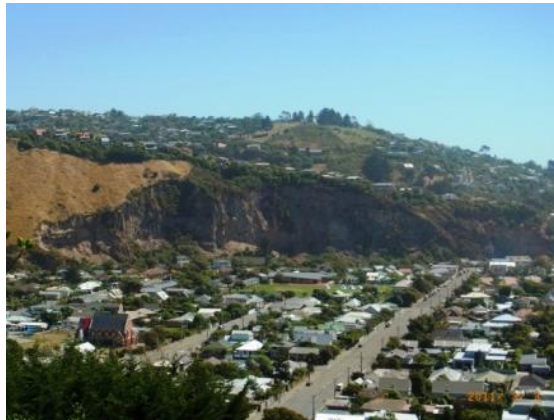
Figure 27 shows a landscape of the affected cliff located at the west side of Wakefield Avenue in Sumner. This cliff is approximately 70 m high and 500 m long in north-south direction. The cliff surface was previously covered with vegetation, but became bare due to earthquake disturbance.

Figure 27. Panoramic view of a disturbed cliff (Sumner).

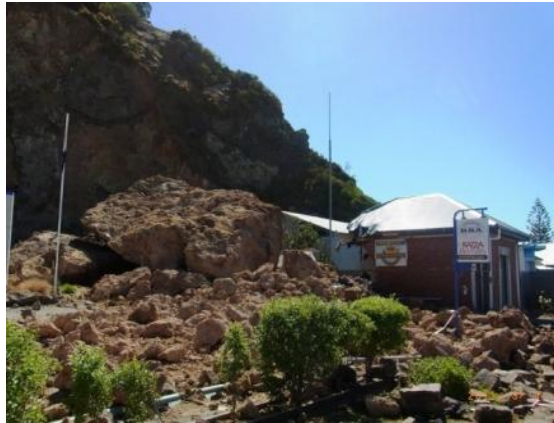
Figure 28 shows a rock fall near a building. The fallen rock is about 4.8 m wide, 6.6 m high and 15.8 m long. Numerous rock falls occurred in other hilly areas adjacent to the epicenter and residential houses and traffic were severely affected.

Figure 28. Huge rock fall adjacent to a building (Sumner).
