# Analysis of Liquefaction-Induced Lateral Spreading Data from the 2010 Darfield and 2011 Christchurch Earthquakes

K. Robinson, B. A. Bradley, & M. Cubrinovski

**2012 NZSEE  
Conference**

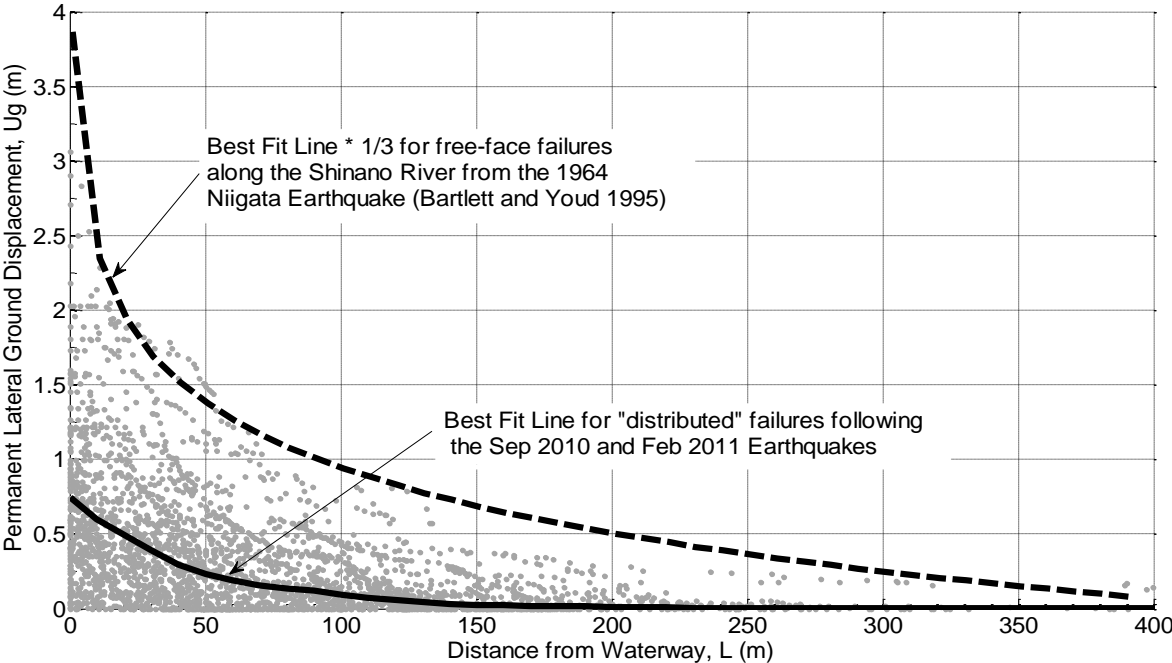
The best-fit line based on data from the 1964 Niigata Earthquake (Bartlett & Youd, 1995) was multiplied by a factor of 1/3 and plotted on Figure 1 as the dotted line to show the shape or failure pattern from that event. As can be seen in Figure 1, the “distributed” failure data from the Christchurch events follows a similar distribution (though of smaller magnitude) to that of the Niigata earthquake. The mean or best-fit line from the Canterbury data is presented in bold and shows that, on average, relatively small (< 10 cm) displacements occurred at distances greater than 100 m.

Figure 1. Observed permanent lateral displacement ( $U_g$ ) with distance from the waterway ( $L$ ) for all distributed-type failures in the 4 Sept 2010 Darfield and 22 Feb 2011 Christchurch earthquakes.

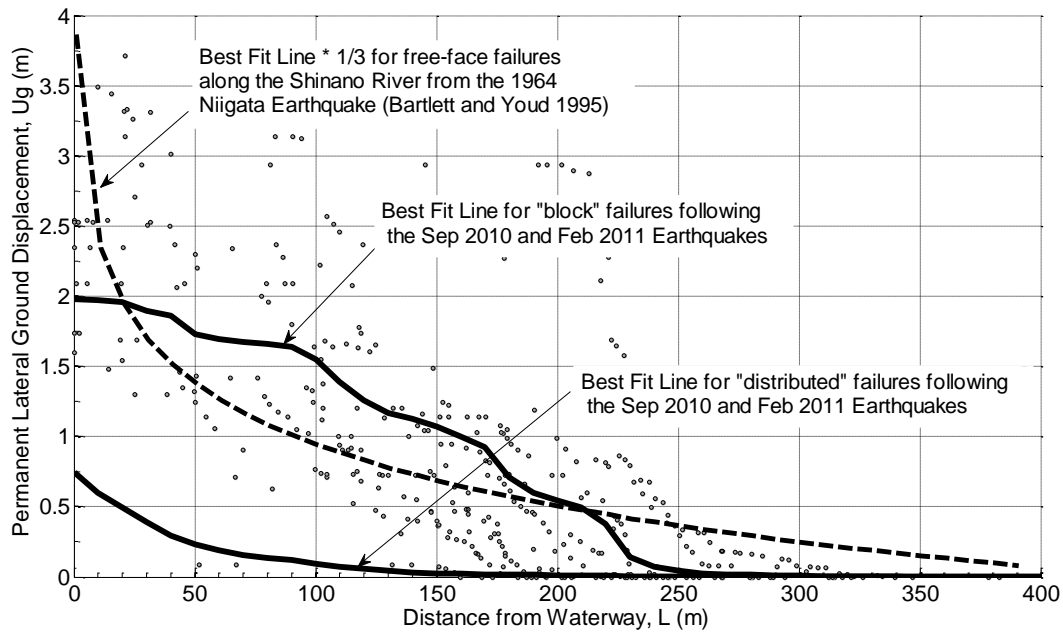
“Block” type failures found in the areas of South Kaiapoi and Burwood are plotted in Figure 2 and show a significantly different trend to the distributed failures in Figure 1. Again, the best-fit line from the 1964 Niigata data (multiplied by 1/3) is presented as the dotted line and emphasizes the differences in the two types of failure patterns, as seen in the different shapes of the trend lines. The Canterbury data best-fit line shows, on average, relatively large displacements of about a half meter still occurring at distances of 200 m from the river bank. The general pattern of these failures appears to follow a ‘step-like’ pattern, rather than the typical exponential decrease seen in previous events other locations surveyed.

Figure 2. Observed permanent lateral displacement ( $U_g$ ) with distance from the waterway ( $L$ ) for all distributed-type failures in the 4 Sept 2010 Darfield and 22 Feb 2011 Christchurch earthquakes.

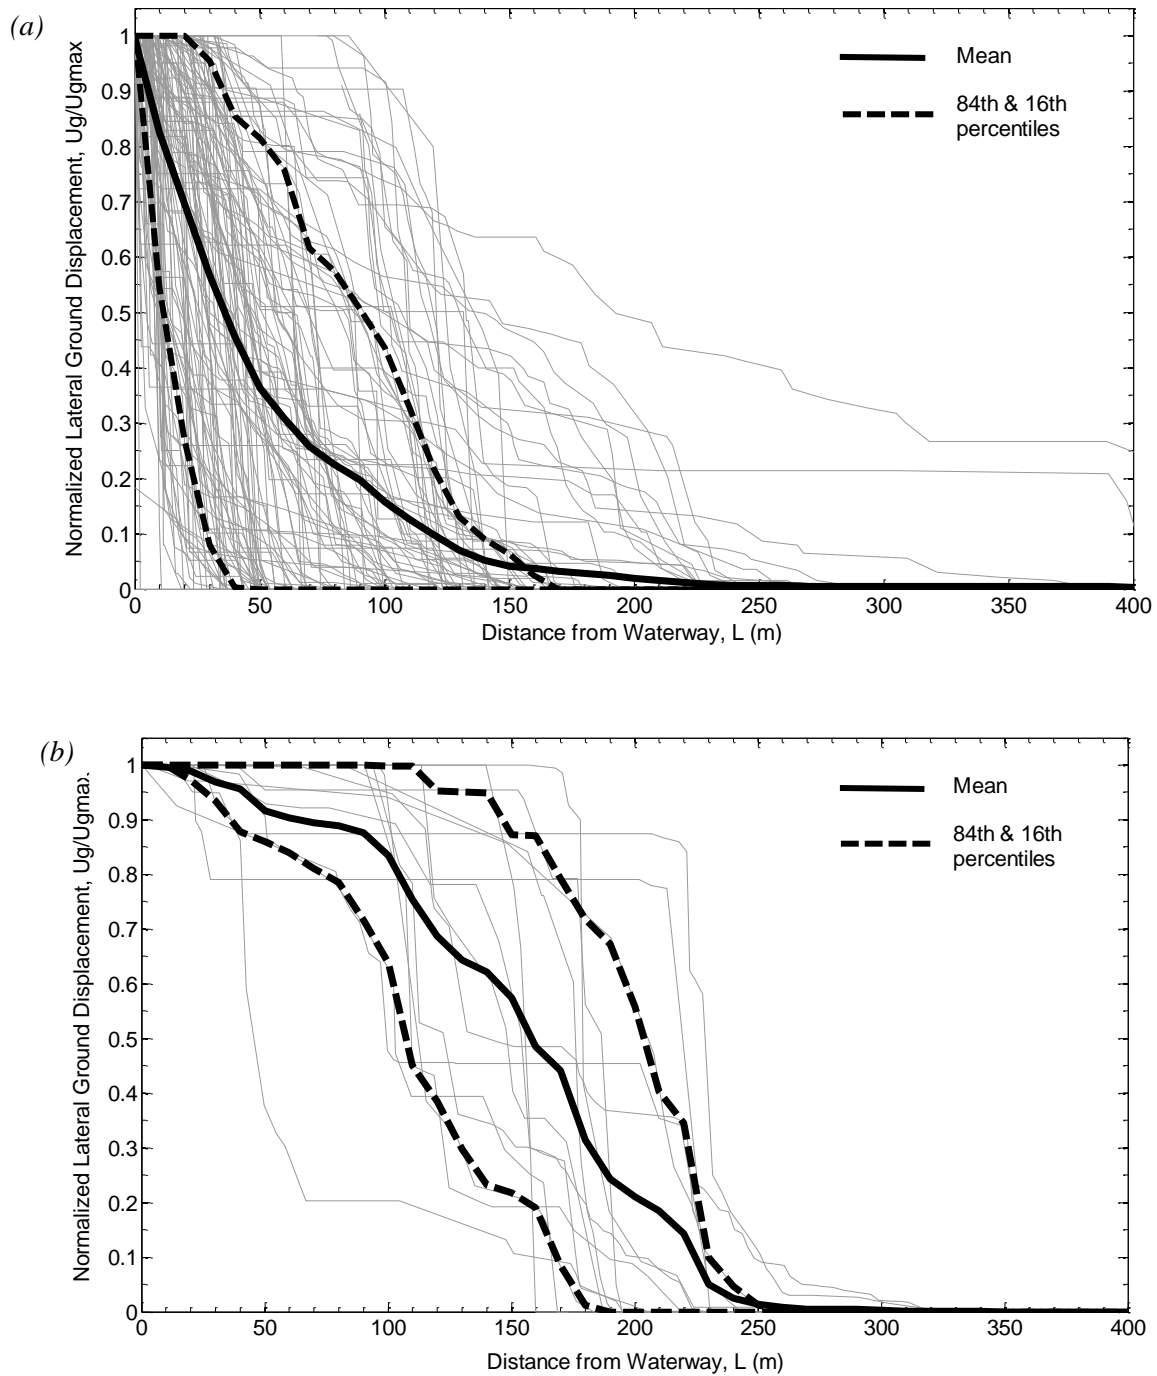
In order to show a more detailed representation of the lateral spreading distribution, lateral spreading data from the September 2010 and February 2011 events was normalized by the free-face displacement, and is shown in Figure 3(a) and (b) for each failure type. The mean is shown in bold and the 84<sup>th</sup> and 16<sup>th</sup> percentiles (corresponding to  $\pm$  one standard deviation for a normal distribution) are shown as dotted lines. For the distributed failures, the mean shows that on average, half of the maximum displacement occurred within about 50 m of the waterway, whereas the block failures show on average 50% of the maximum displacement occurred at about 150 m from the waterway.

It is inferred that the observed block failures are likely associated with a circular failure wedge as a result of a combination of very loose soil conditions and historic geologic conditions in the area. Wotherspoon et al. (2012), for example, indicate a branch of the Waimakariri River once flowed through the area of block failure in South Kaiapoi. Preliminary assessment of CPT data in this area indicated the soils to be relatively uniform in the upper 4 to 6 meters with CPT tip resistances,  $q_c$ , generally less than 6 MPa (Tonkin & Taylor Limited). This low-resistance layer, highly susceptible to liquefaction, appeared to extend more than 150 m inland from Courtenay Stream. Furthermore, a compilation of the 1856 “Black Maps” of Christchurch (Scott & Christchurch Drainage, 1963) indicates that the area south of Bottle Lake in Burwood (where the block failure was observed) previously consisted of “wet swamp.” CPT data from explorations located between about 150 and 200 m from Bottle Lake showed a generally consistent liquefiable layer in the upper 4-6 m with  $q_c$ -values of less than 5-6 MPa (Tonkin & Taylor Limited, 2011). Further research is however necessary to confirm the above anecdotal inferences.

Figure 3: Normalized lateral displacement versus distance from the waterway: (a) distributed failures; and (b) block failures

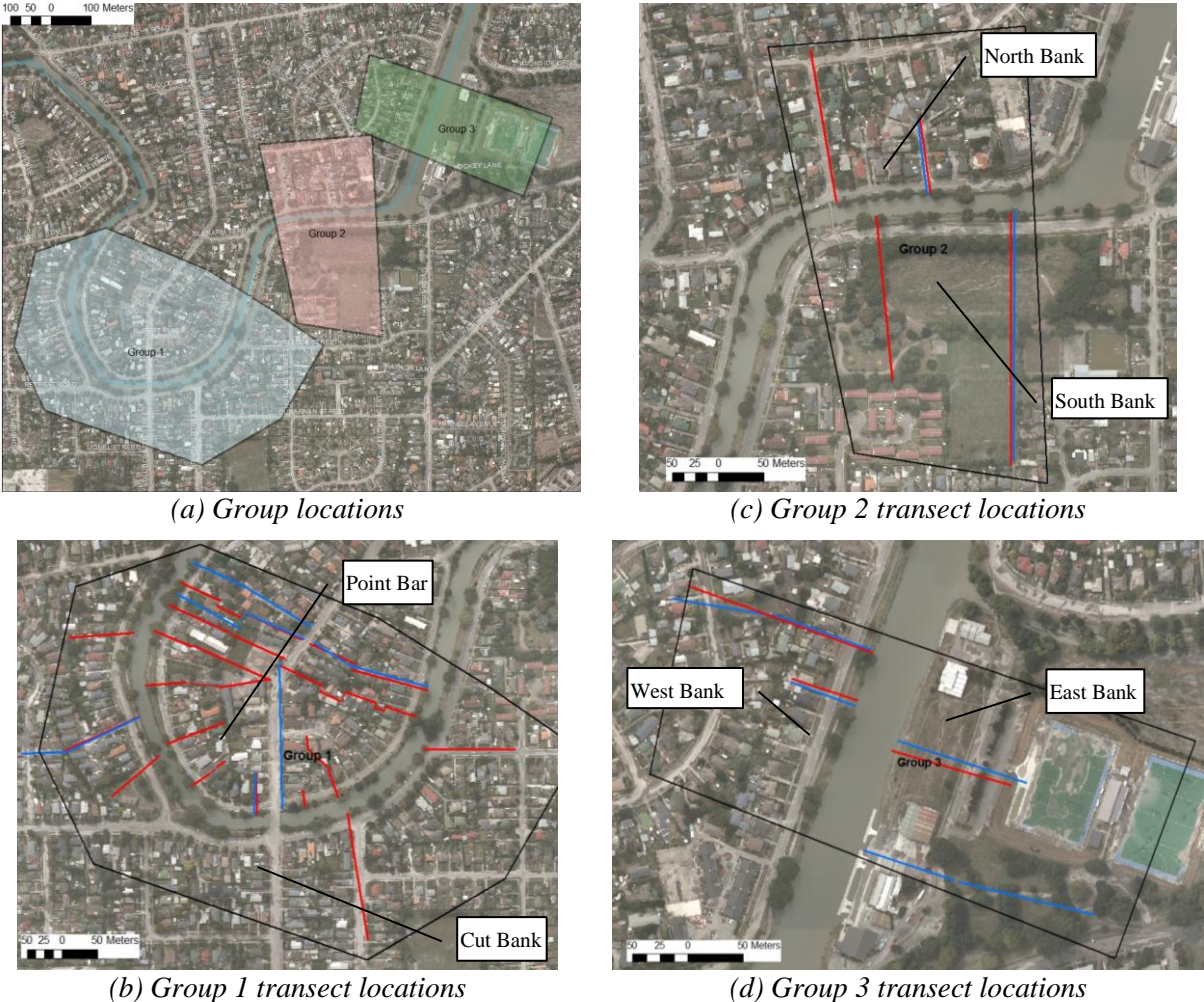
An interesting geographic pattern along the Avon River is the meandering loop in Dallington/Avonside which creates a point bar and cut bank features, as shown in Figure 4.

Downstream of the loop, the river bends into a near 90-degree angle to create two relatively straight segments. An analysis was performed to compare the different spreading patterns observed along the various geometrically different areas of the river by breaking the region into three groups, as shown in Figure 4. Within each group, the maximum displacements from selected transects located on one side of the bank were compared with those on the opposite bank.

Figure 4. Location of lateral spreading transects within selected area of Dallington, Avonside, and Wainoni (red lines correspond to 2010 Darfield data, blue lines correspond to 2011 Christchurch data)

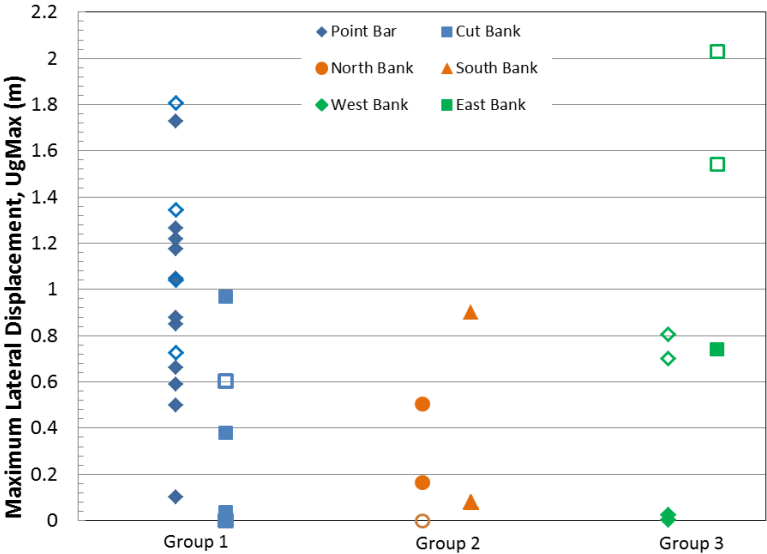
The maximum lateral displacements ( $U_{g,max}$ ) computed from transects within the point bar area and cut bank area are summarized in Figure 5 (Group 1). The figure shows the majority of displacements are much higher in the point bar area than along the cut bank. The point bar data indicates a maximum displacement of about 1.8 m and an average of approximately 1.0 m; while the cut bank data shows a maximum displacement of about 1 m and an average of only 0.3 m. The differences in the observed displacements within such a relatively small geographic area (where ground accelerations and general topography are relatively constant) may be attributed to the difference in soil conditions as a result of the unusual river geometry of the meandering loop. From a geologic perspective, one might assume the river to “cut out” the soils along the cut bank, exposing stiffer materials, and deposit loose materials on the inner bank (point bar) where the velocity of the river would be lower. In order to provide an independent assessment of the above arguments based on observed lateral spreading displacements, a preliminary review of CPT data (Tonkin & Taylor Limited, 2011) was performed to gain a better understanding of the geotechnical conditions at the locations of interest. The CPT data revealed a complex pattern of soil conditions along the bank. In general, however there appears to be a greater total thickness of loose ( $q_c < \sim 10$  MPa) liquefiable material within the upper 6 meters associated with CPTs located along the point bar.

Looking at the maximum displacements from Group 2 in Figure 5c, there is an obvious variability in the results with respect to the north and south banks, and even at different locations along a given bank. Given the straight-away section of the river in this area, one might anticipate the results from these transects to be more similar. The large variability in observed transect data is however consistent with the complex soil pattern with highly variable conditions ascertained from CPT data (Tonkin & Taylor Limited, 2011).

The transects in Group 3, shown in Figure 5d, indicate significantly larger displacements occurring on the east bank. Although this section appears to have similar river geometry to that of Group 2 and therefore one might assume to see the same variability in the data, Group 3 shows an obvious bias to the east bank displacements. Review of a historical map provided in Scott & Christchurch Drainage (1963) and compiled from the 1856 “Black Maps”, indicates the original Avon River actually flowed east of the present-day bend along the channel of the current stream surrounding Porritt Park. CPT data (Tonkin & Taylor Limited) in this area indicate a drastic difference in soil conditions on either side of the bank. Data from the west bank indicates relatively dense material ( $q_c > 20\text{MPa}$ ) occurring at a depth of about 3.5 m; whereas, a CPT located near the east bank shows loose material ( $q_c < 10\text{MPa}$ ) extending to a depth of about 6 m.

Figure 5. Comparison of lateral spreading measurements within specific areas along the Avon River (solid symbols correspond to 2010 Darfield data, hollow symbols correspond to 2011 Christchurch data)
