Geotechnical Aspects of the M_w 6.2 2011 Christchurch, New Zealand Earthquake

ABSTRACT

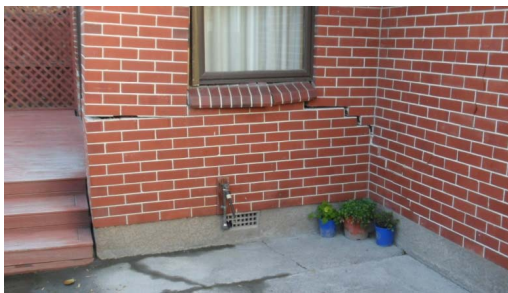
In total, nearly 15,000 residential houses and properties were severely damaged due to liquefaction and lateral spreading, with more than half of these damaged beyond economical repair. As shown in Figure 2a, the severity of the liquefaction led to large settlements of many houses including differential settlements that caused foundation and structural damage. Lateral spreading also damaged many residences, as shown in Figure 2b for example. (Note that the houses in Figure 2 were initially damaged during the Darfield earthquake and further damaged during the Christchurch earthquake, as were many residences throughout the region.). Lateral spreading ranged from a few tens of centimeters, up to 2 m at river banks and extended as far as 200-300 m inland from waterways.

Figure 2. Examples of liquefaction damage to houses in: (a) Hoon Hay with differential settlement, and (b) south Kaiapoi with lateral spreading.
