The seismic impact on chemistry teaching and research at University of Canterbury*

Bryce Williamson and Richard Hartshorn

Department of Chemistry, University of Canterbury, Christchurch, New Zealand

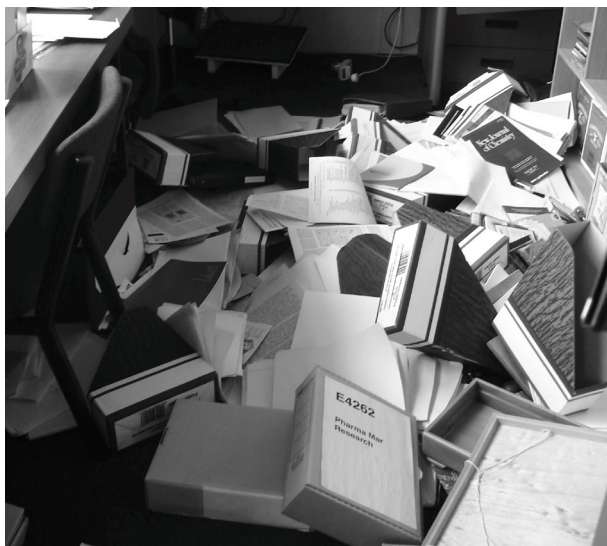
Fig. 2: Superficial mess in an upper-floor office.

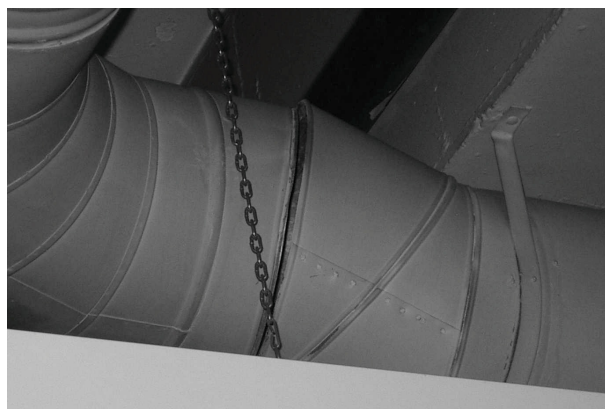
Fig. 3: Broken fume-hood ducting

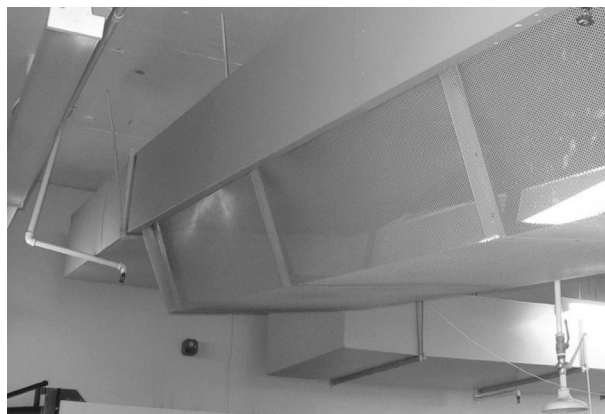
Fig. 4: Ceiling mounted services broke free and finished up resting on sprinkler pipe-work.

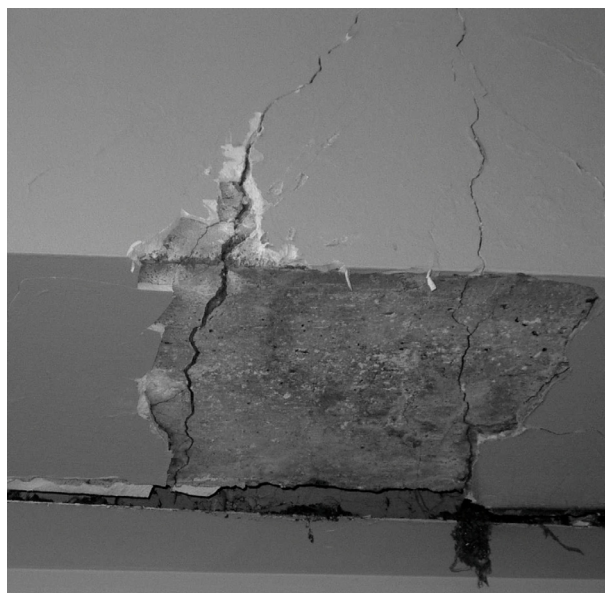
Fig. 5: Cracked beam on Level 8 of the Rutherford Building.

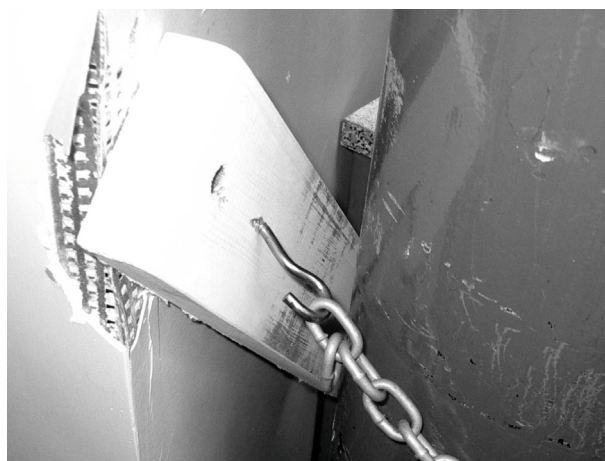
At the University of Canterbury, buildings were evacuated without incident and the campus closed once again. Within the Department of Chemistry, the damage was again worse higher in the building, but the improved housekeeping limited problems with glassware and chemicals. A more significant issue was that the building and its fixtures had been hit hard. Fume-hood ducting was damaged (Fig. 3) and, in some laboratories, other fixtures broke away from the ceiling and ended up resting on the sprinkler pipes (Fig. 4). The placement of sprinkler pipes may have been fortuitous, but is something for which the workers in those labs might be grateful. Significant cracking was caused in some beams high in the building (Fig. 5), and the effect on cylinder restraints (Fig. 6) is both remarkable and sobering. The scratches made by the chain on the cylinder show the intensity of the vertical motion, and the effect on the attachment of the hook to the wall should

cause others to reassess the nature of their cylinder restraints and the integrity of the structures to which the hooks are attached. Once again, our instruments suffered. One NMR spectrometer did not survive the earthquake, while the X-ray diffractometer and a replacement mass spectrometer were damaged.

Fig. 6: Damage to cylinder mounting. This cylinder did not topple, but in other cases hooks were snapped off or straightened and the cylinders fell to the floor.

1. For items (such as gas cylinders) secured by chains, closed-loop chain-hooks should be used with attachment by way of karabiner-like shackles. Open-loop hooks permit the risk that the chain will jump free during shaking. Adding a second chain at a lower height should be considered, and the strength of the structures to which the hooks are attached should be carefully assessed.

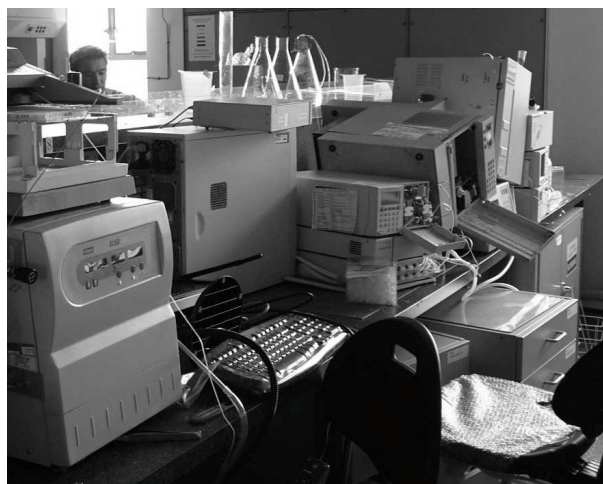
Fig. 7: Unsecured stacks of bench-top equipment are prone to toppling.

3. Low lips should be considered for the edges of research-laboratory benches to limit the possibility of items rolling off the bench on to the floor. Bench-top instruments (chromatographs, ovens, spectrometers etc.) should be fixed to the bench and stacks of such items should be strapped down (Fig. 7).

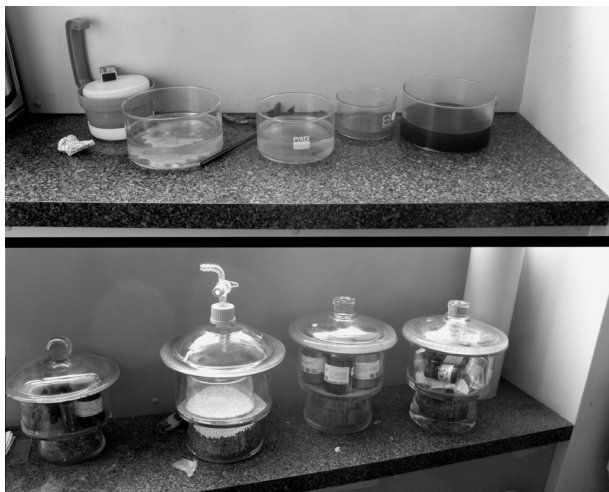
Fig. 8: Sub-optimal storage of silicone-oil baths (top) and desiccators on unguarded sills. Fortunately, these items had not fallen, but silicone oil had splashed down the wall on to the floor.

2. Guards (for example Perspex or wire) should be affixed to any shelves or sills where loose items (sample vials, chemical jars, desiccators etc.) are likely to be stored. This includes the tops of cabinets, refrigerators, ovens and any other places that are likely to provide tempting places for storage.

4. Spilt silicone oil is very problematic (Fig. 8, Fig. 9). Where appropriate, alternatives to oil-bath heating should be used. If oil-bath heaters are required, splash-proof baths should be employed (we need a design) and the oil should be returned to a sealed container when not in use.

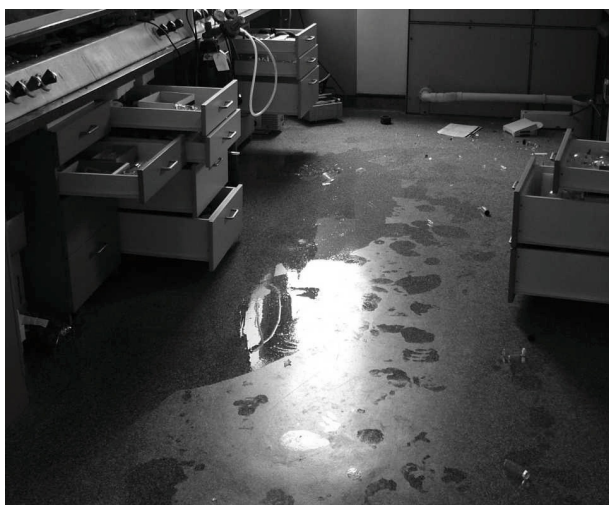
Fig. 9: Spilt silicone oil presented a major slip hazard and was very difficult to clean up.

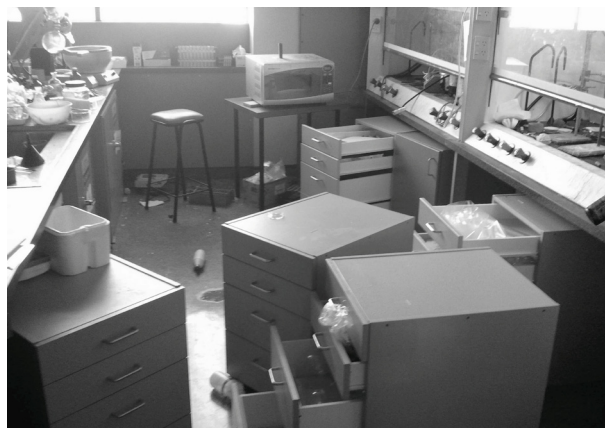
Fig. 10: Wheeled storage cabinets in research laboratories had migrated by as much as several metres. All of the cabinets in this photo had originally been under fumehoods or benches

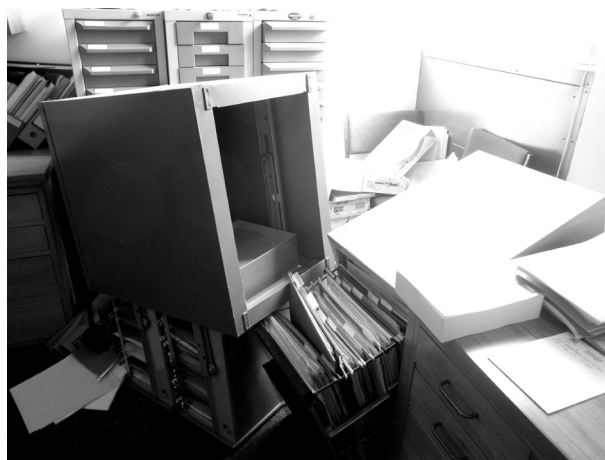
Fig. 11: A consequence of stacked filing cabinets. Topped cabinets would have presented a significant threat to personnel if offices had been occupied during the September earthquake.

7. Half-sized filing cabinets should not be stacked on top of each other (Fig. 11). Filing-cabinet drawers should be closed with the key in the locked position to prevent drawers from shaking open and overbalancing the cabinet. Cabinets and bookcases should be fixed to walls.
