Residual strength assessment and destructive testing of decommissioned concrete bridge beams with corroded pretensioned reinforcement

Rhys A. Rogers, Liam Wotherspoon, Allan Scott, and Jason M. Ingham

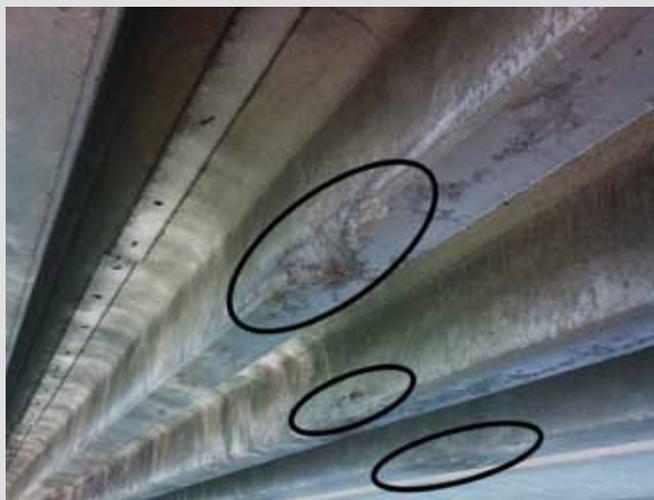
Figure 3 shows evidence of longitudinal cracking and rust staining in three beams from the same span and similar cracking in one beam. The maximum measured width for this type of crack was 5 mm (0.20 in.), and the cracking was consistently at the level of the bottom layer of pretensioned reinforcement.

Corrosion-induced cracking in three beams from one span

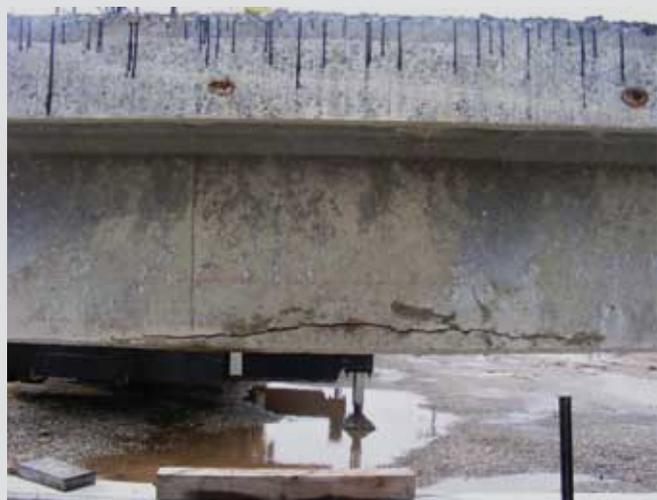
Close-up of corrosion crack in one beam

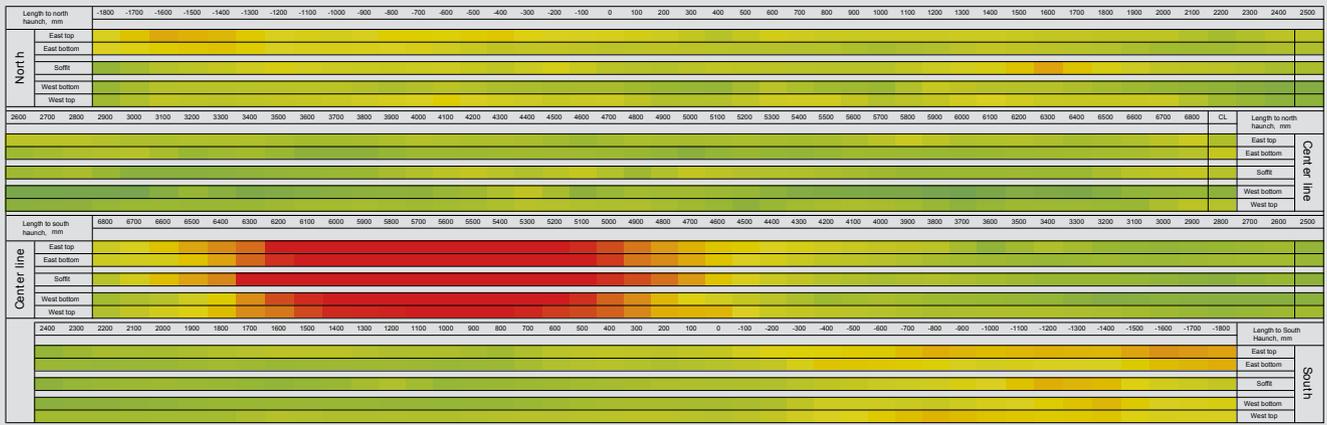
Figure 4. Electro-potential mapping results from beam 2C. Red regions indicate a high likelihood of corrosion. Note: 1 mm = 0.0394 in.

Figure 4 gives an example of an electro potential map of the web of a beam. The beam has been cut into four sections so that the entire length can be shown in one figure. Each column represents five readings at one section of the beam, two readings from each side of the web, and one from the soffit. Red cells indicate areas with a high likelihood of corrosion, yellow and orange indicate some likelihood, and green cells indicate low likelihood.

In this case there is an area of active corrosion just south of the centerline, and some likelihood of corrosion at the south end of the beam. In the destructive test, beam 2C displayed flexural failure in the red EPM region, and breakout of the concrete after the test confirmed that all four of the bottom pretensioned strands were severely corroded and unable to carry load. While the electro potential maps had a strong correlation with sites of active corrosion, in this study they did not provide significantly more insight than a thorough nondestructive visual inspection would have.

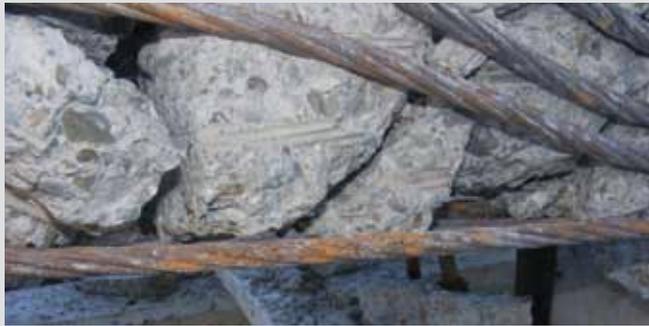
Broken-out strands with uniform corrosion

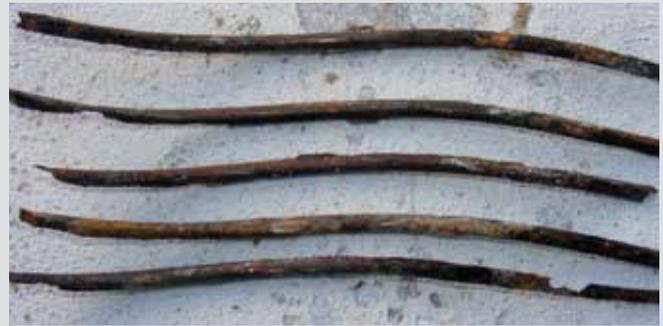
Individual wires with pitting damage

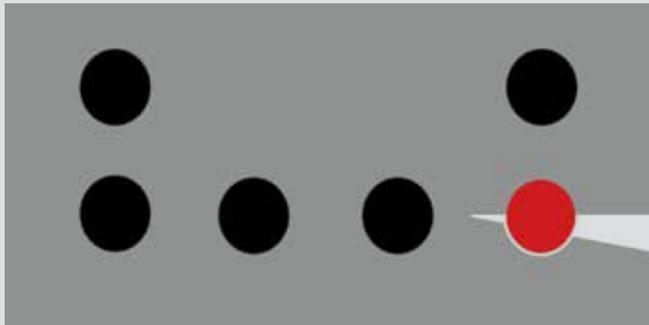
After longitudinal cracking of the concrete has occurred, seawater and oxygen are more readily available to the corroding steel and the process accelerates. The cracking usually causes debonding of the lower part of the strand because the concrete is less stiff in the direction of the soffit. This debonding forms a void below the strand where seawater collects (**Fig. 7**). The presence of seawater around the bottom of the strand causes the strand to corrode uniformly upward toward the top of the strand. This type of corrosion was widespread in cracked regions of the corroded test beams (right part of **Fig. 7**). Because each strand

Corrosion-induced crack allowing water and air to bottom surface of corner strand

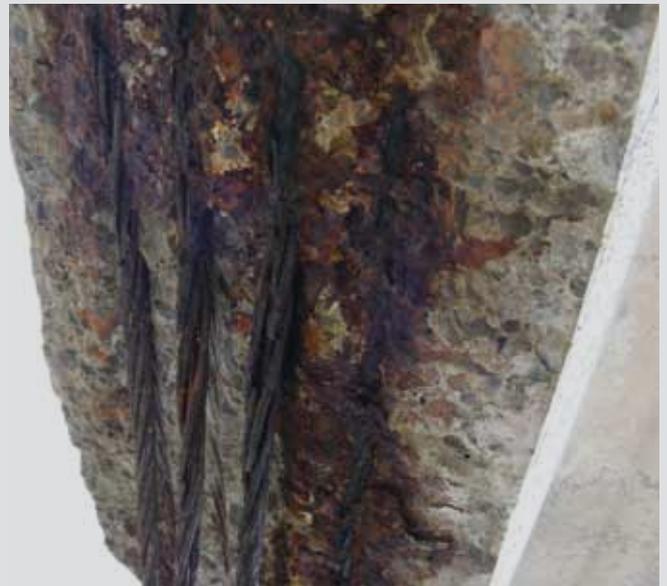
Evidence of upward strand corrosion

comprised six helical wires wrapped around a seventh straight central wire, all six of the helical wires rotate past the bottom of the strand in a length of less than 200 mm (7.87 in.). Combined with the compromised bond in corroded and cracked regions, it is not overly conservative to assume that 85% of the capacity of a strand is lost when corrosion has progressed one-third of the height of the strand, which correlates to a loss of approximately 30% of the strand's cross-sectional area. When corrosion has progressed to two-thirds of the height of the strand, 100% of the capacity is lost.

debonding occurs. For this reason, any strand that is determined to be intersected by a longitudinal crack should be assumed to be ineffective and should be neglected in the calculation of residual strength of the beam. This approach is only slightly conservative and is more accurate than estimating the percentage of cross section lost and assuming that the remaining cross section is effective.

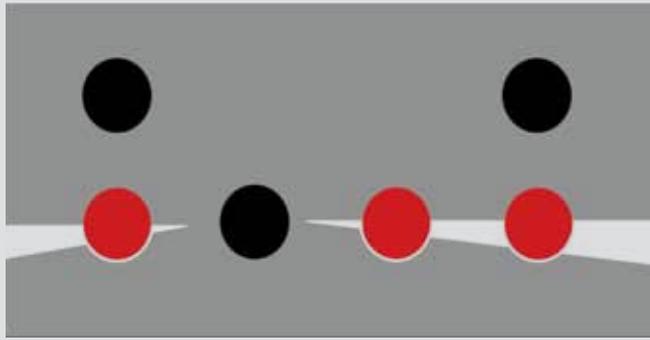
As corrosion in the corner strand progresses from the situation shown in Fig. 7 (bottom left), the crack widens and propagates farther horizontally across the beam soffit. In the beams with 12 pretensioned strands, 4 strands were present in the bottom layer. In these beams the crack intersected the adjacent strand in the bottom layer where the debonding and upward corrosion process began again. Because both sides of each beam's web are subjected to similar exposure environments and concrete conditions, many of the beams had this process occurring concurrently on both sides of the web. This process repeats until the crack reaches the entire width of the web and the soffit concrete is completely delaminated. **Figure 8** shows this sequence diagrammatically, and **Fig. 9** gives an example of a beam after the delaminated soffit had fallen away during the destructive test, with evidence of strand corrosion visible on the spalled concrete section.

Progression of cracking from both sides of the web

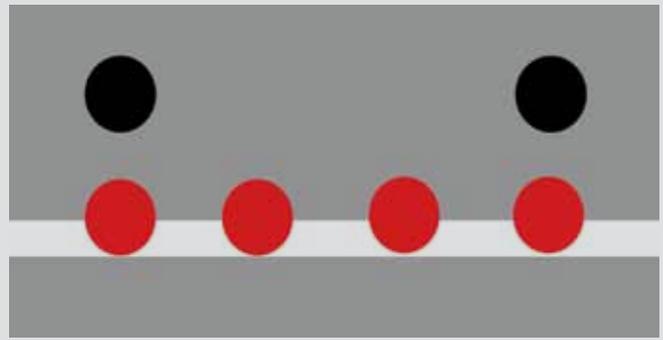
Delamination of soffit

In the beams with 10 pretensioned strands there were only two strands on the edges of the bottom layer, so the crack did not intersect another strand but instead propagated downward to the soffit and caused the corner concrete to spall. This exposed the corroding strand to the atmosphere, allowing chloride ingress to occur on the freshly exposed concrete surface and reducing the time to initiation for the next strand.

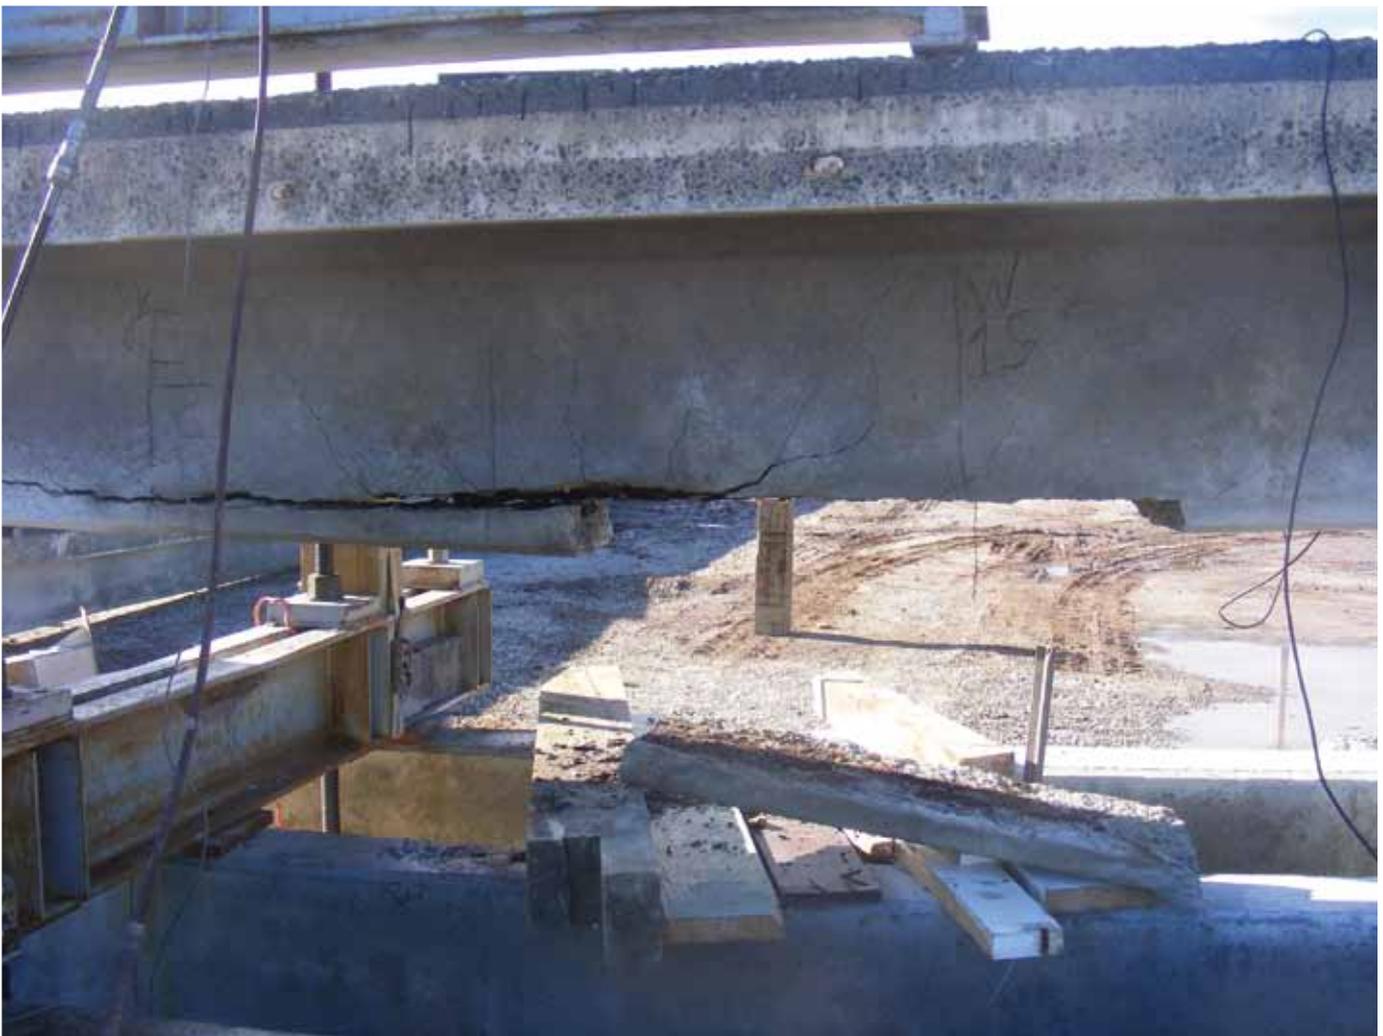
Figure 9. Evidence of soffit delamination during a destructive test.

By the time the crack has propagated to intersect the fourth strand, only a small amount of sound concrete remains, so it is likely that delamination of the soffit would have occurred due to tensile forces caused by opening of the crack. For this reason, if a longitudinal crack is only visible on one side of the web it is fair to assume that at least one strand on the opposite side is intact.

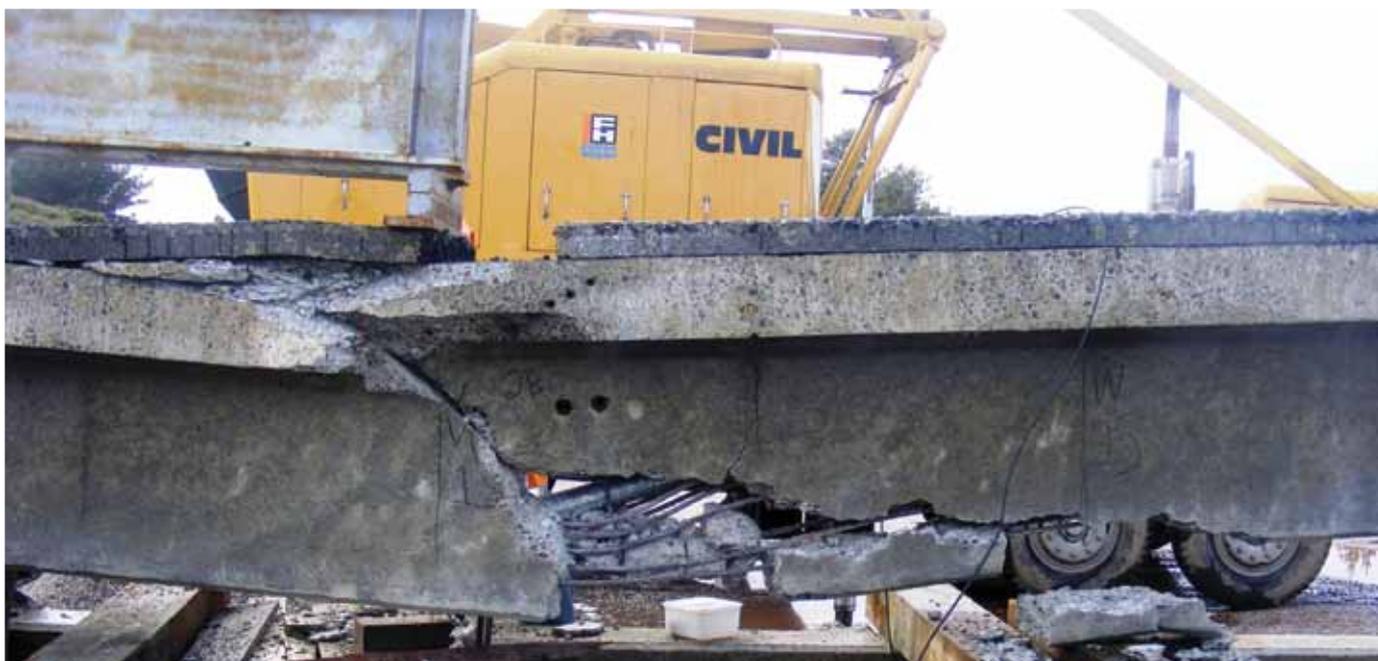
Figure 12. Typical good-condition failure crack.

Figure 12 gives an example of the typical failure mode for the good condition beams. Concrete crushing was evident under the loading point, and the longitudinal reinforcement is intact and visible where the cracked concrete in the tension zone fell away during failure of the beam. The acoustic emissions system detected no strand breakage during the good condition tests, and this result was confirmed by post-test breakout and inspection around the failure plane.

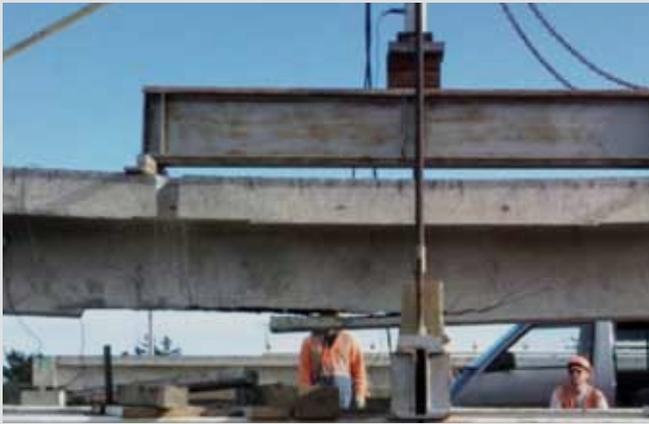
The curvature of deflected beams with corrosion damage was typically concentrated around the damaged area. Flexural cracking would extend up and outward from the original corrosion crack, and the soffit would spall off at a small deflection. The acoustic emission system did not detect any strand failures outside of the corroded area that ultimately failed. **Figure 13** shows a typical cracking pattern for a corroded beam (top left and top right). Usually failure would occur at a loading point, with the failure crack extending from the corroded area to meet the loading point (Fig. 13 bottom left and bottom right). If the corroded area was too far away from the loading point, the strands would fail at the corroded section and then pull through to a separate failure crack closer to the loading point (Fig. 13 bottom right).

Delamination of soffit in corroded region

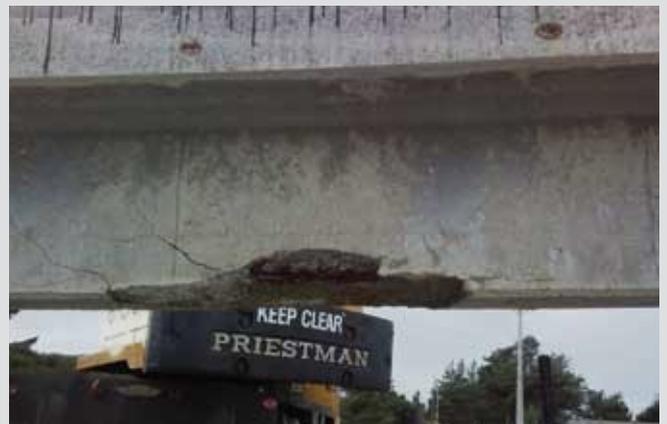
Typical cracking pattern emanating from corroded area

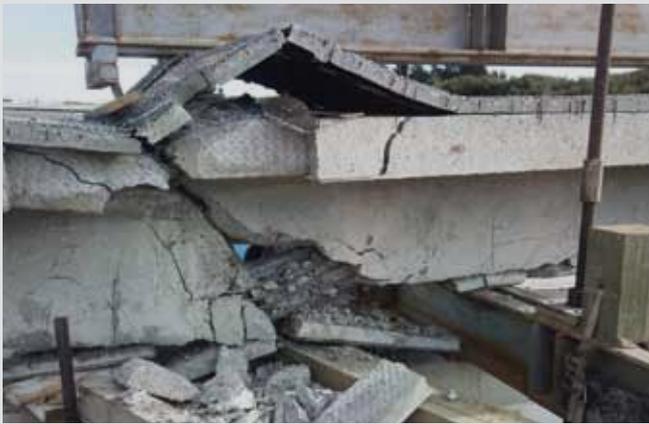
Failure crack location emanating from corroded area to loading point

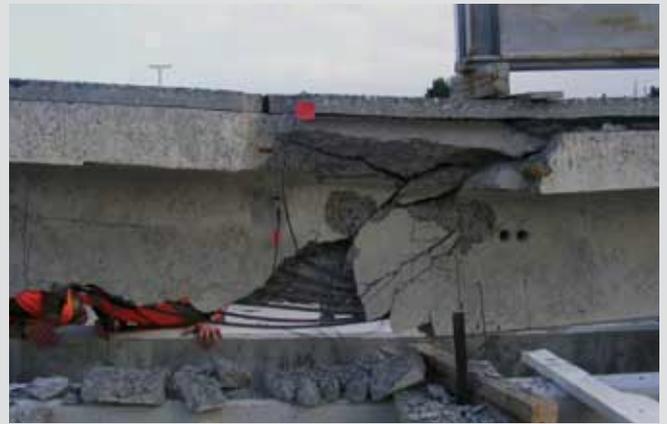
Corroded strands failed and pulled through to separate failure crack at loading point
