Power Quality Observations at a Light Industrial Site

Hamish Laird, *Student Member, IEEE*, Simon Round, *Member, IEEE*, Richard Duke, *Member, IEEE*
Alister Gardiner.

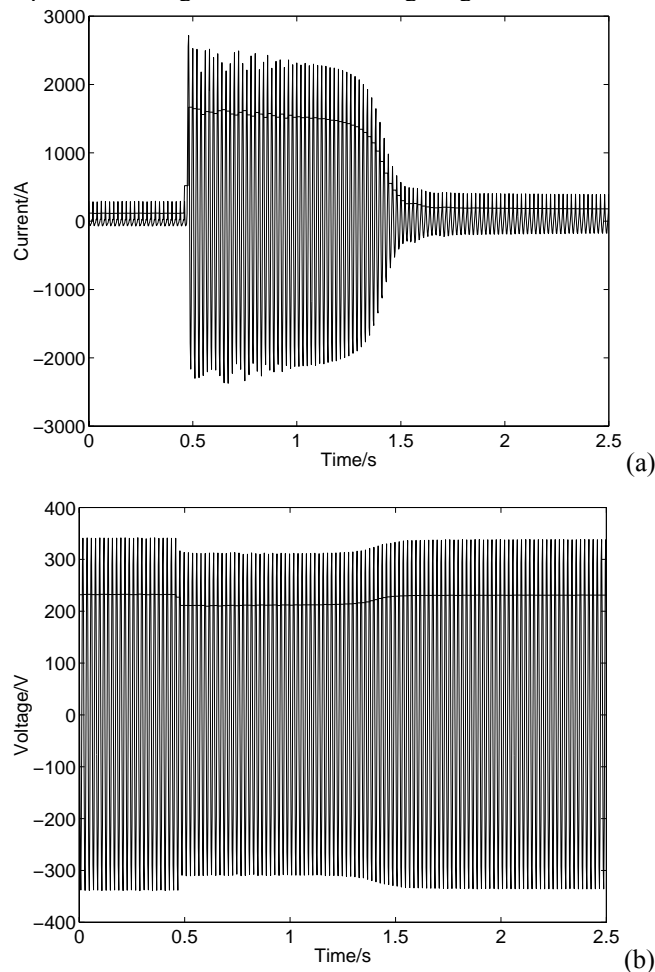
water resistor starters to lower the start current. This large start current, Figure 2(a), causes a 10% drop in the supply voltage, (as shown in Figure 2(b)) which the customer has reported noticing as a flicker in the lighting.

Figure 2. Induction Motor Start Transient (a) Motor Current (b) Supply Voltage (Instantaneous and RMS values)

The induction motor start transient typically causes a 10% drop in the site voltage. A solid-state or star-delta starter could lower the start current and so lower the voltage drop. The cost involved may not be justifiable as the motor start induced sag caused no reported problems other than the customer's concern about the "flick" in the lights. Another option to prevent the voltage drop is to control the motor run up with an adjustable speed drive. This again is an expensive option and is probably not worth pursuing. A more reasonable approach is to ensure the customer is aware of the possible consequences of the voltage dip, such as nuisance tripping and PLC malfunction. This awareness will ensure that any problems that the dips do cause will be noted.

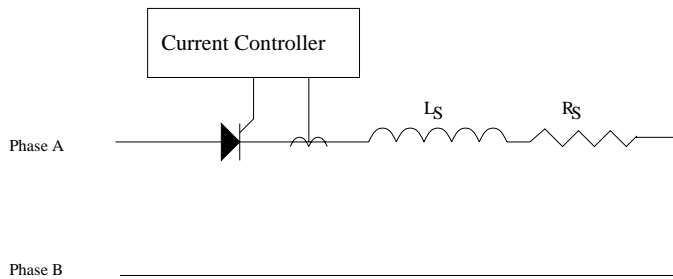
Figure 3. Induction Motor Heating Unit Circuit Diagram

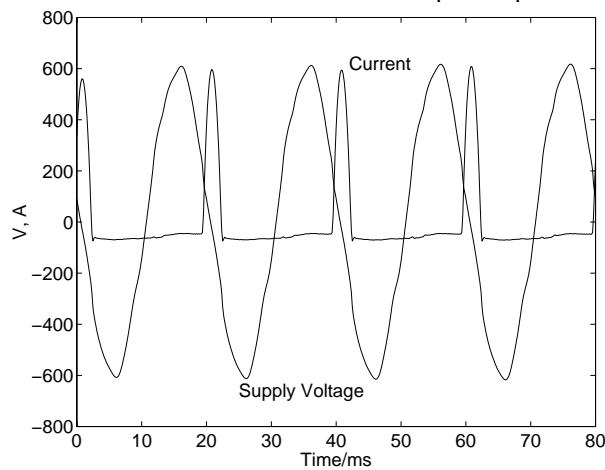
The units are half-wave controlled rectifiers having only one thyristor and they produce DC, odd and even harmonics in the AC current. The lack of half-wave symmetry indicates that there are even harmonics and a DC component present.

Figure 4. Induction Motor Heating Unit Current and System Line to Line Voltage

The induction motor heater unit current harmonics are large and the presence of even harmonics is unusual. The apparent lack of problems that the DC component of the heater current causes is perhaps fortuitous as the resulting transformer MMF offset could cause transformer damage through saturation. No such damage has occurred and the transformer operating temperature during the site survey was 38 C. The fact that the heater units operate only when the site load is low means any adverse transformer heating from saturation is offset by reduced heating due to the low load. Configuring the rectifiers to produce a half wave symmetric current waveform would eliminate the DC current produced by the induction motor heaters. One way to do this is to reverse the phase connection of one of the induction motor heaters. The two heater units would then conduct in opposite half cycles and together would produce a half-wave symmetric waveform. This would decrease the peak current and remove the even harmonic currents. The current waveform would however not be half-wave symmetric at all times as the heating units are on occasion operated separately. However the maximum level of DC current flowing in the transformer would be lowered as DC current would flow only when one heater was operating.

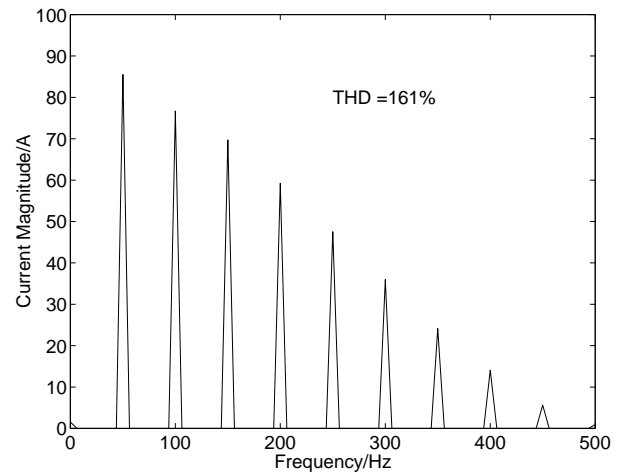
The frequency spectrum of the heater current is shown in Figure 5. There is no DC component shown on the spectrum, as the current sensors are current transformers that are not capable of measuring the DC component. The presence of the DC current component was confirmed by on site measurement with a meter capable of DC current measurement. The even harmonic content is shown and the presence of these means that a system resonance at or near an even harmonic could be excited by this waveform. A current without even harmonics could not excite such a resonance.

Figure 5. Induction Motor Heater Current Frequency Spectrum

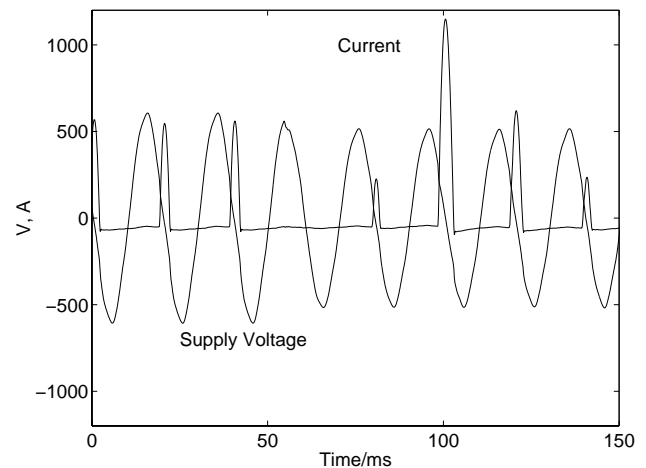
heating units is apparent when a voltage sag occurs (as shown in Figure 6). The relatively small voltage reduction of 15% causes a large transient excursion with a peak of 1200A along with one missed conduction cycle.

Figure 6. Induction Motor Heater Current and Supply Voltage during a Sag

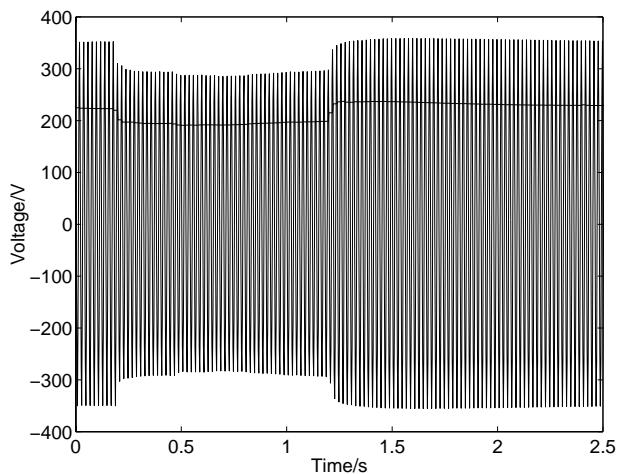
A large number of sags that have been recorded at the site cannot be correlated with events internal to the site. These sags vary in magnitude and duration. No statistical analysis is covered in this paper but the voltages during two sag events are shown in Figure 7 and Figure 8. The clearing times of the faults that caused these sags show that the faults occurred on the 50kV or the 11kV network. Correlation studies between faults on the transmission network and the sags measured at the monitored point show faults on the high voltage 110kV transmission network appear relatively infrequently as the cause of sags at the monitored site.

Figure 7. Sag Example 1 (Instantaneous and RMS Voltage)

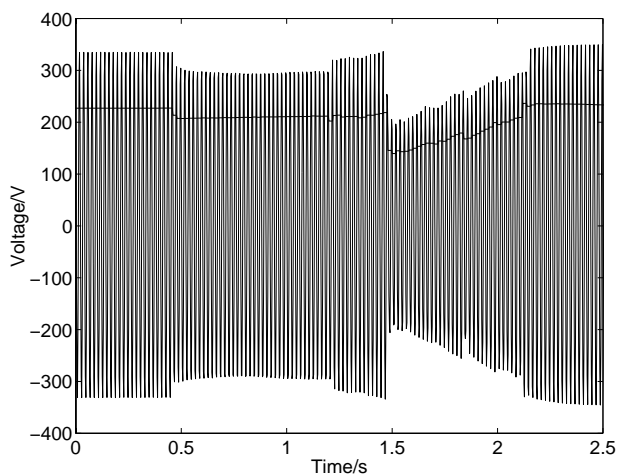
Figure 8. Sag Example 2 (Instantaneous and RMS Voltage)

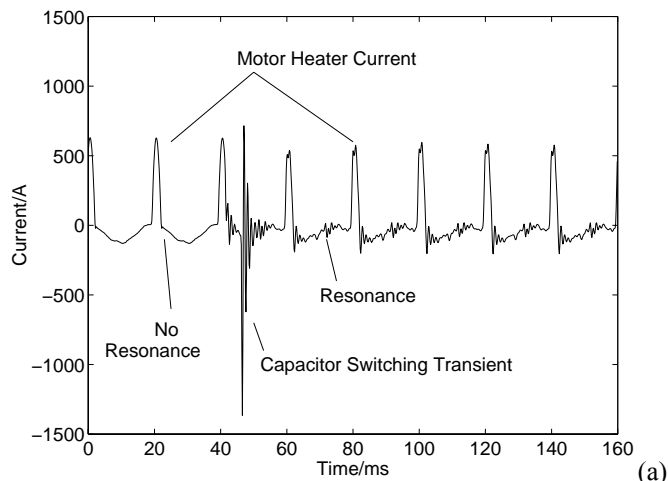
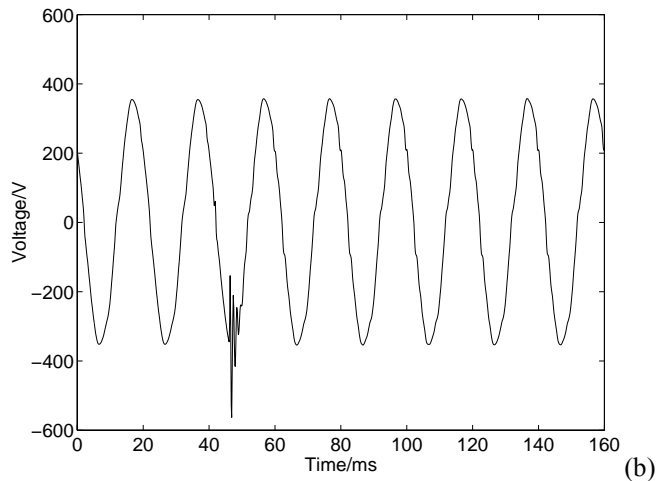
Power factor correction capacitor banks are switched to maintain close to unity power factor because the supply company's conditions of supply are such that VA demand is not a consideration as long as the power factor is unity. The supply company have mobile power factor loggers that are rotated through their industrial customers' sites on a regular basis to ensure compliance. The displacement power factor at the site is almost unity at all times except under very low load levels. A power factor correction capacitor switching event is shown in Figure 9. The initial switching transient is large with a 1400A peak. The transient disturbance is also apparent from the voltage waveform where the peak phase to neutral voltage reaches almost 600V. This transient is quickly damped away but a resonance now occurs which can be seen in the current in Figure 9(a).

Figure 9. Capacitor Switching Transient (a) Current (b) Voltage

The capacitor switching and the associated resonance indicate that the AC system is not well damped, which is consistent with the loading figures for the system. The resonance could be damped with a harmonic filter tuned to the resonant

frequency or the power factor correction capacitor banks could be tuned by adding series inductors. As these solutions are expensive it is unlikely they will be adopted and the lack of reported problems means that no solution is required.
