# Power Quality Observations at a Light Industrial Site

Hamish Laird, *Student Member, IEEE*, Simon Round, *Member, IEEE*, Richard Duke, *Member, IEEE*  
Alister Gardiner.

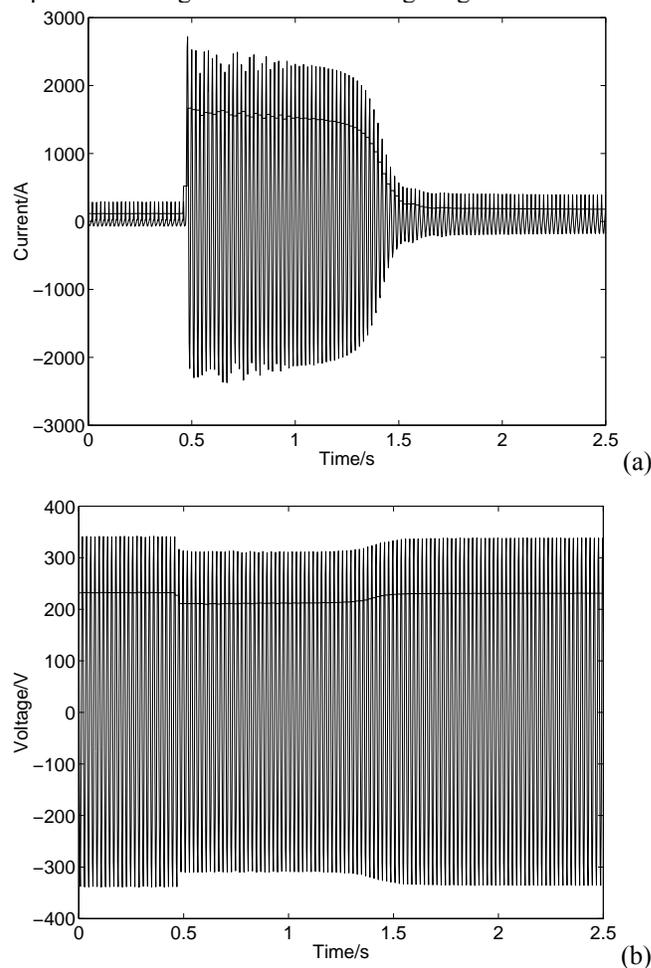
Figure 2. Induction Motor Start Transient (a) Motor Current (b) Supply Voltage (Instantaneous and RMS values)

water resistor starters to lower the start current. This large start current, Figure 2(a), causes a 10% drop in the supply voltage, (as shown in Figure 2(b)) which the customer has reported noticing as a flicker in the lighting.

The induction motor start transient typically causes a 10% drop in the site voltage. A solid-state or star-delta starter could lower the start current and so lower the voltage drop. The cost involved may not be justifiable as the motor start induced sag caused no reported problems other than the customer's concern about the "flick" in the lights. Another option to prevent the voltage drop is to control the motor run up with an adjustable speed drive. This again is an expensive option and is probably not worth pursuing. A more reasonable approach is to ensure the customer is aware of the possible consequences of the voltage dip, such as nuisance tripping and PLC malfunction. This awareness will ensure that any problems that the dips do cause will be noted.

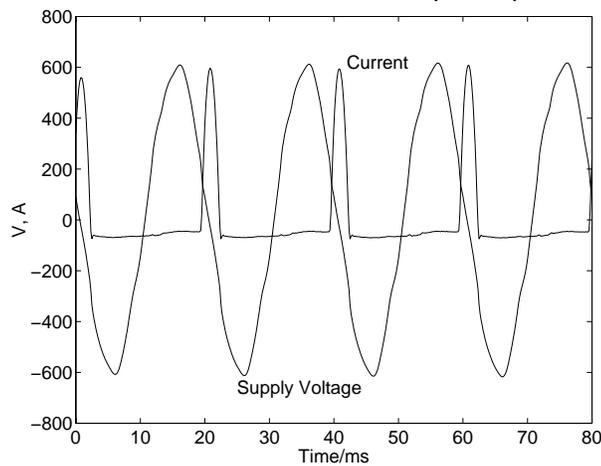
Figure 4. Induction Motor Heating Unit Current and System Line to Line Voltage

The units are half-wave controlled rectifiers having only one thyristor and they produce DC, odd and even harmonics in the AC current. The lack of half-wave symmetry indicates that there are even harmonics and a DC component present.

The DC current has impact on transformer operation as it produces a DC MMF that will offset the magnetising hysteresis of the transformer core. If the offset is large enough to drive the core sufficiently into saturation the magnetising current will increase and this could cause transformer overheating and possibly failure. As the rectifiers are connected line to line, the current has non-zero sequence triplen harmonic components that propagate through a star-delta supply transformer. Such harmonic currents may cause resonance that would not be excited by zero sequence triplen harmonics (produced by balanced harmonic loads) which are blocked by a star-delta transformer. The impact of the motor

The induction motor heater unit current harmonics are large and the presence of even harmonics is unusual. The apparent lack of problems that the DC component of the heater current causes is perhaps fortuitous as the resulting transformer MMF offset could cause transformer damage through saturation. No such damage has occurred and the transformer operating temperature during the site survey was 38 C. The fact that the heater units operate only when the site load is low means any adverse transformer heating from saturation is offset by reduced heating due to the low load. Configuring the rectifiers to produce a half wave symmetric current waveform would eliminate the DC current produced by the induction motor heaters. One way to do this is to reverse the phase connection of one of the induction motor heaters. The two heater units would then conduct in opposite half cycles and together would produce a half-wave symmetric waveform. This would decrease the peak current and remove the even harmonic currents. The current waveform would however not be half-wave symmetric at all times as the heating units are on occasion operated separately. However the maximum level of DC current flowing in the transformer would be lowered as DC current would flow only when one heater was operating.

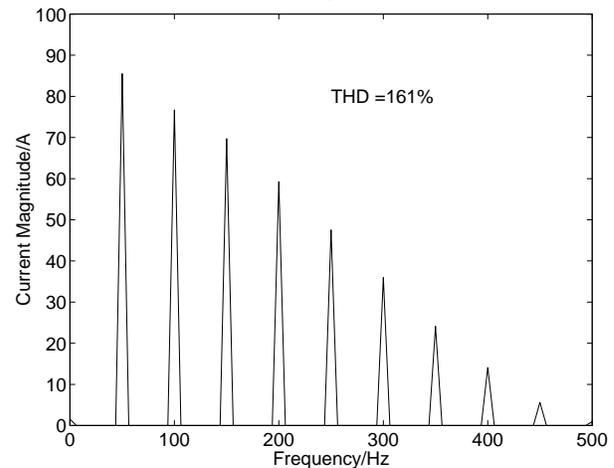
Figure 5. Induction Motor Heater Current Frequency Spectrum

The frequency spectrum of the heater current is shown in Figure 5. There is no DC component shown on the spectrum, as the current sensors are current transformers that are not capable of measuring the DC component. The presence of the DC current component was confirmed by on site measurement with a meter capable of DC current measurement. The even harmonic content is shown and the presence of these means that a system resonance at or near an even harmonic could be excited by this waveform. A current without even harmonics could not excite such a resonance.

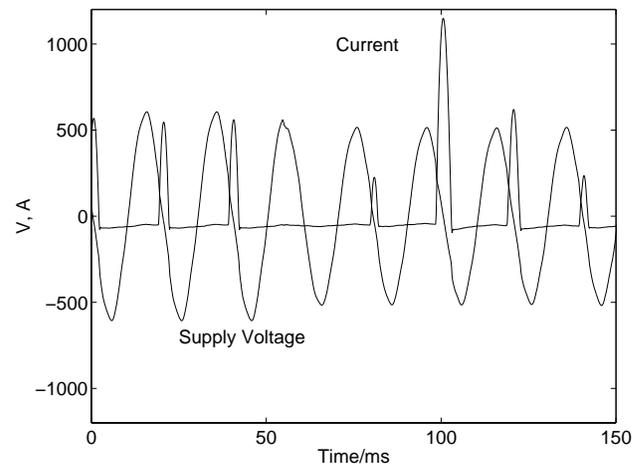
Figure 6. Induction Motor Heater Current and Supply Voltage during a Sag

heating units is apparent when a voltage sag occurs (as shown in Figure 6). The relatively small voltage reduction of 15% causes a large transient excursion with a peak of 1200A along with one missed conduction cycle.

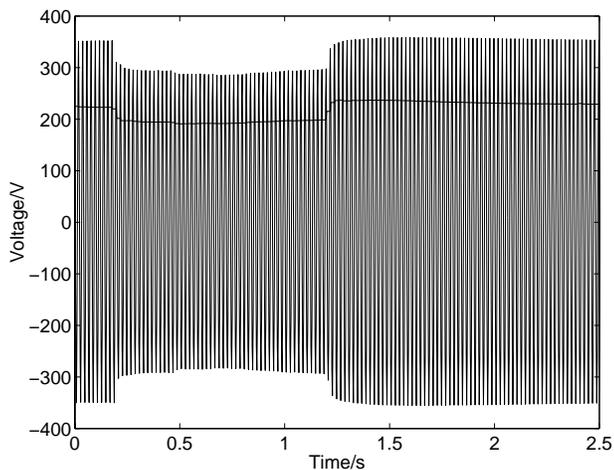
Figure 7. Sag Example 1 (Instantaneous and RMS Voltage)

A large number of sags that have been recorded at the site cannot be correlated with events internal to the site. These sags vary in magnitude and duration. No statistical analysis is covered in this paper but the voltages during two sag events are shown in Figure 7 and Figure 8. The clearing times of the faults that caused these sags show that the faults occurred on the 50kV or the 11kV network. Correlation studies between faults on the transmission network and the sags measured at the monitored point show faults on the high voltage 110kV transmission network appear relatively infrequently as the cause of sags at the monitored site.

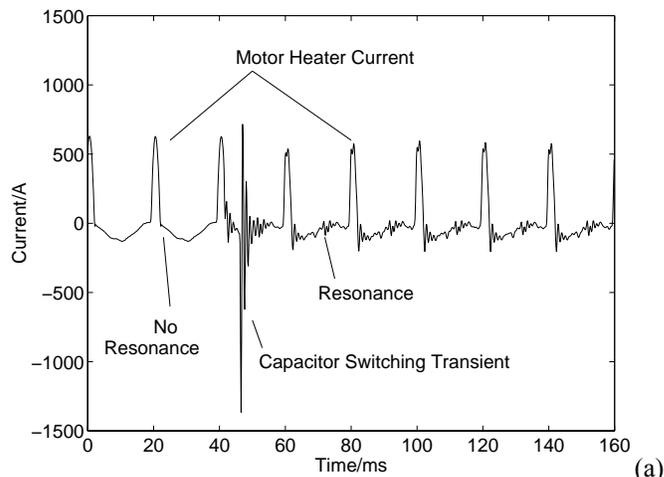
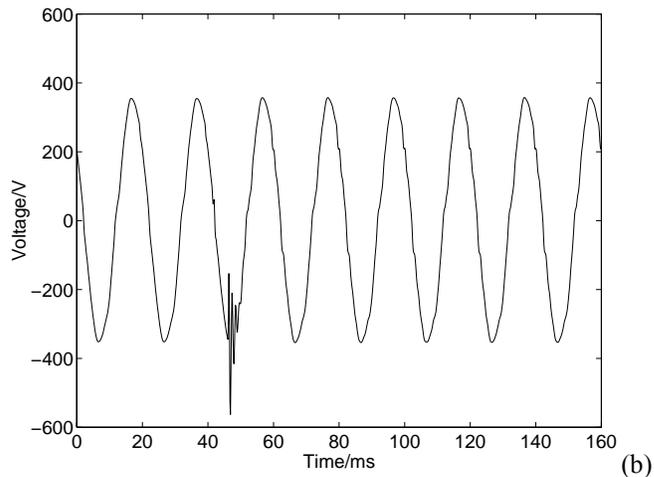
Figure 9. Capacitor Switching Transient (a) Current (b) Voltage

Power factor correction capacitor banks are switched to maintain close to unity power factor because the supply company's conditions of supply are such that VA demand is not a consideration as long as the power factor is unity. The supply company have mobile power factor loggers that are rotated through their industrial customers' sites on a regular basis to ensure compliance. The displacement power factor at the site is almost unity at all times except under very low load levels. A power factor correction capacitor switching event is shown in Figure 9. The initial switching transient is large with a 1400A peak. The transient disturbance is also apparent from the voltage waveform where the peak phase to neutral voltage reaches almost 600V. This transient is quickly damped away but a resonance now occurs which can be seen in the current in Figure 9(a).

The capacitor switching and the associated resonance indicate that the AC system is not well damped, which is consistent with the loading figures for the system. The resonance could be damped with a harmonic filter tuned to the resonant

frequency or the power factor correction capacitor banks could be tuned by adding series inductors. As these solutions are expensive it is unlikely they will be adopted and the lack of reported problems means that no solution is required.
