EEA Conference & Exhibition 2008

An investigation of excessive corona on a new 275kV line

Authors: Dr. Stewart Hardie, Dr. Alan Wood and Prof. Pat Bodger

Organisation: Electric Power Engineering Centre (EPECentre),
University of Canterbury,
Christchurch,
New Zealand

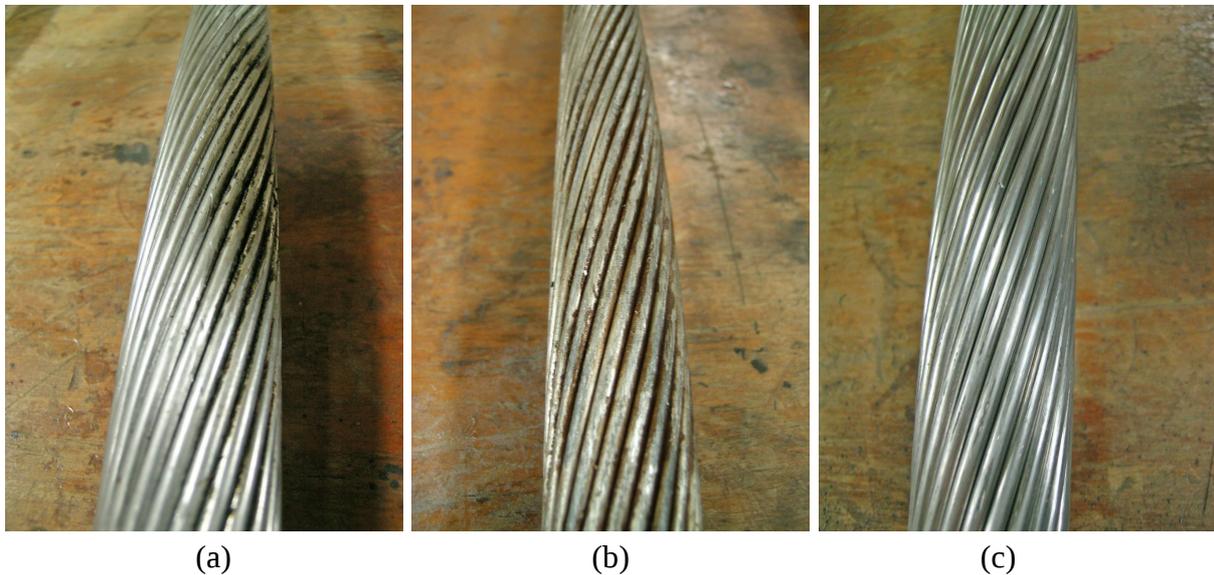
Figure 2 – (a) 'New Olex', (b) 'Used Midal Bungama' and (c) 'New Midal other project'.

The 'New Olex' surface had an oily feel. One side of the conductor had patches of black, dirty grease between the strands. The strands were otherwise clean, smooth and shiny. There were a few minor scratches and nicks on the outer strands. Internally, clean grease appears to be present on all conductors except the outer layer. This conductor is shown in Figure 2(a).

The 'Used Midal Bungama' had an oily feel, but dryer than the 'New Olex' conductor. There were a lot of dirty greasy patches that generally felt dry, and were mostly between the outer strands, but also right around the strands in places. There were a reasonable number of minor scratches on the outside of the outer strands, removing the shiny look. There were no lumps present, as seen on the live conductor at Bungama by EPECentre staff (described later in this paper). Unfortunately, it also appeared handling and packaging had removed some of the dirt and grease from the outside of the conductor. Internally, clean grease appeared to be present on all conductors except the outer layer. This conductor is shown in Figure 2(b).

The 'New Midal other project' conductor was generally clean, non-greasy and shiny all around. There was no dirty grease seen between strands. There were some minor scratches and nicks. Internally, clean grease appeared to be present on all conductors except the outer layer. This conductor is shown in Figure 2(c).

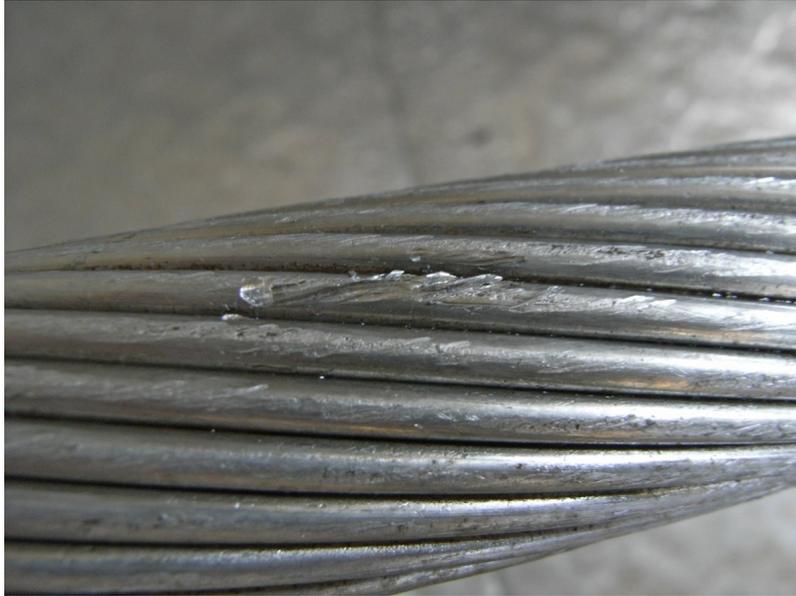
Table 5 shows the results of the HV tests on the three conductors. In addition, corona flares were particularly apparent from scratches such as the one in Figure 4.

Figure 4 - 'Used Midal Bungama' conductor with a jagged scratch which corona flared from.

The used conductor supplied showed evidence of rough handling, with significant surface scratches. It is unknown if this was a result of the line stringing process, or from the decommissioning of a span for sample testing. However, scratches and scrapes on the conductor surface are a very significant source of corona, and should be minimised when the line design results in high surface voltage gradients.

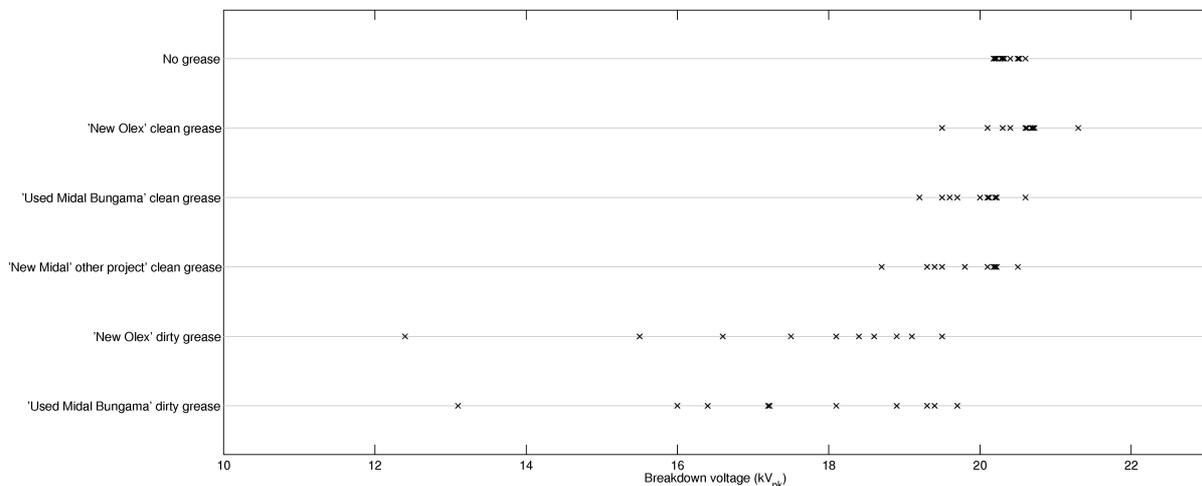
Figure 6 – Breakdown voltages across sphere gaps with various conductor greases applied to one sphere.

- No grease = 20.4 kV_{pk}
- 'New Olex' clean grease = 20.5 kV_{pk}
- 'Used Midal Bungama' clean grease = 19.9 kV_{pk}
- 'New Midal other project' clean grease = 19.8 kV_{pk}
- 'New Olex' dirty grease = 17.5 kV_{pk}
- 'Used Midal Bungama' dirty grease = 17.5 kV_{pk}

Applied dirty greases significantly lowered breakdown voltages, including some very low voltage values. There appeared to be little difference between the dirty grease sampled from the 'Used Midal Bungama' conductor and the 'New Olex' conductor.

The primary conclusion is that clean conductor grease that is present on the exterior of a conductor is unlikely to cause a significant corona problem. Unfortunately, when clean grease is initially present on the conductor exterior, it is highly likely to become contaminated with dirt or other similar material, either during conductor installation on the transmission line or later when wind blown dust is deposited on the conductor. Then, when grease is contaminated, the chances of corona will significantly increase.

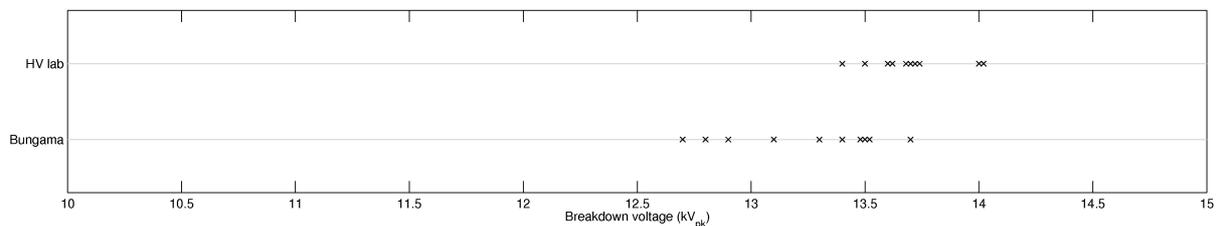
Figure 7 – Breakdown voltages across sphere gaps at Christchurch and at Bungama.

It is unknown why the atmospheric breakdown conditions are slightly lower at Bungama. However, this result means that corona is more likely to start at lower voltages at Bungama.

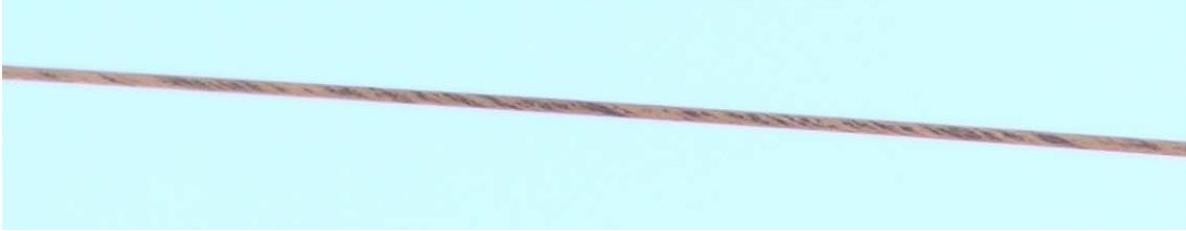
Standing under the HV lines of the new Bungama line, a loud coronal buzzing noise could be heard coming from the transmission line. It was far higher than any level of coronal audible noise that the authors have heard from any HV power line, especially considering the dry, warm conditions. A black surface layer appeared to cover up to 50% of the conductor, in a patchy fashion. The coronal noise appeared to come from all sections of the transmission line. Figure 8 shows the black substance diagonally aligned with the strands of the conductor, suggesting that it has been sourced from within the conductor rather than being applied from an external source.

Figure 8 – Bungama transmission line conductor with a black substance apparently being emitted between strands.

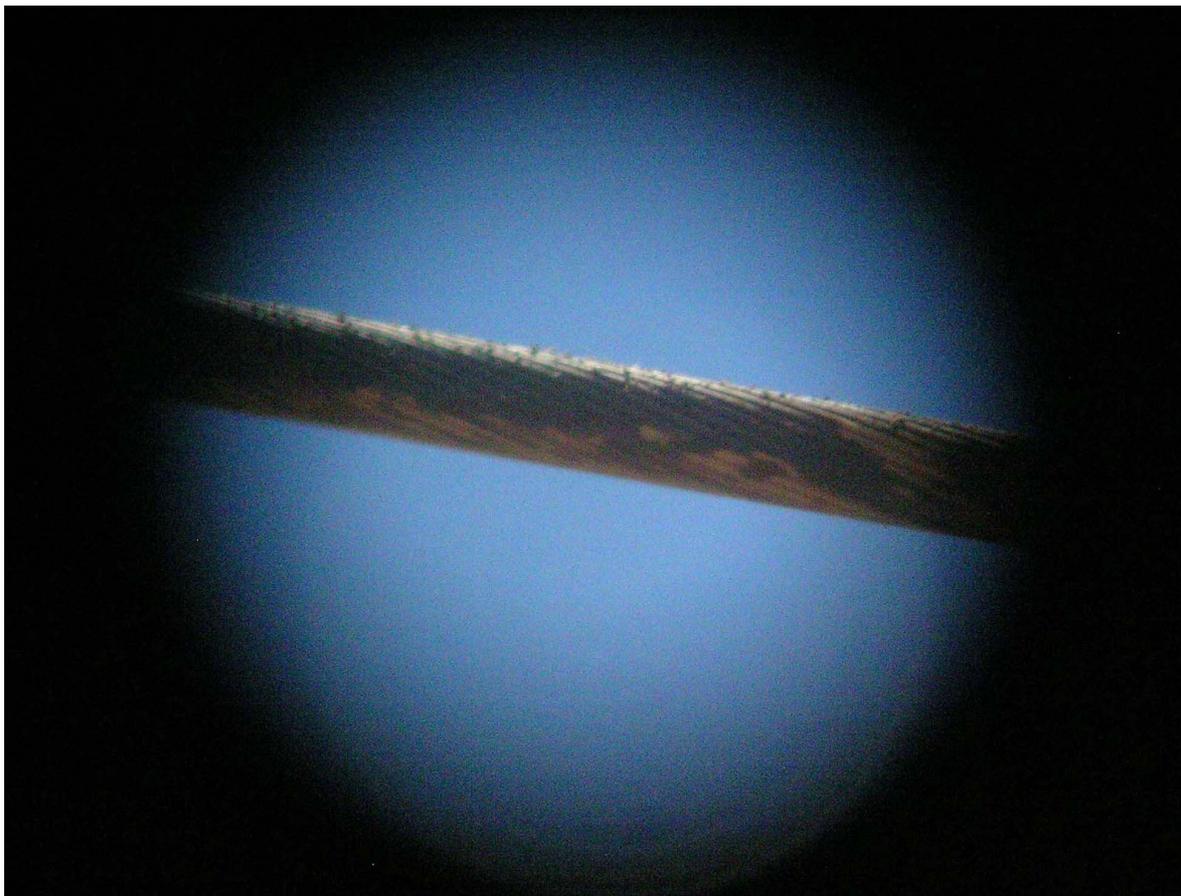
Black lumps were also observed with binoculars along all sections of the Bungama conductors, as shown in Figure 9. The lumps ranged in size up to approximately 3 mm, with dozens to hundreds of lumps per metre of conductor. They appeared to be present on all of the conductors. The nature of the lumps could not be determined, but had the same colour as the substance covering the conductor. Considering the size of the black lumps and how much they protruded from the conductor surface, it is highly likely that they are a major contributing factor towards corona generation. It is possible the substance is grease leaking from the conductor, and allowing small objects such as dirt or flies to stick to the conductor. The surrounding countryside is dry and dusty. Also, a small wind twister was observed sucking dust up to heights above the Bungama transmission towers.

Figure 9 – Unknown black lumps present on the surface of one of the conductors on the Bungama transmission line.
