COST-EFFECTIVE CONSIDERATION OF NON-STRUCTURAL ELEMENTS: LESSONS FROM THE CANTERBURY EARTHQUAKES

ABSTRACT

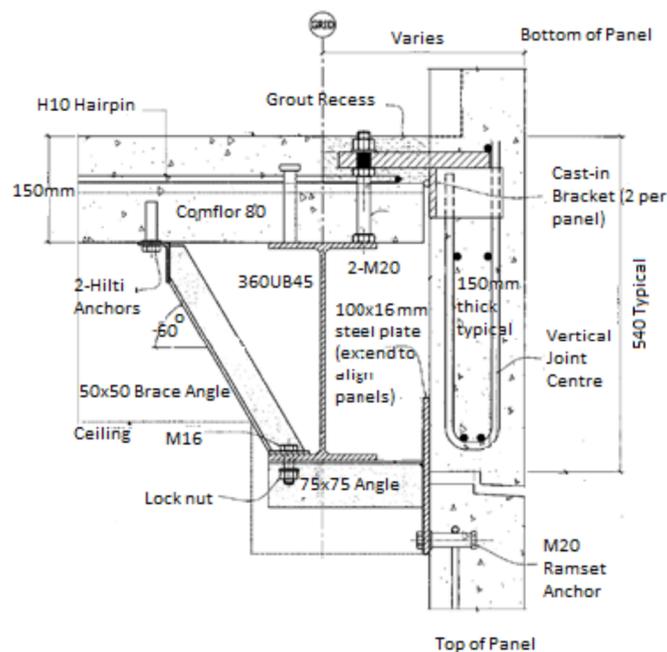
In New Zealand, there does not appear to be a standard detailing approach for precast concrete elements and the cladding connection detail (obtained from the Christchurch City Council) for this building is shown in Figure 3. Note that this detail shows the bottom of the precast concrete panels to be integral with the composite concrete flooring system whereas the top of the panels are restrained via 75mm x 75mm steel angle sections of varying lengths. The angles are connected with single bolts to the steel framing at one end and are welded to steel plates, which are in turn fixed to the concrete panels via anchor bolts, as shown. The figure also shows that a gap is detailed between adjacent panels although talking with local engineers there is some doubt about whether this was provided during construction.

Figure 3. Precast cladding connection detailed for the 22-storey building.

The cladding was damaged a moderate amount in the Canterbury earthquakes, with damage occurring to either the steel angle connections or via cracking of concrete around the bolts that anchor into the precast units (refer Figure 3). The reported damage to the panels is expected to have arisen because of the unusual connection details shown in Figure 3, which meant that the panels provided some restraint against the lateral movement of the main structure.

Good earthquake engineering practice would encourage the detailing of precast cladding connections so as to allow lateral movement of the main structural system without deforming or straining the panels. The detail drawn for the case-study building (Figure 3) did not appear to ensure this and hence the question was posed as to whether retrofit of the cladding connection details could have been an effective strategy for reducing damage, disruption and losses in the building. Figure 8 compares the peak storey drifts and floor accelerations obtained from non-linear dynamic analyses with and without the precast cladding stiffness present in the model. As would be expected, the presence of the precast cladding tends to reduce peak storey drifts but increase peak floor accelerations. Note that the cladding panels were not present on all floors (refer to Arifin, 2017). As such, only floors with panels are significantly affected.

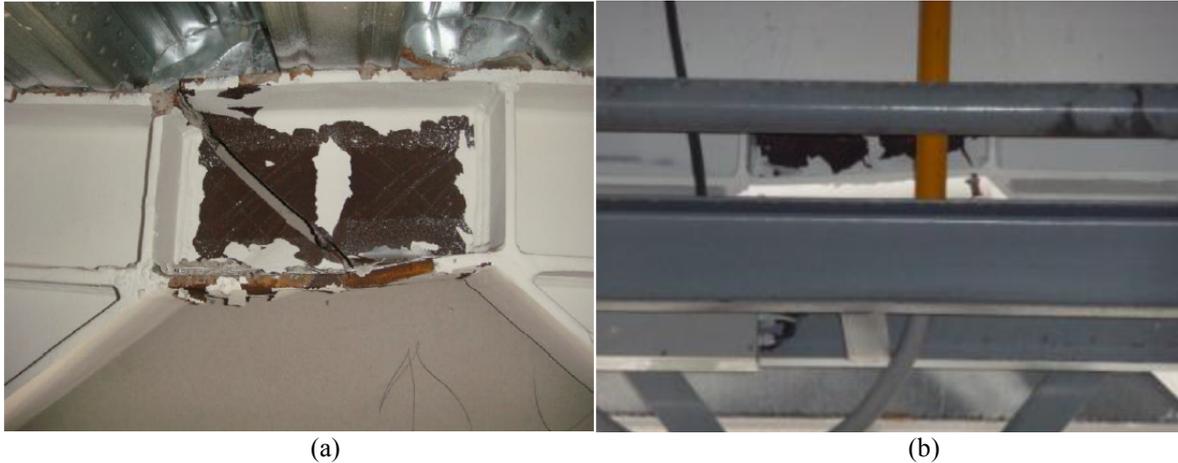
Considering the intensity of the earthquake shaking, the steel EBF structure performed reasonably well, as reported by Clifton et al. 2011, and the building was able to be repaired economically. A maximum residual drift in a storey was reported to be 0.3%. Figure 5 illustrates damage that occurred to EBF links, and the worst damage observed to a link, a fracture, can be seen in Figure 5(a). Figure 5(b) illustrates a link that has also undergone significant strains, as is evident from the flaked off paint, but has not fractured. Repair of such links (that did not fracture) may require heat treating and straightening. Also note the non-structural elements located close to the link itself.

Figure 5. (a) Photo of fracture of an EBF link at level 6 after the February 2011 event, and (b) photo showing non-structural elements in the vicinity of a less damaged EBF link, from Clifton et al. (2011).

The damage to the EBF links of the type illustrated in Figure 5, required costly repair work, as would be expected in order to replace sections of the steel structure. However, as can be seen from Table 1, an apparent lesson to be learnt from this study is that the decommissioning or rerouting of non-structural elements (and in particular, services) in the vicinity of damaged links reportedly attributed to approximately half the total cost of their repair. Such costs could be significantly reduced or possibly even avoided if, as part of the building's original design, the positioning of non-structural elements took account of the likely need to repair the EBF links.

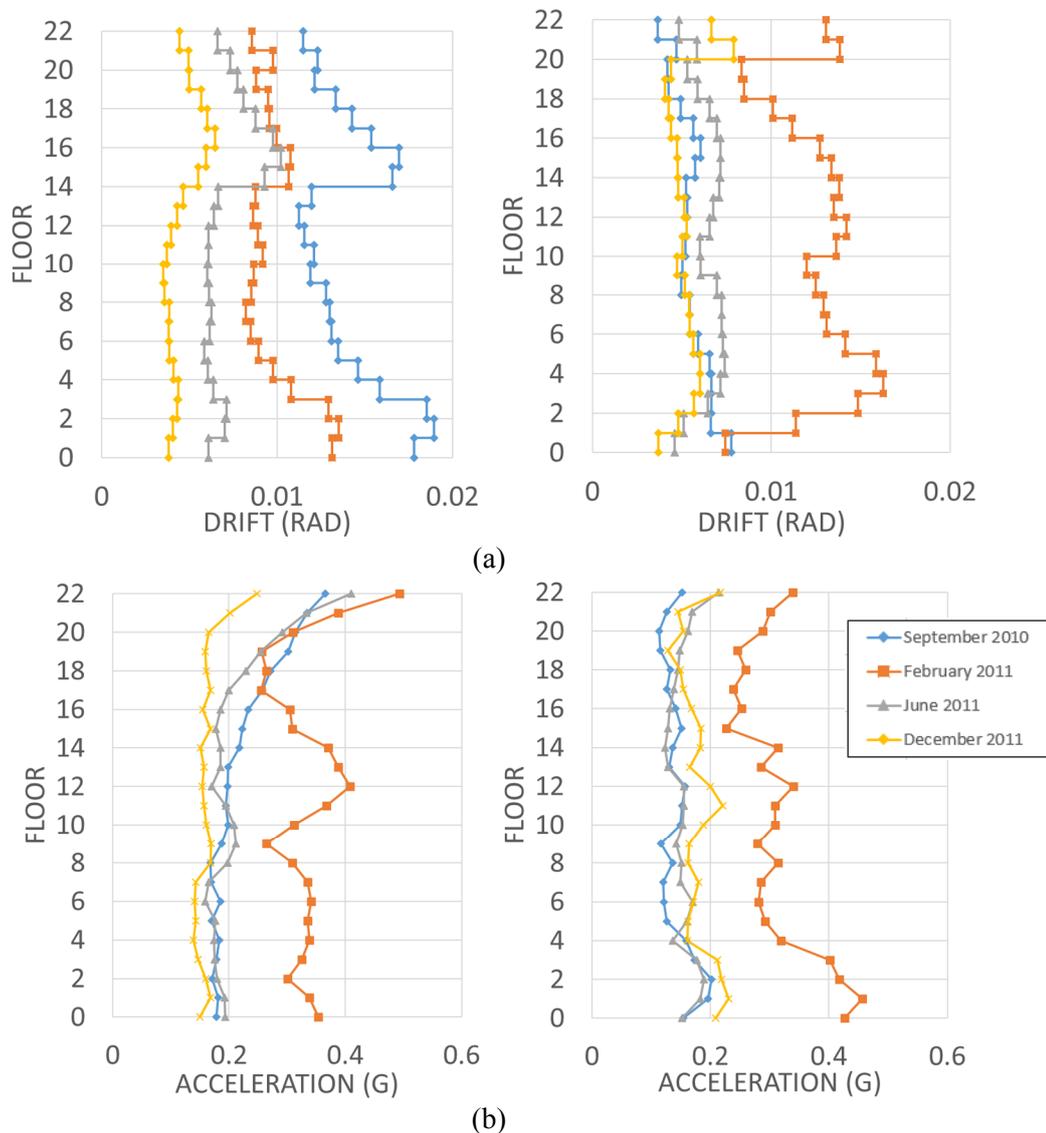
Figure 6 shows the peak storey drifts and floor accelerations predicted from non-linear dynamic analyses in the February 2011 event. Note that in recognition of the fact that the building had already been subject to the September 2010 event, analyses were run with the February 2011 event tagged onto the end of the September 2010 (and with a period of free oscillation in between). It can be seen that the drifts were greatest over the lower six storeys, around the 12th floor and at the top of the building in the E-W direction. Encouragingly, damage to partition walls and cladding in the actual building was located around the same areas.

Figure 6. (a) Peak storey drifts (Left: N-S direction; Right: E-W direction) and (b) peak transient floor accelerations (Left: N-S direction; Right: E-W direction) predicted in the Canterbury Earthquake events from non-linear dynamic analyses of the case study building model.

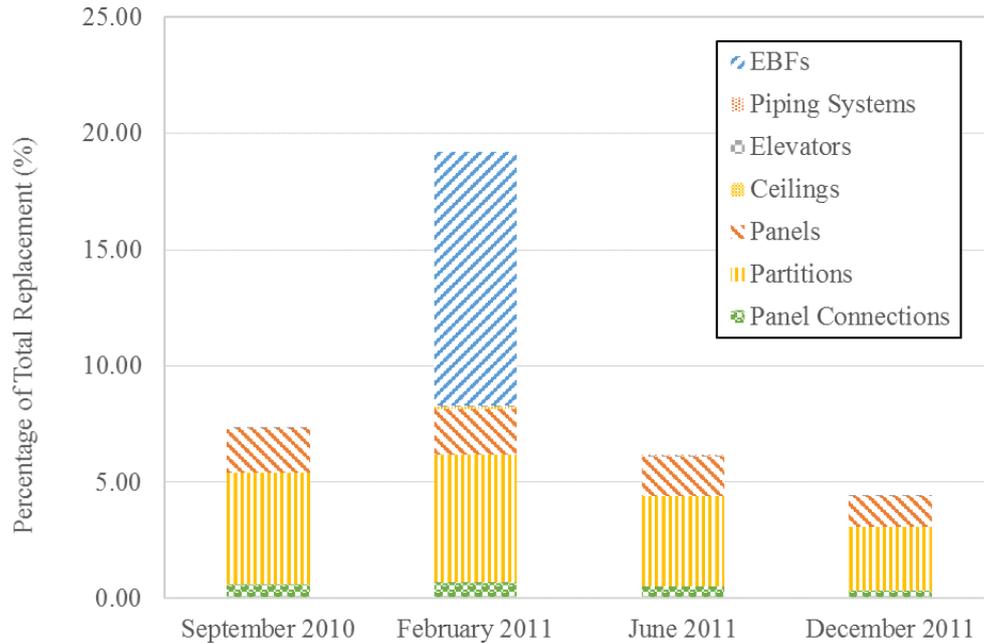
The predicted losses due to repair for the four most intense earthquake events are shown in Figure 7, in which the contribution of different components to losses is identified. No structural losses appear for the September 2010 event in Figure 7 not because they were not predicted (as large drift demands can be seen in Figure 6) but because inspection of the structure was not carried out until after the February 2011 event and thus the loss values are conditional on inspection. The results align with observations as damage to the EBF links was most intense in the February 2011 event, as reported in (Gardiner, 2012), whereas precast panels and lightweight partitions were expected to suffer damage in all four events.

Figure 7. Predicted losses for the case study building, conditional on inspection (the EBF structure was inspected only after the February 2011 event).

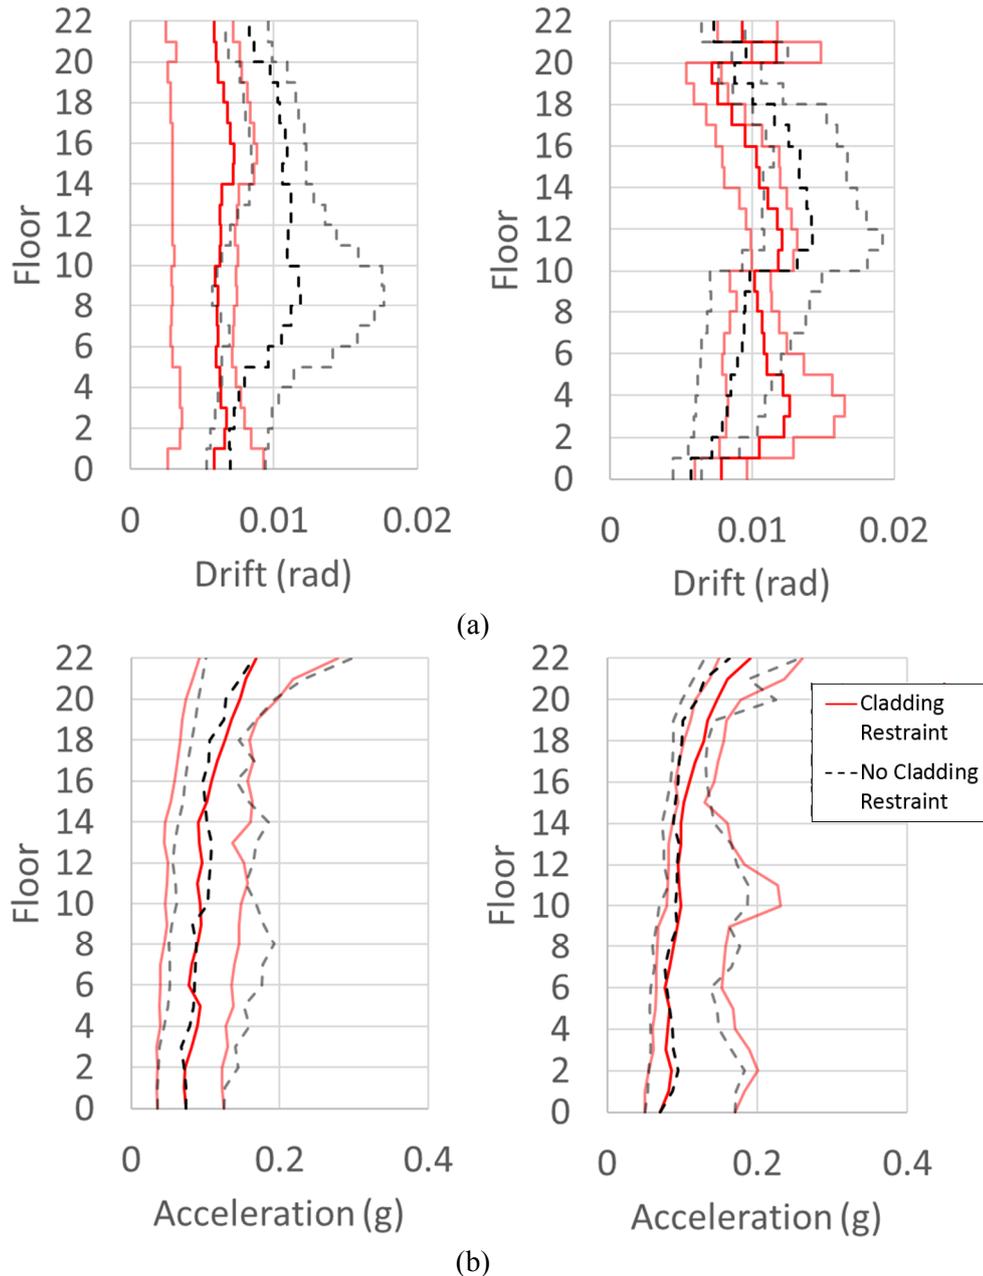
Figure 8. (a) Peak storey drifts (Left: N-S direction; Right: E-W direction) and (b) peak transient floor accelerations (Left: N-S direction; Right: E-W direction) predicted in a 2% in 50-year event from non-linear dynamic analyses of the case study building model with and without precast cladding stiffness present.

Inputting the EDPs obtained from the analyses of a system without cladding restraint into the PACT model, expected annual loss estimates were computed with and without the presence of cladding. From this exercise it emerged that the expected annual loss for the building and overall repair costs would likely have been greater if the cladding had been detailed to provide no restraint, even though the cost of repairing the cladding itself was removed with good detailing. This occurred because even though there was no damage or repair costs for the precast panels themselves, the additional drifts that would be expected over the height of the system would have implied significant increases in damage to the partition walls.

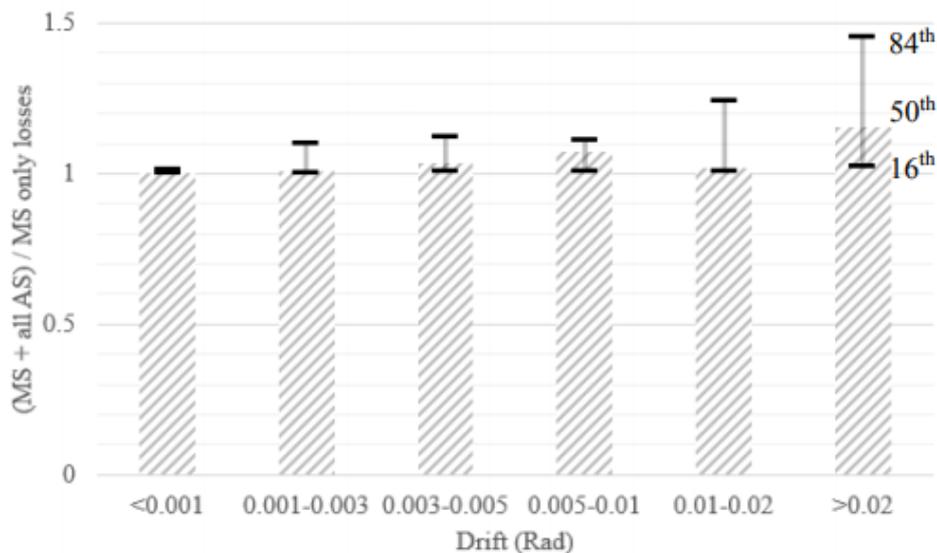
Another important observation from Figure 7 (and from discussions with local engineers about building behaviour around Christchurch) is that costly repairs to non-structural partition walls were required not only after the moment magnitude 7.1 earthquake in 2010 but also in multiple aftershocks in the years that followed. The repair costs associated with the aftershock events exceeded those from the main event, emphasizing both the need to consider aftershocks within modern performance-based earthquake engineering assessments and also the opportunity that exists to make more cost-effective repair strategies following damaging earthquakes. For example, if it had been decided following the first event that damaged partition walls should be replaced with low-damage partition systems, the difference in cost compared to simply reinstating like-for-like partitions would have been easily recovered. This observation may be particularly useful for insurers interested in identifying cost-effective repair options. A further detailed study by Arifin (2017) into the potential impact of aftershocks on the results of loss assessment led to the conclusion that, by neglecting the hazard posed by aftershocks, EAL estimates obtained from application of procedures such as PEER PBEE will generally be underestimated. To demonstrate this, Arifin (2017) first computed the likely losses for the 22-storey case study building in the event that it were subject only to a number of large magnitude events in Japan and New Zealand. Subsequently, the losses were re-computed considering damage from the main shock and aftershocks for the same events. This provided data for Figure 9 that presents the ratio of estimated losses with and without consideration of aftershocks. Figure 9 shows that the extent to which losses are underestimated is likely to be a function of the intensity of the main shock, since it can be seen that as the peak storey drift generated by the main shock increases, so too does the likely loss due to aftershocks. This reflects the notion that larger intensity aftershocks are more likely to follow larger intensity main shocks. Also shown in Figure 9 are the ratios obtained considering plus and minus one standard deviation of the data, illustrating that there is considerable variability in the effect of aftershocks on losses.

Figure 9. Relationship between the change in losses due to inclusion of aftershocks and the storey drift predicted in the main earthquake event.
