The recognition and identification of debris flow hazards for proposed development sites in New Zealand

Keywords: Debris flow; natural hazard; field study; case study

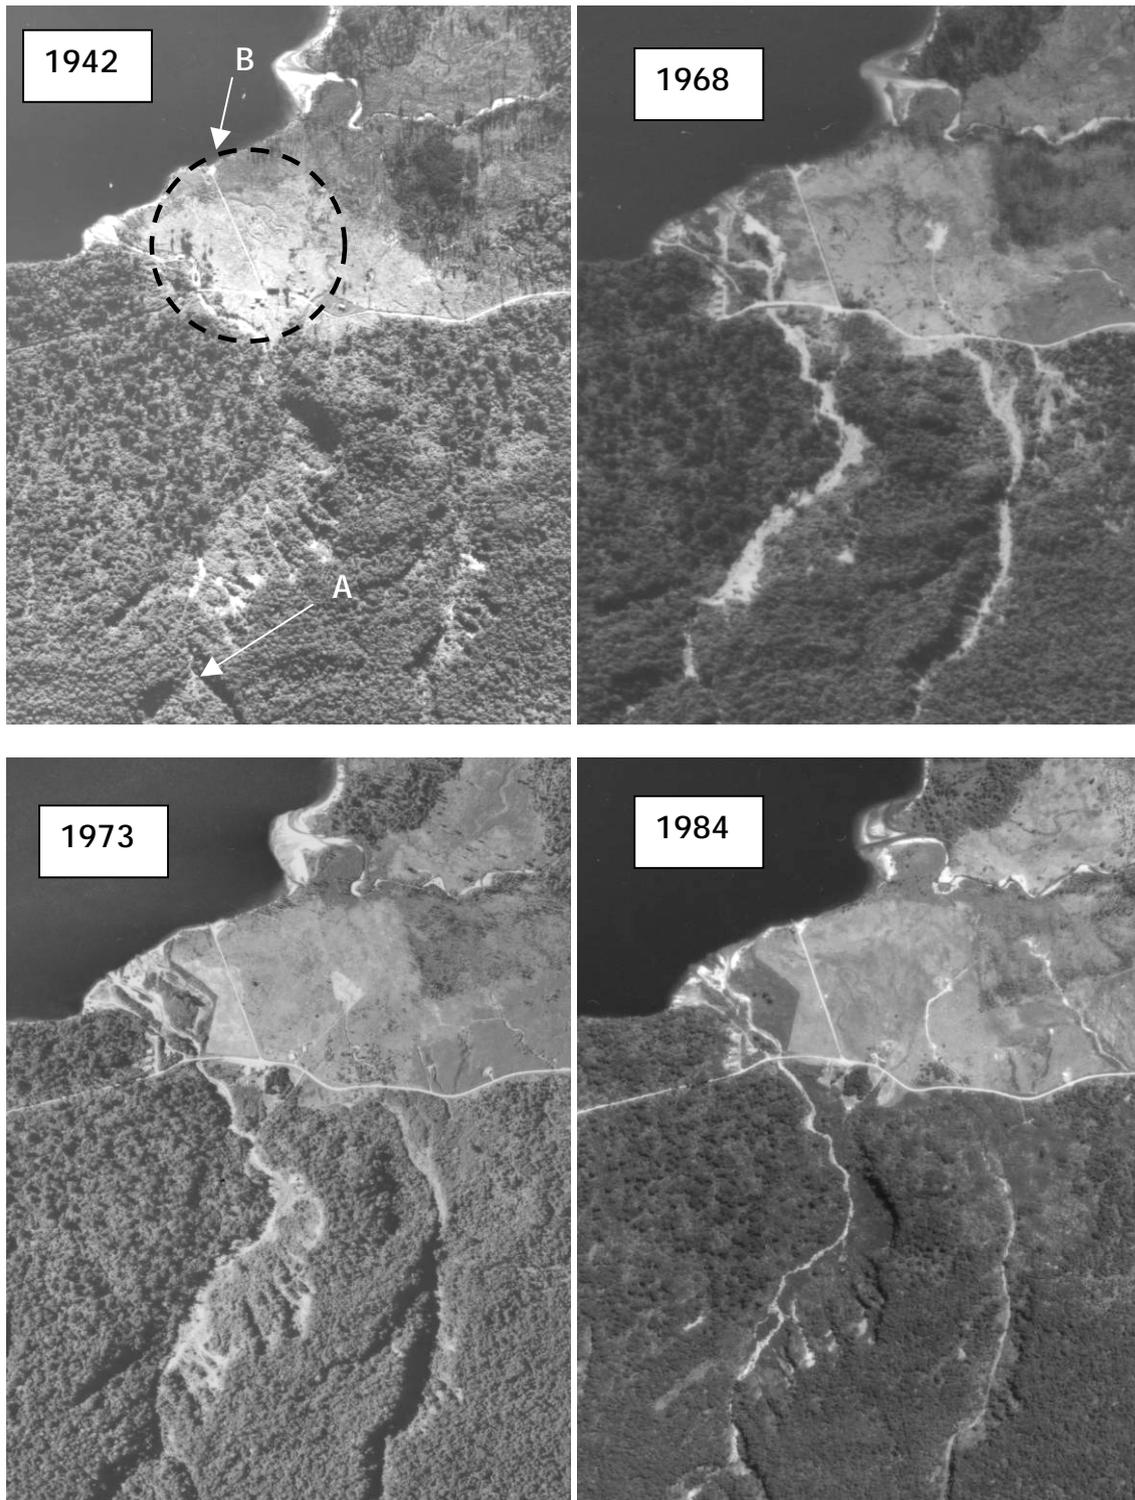
Even without the use of stereoscopy, from Figure 2 it is evident that there is much activity along the route of Creek Y. In particular it can be noted that the 1942 aerial photo shows the channel of Creek Y almost completely covered with vegetation from the base of the waterfall (indicated as “A” on 1942 photo) to about 200m above the bridge. Subdued grassed-over debris-flow lobes (arc-shaped ridges) lead from upstream of the bridge, across the site towards a small subfan at point “B” and the central part of the fan toe is in a position significantly inland of its 1964 position between the subfan at B and the active Creek Y subfan.

The 1964 aerial photo appears to show several recent slips in the upper catchment; a large slip in the true right moraine wall just downstream of the waterfall; a broad, unvegetated stream channel all the way down Creek Y; Creek Y widely braided downstream of the bridge, and occupying a wide area NW of the proposed development site; and advance of the fan toe between the two subfans, indicating substantial sediment deposition on the distal fan.

Aerial photos since 1964 show gradual revegetation of the channel, with minor erosion events (some photos are omitted from this paper).

Figure 1: Selected aerial photos spanning approx. 40 years at site, showing erosion and revegetation of Creek Y and fan development into Lake X.

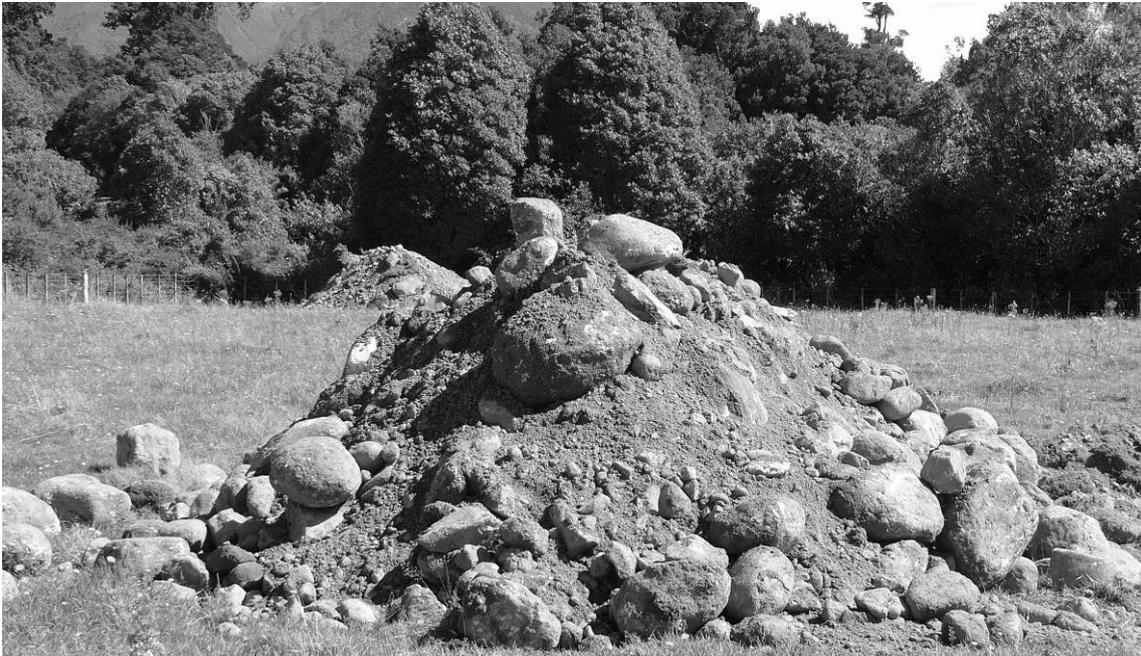
The six trial pits (TP) dug at the site showed large rounded boulders (up to 1 m diameter) in all but the pit about 50m from (closest to) the lakeshore. Boulders were apparent in the surface soils of locally high points. There was also evidence of some shallow buried soil in a pit midway down the proposed subdivision site. Organic material was taken from this pit at a depth

of 1m for dating, although the results of tests were inconclusive. The presence of large clasts in the TPs clearly showed that debris flows had occurred at the site in the past and were likely interspersed with flood events, as indicated by the finer sediment bands. The debris flow hazard appeared to reduce with proximity to the lake.

Figure 2: (a) Debris removed from TP located furthest from lake; (b) Side of TP in (a) with alternating bands of coarse material and finer alluvial deposits; (c) TP closest to lake with large bands of alluvial material and little coarse sediment

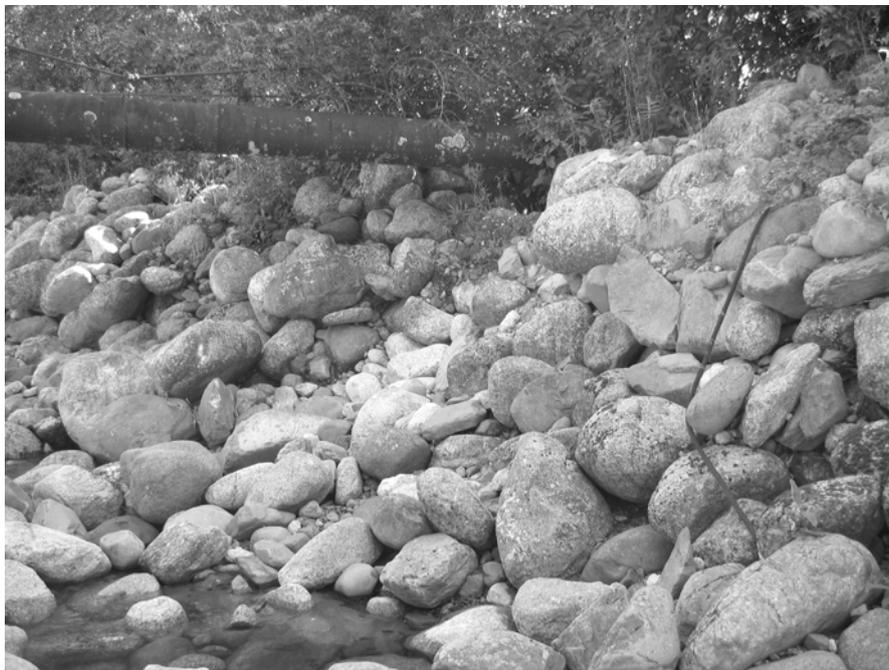
A channel survey was undertaken by walking up Creek Y from the bridge, taking into consideration the safety of the activity with regard to the season and the weather that had been dry in the preceding several weeks. The channel of the creek showed clear evidence of debris flows several metres deep in a reach about 100-300m upstream of the bridge. Prominent levees of rounded boulders up to 1m diameter bounded the outside of bends, a common deposition zone of debris flows. The most downstream of these levees appeared to be about a decade old, based on the extent of revegetation.

The hydro penstock that crossed the Creek in this reach showed signs of repair. It also had apparently been replaced on the top of the levee of the debris flow that had damaged it. Before this damage, it was sited on a lower levee surface, as determined from location of the original supports and cables and from locating the original damaged pipe in the bush to the sides of the creek (Figure 3).

Figure 3: Debris flow levee with partially buried cable (RHS) & original pipe

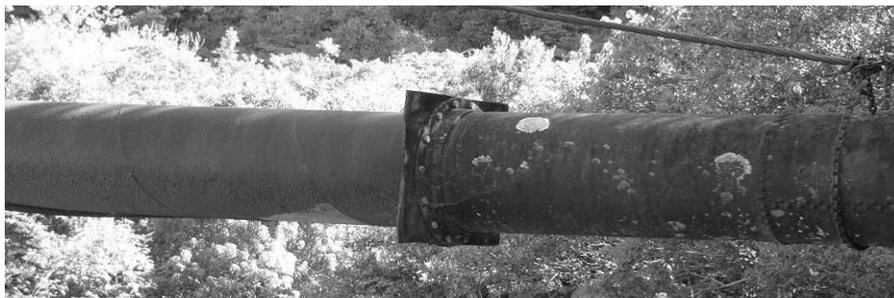
From the aerial photos, it is clear that a large debris flow event occurred between 1942 and 1968. Examination of landslide reports in the general vicinity suggested the year of 1958 to be a good candidate with usually high rainfall events reported throughout February to May (>150mm over 24 hours in nearby areas) resulting in multiple landslide and mudslide events. Further, the pipe repair (a spiral welded pipe abutting the original rivetted conduit at the stream cross-over point – Figure 4) could be dated to the late 1950s or early 1960s (Mullenger, 2006).

Figure 4: Spiral welded pipe abutting original riveted cast iron pipe
