# Resting among stars

The NASA Space shuttle must be the most sophisticated engineering accomplishment of humankind. The catastrophic loss of *Columbia* and crew at re-entry early this year was totally unexpected and a blow to manned space exploration. DIRK PONS looks into the final moments of *Columbia*.

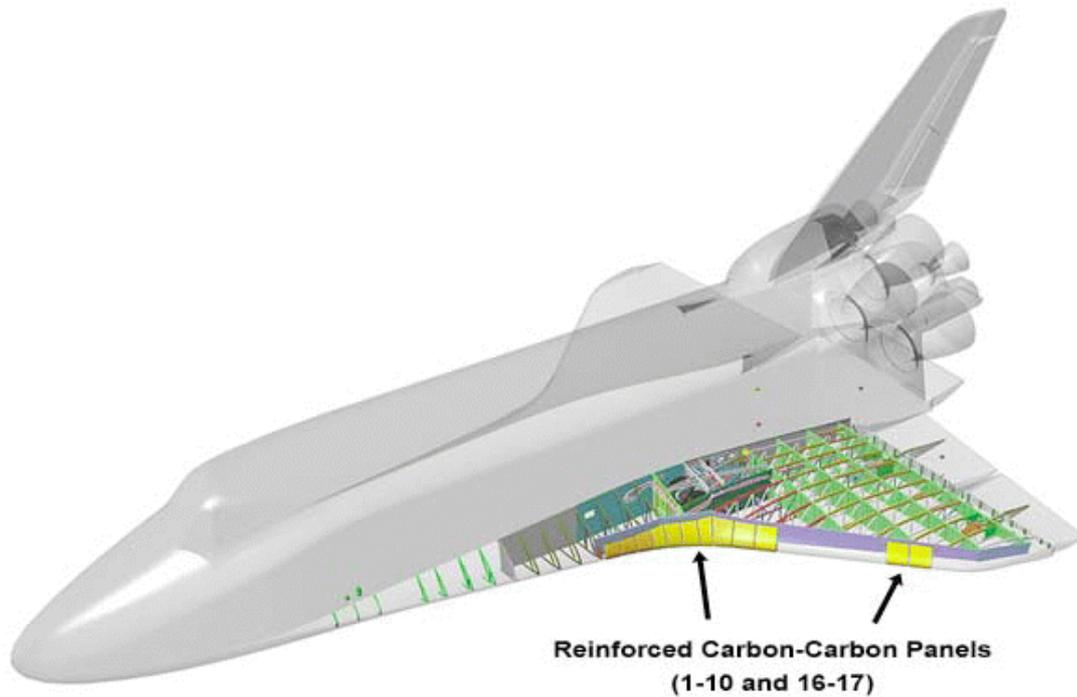
Figure 2: Diagram of Space Shuttle showing position of left wing structures relative to the vehicle. The RCC tile #8 was damaged by a foam strike at launch. Courtesy NASA (2003a).

So what went wrong with *Columbia*? The final sequence of *physical* failure events started with the piece of foam. It detached from the external tank, where it was providing cryogenic insulation for the propellents, and struck the leading edge of the left wing, approximately on panel 8, making a hole about 8x10 inches in the panel, Figure 2. During re-entry, this breach permitted hot plasma to enter into the cavity behind the leading edge, and then melt into the aluminium wing structure. The drag increased, and the lift changed (first decreased, then increased), until the control system was overwhelmed. Once the attitude of *Columbia*, especially yaw and roll, changed sufficiently, the vehicle became aerodynamically unstable.

All the evidence suggests panel 8 (or maybe 9) as the location of the breach. Image analysis suggests this location, as does computational fluid mechanics. A breach here also reconciles the temperature and strain data found from the on-board data storage.

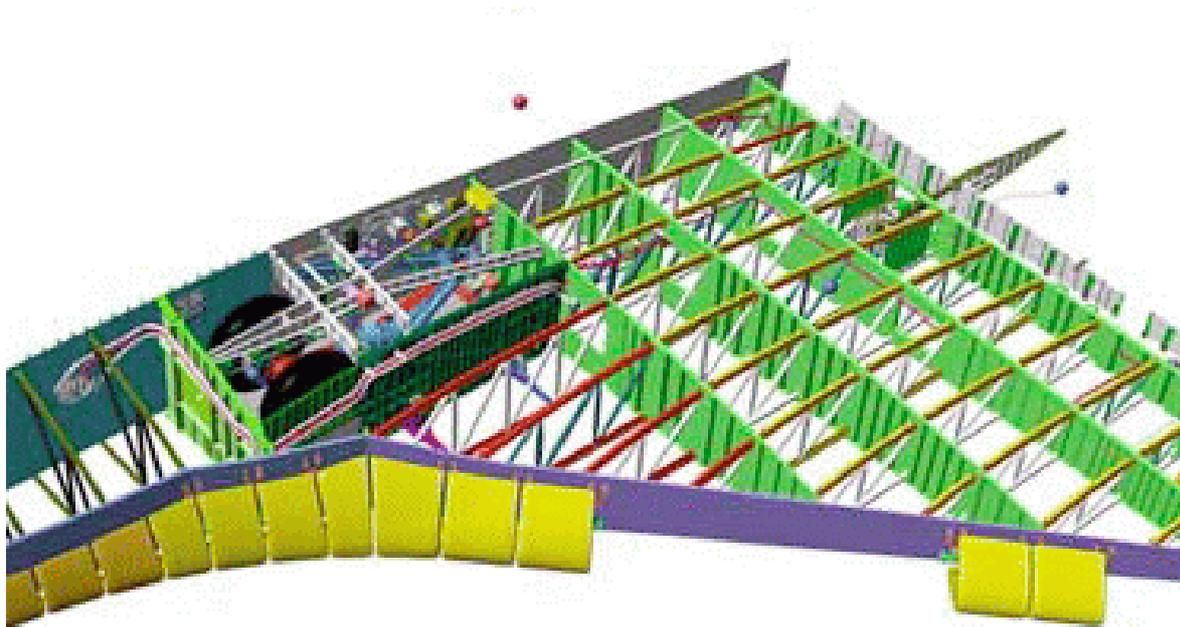
an increase in wing temperature and strain behind panels 8/9 soon after re-entry (CAIB 2003b: p64). Recovered parts from this region of the wing (yes, some of the crucial parts were miraculously found) show high temperature erosion and deposition of Inconel alloy (ex RCC attachment fittings). It was even possible to determine the time and location at which the aluminium spar behind the leading edge burned through, from MADS data and the progressive failure of the wing instrumentation.

Figure 3: Internal detail of left wing, showing the RCC leading edge panels, the wing structural members, and the wheel well with instrumentation and cables. The breach was in the underside of RCC panel #8, and allowed superheated air to enter the internal structure of the wing at re-entry. This heat rapidly caused structural damage, changed the shape of the wing (and hence the aerodynamic flight characteristics), debonded the protective thermal tiles, and eroded instrumentation cables. Towards the end, the air flow penetrated the wheel well, causing further damage there. Courtesy NASA (2003a).

The air entering the wing was at about 4400 deg C, more than enough to melt the internal aluminium structure, and it seems that the wing started to collapse internally. The plasma even managed to penetrate the wheel well, heating up the tyres and causing sensors there to fail too, Figure 3.
