## Shake proves precautions at chemistry faculty

Bryce Williamson, PhD.

Chemistry Department, University of Canterbury

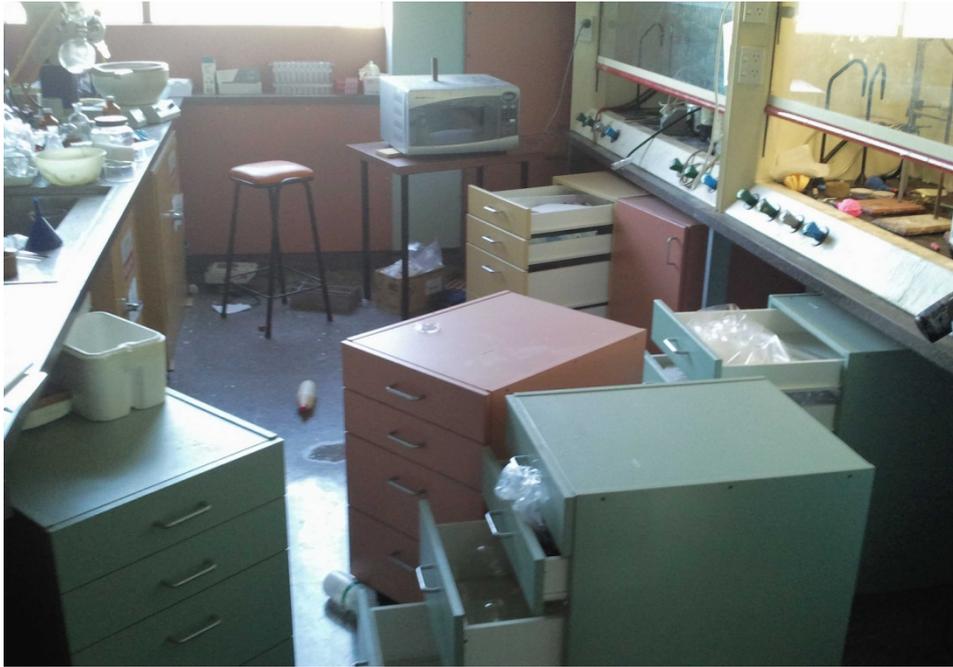
Wheeled storage cabinets in research laboratories had migrated by as much as several metres. All of the cabinets in this photo had originally been under fumehoods or benches

6. Wheeled storage cabinets had migrated by as much as a few metres. We wonder whether such cabinets should be fitted with wheel locks. However, it is possible the motion of the cabinet as a whole dampens the risk of items toppling within the cabinet. This is a question that could do with investigation.

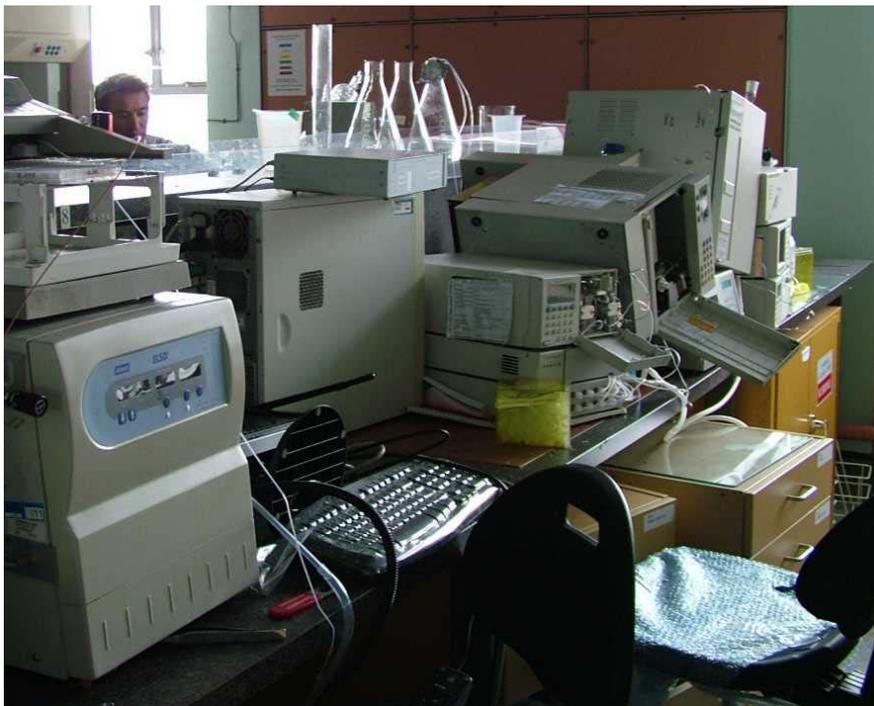
Unsecured stacks of bench-top equipment are prone to toppling.

3. Low lips should be considered for the edges of research-laboratory benches to limit the possibility of items rolling off the bench on to the floor. Bench-top instruments (chromatographs, ovens, spectrometers etc.) should be fixed to the bench and stacks of such items should be strapped down.

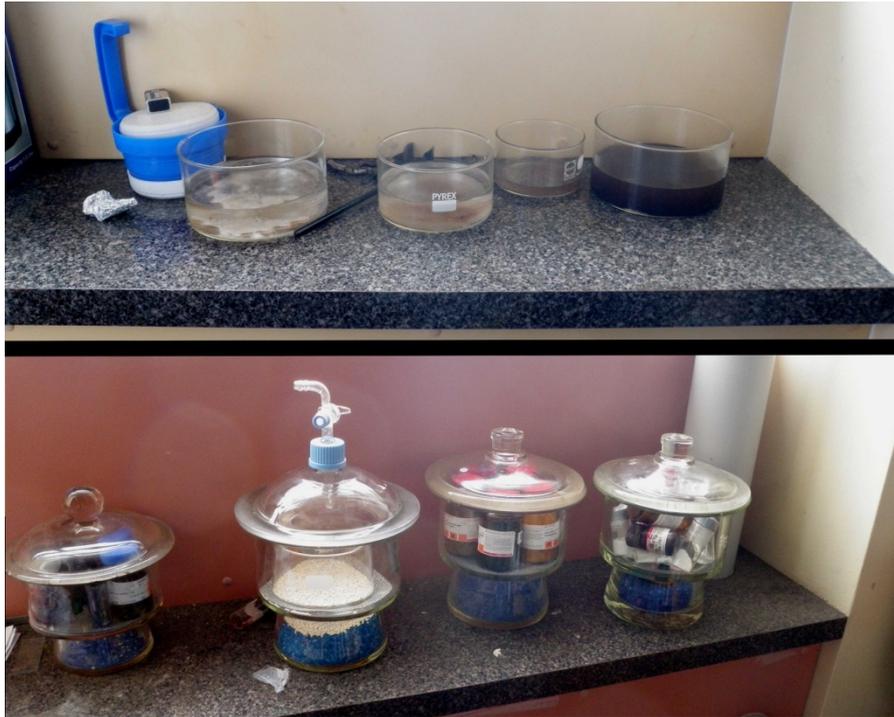
Sub-optimal storage of silicone-oil baths (top) and desiccators on unguarded sills. Fortunately, these items had not fallen, but silicone oil had splashed down the wall on to the floor.

2. Guards (for example Perspex or wire) should be affixed to any shelves or sills where loose items (sample vials, chemical jars, desiccators etc.) are likely to be stored. This includes the tops of cabinets, refrigerators, ovens and any other places that are likely to provide tempting storage spots.

4. Spilt silicone oil is very problematic. Where appropriate, alternatives to oil-bath heating should be used. If oil-bath heaters are required, splash-proof baths should be employed (we need a design) and the oil should be returned to a sealed container when not in use.

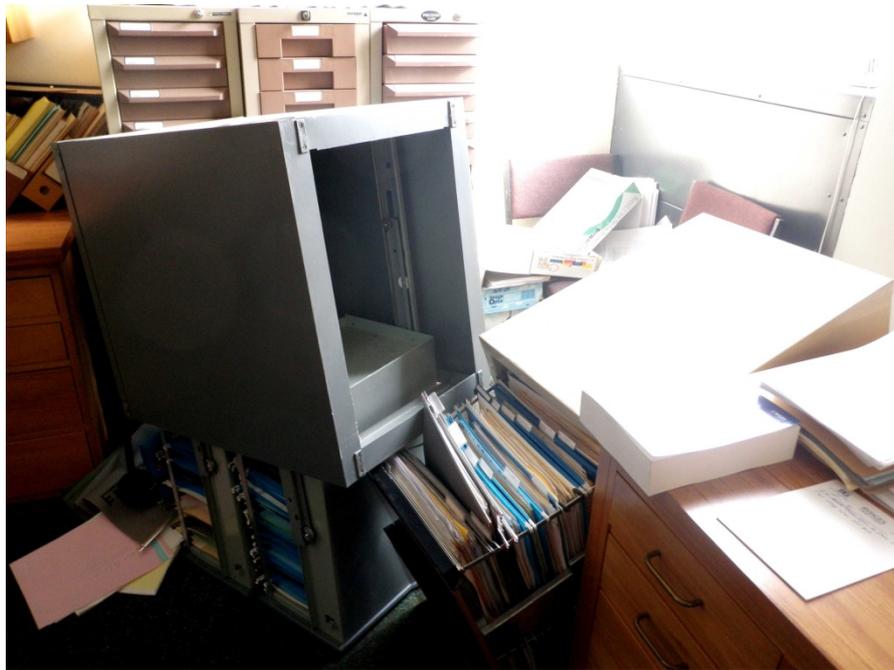
A consequence of stacked filing cabinets. Toppled cabinets would have presented a significant threat to personnel if offices had been occupied during the earthquake.

7. Half-sized filing cabinets should not be stacked on top of each other. Filing-cabinet drawers should be closed with the key in the locked position to prevent drawers from shaking open and overbalancing the cabinet.

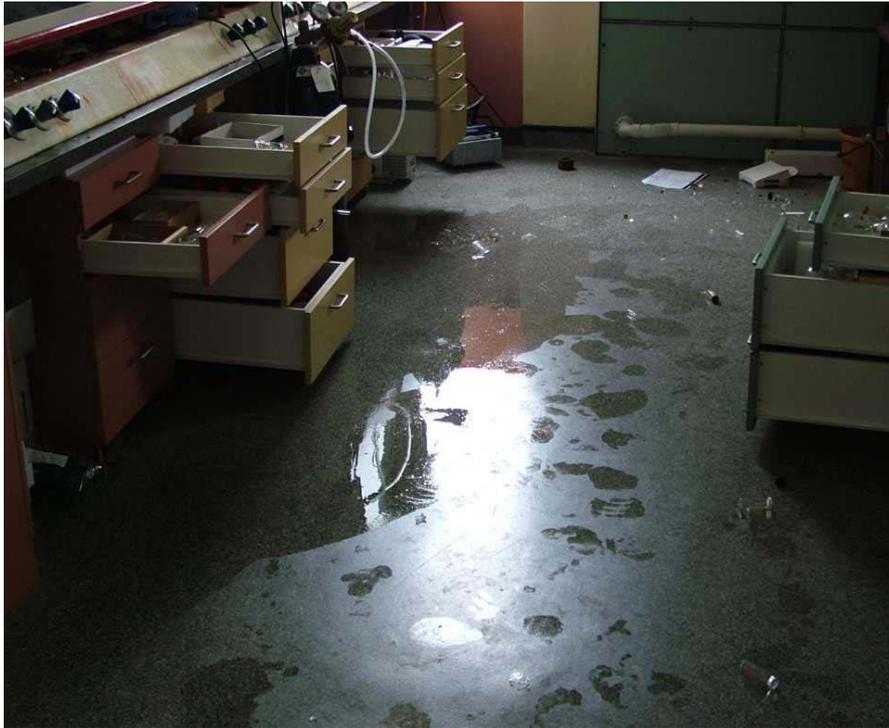
A few things didn't fare so well. Chains used to fix light fittings to the ceiling and (in a couple of instances) gas cylinders to walls had been shaken off open-loop hooks. Items left on un-lipped bench tops fell to the floor resulting in a lot of broken glassware. The latter problem was exacerbated by the fairly extensive spillage of silicone oil (used as an inert heating-bath medium). The mixed glass and oil was both the greatest hazard and the most difficult thing to clean up.

Spilt silicone oil presented a major slip hazard and was very difficult to clean up.

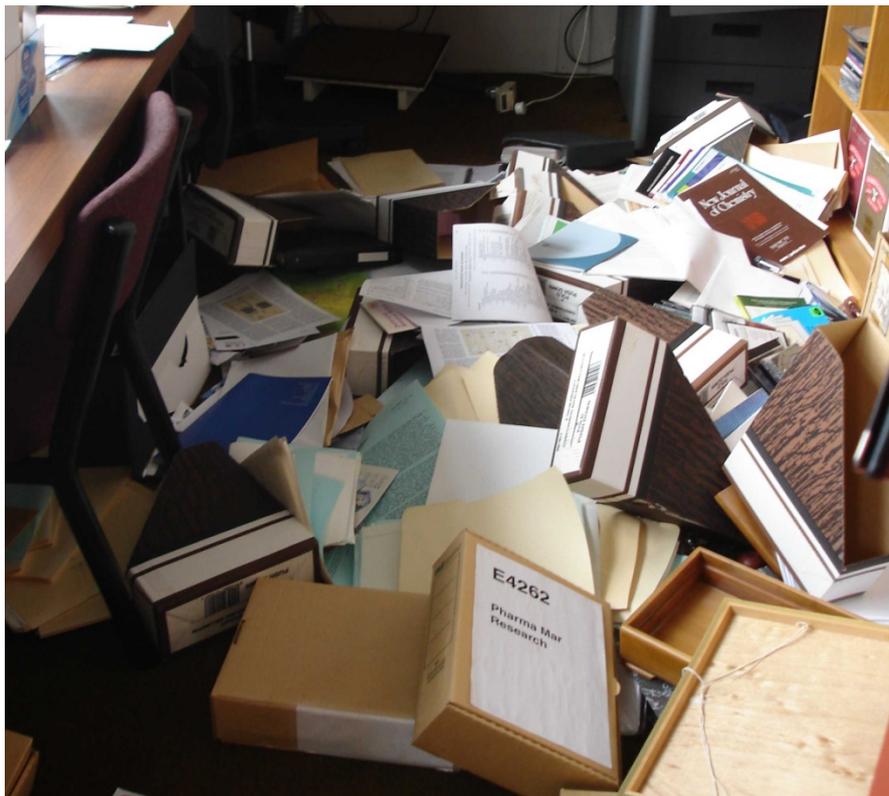
Superficial mess in an upper-floor office.
