## PERFORMANCE OF CEILINGS IN THE FEBRUARY 2011 CHRISTCHURCH EARTHQUAKE

Rajesh P. Dhakal<sup>1</sup>, Greg A. MacRae<sup>1</sup> and Keith Hogg<sup>2</sup>

### SUMMARY

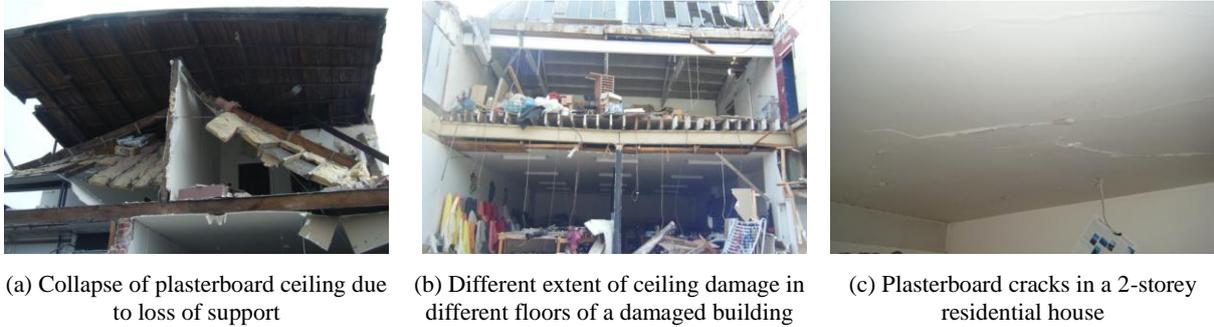
**Figure 3: Typical damage to residential plasterboard ceilings.**

Ceilings in residential buildings are typically small in size; which are made of plasterboards nailed and/or glued to timber studs. As shown in Figure 3, the damage to residential ceilings was related to the damage to the building's structural system. In residential buildings that had little structural damage, often ceilings also had little damage; mainly in the form of cracks on the plasterboard. However, there were cases, especially in the hill suburbs, where the ceiling diaphragm action was lost due to many cracks occurring in the ceiling. In structurally damaged buildings, ceilings and non-structural damage was often severe. For example, in the central city, most two-storey old unreinforced masonry (URM) buildings by the side of main streets had plasterboard ceilings. In most of these buildings, the front URM wall suffered out-of-plane collapse and the damaged ceilings were visible from the road. In some buildings, the ceiling was intact in one floor and severely

damaged in the other. In other buildings where the side walls were also damaged, the ceilings had collapsed.

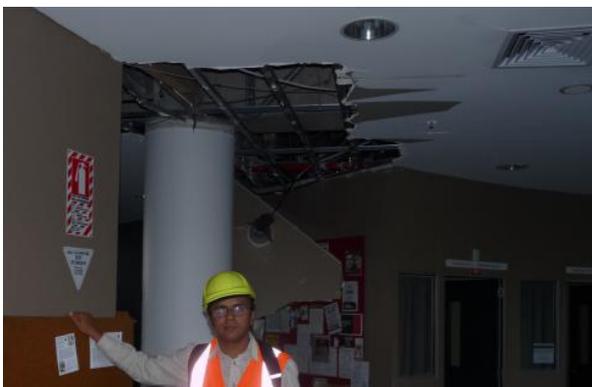
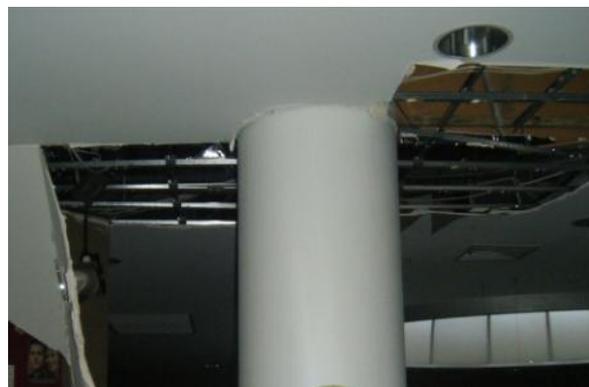
Some multi-storey office buildings in the city were found to have flush type ceilings which had gypsum plasterboards glued and nailed underneath steel channels. This type of ceiling was found in two buildings the authors inspected in the city. As shown in Figure 4, these ceilings were found to have suffered damage of different extent. In a four storey building in Hereford Street which had significant but repairable structural damage, parts of the plasterboard had ripped off at different locations; mainly in the periphery of circular RC columns (see Figure 4 first row). This damage seemed to have been caused due to a combination of the column drift and movement of services above the ceiling, both of which applied extra force on the ceiling board. In another high-rise building (more than 10-storey) which also had significant structural damage, the flush type ceilings were found to have been damaged in the lower 3 floors (upper floors could not be

accessed due to safety concerns). In this building too, the ceiling damage was in the form of long/wide cracks leading to tearing of the board at some locations. The damage was found to be more around the edge/corner and less (almost none) towards the middle.

Damage to flush type ceiling in a four story building in Hereford Street

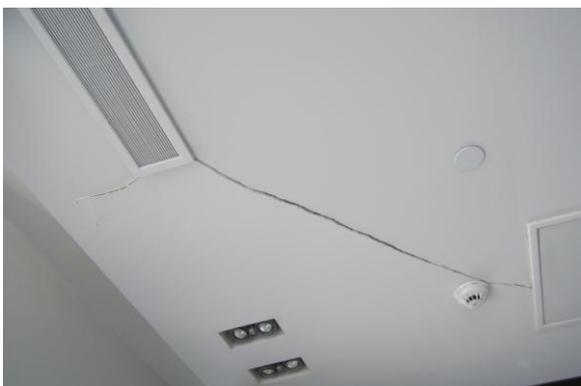
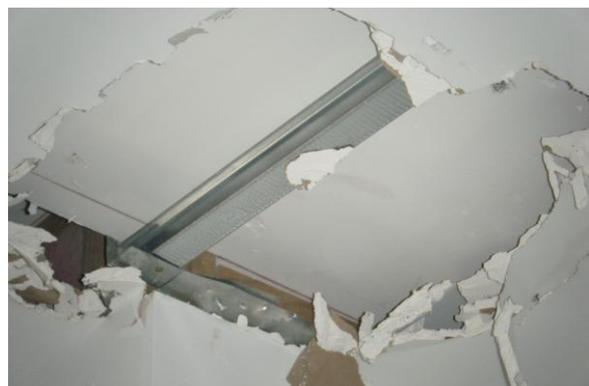
Damage to a plasterboard ceiling in a high rise office building in the city

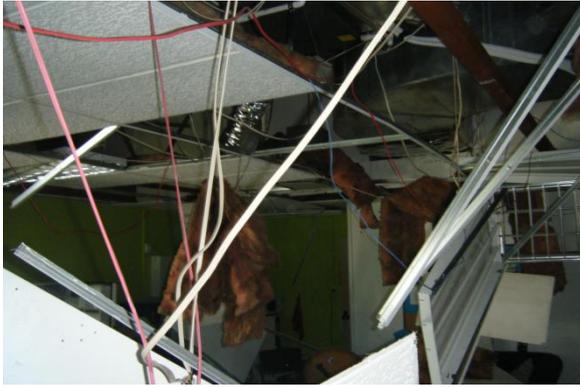
Failure of splice connection of the main beam

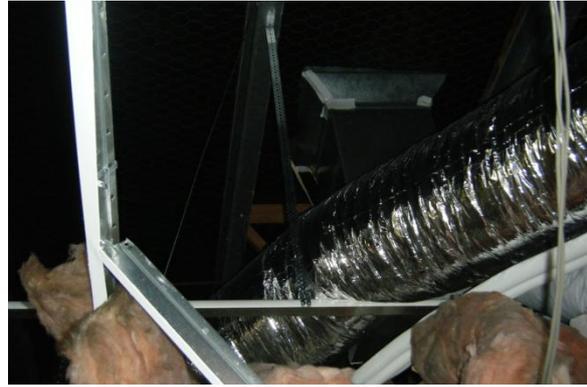
Failure of grid cross-member connection

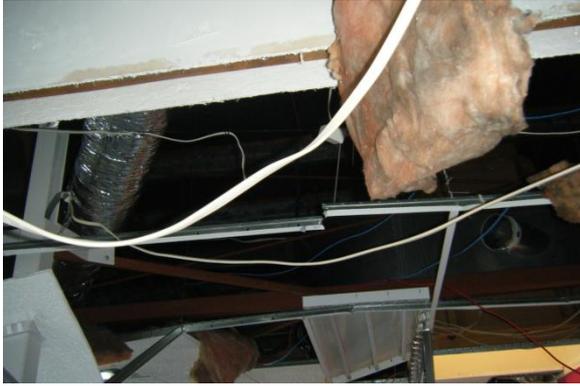
Breaking, buckling and twisting of grid members due to large compression force

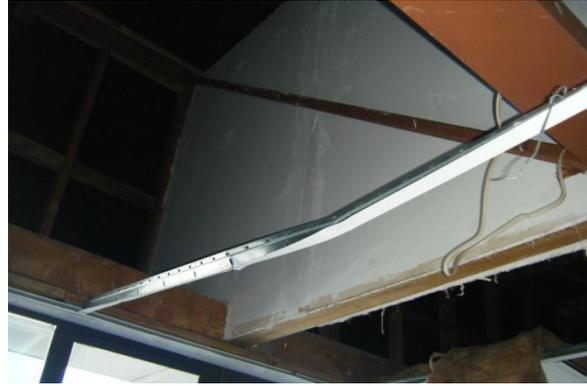
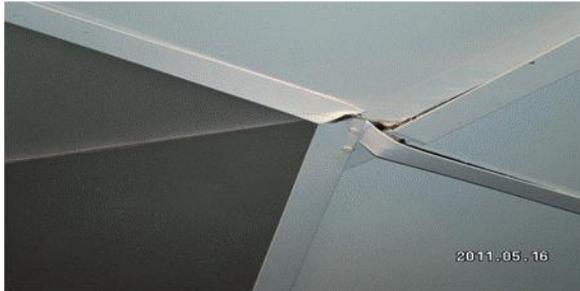
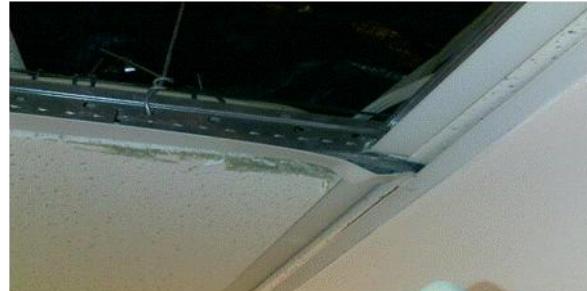
Damage to grid members due to excessive compression force (Photos: K Hogg)

Grid damage results from excessive force on the grid members or connections. This then results in distortion of the ceiling grid under compression and subsequent buckling of the grid members or failure of the connections while the perimeter connections remained intact. Often, failure of one member or connection in a grid leads to a progressive failure of other members and connections; thereby resulting in a chaotic global collapse of the whole ceiling system. As tiles generally fall from the damaged grid, this type of damage poses a life-safety hazard. In some cases heavy tiles fell as far as 6 m onto the area below and it was fortunate that there was no injury or loss of life.

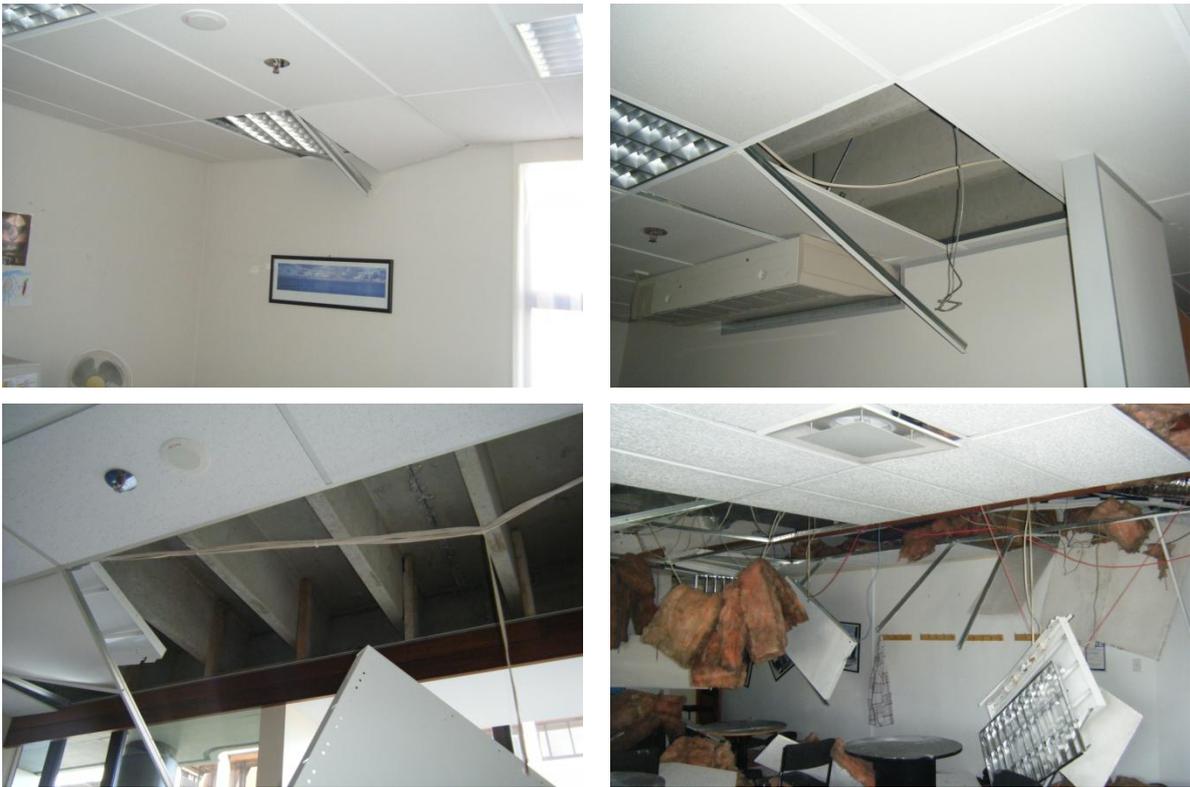
**Figure 6:** Localised ceiling damage due to failure of the grid members to wall angle connection.

Perimeter damage results from the main or cross-tee losing seating on the perimeter angle around the ceiling. Loss of seating can result due to a lack of a rivet to connect the grid member to the angle or failure of the rivet itself. This results in the grid members and tiles dropping from the ceiling. The

In most cases, the cause of perimeter damage was inadequate performance of the rivets used to connect the grid members to the wall angle. Common current practice is to connect the grid members to the perimeter angle with centre single size riveting which only connects to the face cap. As shown in the first two photos in Figure 7, such a riveting system was found to be inadequate. In some cases, the inadequate rivets were observed to fail in tension, leaving only the aluminium cap to hold the system together. In other cases, the rivets were also found to have ripped through the steel wall angles and tee rails. Detail specification on the number, size and location of the rivets for such perimeter connections are currently missing from the standards. In one case, during repair after the Christchurch earthquake in February, the end tee connections were provided

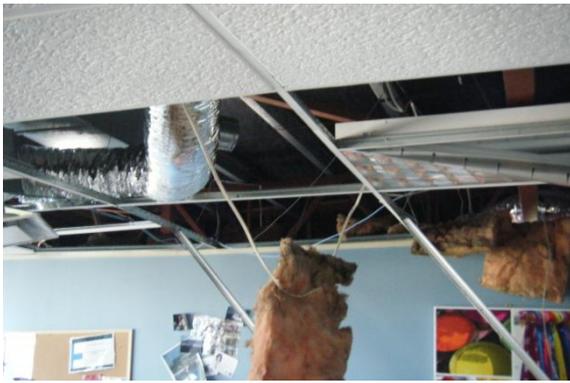
Ceiling damage caused by unbraced AC ducts

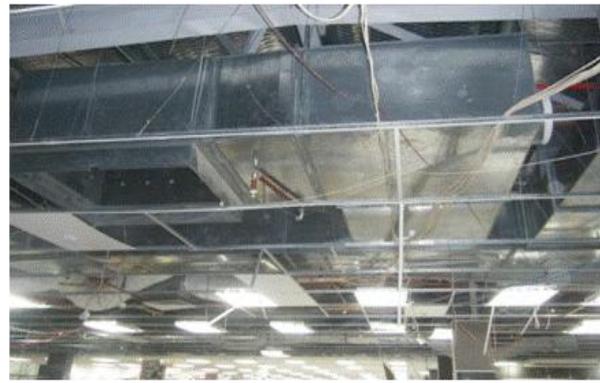
In some cases, the ducting volumes make it difficult for bridging and fixing of sprinkler ducts and in some buildings, the service height provided was found to be too small with no room for proper bridging under services. The right photo in the first row in Figure 8 shows a case like this. In one ceiling, a ceiling tile was broken due to a rigid sprinkler with an inadequate gap pushing the tile. It was felt that if a sufficient gap was provided around the sprinklers and any service and equipment were properly secured independent of the ceilings, the damage to suspended ceilings could have been greatly reduced.

Damaged ceiling with inadequate service height

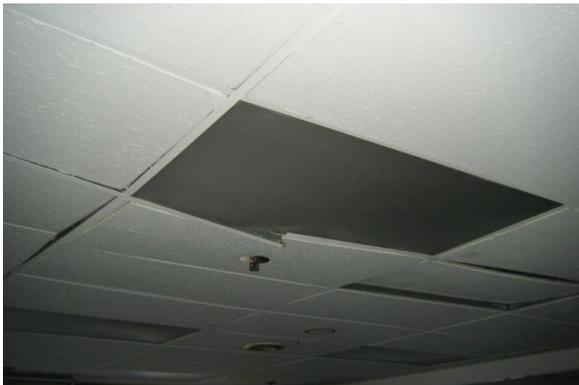
Localised damage to ceiling grid and tile due to interaction with sprinkler

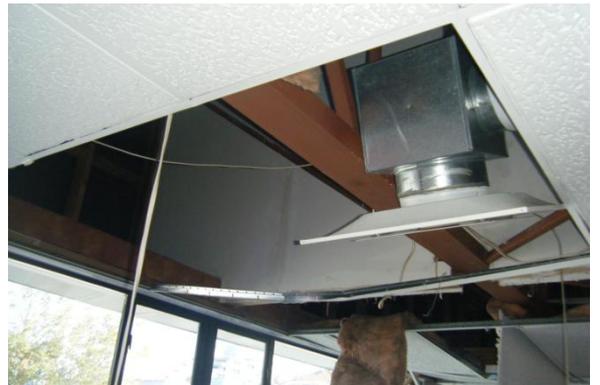
Interaction with service

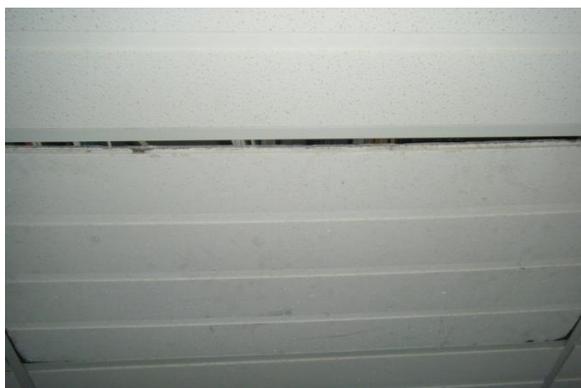
Typically the ceiling tiles sit on the flange of inverted T-beams of the grid without any fastening. No clips are used to hold the tiles in place, which implicitly assumes that the weight of the tiles is enough to keep them on the beam flanges. However, large vertical accelerations (as high as 2.2g) were recorded in some stations in and around Christchurch. When the tiles are subjected to vertical acceleration in excess of 1g, they will jump up, and when they come down they may not sit exactly inside the same grid. Vertical movement of ceilings may also have resulted from vertical deformations or rocking of some structural systems. As a result, it is not surprising to see some tiles dislodged from their original positions, and some fallen ceiling tiles possibly resulting from the vertical acceleration effect. In one case, the grid members

Dislocation of ceiling tile due to vertical acceleration

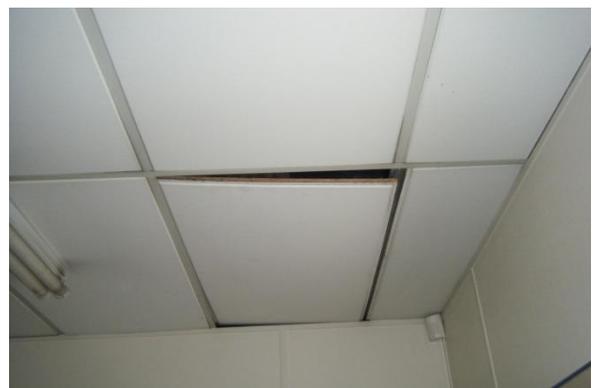
were intact in the shape of a rectangle but the tile was missing. In another case, the impact from the jumping tile seemed to have broken the flange of the grid member; resulting in skewed and tilted ceiling tiles (see Figure 9). The consequences of damage possibly caused by vertical shaking were not as severe as that caused by horizontal shaking.

Damage to flange of the grid beam due to tile impact

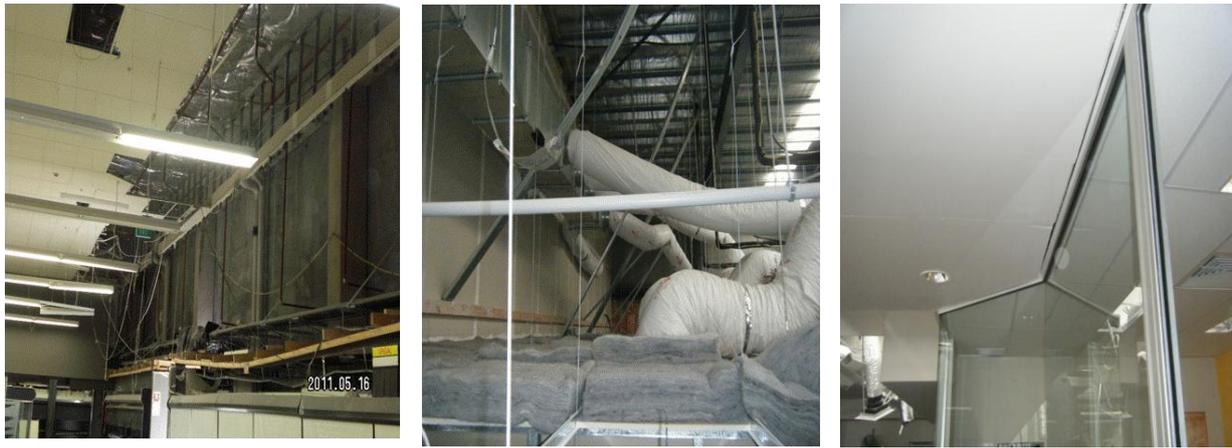
**Figure 10: Ceilings and other components likely to be damaged due to mutual interaction.**

Damage to ceiling and bulkhead

Bracing of partition wall can damage the nearby hangers during movement

Damage to glazed partition: glass panel detached from the top track

constructed this way can apply extra force into the ceiling during an earthquake; thereby damaging the ceiling. In some cases, the observed damage could be attributed to the interaction between ceilings and bulkheads. Bulkheads hanging from tiled ceilings dropped when the ceiling perimeter connection failed, as shown in Figure 10 left. In one building it was found that during renovation, bulkheads were removed but no bracing was put in place to take the ceiling load.

Interaction with partition walls also caused damage to some ceilings braced to the walls. Some internal walls extend to the floor above and are supported either directly by the floor or a beam through inclined braces. In some cases, the ceiling may also be supported on these internal walls. The braces of these walls are close to the ceiling hangers and other equipment braces and are likely to interact with the system. It was found that the failure of the braces (some of which fell off) could easily have caused significant damage to the ceilings (see Fig 10 centre). In some cases, the partition walls stop at the ceiling level and are braced by ceilings. Obviously, in such cases the ceiling needs to cater for the wall as well. Any change to these partitions during renovation can increase the ceiling loads. Glazed partitions fall into this category, and due to small aluminum sections they are difficult to brace. In some buildings, such wall partitions were found to be out of plumb and in glazed partitions the glass jumped out of the top track (see Fig 10 right).

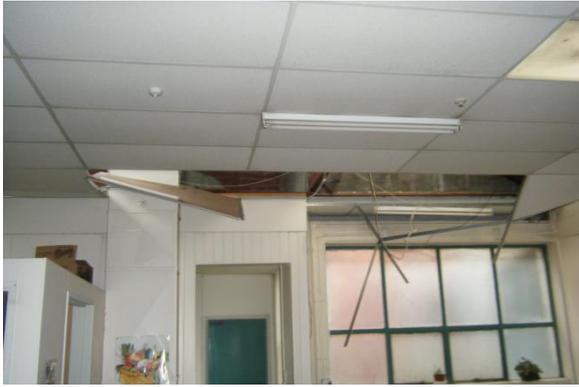
Typical grid failure at the end span near the wall due to accumulated force

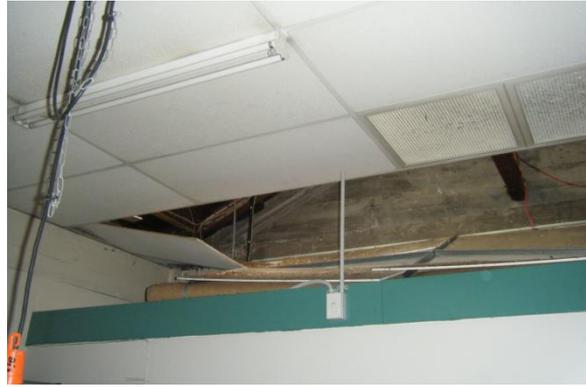
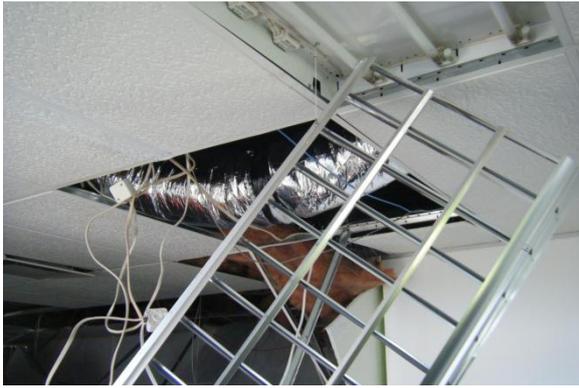
Damage incurred to a small ceiling

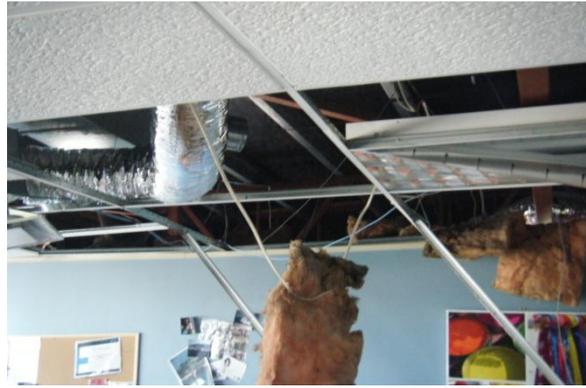
Damage to a large (7m x 12m) ceiling

ceiling in the bigger room is visibly more severe with failed grid members and connections in the perimeter and a large number of tiles fallen down. This strongly indicates that the size of the ceiling has a significant effect on the extent of damage.

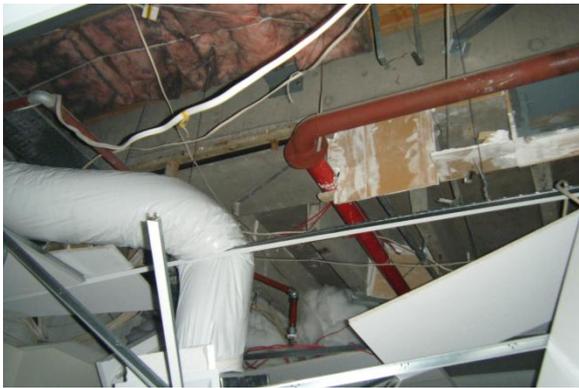
Ceiling damage in the upper floor with heavy tiles

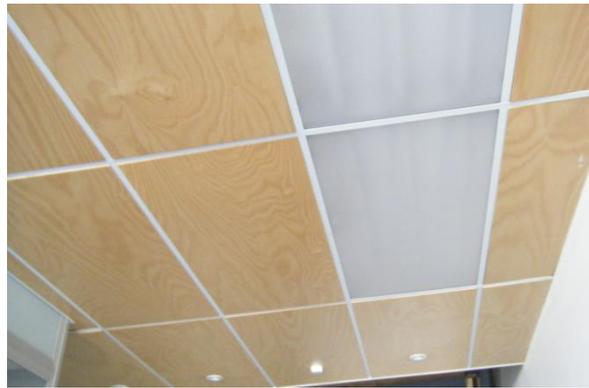
Undamaged light tile ceiling in the lower floor

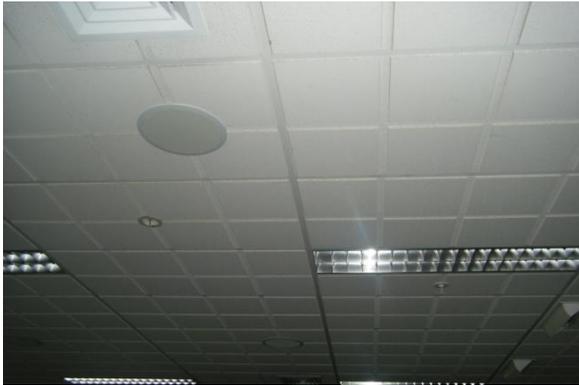
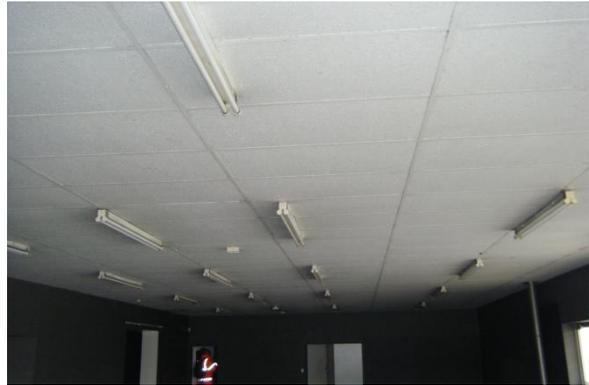
The second row of Figure 12 shows two ceilings which were reasonably large (one was 15 m long) but still remained intact after the earthquake. The left one is from a single storey lecture theatre in the University of Canterbury and the right one is from the ground floor of a two-storey commercial building in Tuam Street. Both of these ceilings used light-weight tiles. All heavy tiled ceilings of comparable size the authors visited were severely damaged. These observations further support the argument that the weight of the tiles has significant effect on the damage of suspended ceilings.

Rare cases of large suspended ceilings with little or no damage (both had light tiles)

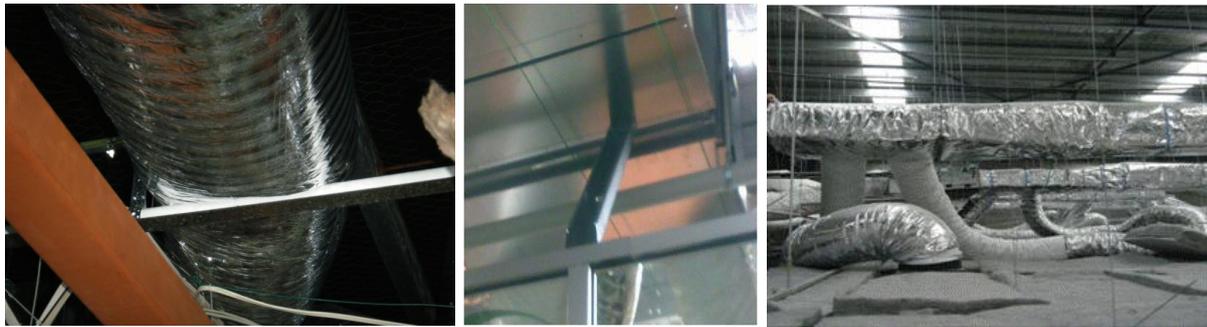
**Figure 14: Examples of malpractices in installation of components and services interacting with ceilings.**

Instances of unsecured services, improperly braced components, insufficient gap around sprinklers, inadequate gap above the ceiling, partition braces flirting with ceiling hangers etc could be noticed in a number of ceiling damage photographs provided in the previous sections. Some additional examples of such poor practices are shown in Figure 14. As can be seen in the photos, it is not uncommon to see the HVAC and other service pipes resting directly on the ceiling without any bracing from the floor above. Similarly, in

another example shown below, a damaged ceiling is being fully replaced with a seismically designed ceiling after the Christchurch earthquake, but the partition contractor braced the glazed wall to the A/C unit.

HVAC pipe supported by ceiling grid      Glazed wall braced to AC unit      Unbraced AC ducts resting on the ceiling
