GEOTECHNICAL ASPECTS OF THE 22 FEBRUARY 2011 CHRISTCHURCH EARTHQUAKE

SUMMARY

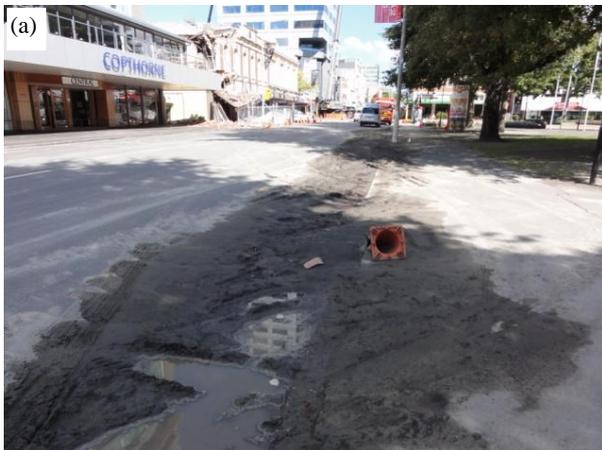
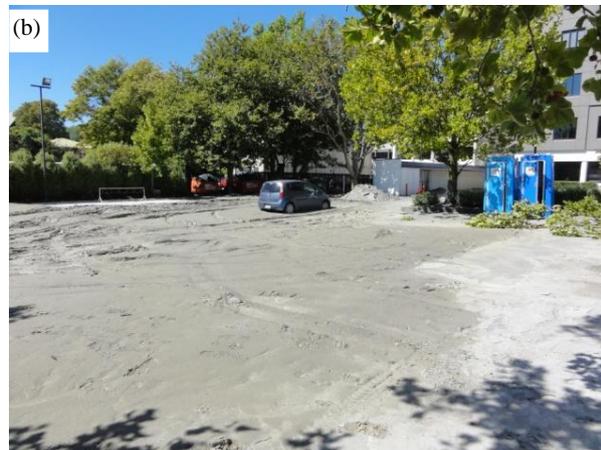
Even though the map shown in Figure 7 distinguishes the zone most significantly affected by liquefaction, the severity of liquefaction within this zone was not uniform. The manifestation of liquefaction was primarily of moderate intensity with relatively extensive areas and volumes of sediment ejecta (Figure 8). There were also areas of low manifestation or only traces of liquefaction, as well as pockets of severe liquefaction with very pronounced ground distortion, fissures, large settlements and substantial lateral ground movements. This non-uniformity in liquefaction manifestation reflects the complex and highly variable soil conditions even within the CBD principal liquefaction zone.

Figure 8. Representative areas of: (a) moderate liquefaction; and (b) severe liquefaction within the CBD principal liquefaction zone [7].

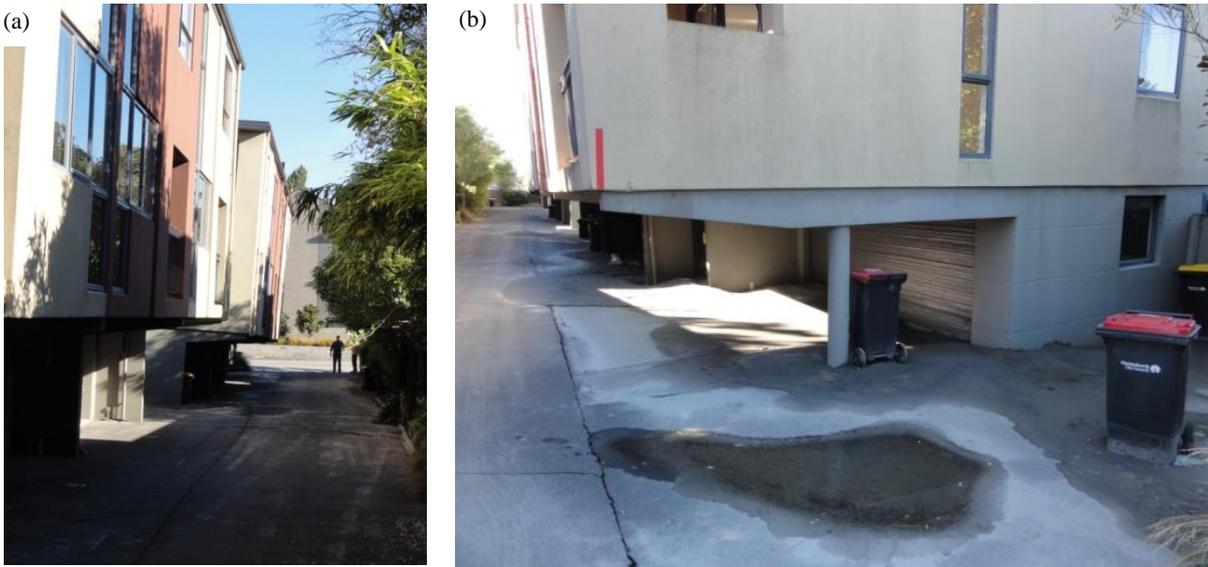
A mini-complex of three nearly identical buildings (with one small but important difference) is shown in Figure 9. The buildings are three-storey structures with a garage at the ground floor, constructed on shallow foundations. This case clearly illustrates the impact of liquefaction, with nearly identical structures built across the east-west trending geomorphic feature identified previously in Figure 7, one

Figure 9: Apartment complex: (a) looking south from northern building showing tilt of southern building, and (b) looking north at liquefaction feature at edge of southern building [7].

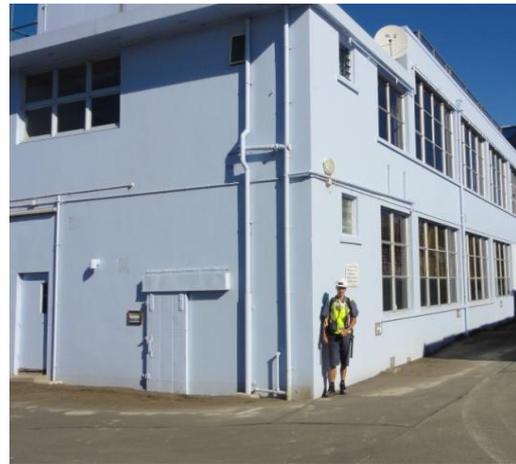
Several buildings with shallow foundations located within the liquefied zone underwent punching settlements with some undergoing significant differential settlements. An example of such performance is shown in Figure 12 for a two-storey industrial building located 200 m south-west of the buildings discussed previously. There was clear evidence of the mud-water ejecta on the walls of the building indicating about 25 cm thick layer of water and ejected soils due to the severe liquefaction. Note the continuous sand ejecta around the perimeter of the footing and signs of punching shear failure mechanism in Figure 12. At the front entrance of the building large ground distortion and sinkholes were created due to excessive pore water pressure and upward flow of water. Settlement of the building around its perimeter was evident and appeared substantially larger than that of the surrounding soil that was unaffected by the building. The building settled approximately 25 cm relative to a fence at its south-east corner and settled 10-20 cm relative to the ground at its north-west corner. The ground floor at the entrance was uplifted and blistered which is consistent with the pronounced settlement beneath the walls or along the perimeter of the building.

Figure 12: Two-storey building that underwent liquefaction-induced punching movements [7].

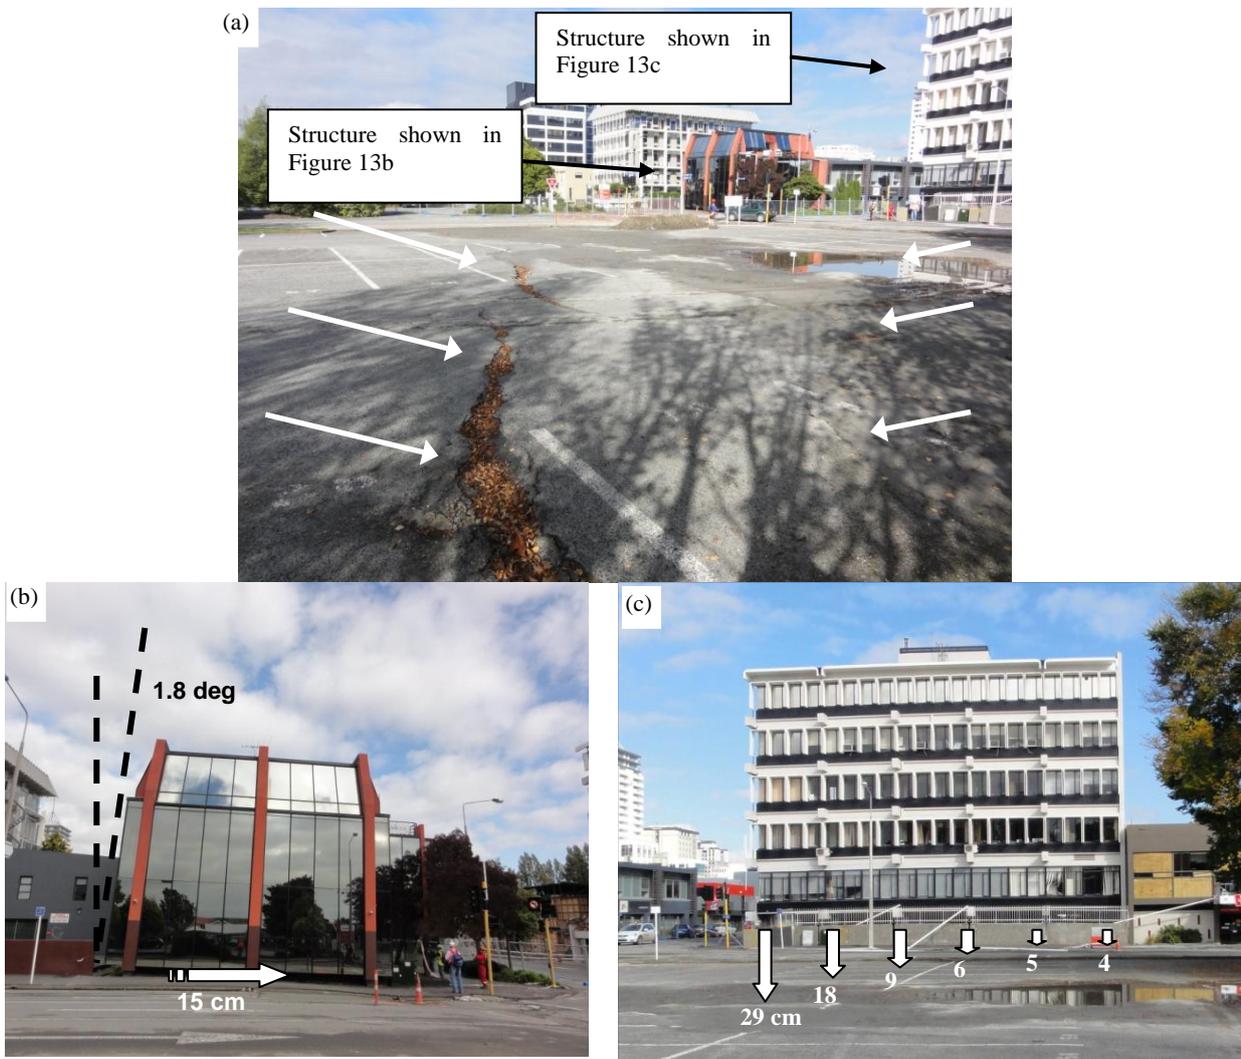
Further to the south at the intersection of Madras and Armagh Streets, several buildings were affected by severe liquefaction that induced significant differential settlements or lateral movements. At this location, the liquefaction was manifested by a well-defined, narrow zone of surface cracks, fissures, and depression of the ground surface about 50 m wide, as well as water and sand ejecta (Figure 13a, and the wide black zone to the south of the Avon River in Figure 7).

This zone stretches from the Avon River to the north towards the buildings, which were affected by this liquefaction feature. Traces of liquefaction were evident further to the south of these buildings. Figure 13b and Figure 13c illustrate two buildings, founded on isolated shallow foundations, that were located on the edges of the well-defined liquefaction zone in Figure 13a. It can be seen that for both structures lateral displacements, differential settlements, and consequent tilting were observed. Both buildings were considered uneconomical to repair and will be demolished.

Figure 13: Relatively narrow liquefaction-induced feature and induced differential settlement and sliding of buildings [7].

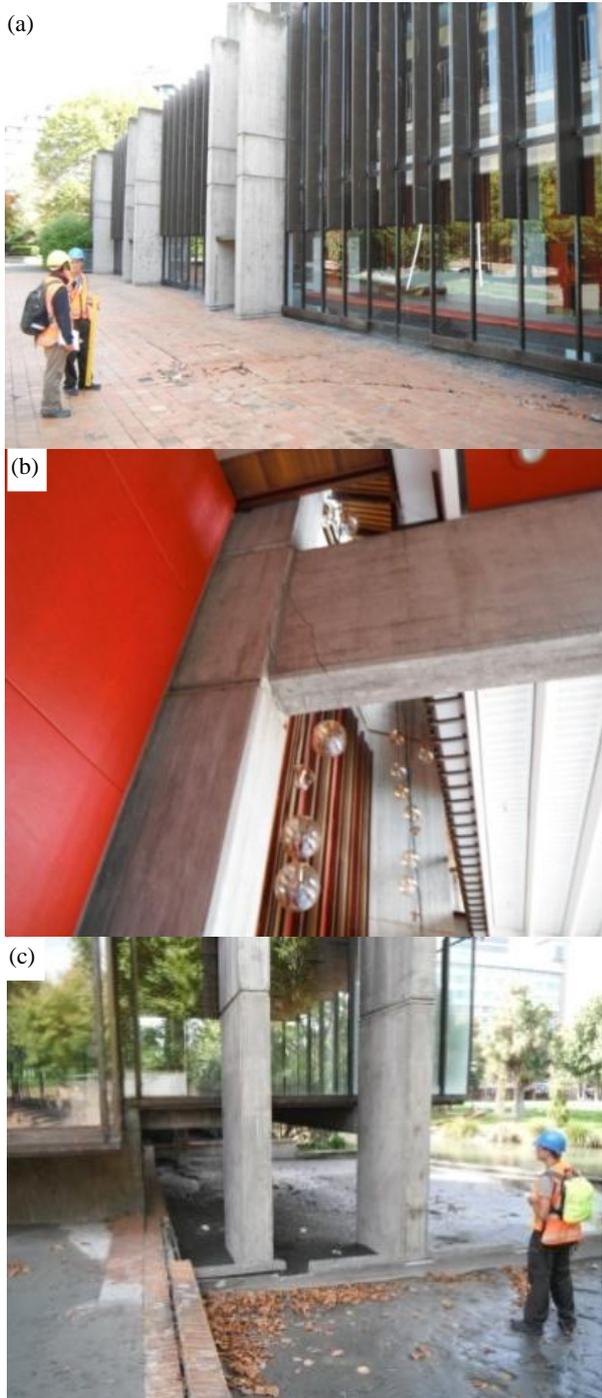
The facility suffered extensive damage primarily caused by liquefaction-induced ground failure. Differential settlements caused by punching shear beneath the building's main internal columns that surround the auditorium and carry the largest dead loads to shallow foundations and a second ring of exterior columns (Fig. 14a) that are connected to the inner ring via beams (Fig. 14b) caused distortion to the structure. The cracked beam shown in Fig. 14b underwent an angular distortion of 1/70 across its span. The seating for the auditorium has been tilted; dragged backward by the settlement of the columns, leaving a large bulge or doming to the floor of the auditorium itself. The air bridge connecting the main auditorium to the Christchurch Convention Centre to the north (away from river) has separated from the building.

Figure 14: Town Hall auditorium and adjacent dining facility undergoing significant liquefaction-induced differential settlement and lateral movements [7].

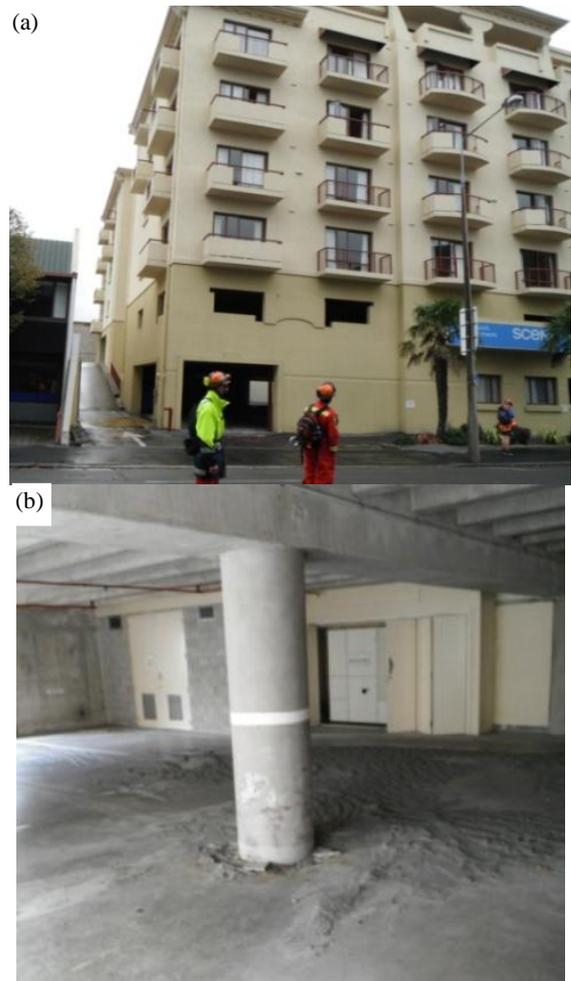
Contrary to the liquefaction-induced punching settlement of buildings into the surrounding ground that was observed at the Town Hall and in other parts of the CBD, the seven-storey building on shallow foundations shown in Figure 15a did not punch significantly into the liquefied ground nor undergo significant differential settlement. As shown in Figure 15b there were significant amounts of sand ejecta observed in this area. However, there was no obvious evidence of significant differential ground or building movement. The differential settlement measured between adjacent columns was typically negligible, but differential settlements of up to 3.5 cm were measured at a few locations. This building is across the street and slightly to the west of the Town Hall. It is a case of liquefaction without significant differential settlement and building damage.

Figure 15: Building in area of significant liquefaction that displays negligible to minor differential settlement or punching settlement [7].

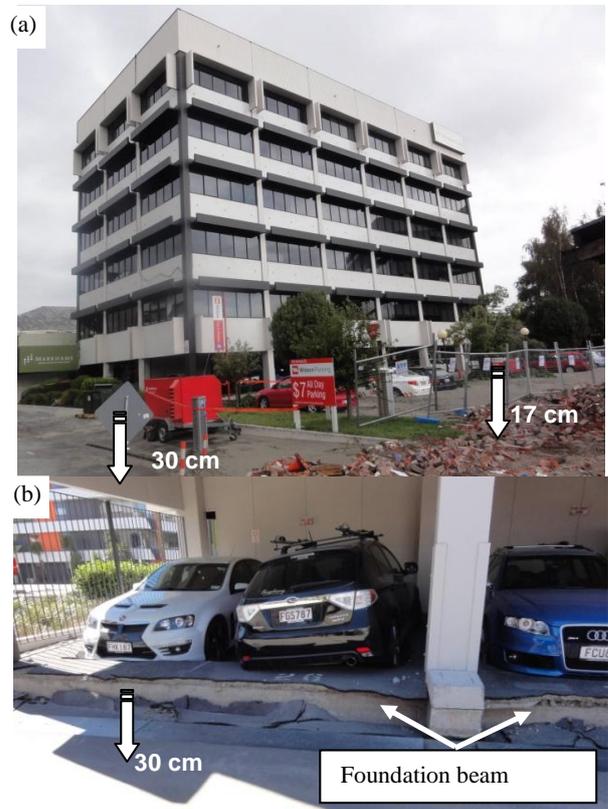
Several pile-supported structures were identified in areas of severe liquefaction. Although significant ground failure occurred and the ground surrounding the structures settled, the buildings supported on piles typically suffered less damage. However, there are cases where pile-supported structures were damaged in areas that underwent lateral spreading near the Avon River. In other cases, such as the building shown in Figure 16, located approximately 200 m to the east from the Town Hall, the ground floor garage pavement was heavily damaged in combination with surrounding ground deformation and disruption of buried utilities. The settlement of the surrounding soils was substantial with about 30 cm of ground settlement on the north side of the building and up to 17 cm on its south side. The first storey structural frame of the building that was supported by the pile foundation with strong tie-beams did not show significant damage from these liquefaction-induced ground settlements. Following the 13 June 2011 earthquakes, the settlement of the surrounding soil at the north side of the building reached about 50 cm.

Figure 16: Building on pile foundations in area of severe liquefaction showing large settlement of the surrounding soils relative to the foundation beams [7].

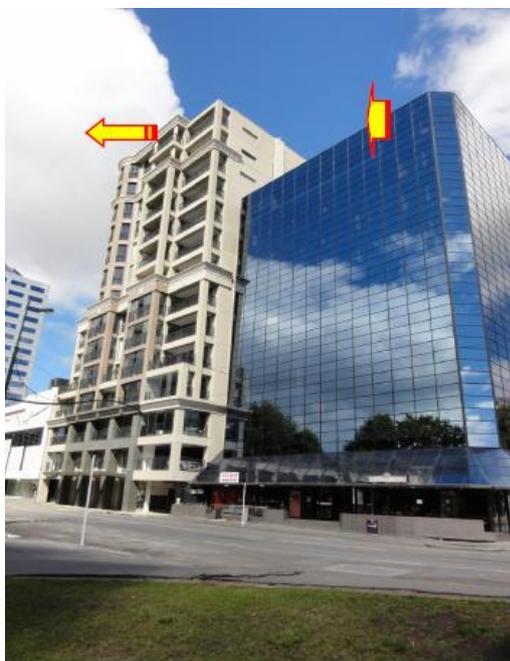
Near Victoria Square, the liquefied zone was predominantly composed of relatively loose sand deposits that transitioned relatively sharply into a zone where gravelly soil layers reach close to the ground surface. Shallow foundations (spread footings and rafts) for many of the high-rise buildings in this latter area are supported on these competent gravelly soils. However, the ground conditions are quite complex in the transition zone, which resulted in permanent lateral movements, settlements, and tilt of buildings either on shallow foundations or hybrid foundation systems (with both shallow and pile foundation elements), as illustrated in Figure 17. Immediately to the north of these buildings, the liquefaction was severe with massive sand ejecta; however, approximately 100 m further to the south where the gravels predominate, there was neither evidence of liquefaction on the ground surface nor visible distress of the pavement surface. Again, it appears that the ground and foundation conditions have played a key role in the performance of these buildings, with these buildings, accordingly, being selected for further in-depth inspections and field investigations.

Figure 17: Buildings on shallow and hybrid foundations in transition area from moderate liquefaction to low/no liquefaction; arrows indicate direction of tilt of the buildings [7].

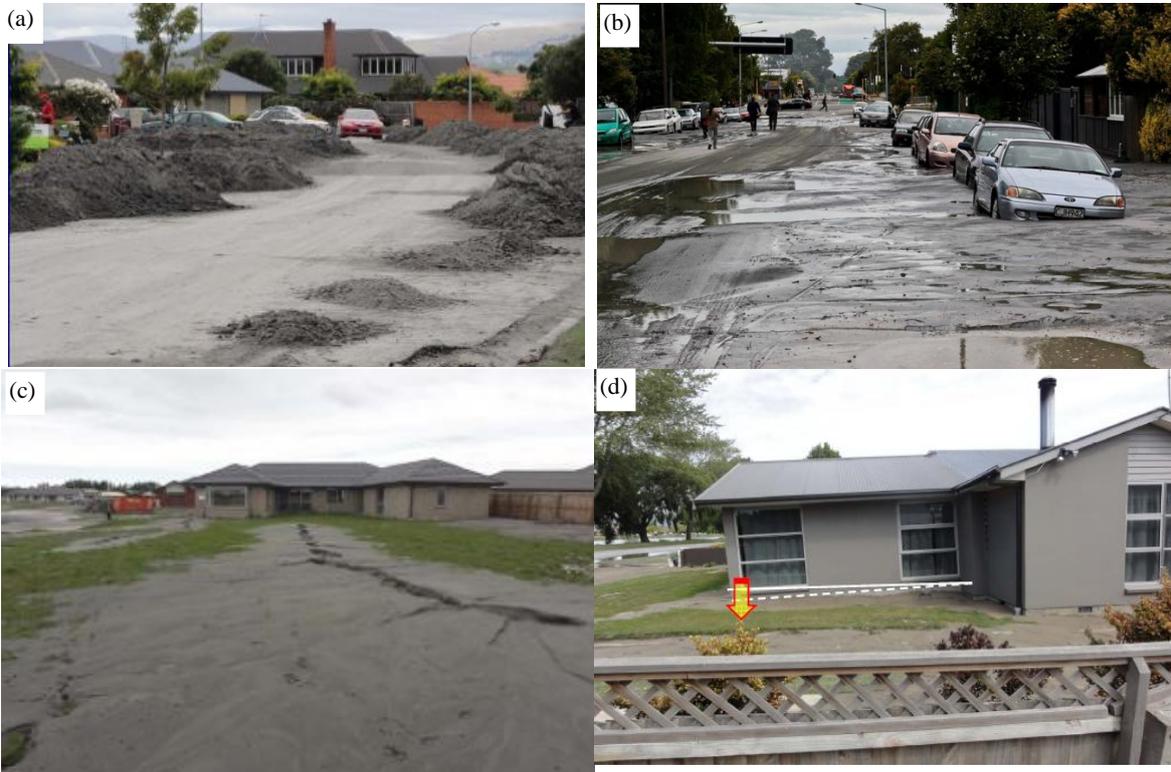
Figure 19: Typical manifestation of liquefaction in residential areas.

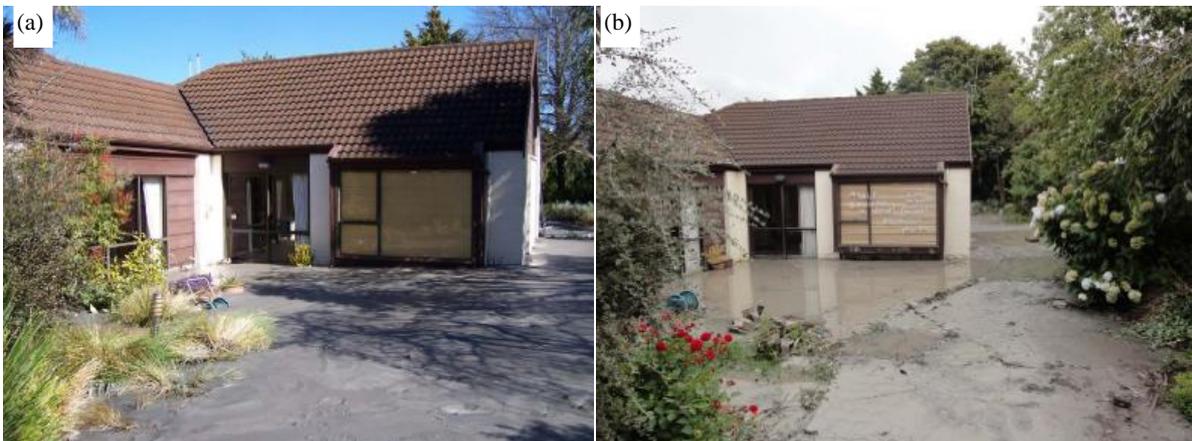
Figure 20: Illustration of a house in Kaiapoi which sustained liquefaction in both the (a) 4th September 2010 Darfield; and (b) 22 February 2011 Christchurch earthquakes.

Figure 20 indicates damage to a residence in Kaiapoi after the Darfield and Christchurch earthquakes. Following the Darfield earthquake there was large settlement of the ground and house, and approximately 40 cm of ejected material covering the ground surface. Site investigations performed following the Darfield earthquake indicated loose/soft soils up to depths of 9 m. Ground motions were largest in Kaiapoi during the Darfield earthquake and lesser in the Christchurch earthquake (PGA's of approximately 0.33g and 0.21g, respectively). Despite this, Figure 20b illustrates that the volume of ejected material following the Christchurch earthquake was again significant, and highlights the potential for repeated liquefaction during multiple earthquakes of the typical soil deposits in the region. A smaller volume of ejected material was again evident at this site following the 13 June 2011 earthquakes.

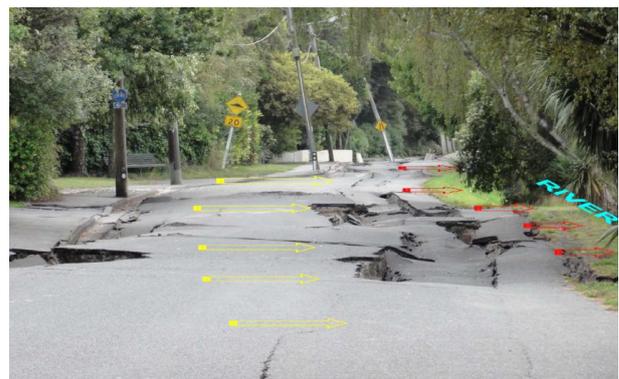
Along the Avon River, particularly to the east of CBD, lateral spreading occurred, causing horizontal displacements at the river bank on the order of several tens of centimeters to more than two meters (Figure 24). At ten locations along the Avon River, where lateral spreading measurements were conducted after the 4 September earthquake, measurements of lateral spreading displacements were carried out again after the February earthquake. It was found that the permanent lateral displacements were two to three times the displacement measured after the September earthquake indicating increased spreading movement which is in agreement with the more severe liquefaction observed in these areas during the February event. Ground surveying indicated that ground cracks associated with lateral spreading extended as far as

Figure 24: Lateral spreading toward the Avon River.

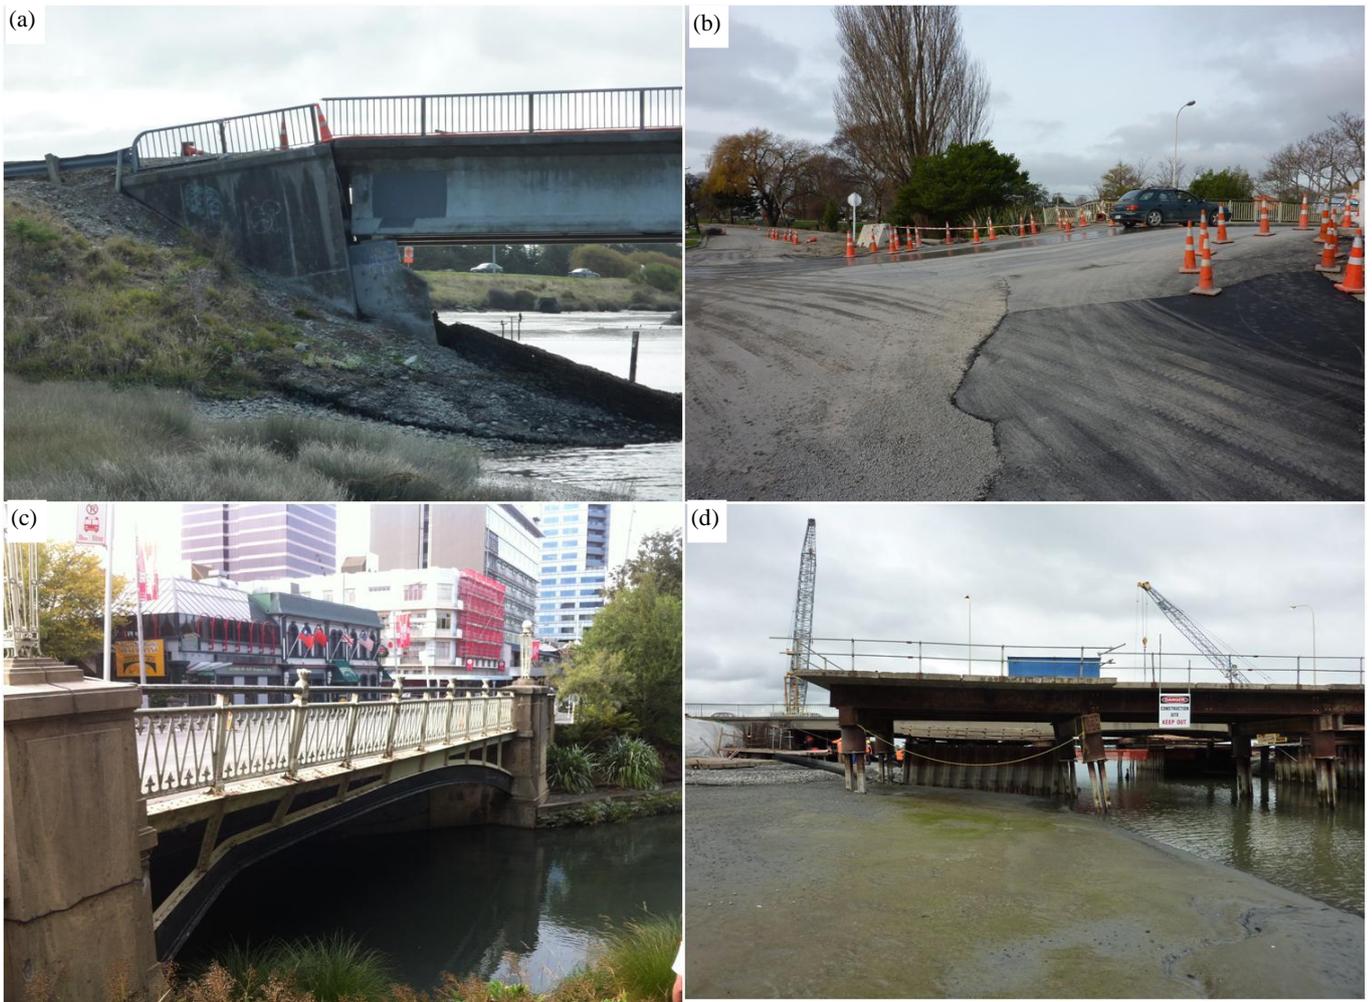
Figure 26: Summary of bridge damage: (a) back-rotation and settlement of the western abutment of South Brighton bridge; (b) settlement of the northern approach of Gayhurst Road bridge following the June 13 2011 earthquake; (c) abutment back-rotation and buckling of the steel arches of Colombo Street bridge; and (d) movement of temporary construction platform for Ferrymead bridge due to lateral spreading.

Bridge was one of the few bridges in the CBD to develop noticeable back-rotation of its abutments, being also one of the only bridges in the city with shallow foundations. This back-rotation resulted in the buckling of the arched steel girders and handrails at the edge of the bridge, as shown in Figure 26c.

Of the 14 bridges along the Heathcote River, one had major damage, two were moderately damaged, and the remainder were either undamaged or suffered minor approach damage, despite being near the fault rupture. This lack of damage is inferred as a result of soils in this region having larger resistance to liquefaction and lateral spreading than those in the vicinity of the Avon River. The most severely damaged bridge was the Ferrymead Bridge, at the mouth of the Heathcote River and entrance of the Avon-Heathcote Estuary. This structure was undergoing a deck widening upgrade at the time of the Christchurch earthquake, with the original structure, partially completed upgrade, and the temporary construction platforms all damaged by lateral spreading of the river banks (Figure 26d).

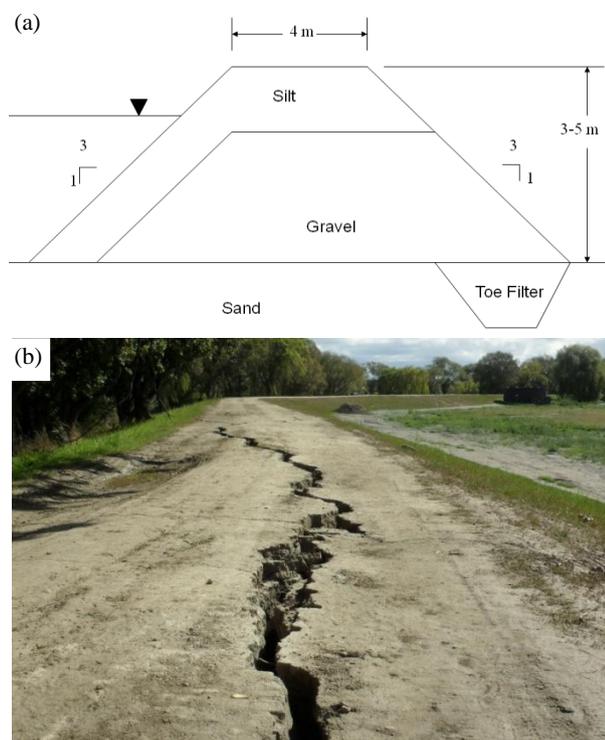
made up of a gravel core with 1-m thick silt cap, which extends from the river side and across the top, as shown in Figure 27a. The stop banks typically sit on sandy soils at or near the ground water level. A toe filter was also constructed on the land side of the levee to prevent piping of sand during a high water event. The majority of the damage to stop banks during the Christchurch earthquake was a consequence of liquefaction in the foundation soils that resulted in lateral spreading, slumping, and/or settlement. As illustrated in Figure 27b, longitudinal cracks were observed along the crest of the stop banks. Although not desirable, moderate longitudinal crack widths are not as critical to the functionality of the stop banks as transverse cracks because they do not provide a direct seepage path through the stop bank. However, there is the potential for such longitudinal cracks to connect undetected transverse cracks or flaws that only penetrate partway through opposite sides of the stop bank. The resulting seepage path could potentially rapidly enlarge due to internal erosion and piping at high river levels.

Transverse cracks in the stop banks were less commonly observed than longitudinal cracks and were often associated with sharp bends along the length of the stop banks and/or slumping of the embankment. Because these cracks provide a direct seepage path from one side of the stop bank to the other, they can severely impact the functionality of the stop banks. Even transverse cracks having minor widths could potentially rapidly enlarge due to internal erosion and piping at high river levels and lead to the failure of that section of the stop bank.

Figure 27: (a) Typical geometry and soil composition of stop bank cross section; and (b) typical longitudinal cracks running along the crest [17].

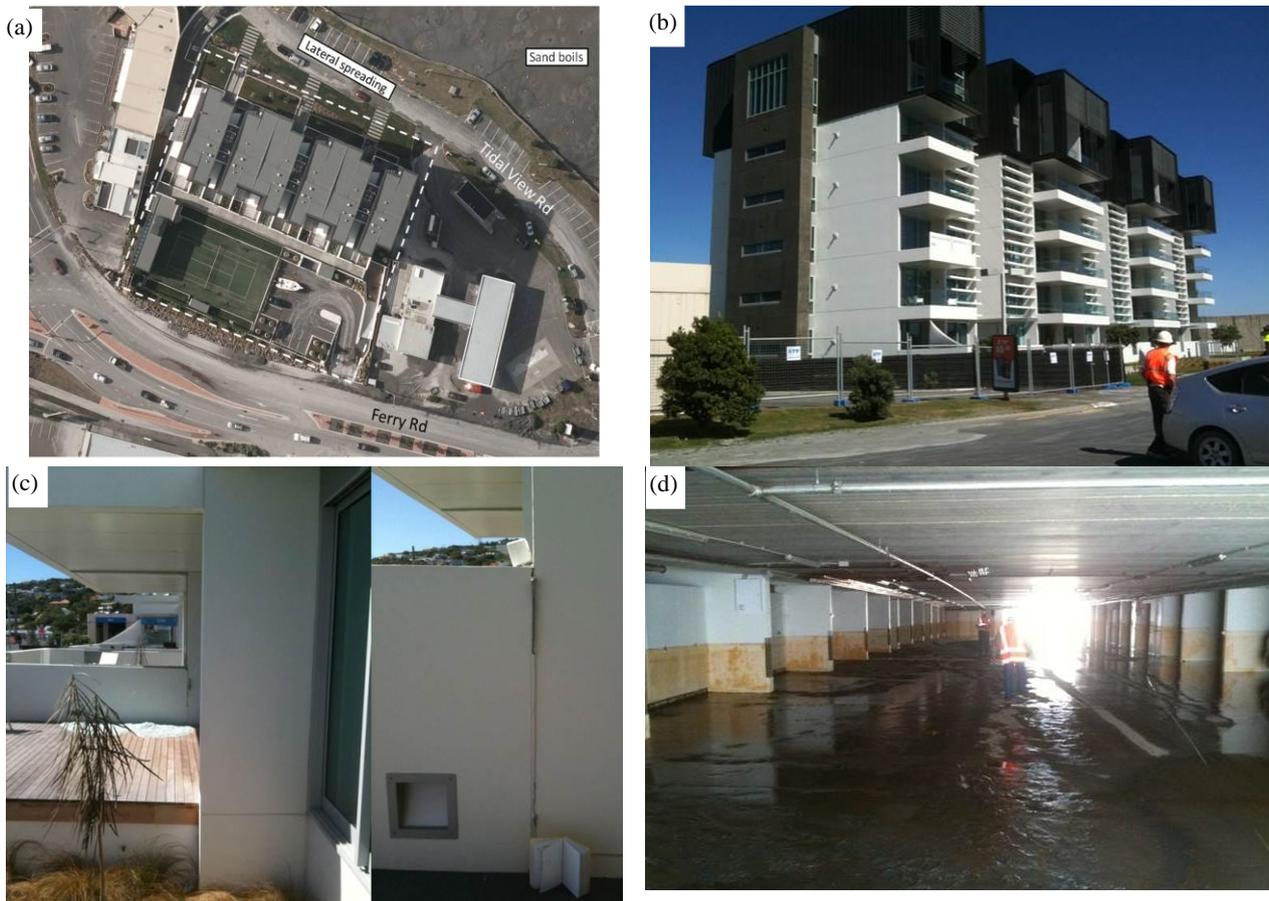
There was evidence of movement of the building following the Christchurch earthquake, however these were relatively minor given the severity of liquefaction in the surrounding area. The building settled between 4 and 8 cm and had a slight tilt toward the water. On the north side of the building, separation walls on the ground surface showed differential movement as shown in Figure 32c. The separation walls sloped downward towards the building at an angle of about 0.4 to 0.5 degrees. This caused the caulk in the expansion joint to

Figure 32: (a) Aerial view of Ferrymead apartment building indicating surrounding ejected material; and (b) south-west looking view of the apartments; (c) separation of walls on the north side of the building, including sloping of the separation walls and shattered glass panels, and compression of caulk at top of expansion joint; and (d) the basement parking garage. Note the high water mark on the walls.

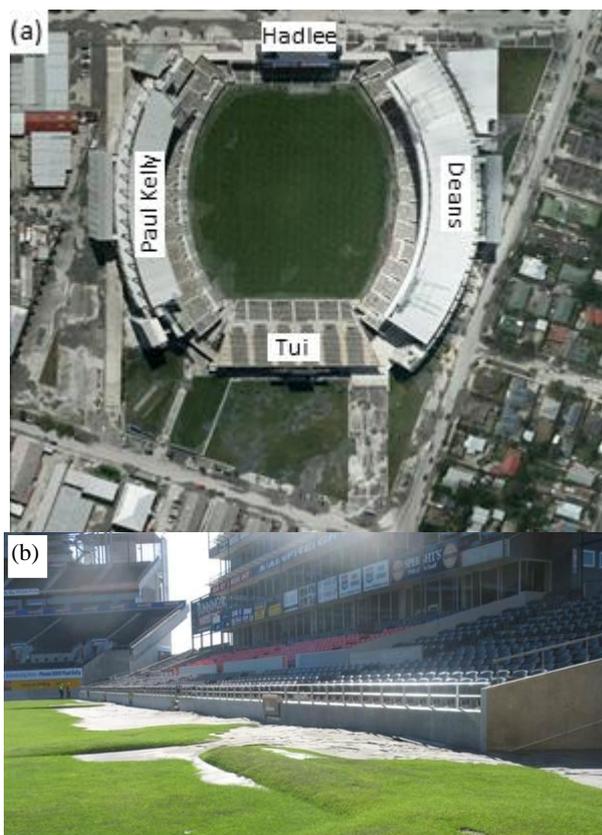
Significant liquefaction occurred on the field and manifested in the form of sand boils and surface deformations (Figure 33b). Due to mesh below the turf, significant undulations of up to 70 cm high occurred across the field because the ejected material could not vent to the surface.

Figure 33: (a) Aerial photo of AMI Stadium indicating liquefaction damage; and (b) Liquefaction damage to the stadium field.

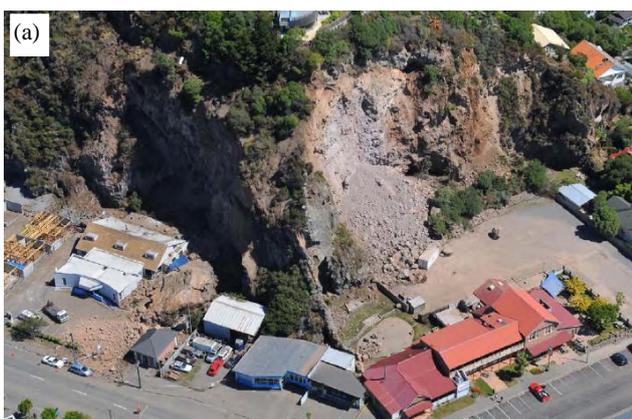
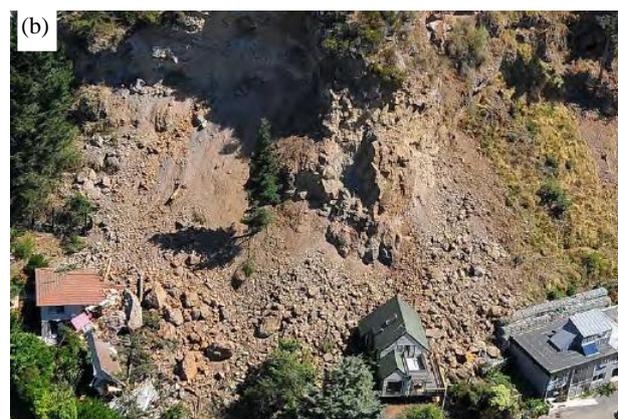
Rock falls, block failures, and other forms of landslides were widespread in the near-fault region around the Port Hills (Sumner, Redcliffs, Lyttelton, Cass Bay, and Rapaki). Landslides were significant on the northern side of Lyttelton Harbour, with relatively less rock falls on the southern side of the Harbour (e.g. Diamond Harbour). These slope failures resulted in five deaths and damaged or destroyed many roads, tracks, and structures. Almost every cliff face in the Port Hills generated a rock fall, while over-steepened road cuts and quarry walls were subjected to block collapse or large volumes of rock fall. Rock falls were the most widespread manifestation of slope failure, causing the five deaths and the most structural damage. Deep-seated landslides were found only at a few locations, most of which were at the top of coastal headlands. Numerous failures occurred in retaining walls and fill slopes, resulting in damage to roads, property, and commercial and residential structures.

Figure 34: Examples of rock falls on the Ports hills.
