# “Recovery of Lifelines” following the 22nd February 2011 Christchurch Earthquake: successes and issues

Sonia Giovinazzi, Thomas Wilson.

**2012 NZSEE  
Conference**

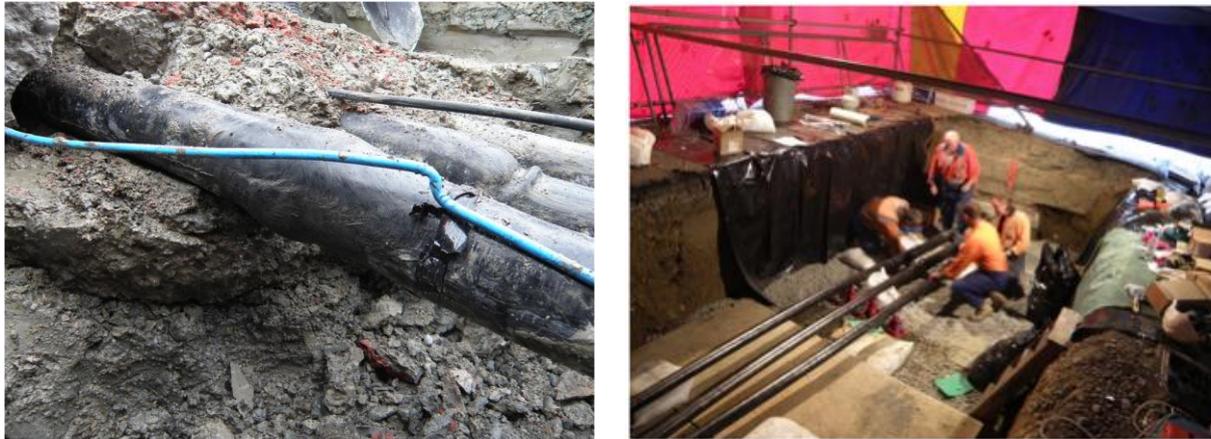
The power distribution network was badly affected following the 22 February earthquake. The large ground deformation induced by the earthquake caused multiple faults in 66 kV and 11 kV underground distribution networks, inducing major power outages and loss of functionality to the power distribution system.

Of the 66 kV underground cable network, 50% of cables were damaged, 30 km out of a total of 60 km. All major 66 kV cables, supplying Dallington & Brighton zone substations were damaged beyond repair and had to be abandoned. These cables were pairs of radial 66 kV 3-core aluminium (300 mm<sup>2</sup>Al), oil filled, aluminium sheathed with an outer cover of semi-conducting plastic sheath over the aluminium (Orion AMP 2009). Multiple faults were also identified in the 66 kV underground cables located within and close by the Christchurch CBD, namely: cable from Transpower Addington GXP to Orion Armagh substation (oil filled cables); cable from Orion Lancaster to Orion Armagh district substation (and the copper cross-linked polyethylene cable, Cu XLPE,), installed in 2002 to provide additional system security to the Christchurch CBD (Figure 1a). As a matter of fact the vulnerability of oil filled cables to earthquake-induced differential ground settlements was previously identified by Orion as potential risks (Orion AMP, 2009). In particular the oil filled cable from Dallington to Bromley 66 kV (damaged beyond repair following the 22<sup>nd</sup> February earthquake, as mentioned above) was identified at higher risk, being located in the area on the south side of the Avon River (Orion AMP, 2009).

**Figure 1. 66 kV underground cable distribution network: a) damage to 1600Cu XLPE cables; b) repair activities (photo credit Orion).**

Each of the cable faults took more than 12 hours to find and repair. The intensive post-earthquake work plan saw 700 electricity sector workers from around New Zealand and Australia contributing, under a mutual aid support agreement, more than 200,000 people-hours to earthquake recovery (Orion Media Release 22 June 2011).

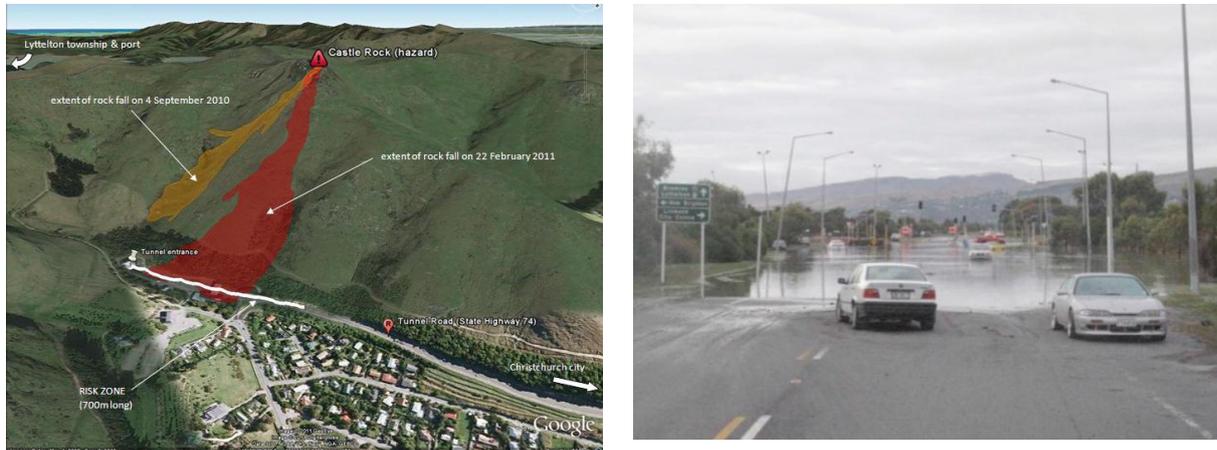
Rockfalls in the Port Hills led to several key road closures due to roads being blocked and were an on-going hazard from unstable rocks (Figure 2a). Closure included Evans Pass, which provides a vital link for oversized or explosive goods between Lyttelton Port and the city via Sumner, and Main Road which links the south-eastern suburbs of Redcliffs and Sumner to the city.

**Figure 2: Earthquake-Induced Damage to the Highway System: a) RockFalls in Port Hills following 4th September 2011 (yellow) and 22<sup>nd</sup> February 2011 (Red), threatening Tunnel Road State Highway 74, (Image credit Max Letham); b) Liquefaction induced flooding on highways.**

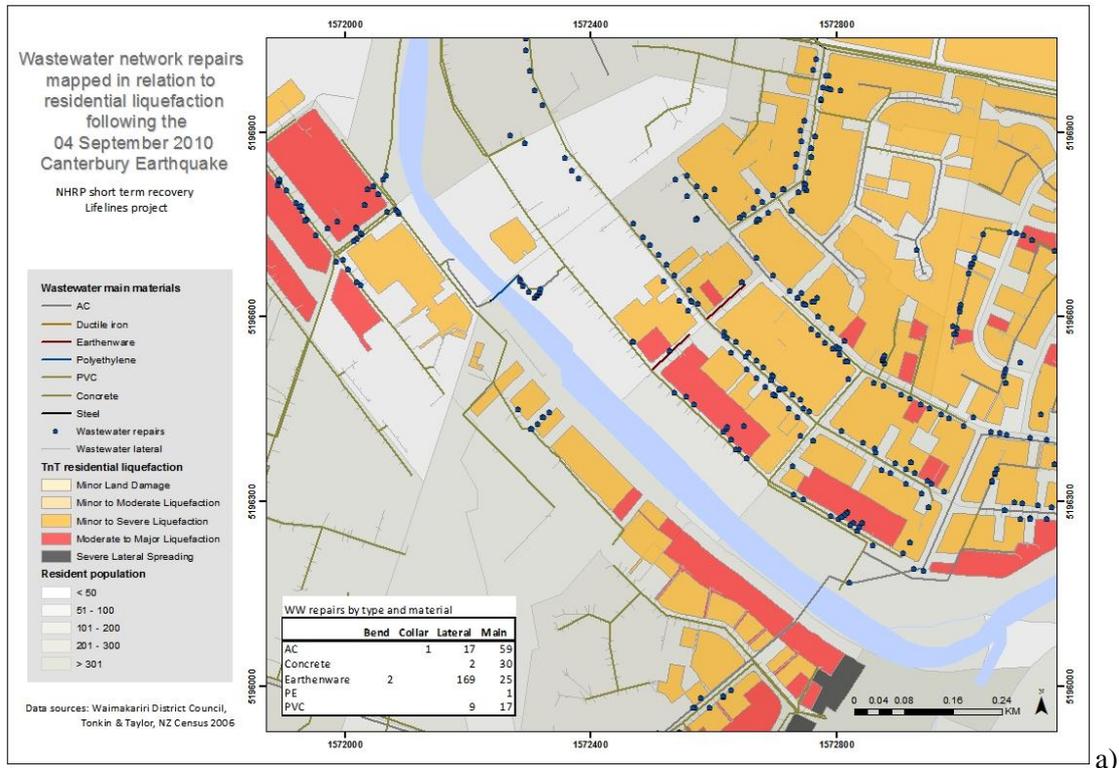
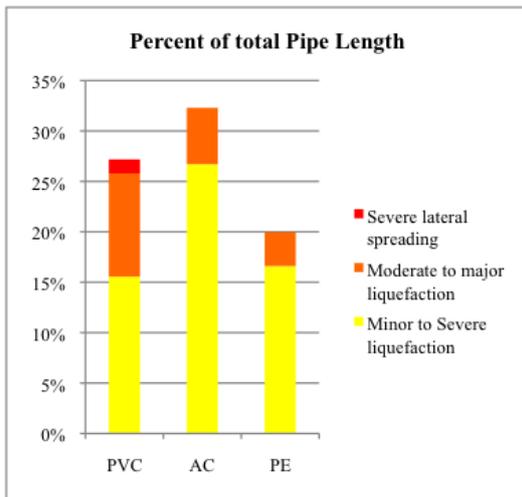
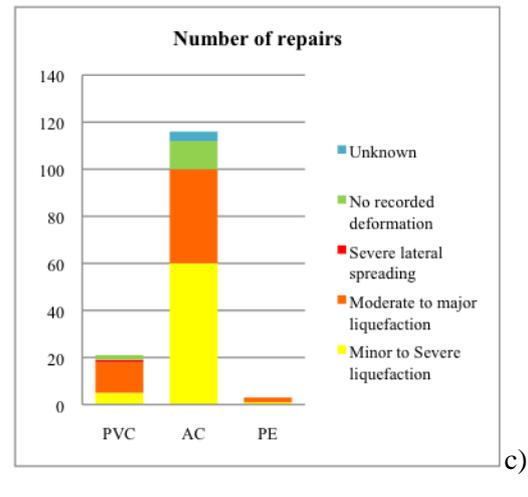
Figure 3 shows some preliminary maps and results of the damage to lifelines systems overlaid with the few maps and data on liquefaction induced ground-damage that were made available to the Recovery of Lifelines project (Table 2). In particular Figure 3a shows checks and repair activities to the wastewater network following 4 September 2011 earthquake. Figure 3b shows the percent of total length of different pipe materials within different ground deformation areas. Figure 3c shows the performance of pipes of different materials for the Kaiapoi water network following the 4 September earthquake. High Density Polyethylene (HDPE) pipes showed excellent performance.

**Figure 3. Kaiapoi waste-water and water networks following the 4 September Darfield Earthquake: a) map representing checks and repair activities to the wastewater network; b) Percent of total length of different pipe materials of the water network within different ground deformation areas (courtesy of Anna Mason); c) Number of repairs made on mains and rider mains in different levels of ground deformation areas. (Knight, 2011).**
