POST-EARTHQUAKE STRUCTURAL DESIGN FOR FIRE – A NEW ZEALAND PERSPECTIVE

Gregory B. Baker*, Peter C.R. Collier*, Anthony K. Abu** and Brent J. Houston***

* BRANZ Ltd, Porirua City, New Zealand
e-mails: greg.baker@branz.co.nz, peter.collier@branz.co.nz

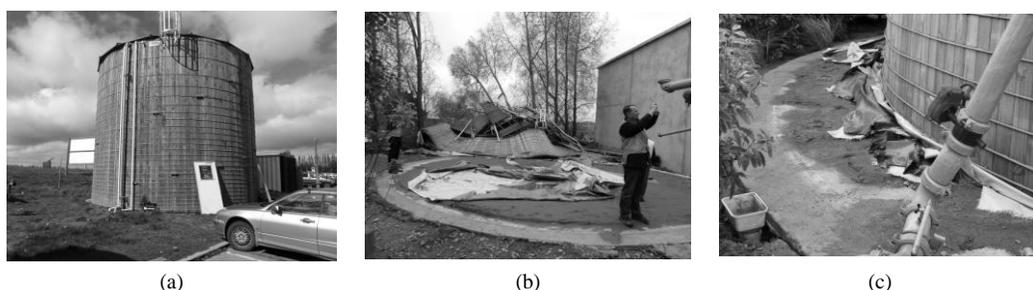
Figure 3. Timber stave water tanks: (a) typical tank c. 1980s; (b) collapsed tank; (c) damaged tank (courtesy FPANZ).

In the 1980s and 1990s, the construction method was mostly timber stave tanks, with an example shown in Fig. 3(a). A significant number of the timber stave tanks were damaged and a number suffered catastrophic failures. In Fig. 3(b), a timber stave tank has collapsed, while in Fig. 3(c), the tank has moved sufficiently to pinch the bladder in the tank and release all the water.

1. Alternative strategies need to be considered to ensure the sprinkler water supply from in situ tanks is more reliable in the event of earthquakes and consideration needs to be given to retrospective upgrading based on individual risk assessment.
2. Alternatives to dual mains supply for existing sprinkler systems need to be considered (now not permitted by the 2007 edition of the automatic fire sprinkler standard).
3. Fire pump systems need to be installed so as to minimise the risk from basements flooding.

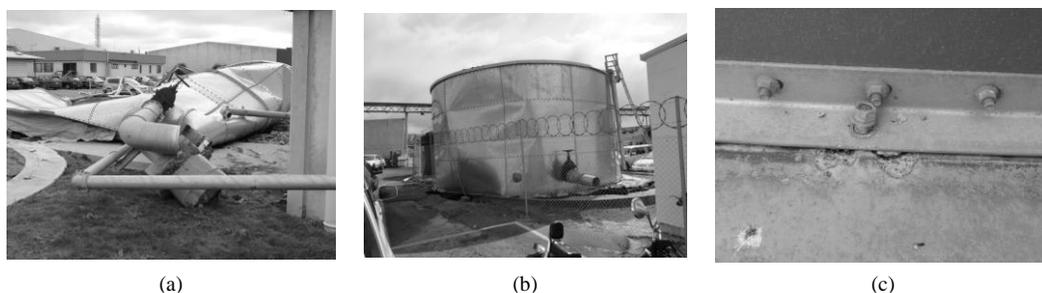
Figure 4. Steel water tanks: (a) collapsed tank; (b) damaged tank; (c) failed base fixings (courtesy FPANZ).

In the late 1990s, steel panel tanks became the norm. The performance of these tanks in the earthquakes was similar to the earlier timber stave tanks, with a collapsed steel tank shown in Fig. 4(a), a damaged tank in Fig. 4(b) and failed base fixings in Fig. 4(c).

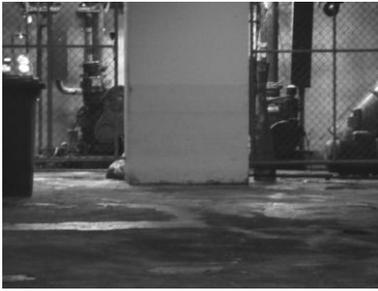
A range of damage to fire sprinkler systems was observed following the 2010 and 2011 earthquakes in Christchurch. Some fire sprinkler systems require a booster pump to boost either the town’s main reticulation or tank supplies. In a number of cases, the basements where these pumps are generally housed

were flooded, and the pumps were rendered inoperable. In Fig. 5(a), the water level is shown in the foreground on a column, which submerged the booster pump system in the background.

Figure 5. Sprinkler system damage: (a) flooded basement; (b) collapsed ceiling (courtesy FPANZ).

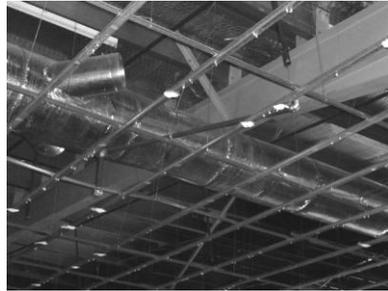
(b)

Figure 5(b) shows a suspended ceiling where the lining has collapsed – in a number of cases, damage to sprinkler systems was observed where non-structural components and systems had collapsed, but in the centre of Fig. 5(b), the sprinkler head has actually remained operable.

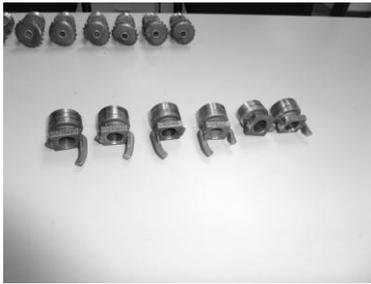
In a number of cases, the roof cross-bracing in low-rise commercial buildings caused damage to sprinkler fittings. Figure 6(a) shows sprinkler heads that have been sheared off as steel angle cross-bracing has moved backwards and forwards in response to the cyclic earthquake ground motion, while Fig. 6(b) shows damage to sprinkler pipework due to vertical movement of steel cross-bracing ‘pounding’ the pipework.

Figure 6. Sprinkler component damage: (a) sprinkler heads sheared off; (b) pipe work damage (courtesy FPANZ).

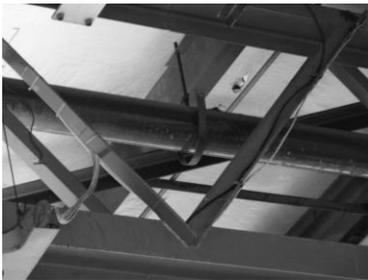
Figure 7. Sprinkler systems: (a) pipework support; (b) collapsed racking system (courtesy FPANZ).

The 1996 edition of the automatic fire sprinkler systems standard introduced requirements for seismic design of sprinkler systems, and as a result, modern pipe systems performed well in the 2010/2011 earthquakes, as shown in Fig. 7(a). A number of racking systems collapsed in the earthquakes, and where in-rack sprinkler systems were present, these also suffered damage, as shown in Fig. 7(b).

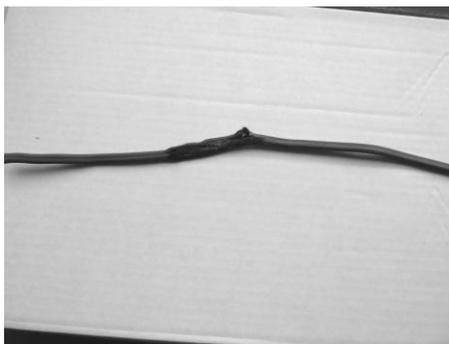
Whereas only some types of commercial/industrial buildings require sprinkler systems, the vast majority require a fire alarm system. The most obvious issue identified during the course of the research related to alarm system cable routing. It was apparent that very little, if any, attention had been paid to the consequences of seismic movement of buildings when installing fire alarm cabling. Damage was observed where cabling passed through holes in or around cut edges of structural and secondary steelwork. Another example of damage to alarm cabling was where cyclic movement of building elements such as concrete tilt-up wall panels crushed cabling, as shown in Fig. 8.

Figure 8. Crushed alarm cabling (courtesy FPANZ).

4. Trade practice with regard to routing of fire alarm cabling needs to be improved.
5. The seismic resilience of non-structural components and systems generally needs to be reviewed.

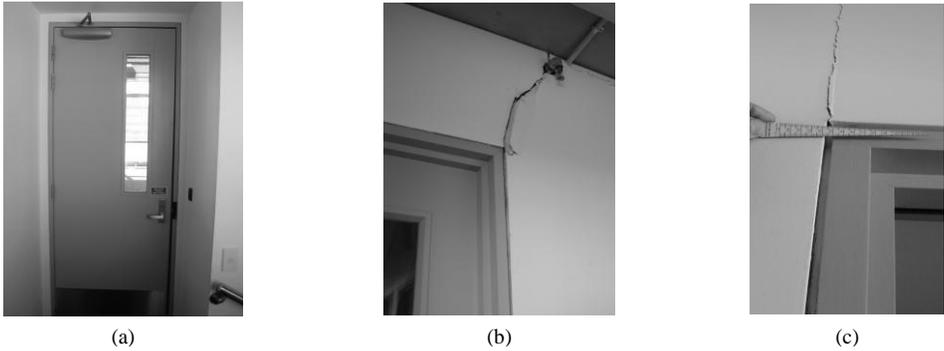
Fire doors were one area of focus for the site inspections, with a range of damage being observed. In Fig. 9(a), the gap down the door jamb has increased from 2–3 mm originally to 4–16 mm after the earthquake, while Fig. 9(b) shows damage to the fire-rated lining at the head of the door and Fig. 9(c) shows a 7 mm gap between the lining and door frame.

Figure 9. Fire door damage: (a) gap around door leaf; (b) diagonal crack; (c) gap between frame and lining.

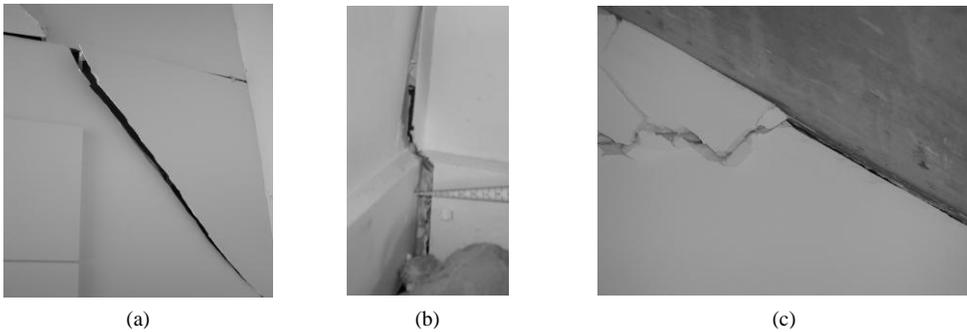
In a number of instances, damage to fire-rated walls was observed, as shown in Fig. 10. Figure 10(a) shows fire-rated lining having separated from the framing, Fig. 10(b) shows a wall-to-wall internal corner junction where a 15 mm gap has opened up in a fire-rated escape stairwell, and Fig. 10(c) shows the underside of a precast concrete stair where the junction to the fire-rated wall beneath has been crushed by earthquake-induced motion.

Figure 10. Compartmentation damage: (a) fire-rated wall; (b) stairwell; (c) stair soffit.

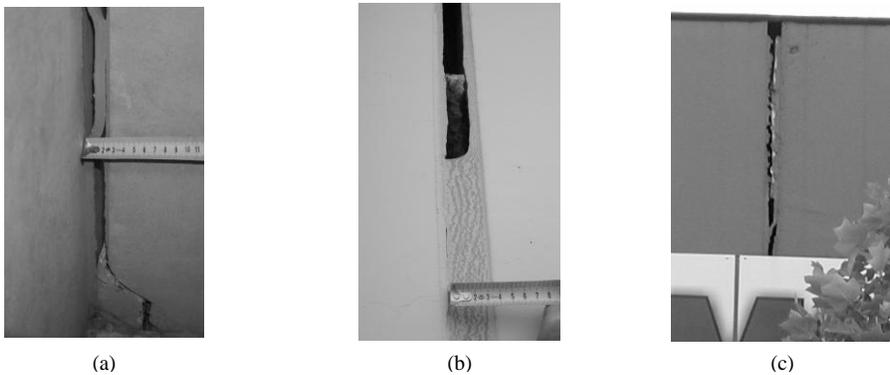
Inspection of concrete tilt-up wall panels in low-rise industrial buildings showed separation of fire-rated sealant joints, as shown in Fig. 11(a)–(c), increasing the risk of fire spread to neighbouring properties.

Figure 11. External walls: (a) wall corner junction; (b) wall panel butt joint; (c) wall panel butt joint.
