Building Pounding Damage Observed in the 2011 Christchurch Earthquake

G.L. Cole & R.P. Dhakal

SUMMARY:

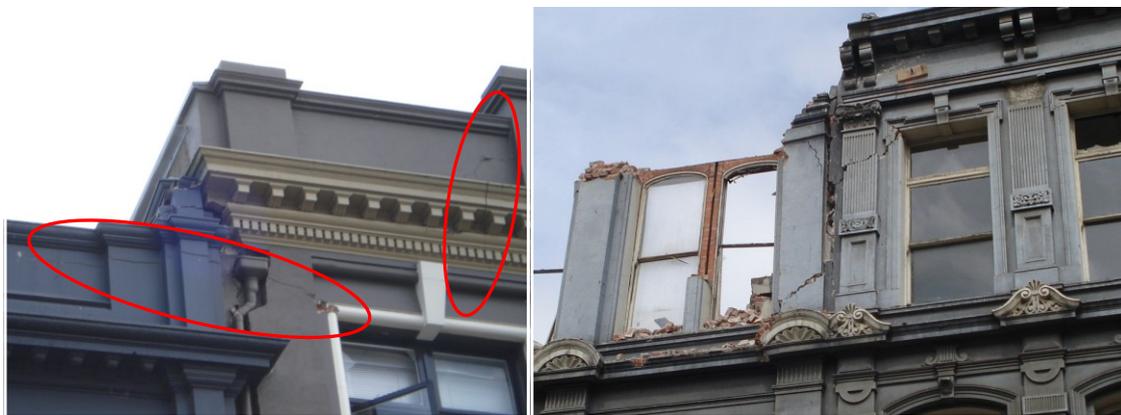
Pounding damage to URM buildings (for example, Figure 2.1) occurred sufficiently frequently to enable identification of common damage patterns (Figure 2.2). Masonry cracking typically extended from the topmost point of contact between two buildings to the nearest window arch or lintel in each building. Cracking frequently extended further from the window opening through to the top of the building’s parapet, although this parapet damage was not usually attributed to pounding. Multistorey buildings occasionally also presented damage at lower floors, although this damage was observed to be progressively less severe as the distance from the topmost point of contact increased. Cracking was also observed to concentrate in stiff lateral elements, such as wall sections with wide spacings between window penetrations (Figure 2.2a).

Figure 2.1 Examples of URM pounding damage. Left: minor damage. Right: major damage partially caused by pounding

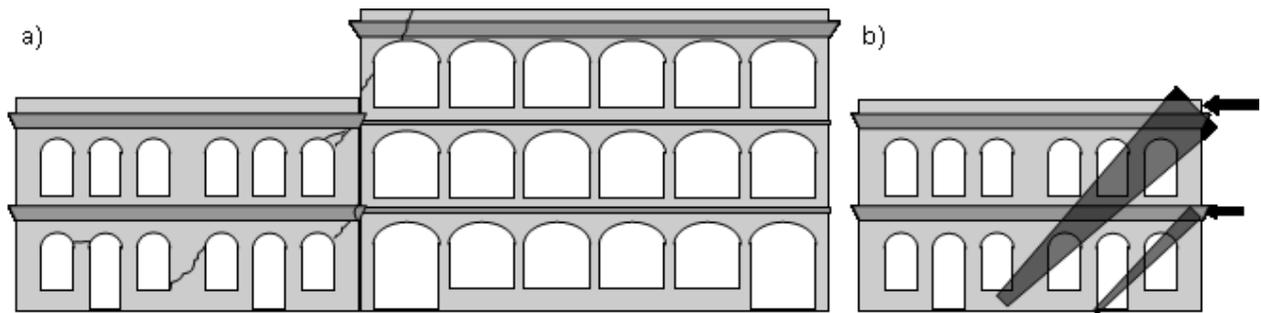
Figure 2.2 Damage to URM buildings. a) Typical pounding damage. b) Idealized masonry strut damage. Arrows denote floor collision points of the adjacent building. Width of the shaded zone indicates approximate severity of damage. Figure reproduced from (Cole et al. 2012).

Occasionally, local crushing of masonry units was observed at the point where two floors collided. When buildings of differing height collided, the floor immediately above the topmost point of contact also frequently suffered notable cracking. Figure 2.2b presents an idealised load path diagram, which also reflects the typically observed masonry damage distribution. In reality, the damage ‘struts’ were not oriented at 45 degrees. This angle was instead governed by the building’s wall penetrations.

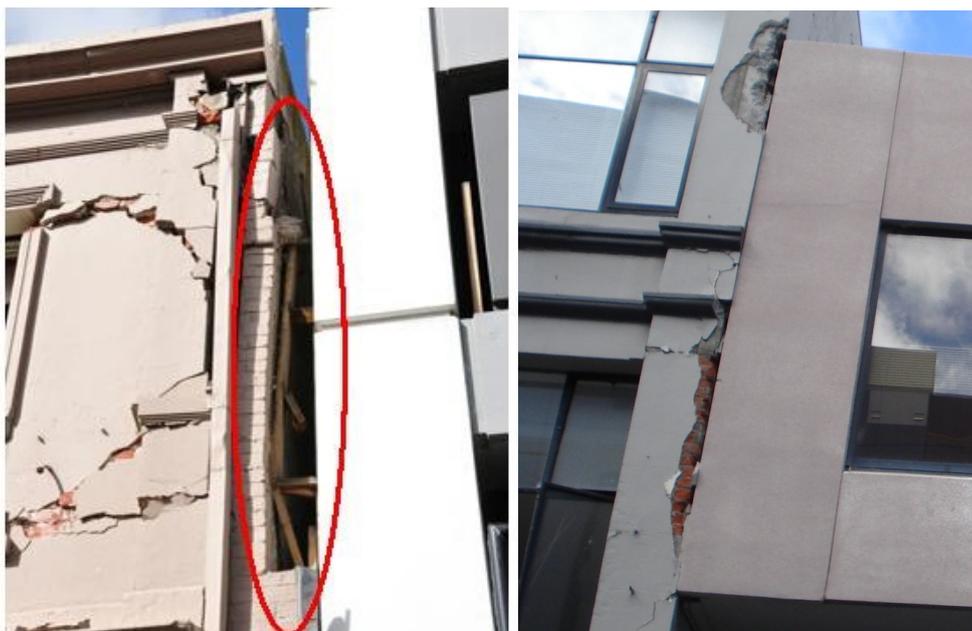
Modern buildings generally suffered less pounding damage. This is attributed to the greater building separations adopted in newer buildings and the presence of weaker adjacent buildings (for example, if a concrete reinforced frame building collided with a URM building, damage is more likely to occur first in the URM building due to its weak, brittle properties). The primary source of pounding damage in modern buildings with separation was instead observed where building separations were infilled with cosmetic flashings (Figure 2.3, Left). While flashings are intended to cover the gap between adjacent buildings, the detailing of some flashings created stiff and strong elements, which transferred significant force between the two buildings. In some instances the flashings caused failure of adjacent building elements, while in other instances the entire flashing detached from both buildings. Flashing detachment can cause a sizable amount of falling debris when the buildings have multiple storeys. Furthermore, this form of damage can be simply avoided by designing flashings to compress/crush and ensuring they are adequately anchored to one building only. Five instances of significant damage resulting from force transfer through building flashings were observed within the CBD.

Figure 2.3 Left: Building damage caused by framed flashing. Right: Detail of spalling damage shown in Figure 3.1

The Christchurch earthquake significantly increased the damage in the central building, and also caused damage at the boundary with the leftmost building. At the right interface of the central building the observed damage is predominantly spalling (Figure 2.3, Right), although cracking also extended below the contact interface. The damage at the left interface is more severe. The masonry column of the central building has been offset approximately 30 mm due to collision with the left building. It is considered that the central building was crushed by the surrounding buildings, primarily due to the greatly differing earthquake response of the taller rightmost building.

2. Modern buildings were primarily endangered by pounding when flashings between buildings were constructed with stiff and strong materials that allowed force transfer across building separations. This hazard can be mitigated by using compressible flashings attached to one building (but not both).

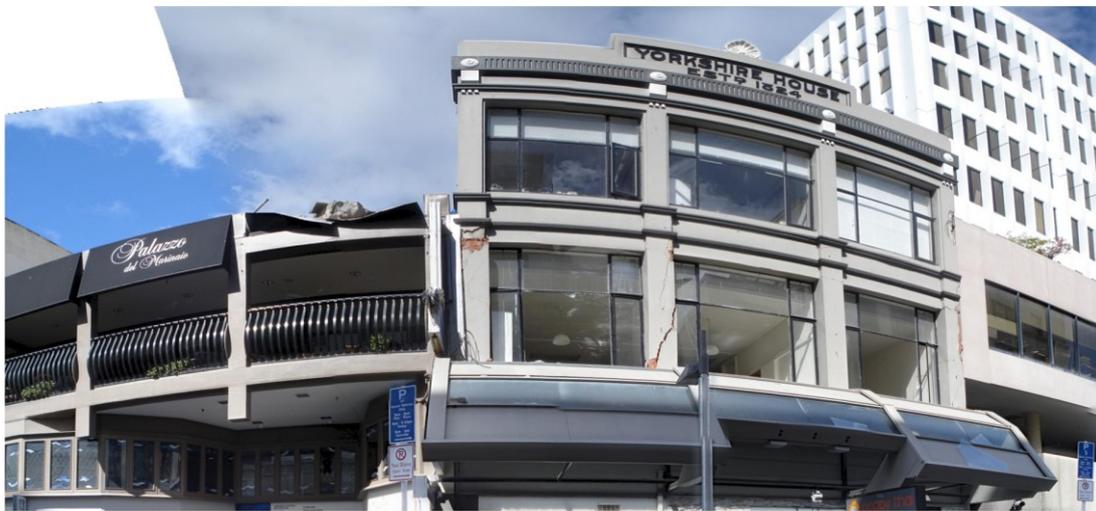
As was also observed in the Darfield earthquake, very little pounding damage was observed between buildings of greatly differing overall heights. This is again primarily attributed to the greater separations that generally surround taller buildings. However, Figure 3.1 presents one building configuration where extensive pounding damage did occur. Pounding between the central building and the taller rightmost building also occurred in the Darfield earthquake. The damage in the Darfield earthquake was minor, although it was noted that this damage occurred in the vertical elements of the primary gravity structure (Cole et al. 2010a).

Figure 3.1 Pounding damage caused by buildings with greatly differing heights. Note image is distorted due to panoramic photography

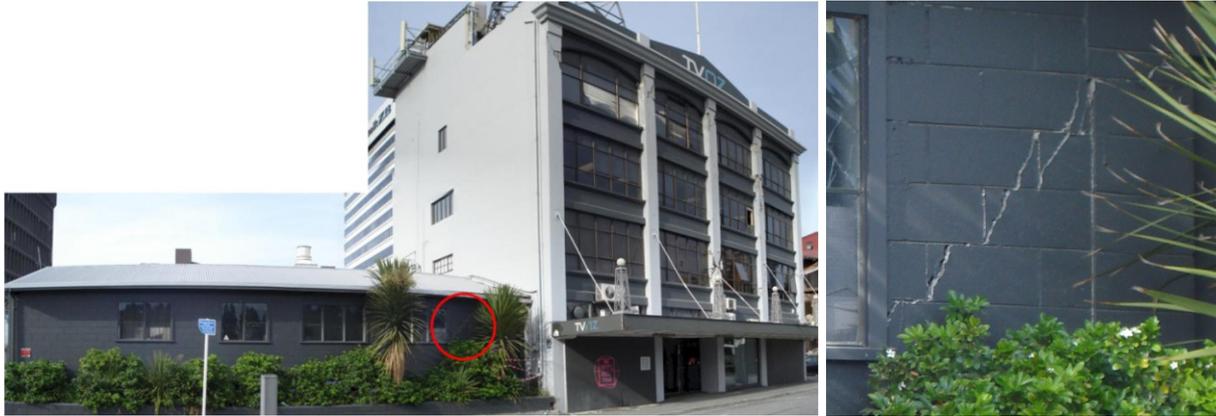
The range of buildings affected by pounding sometimes extended to buildings where pounding would not normally be anticipated. One single storey building was observed to suffer substantial pounding damage as a result of contact with a neighbouring four storey building (Figure 3.2). The neighbouring four storey building was substantially damaged during the Christchurch earthquake, however this damage is not attributed to pounding. As a result of this damage, the lateral stiffness of the neighbouring building reduced, causing greater building deflection. It is considered that this effect has increased building damage, although its significance is unknown. Approximately 10 mm building separation was observed between these buildings.

Figure 3.2 Pounding between 1 storey and 4 storey buildings. Damage to four storey building not attributed to pounding

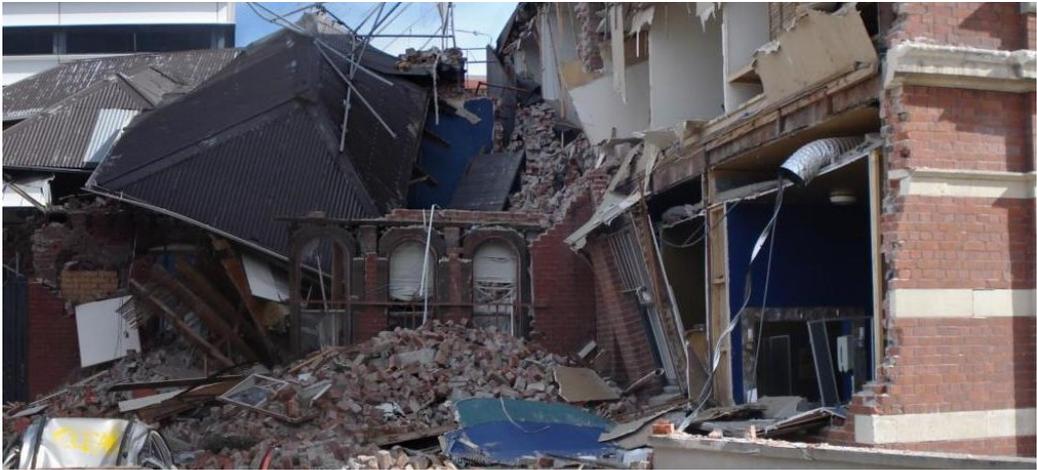
Two building collapses within the CBD are partially attributed to pounding. Both these cases involve URM buildings that were constructed circa 1900. Figure 3.3 illustrates the damage caused to a two storey URM building that sustained pounding during the Christchurch earthquake (shown on the left). Significant damage has also been sustained by the adjacent right building. These buildings were externally surveyed after the Darfield earthquake and were found to be separated by approximately 50 mm at ground level, but were in contact at roof level. It was concluded that the two storey building had begun to lean, although whether this was due to the Darfield earthquake could not be determined. As these buildings were in contact, pounding undoubtedly occurred during the Christchurch earthquake. However, the primary cause of collapse is attributed to the URM construction. Whether pounding appreciably contributed to this collapse is very difficult to determine, due to the level of destruction that has occurred.

Figure 3.3 Two storey building collapse involving pounding. Primary cause of collapse is attributed to URM construction

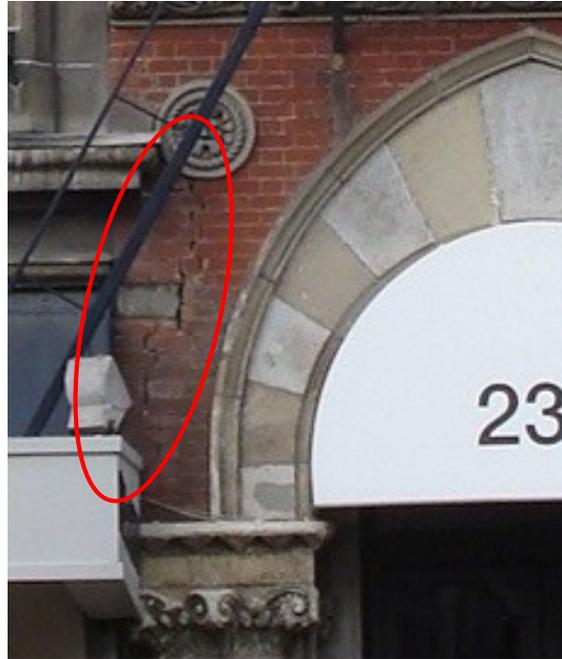
The second building configuration suffering collapse was also documented after the Darfield earthquake, as shown in Figure 3.4 (see also Figure 2 in (Cole et al. 2010a)). Figure 3.5 displays the damage following the Christchurch earthquake. Figure 3.4 is located at the first floor between the left and central buildings, and is quite possibly the initiation point of the global collapse.

Figure 3.4 Masonry damage after the Darfield earthquake

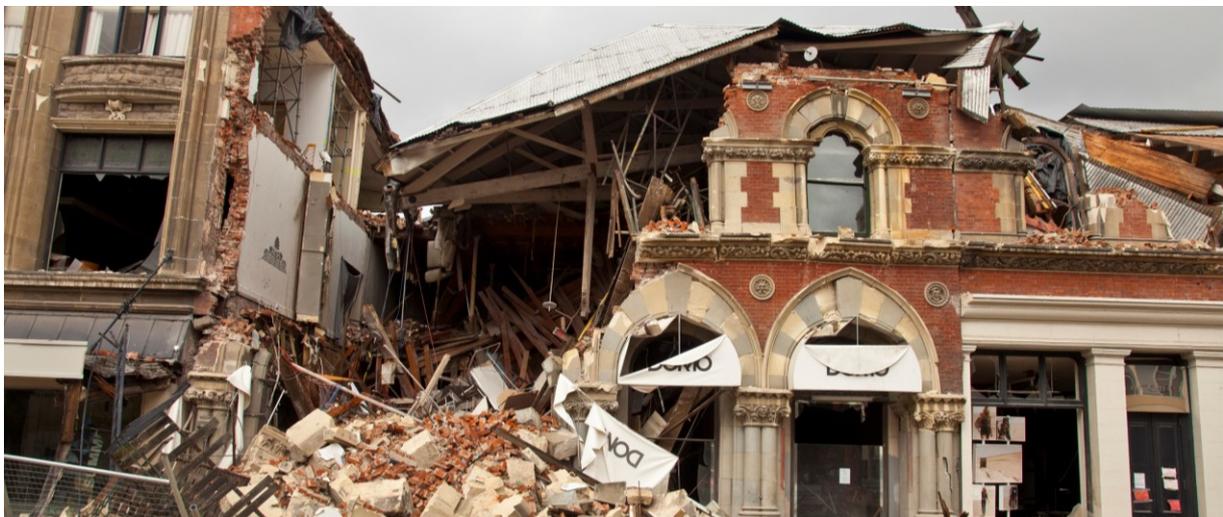
The damage shown in Figure 3.5 indicates that the central and leftmost buildings were likely to be constructed with a shared party wall. This can be observed where wall sections remain standing at the building interface. At the second level, a 100 mm thick brick wall appears to have supported both buildings. This evidence is also supported by the interior finishings that can be observed on the

'exterior' of this wall. Nevertheless, localised damage consistent with pounding is present between the central and rightmost buildings. Once again it is difficult to discern the level of influence pounding has had on the presented collapse. The primary cause of collapse is attributed to the URM construction. However, it is credible that the severity of this damage would have been greatly reduced if adjacent buildings had not been present.

Figure 3.5 Building collapse involving building pounding. Primary cause of collapse is attributed to URM construction. Photo courtesy of Colin Monteath, Hedgehog House

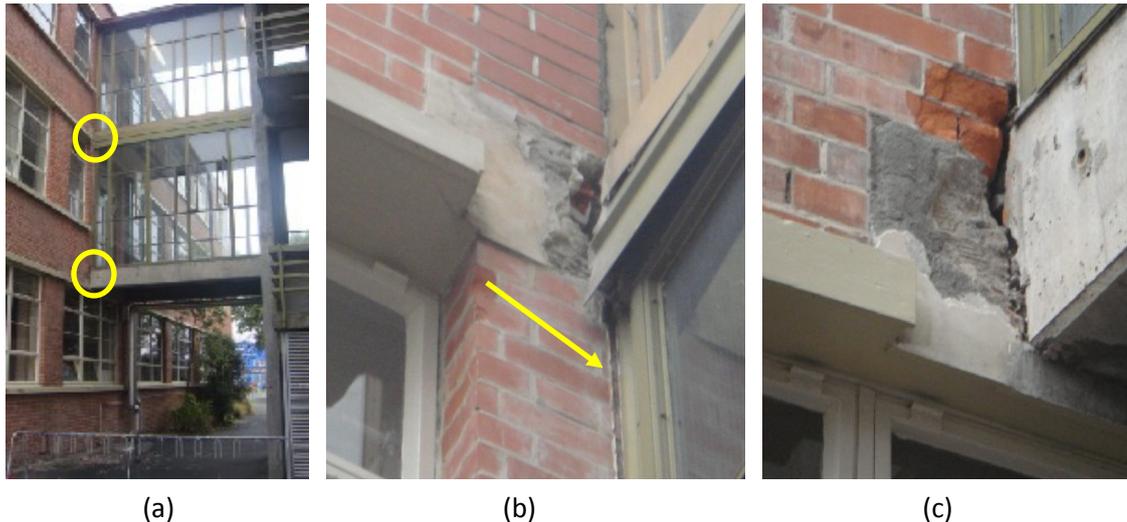
Pounding between adjacent buildings can be avoided if a sufficient gap exists. In some cases, however, although the adjacent buildings are well separated, pounding can still take place. This is the case when the buildings are linked by pedestrian bridges as the buildings at the Christchurch Polytechnic Institute of Technology along the Madras Street in Figure 4.1(a) show. The upper and lower pounding locations are indicated by the circles. The damage due pounding of the upper floor of the pedestrian bridge is displayed in Figure 4.1(b). The residual opening relative movement can also be clearly seen as indicated by the arrow. Figure 4.1(c) shows the damage to the unreinforced masonry wall due to pounding of the lower RC floor of the pedestrian bridge. In the case considered both adjacent buildings have different fundamental periods owing to their dissimilar building configuration, and thus different oscillation patterns are to be expected. Previous studies on pounding responses between buildings linked by pedestrian bridges in near-source earthquakes have shown that neglecting of soil-foundation-structure interaction can underestimate pounding potential and also the induced vibrations in the buildings (Chouw 2002).

Figure 4.1. Pounding damage to buildings at the Christchurch Polytechnic Institute of Technology. (a) Adjacent buildings with pedestrian bridges, (b) upper and (c) lower pounding locations.

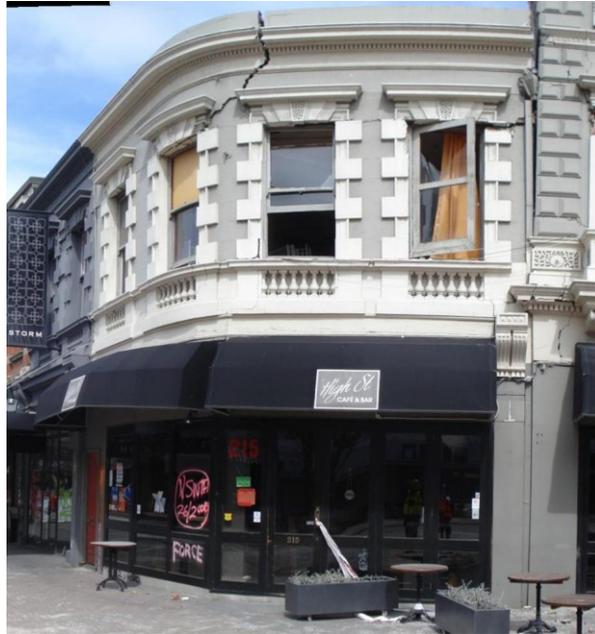
5. *Building subject to torsional actions arising from pounding.* Torsional pounding interaction was found to be particularly difficult to identify from external inspection. Only one possible case of torsional pounding interaction was observed in the CBD (Figure 5.1).

Figure 5.1. Possible torsional building pounding due to irregular plan layout
