**"THE BALLANTYNES DEPARTMENT STORE
FIRE DISASTER"**

CHRISTCHURCH

18 NOVEMBER 1947

D.C. NORTON AND B. GORDON

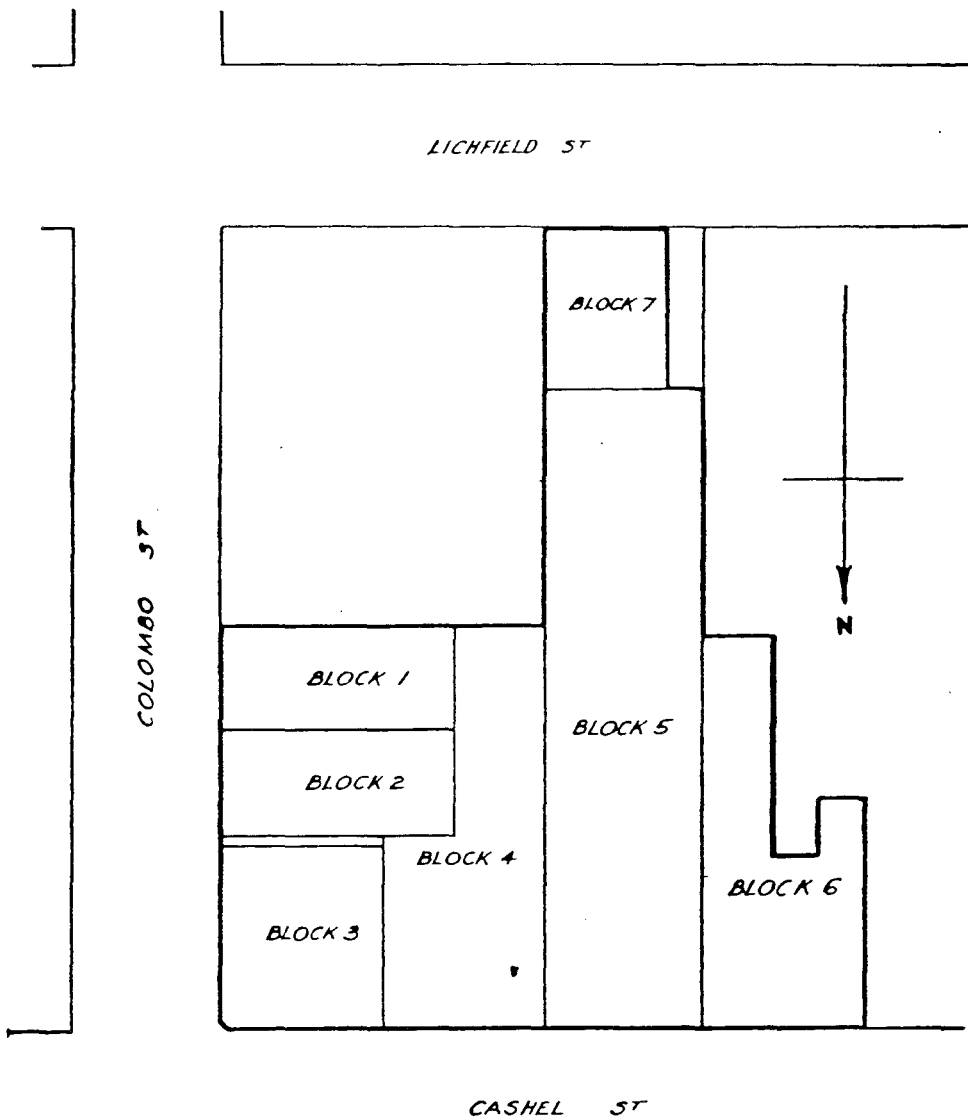
BLOCK PLAN

Plan 1 is a general block plan of the premises prior to the fire. This report focusses on 3 of the buildings outlined in the block plan. (Reference: Ballantynes Fire Disaster, G.G. Walker, p.82).

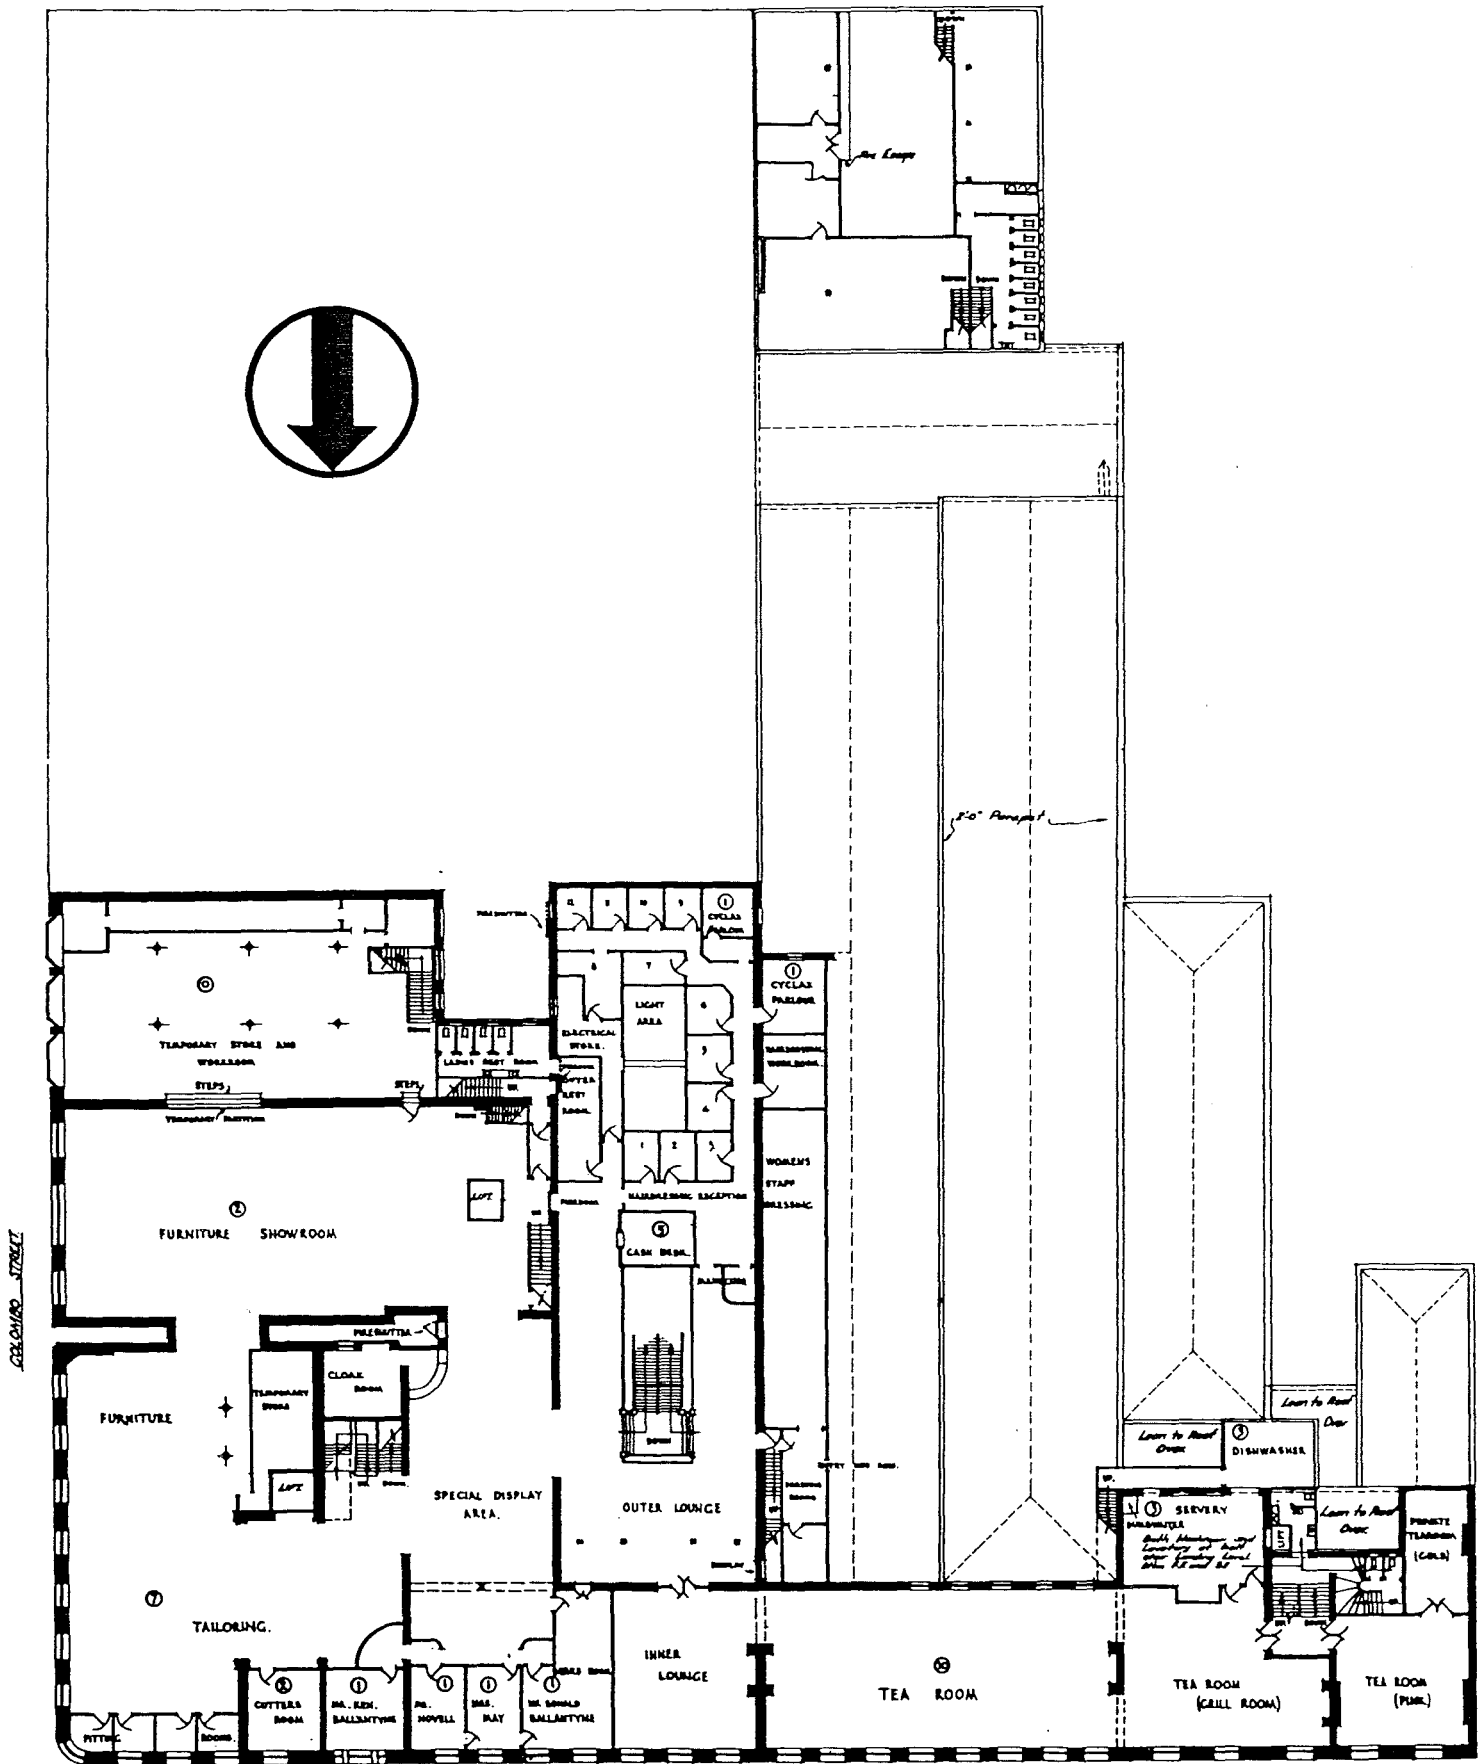
CASHMERE STREET
CASHEL STREET
FIRST FLOOR PLAN

15. Plan 4 - Temporary partitions on first floor separating Goodmans from Congreves building.
16. Plan 4 - No partitioning between Pratts and Goodmans on first floor thus large open display area.

17. Plan 5 - Fire doors onto the alley fire escape between Pratts and Goodmans buildings.
18. Plan 4 - First floor of Congreves Building was a temporary store and workroom and no staff were employed on that floor.

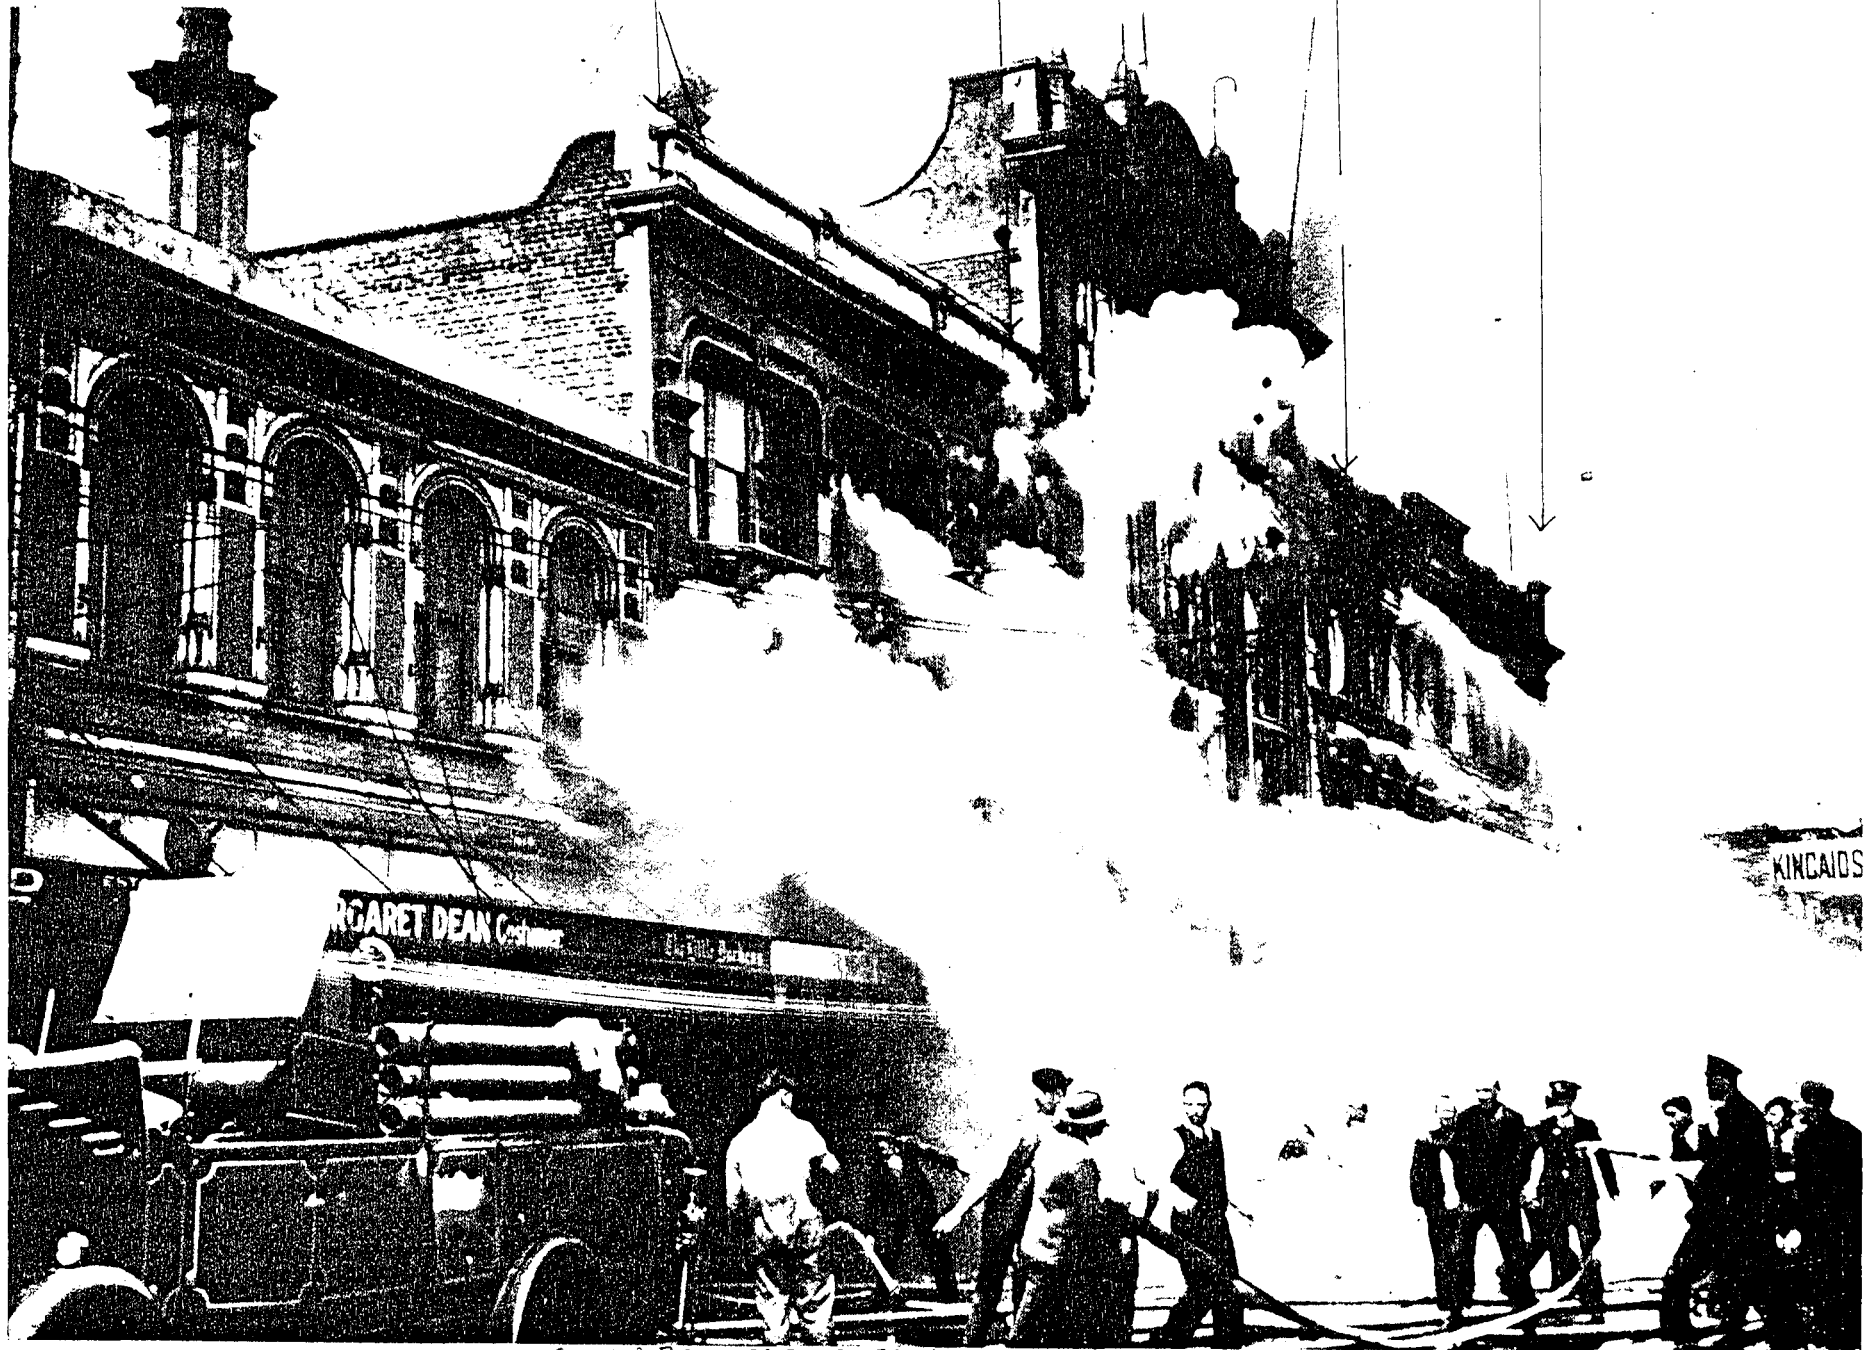
- Photo 1 - Depicts the Colombo Street frontage of the buildings at the height of the fire. The 3 buildings are identified. The smoke from the first and second floor of Congreves building is substantial, as it is on the first floor of Goodmans building. The second floor of Goodmans is fully involved in fire. 7 staff members died directly above on the third floor of Goodmans building via smoke inhalation when their path to the stairway was blocked by smoke before flames impinged that area.
- Photo 2 - Reduced photo version of 1 above.
- Photo 3 - The cashel Street frontage of the building is shown. The magnitude of the fire is evident from the size of the building complex shown in the photo.
- ✓

COLOMBO STREET FRONTAGE.
"Like a scene from the London blitz," said one spectator as firemen and helpers played 6,000 gallons of water a minute into the inferno. A graphic shot of the section of the building in Colombo Street in which the fire is believed to have started.

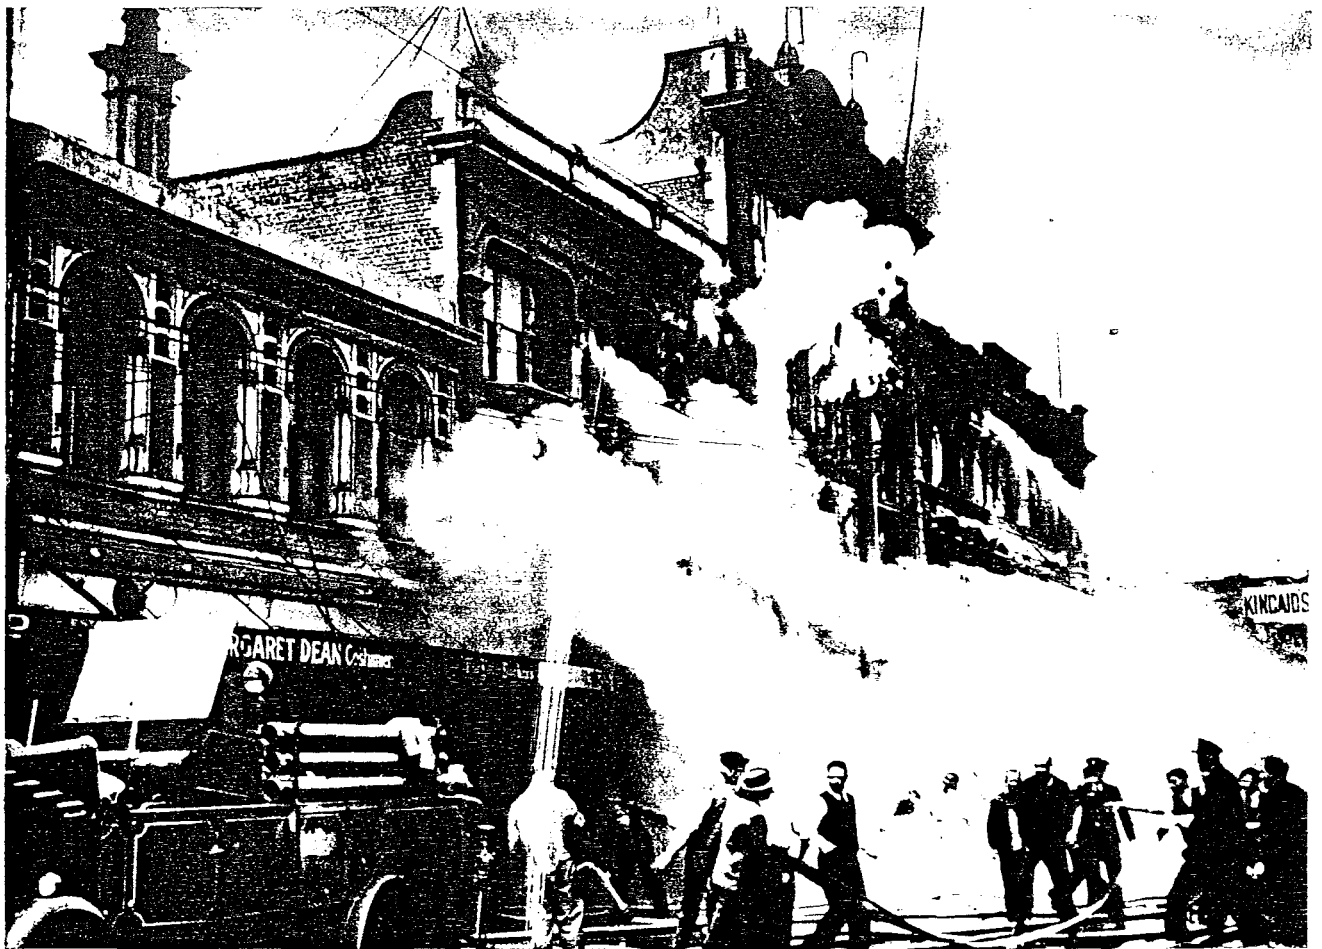
PHOTO 3.

"Like a scene from the London blitz," said one spectator as firemen and helpers played 6,000 gallons of water a minute into the inferno. A graphic shot of the section of the building in Colombo Street in which the fire is believed to have started.

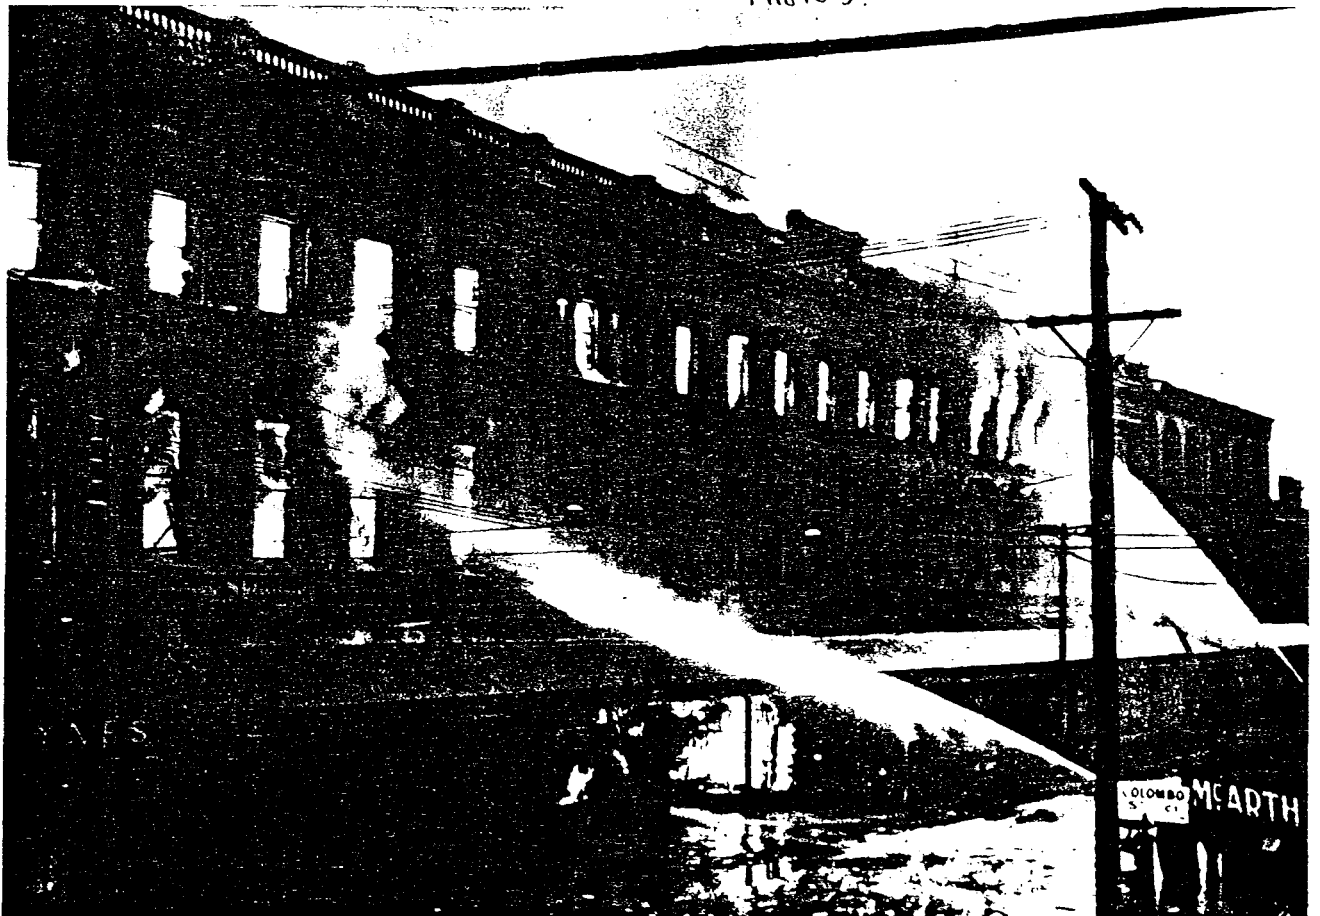
The Cashel Street frontage, with water flooding the street as hoses are played on the windows from which many people trapped in the blazing building were rescued. The heat was so intense that in parts of the building the Oamaru stone facing turned into lime.

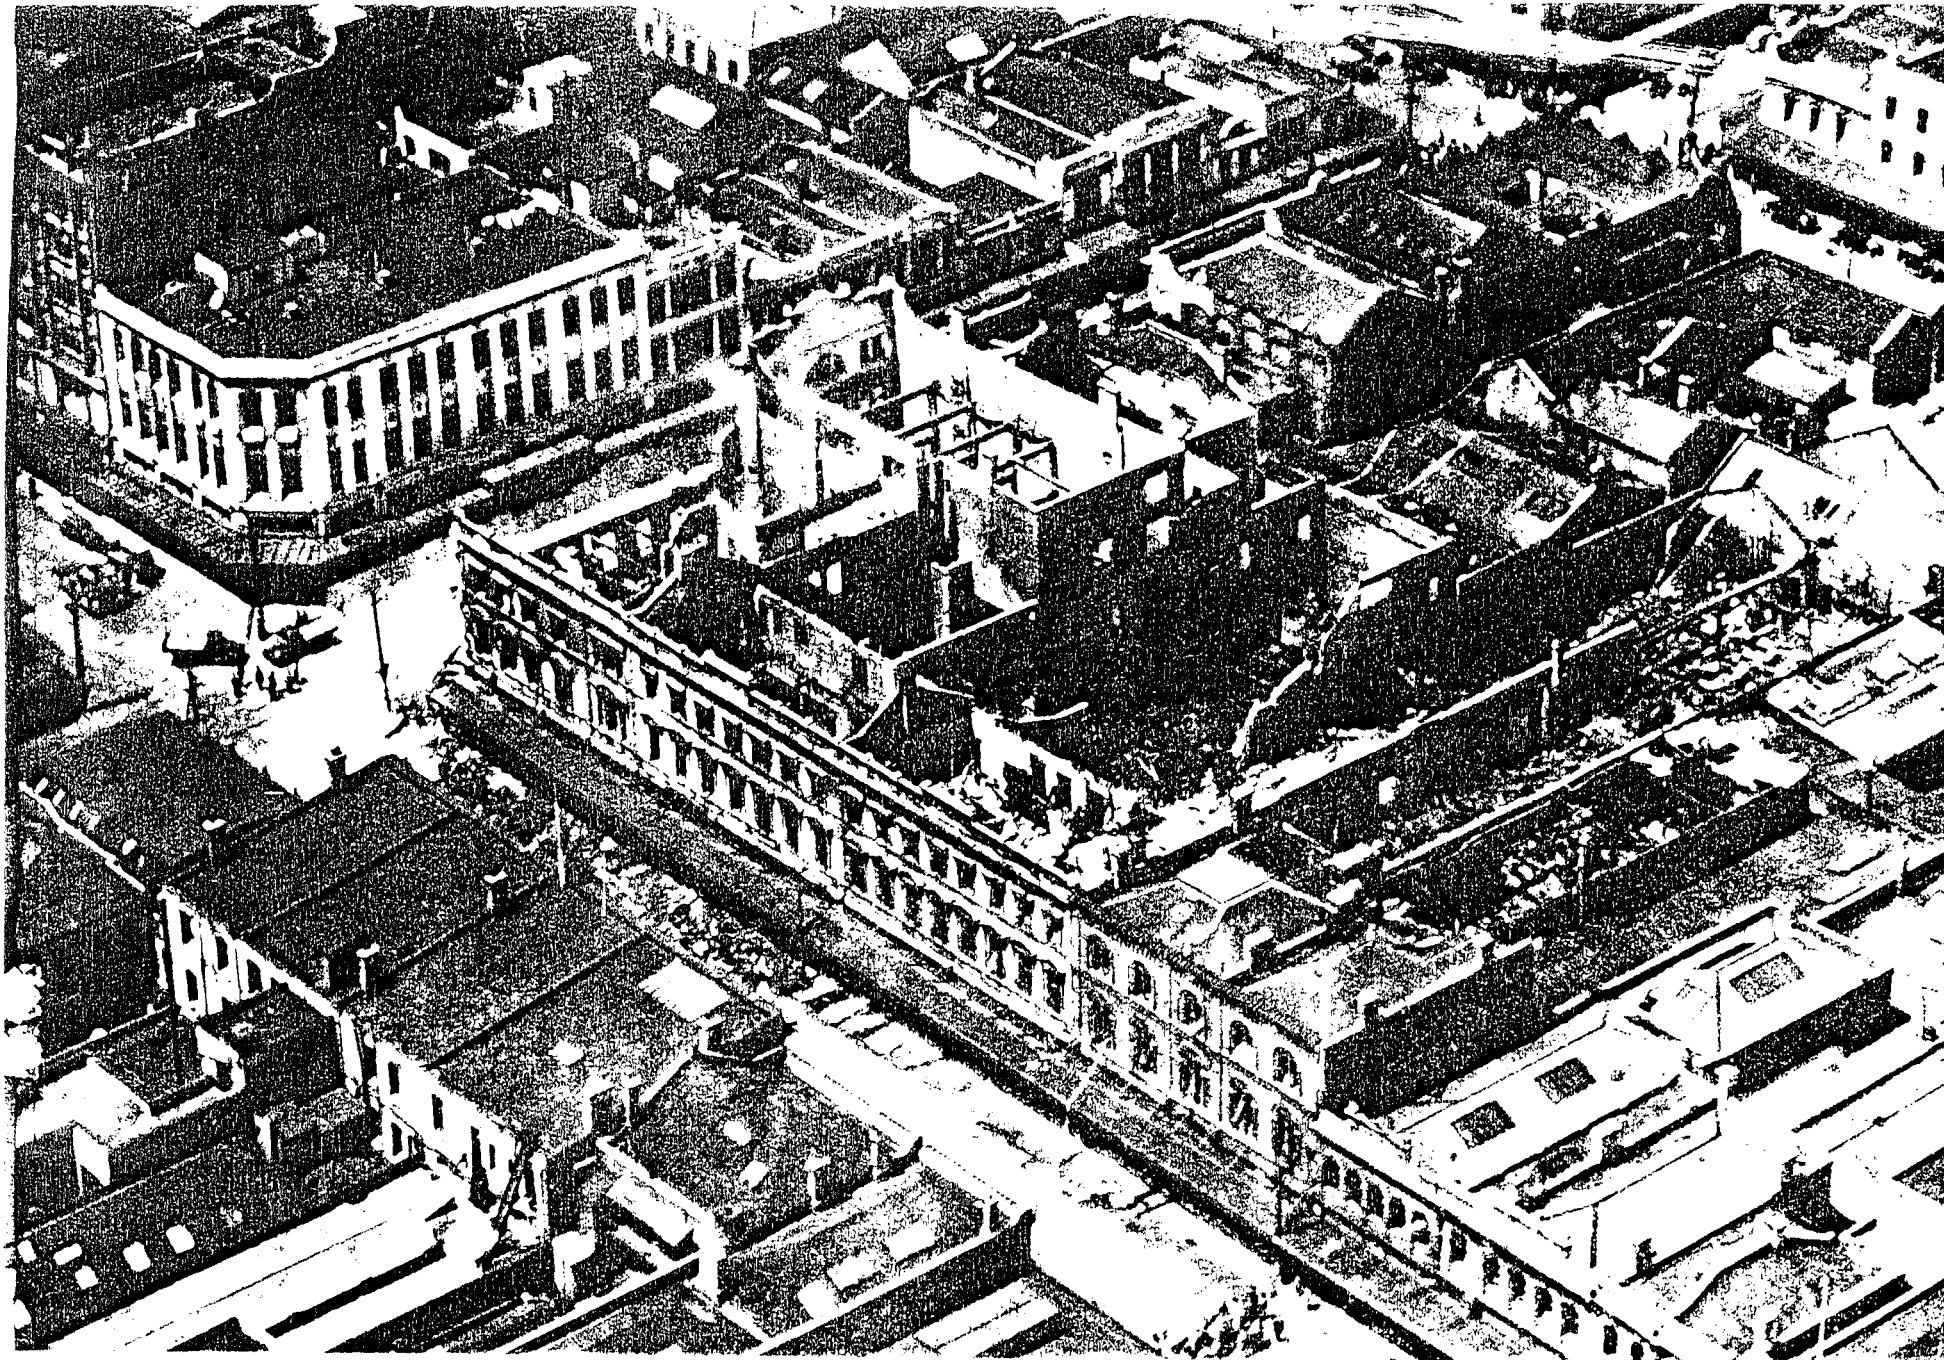
Photo 6 - Is an aerial view of the Ballantynes complex taken a day after the fire. The following aspects are noted.

girls leaped to the veranda. LOWER LEFT: the top of a main wall falling into Colombo Street. It was pulled down as a safety-precaution.

LOWER RIGHT: an aerial view on the day after the fire, showing the extent of the destruction in the buildings.
