Geotechnical Aspects of the 2010 Darfield (Canterbury) Earthquake

Misko Cubrinovski¹

ABSTRACT

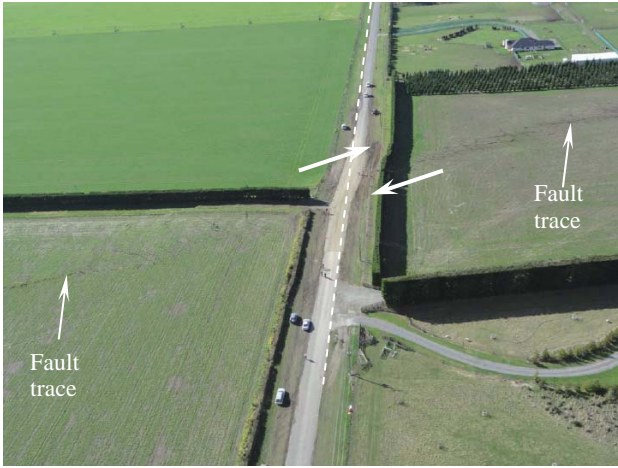
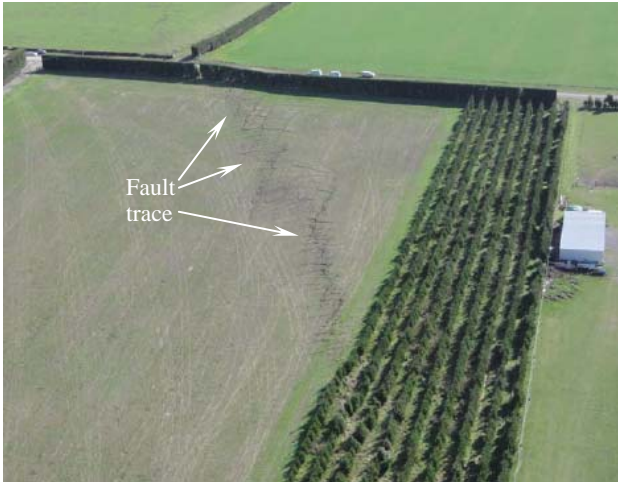
Figure 3. ~4 m offset of road and tree line (top photo) and rupture expression on farm land (both photos)

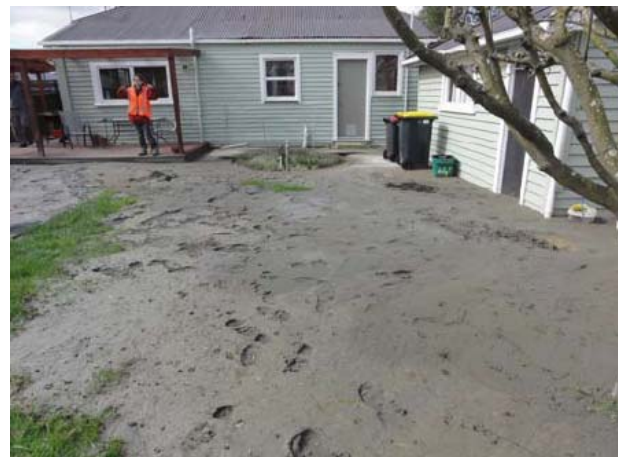
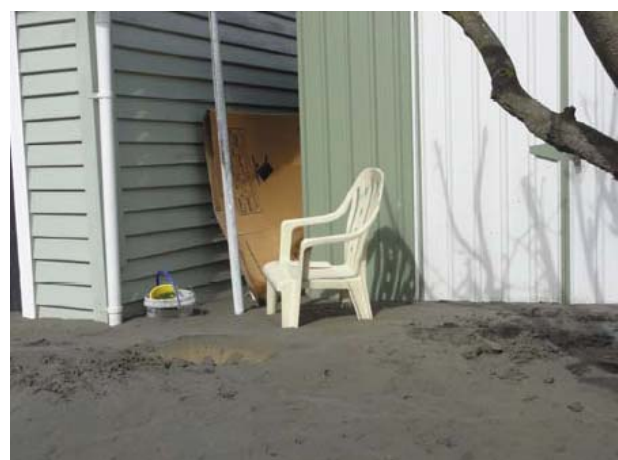
Typical manifestation of liquefaction in the backyard of a residential property is shown in Figure 8. Sand boil ejecta covered most of the lawn and was about 20 cm thick in places. There was evidence of massive liquefaction and large surface distortion in the neighbouring streets. The potable water and sewer systems were out of service at the time of the inspections. Despite significant amounts of liquefaction ejecta and broken utilities throughout the neighbourhood, the house shown in the pictures suffered relatively minor damage in terms of differential settlement and cracking.

Figure 8. Evidence of extensive liquefaction (massive sand boils) in residential areas of Avonside

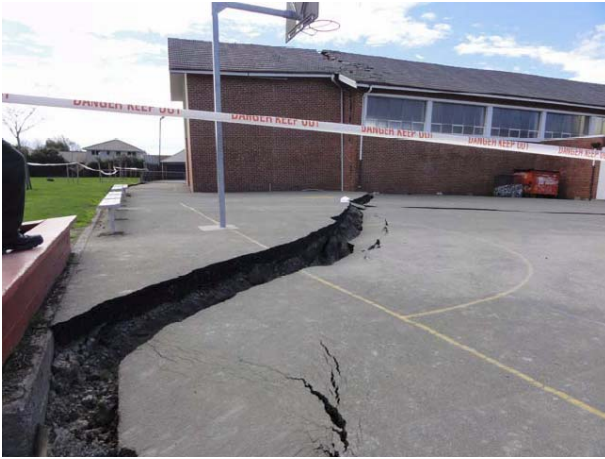
A detailed survey was conducted at St Paul's Church (Dallington) which suffered severe damage due to liquefaction in the foundation soils and lateral spreading. Figure 9 shows a complex pattern of ground distortion including large cracks and vertical offsets around the building. Extensive sand boils covered the paved area around the building, backyard lawn, and around the perimeter of the building and its foundations. The building suffered large differential settlements and severe structural damage.

Specifically, the west (northwest) side of the building suffered structural separation due to a combination of large differential settlements and lateral movement. This site is centrally located in a meandering loop of the Avon River and bounded by the river on all sides at distances of about 150-250 m, except to the north/northeast. There was apparent evidence of lateral spreading in this area, despite being located more than 150 m from the free-face of the river. The tension cracks and fissures around the building were much bigger than those near the river channel, and hence further investigations are required to clarify these details. The building tilted between 2 and 4 degrees, and settled about 50 cm at the southwest corner (Figure 9b). The resulting differential settlement was approximately 30 cm.

(a) 50-90 cm wide ground crack with a vertical offset of 33 cm at its maximum (view looking north)

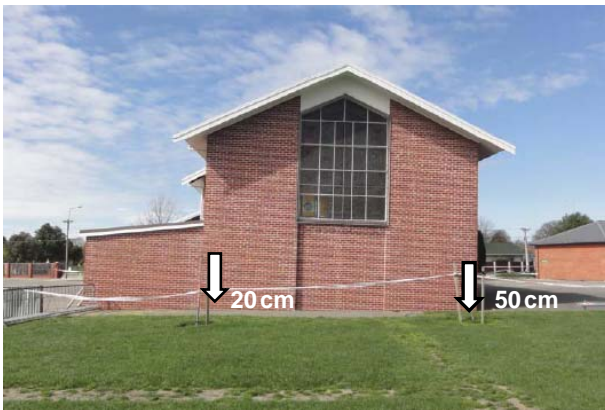
(b) Large global and differential settlements (view looking east)

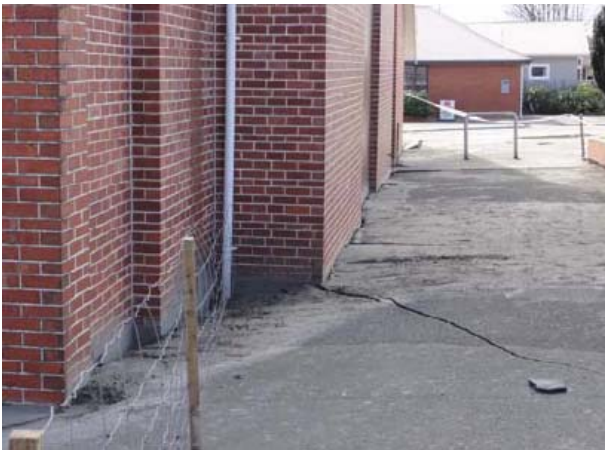
(c) Evidence of liquefaction in foundation soils (view looking north; east side of building)

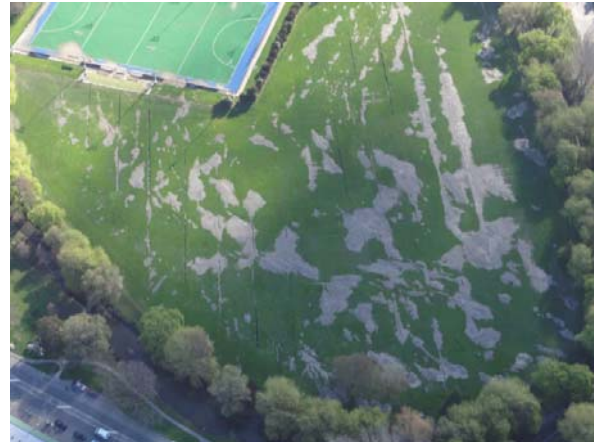
Further to the east of Dallington, extensive liquefaction, including substantial lateral spreading, was observed in Porritt Park (Wainoni), which is enclosed by the Avon River and a diverted stream around the park. Large sand boils covered substantial areas of the park (Figure 10). Parallel cracks spaced regularly along drainage lines were indicative of slumping and spreading towards the north and south branches of the stream. A couple of hockey fields located in the park were severely damaged by the liquefaction, resulting in a very uneven, bumpy surface of the fields.

Figure 10. Evidence of extensive liquefaction (massive sand boils) in Porritt Park; using the vehicles (bottom of photo) or the hockey field (top of photo) for scale gives a good indication of the significant volume of sand ejecta

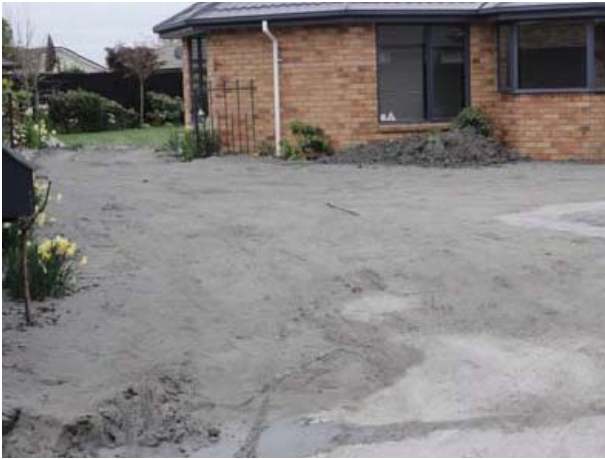
Widespread liquefaction occurred in Bexley, affecting a large number of residential houses (Figure 11). Ground distortion (i.e., differential settlement, large ground cracks, deformation of paved surfaces and substantial sand boils) was observed in the southern part of Bexley. Residential properties along the wetland walkway were severely affected by lateral spreading. Large movement of the walkway towards the water, slumping of the terrace fill and large ground cracks on residential properties were observed in this area. In areas severely affected by lateral spreading, damage to foundation slabs was common, as illustrated in Figure 11(c). Typically, the slabs of one-storey houses were without reinforcement.

(a) Large volume of sand ejecta on residential land

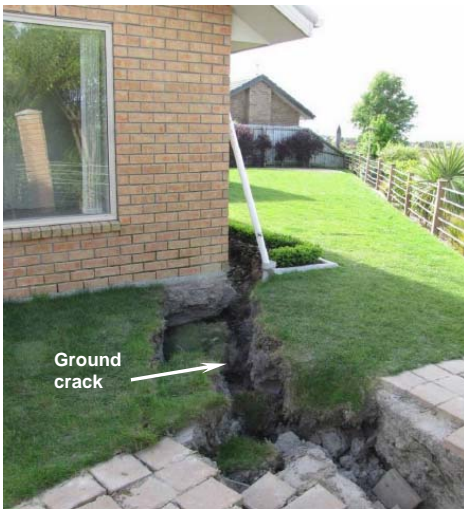
(b) Lateral spreading cracks in foundation soils

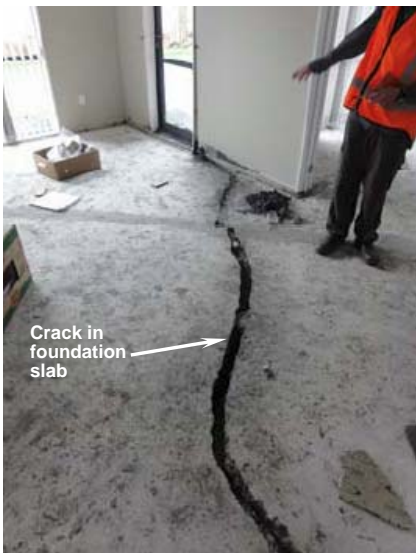
(c) Cracked foundation slab due to lateral spreading

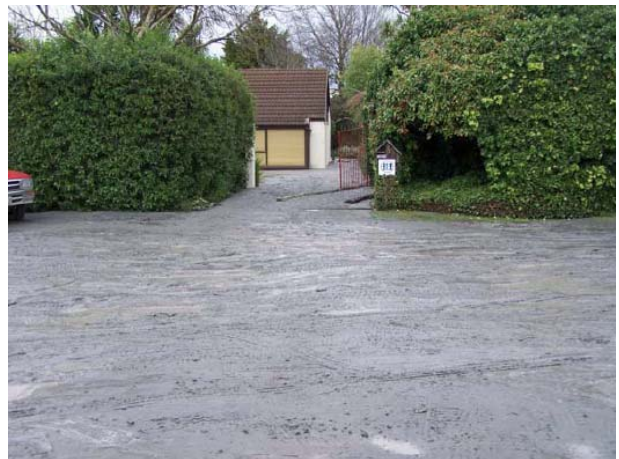
Figure 13. Manifestation of very severe liquefaction in residential area of North Kaiapoi; ~40 cm thick layer of silt-sand-water mixture covering a residential property affected by very severe liquefaction; the house suffered structural damage and large settlement

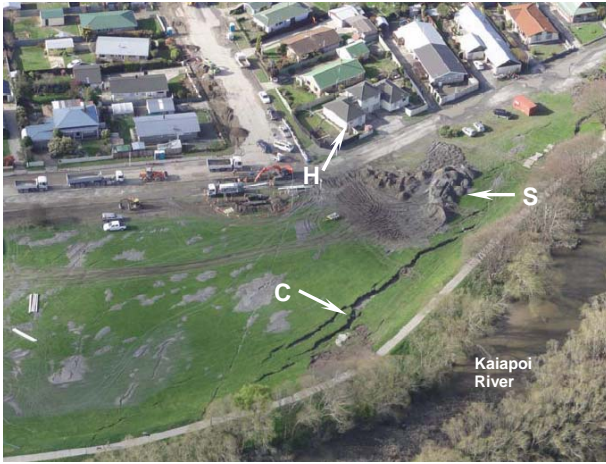
(a) Aerial view of North Kaiapoi (from a helicopter flyover on 10 September)

severity of liquefaction and lateral spreading damage induced in this area. Large size sand ejecta, spread across the area between the stopbank and Charles St, are seen in Figure 14a. The huge piles of cleaned up sand indicated as position S in Figures 14a and 14c clearly illustrate the massive liquefaction that occurred in the area. The liquefaction was accompanied by a significant lateral spreading towards the Kaiapoi River (Figures 14a and

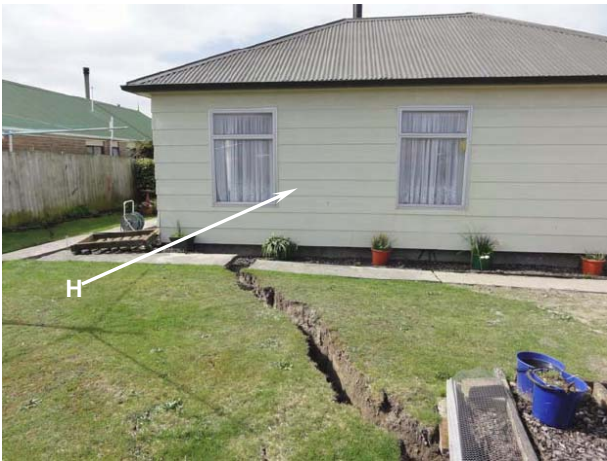
(b) Lateral spreading crack running through residential house

14c) that affected a number of houses along Charles St (Figure 14b). Note that, at this exact location liquefaction was observed during the 1901 Cheviot earthquake (Berrill et al., 1994).

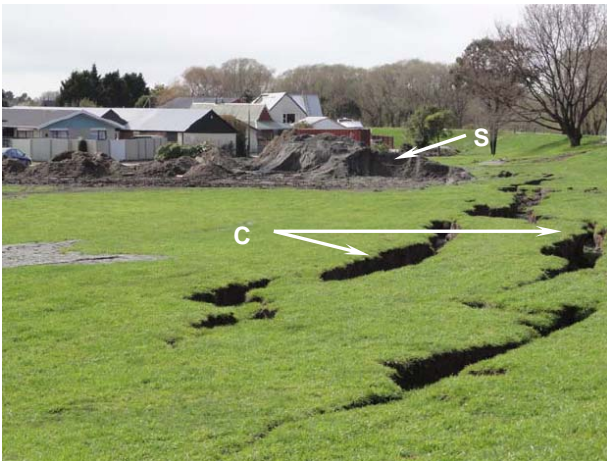
(c) Lateral spread and slumping of the north stopbank of the Kaiapoi River, near the east end of Charles St; note the huge piles of cleaned up sand obstructing the view of the houses

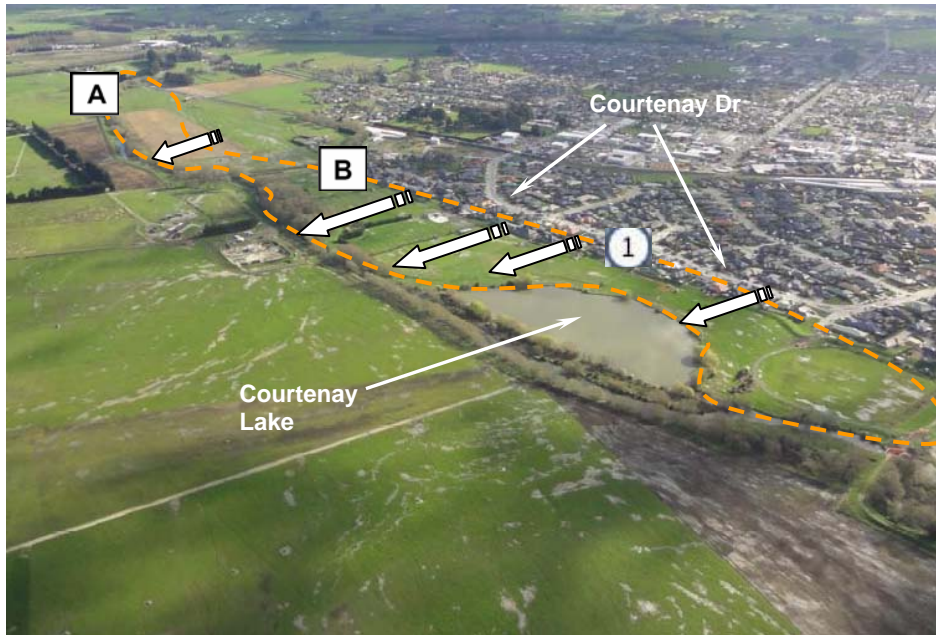
In South Kaiapoi, the most dominant ground failure feature was the liquefaction and massive lateral spreading that affected the eastern branch of Courtenay Drive. The area affected by lateral spreading, shown in Figure 15, was approximately 1-km long in the north-south direction and extended between 200 m and 300 m inland from the Courtenay Stream and Courtenay Lake. The lake was artificially created during the construction of the northern end of Courtenay Dr. Borrow material was removed from the area where the lake is presently located and used as hydraulic fill (about 1 m thick) for the northern branch of Courtenay Dr (WDC, 2010).

The area where massive lateral spreading occurred coincides with the old Waimakariri River channel from 1865. On the eastern side of South Kaiapoi, the old channel passes underneath the present day Courtenay Dr area shown as position 1 in Figure 15, where severe damage to residential properties occurred due to lateral spreading. Further south at positions A and B (Figure 16), large cracks due to lateral spreading towards Courtenay Stream are evident. Along this stretch from position A to the north-east corner of Courtenay Dr (slightly north of position 1), detailed ground surveys were conducted along ten transects including measurement and mapping of width of cracks, vertical offsets, and geo-tagging of major cracks and other lateral spreading features. Figure 17 indicates geo-tagged major cracks and four transects of detailed measurements at position A. Using the vehicles in the photo for scale gives a good indication of the significant size of these cracks and the volume of ejecta.

Figure 15. Massive lateral spreading at South Kaiapoi; sand ejecta and area affected by lateral spreading around Courtenay Lake

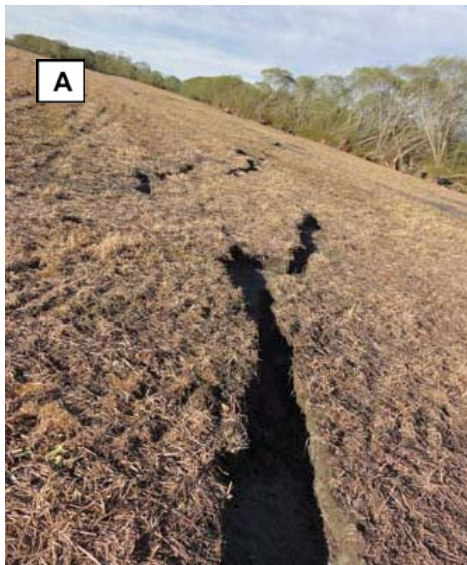
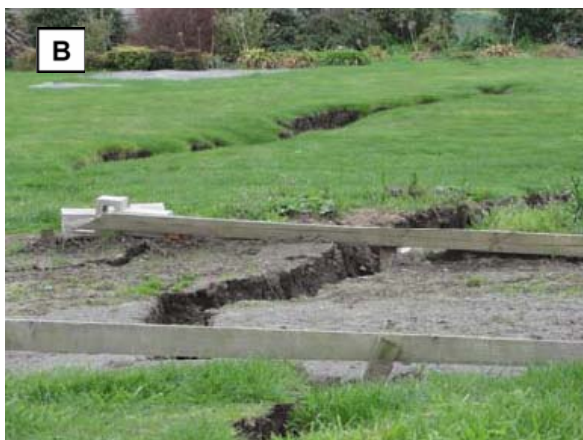
Figure 16. Large lateral spread cracks in farm land (positions A and B shown in Figure 15)

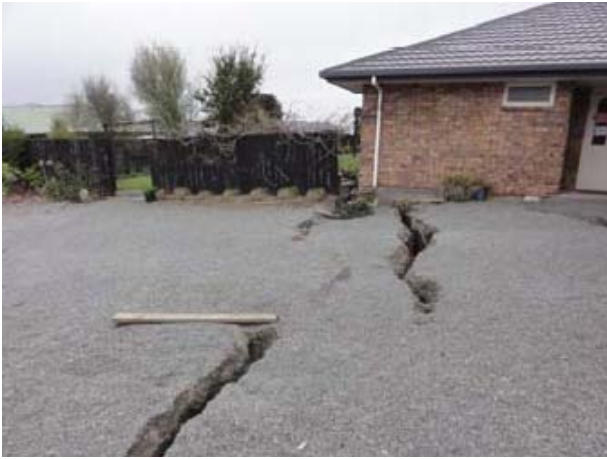
Lateral spreading resulted in large permanent lateral displacements on the order of 1.0-3.5 m with large ground cracks of about 0.5-1.5 m wide running through residential properties and houses along the east branch of Courtenay Dr. In this area, position 1 in Figure 15, single storey and two storey houses suffered very severe damage due to large lateral ground movements including substantial tilt, loss of foundation support, tension cracks in foundations and slabs (Figure 18). It was significant that despite the extreme lateral movement of the immediate foundation soils and the foundations themselves, all houses showed large ductile deformation capacity and continued to carry gravity loads, despite literally being ripped in half in some cases. Detailed inspections and mapping of damage to houses were performed in this area. There was clear evidence that the lateral movement, at least in some parts of the affected area, continued to develop/increase well after the main event. Two consecutive measurements of the width of a large ground crack carried out on 11 and 15 September showed an increase in width of 20 cm over this period (i.e. from 1.4 m to 1.6 m). The residents of the neighbouring property reported new extensive cracks appearing in their house over the same time period. It is believed that this continued deformation was the result of a combination of creep due to static driving shear stresses, significantly softened soils and effects of aftershocks on a structure marginally stable under gravity loads.

(a) Lateral spreading crack running through residential house

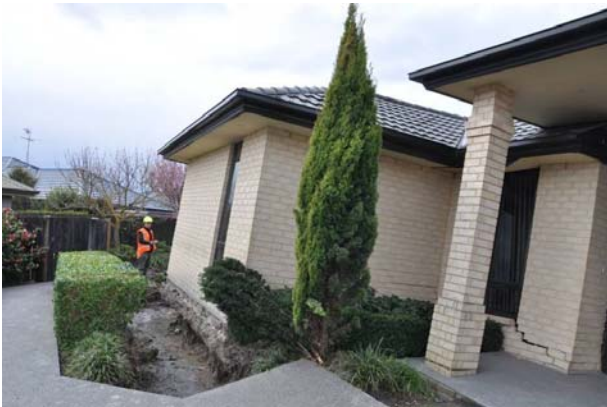
(b) Excessive tilt and uplift of foundations due to lateral spreading displacements of about 1.5 m

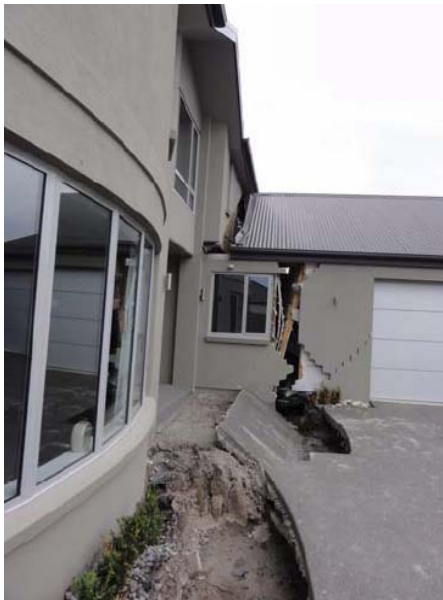
(c) Severe damage to residential house due to lateral spreading displacements of about 1.5 m

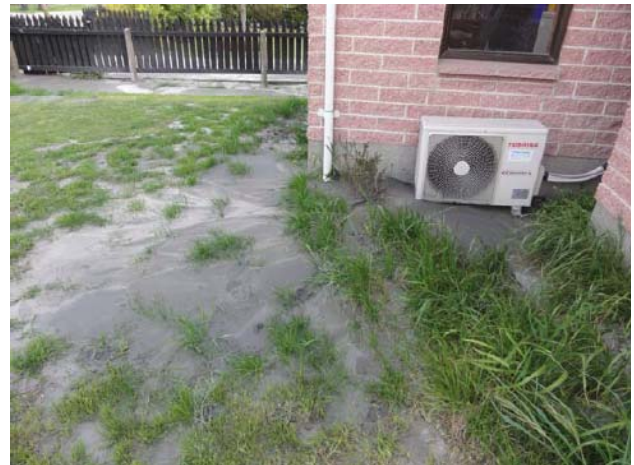
On 19 October 2010, a M_W 5.0 aftershock struck the region, with an epicentre about 10 km southwest of the CBD. The aftershock caused re-liquefaction in the area of Hoon Hay, a suburb located at an epicentral distance of about 8 km. Figure 21a shows large amount of sand ejecta covering the lawn of a residential property due to the re-liquefaction caused by the aftershock. Many residents in the area reported that houses suffered additional damage during the aftershock including widening of the cracks in walls and foundations due to lateral movement of foundation soils. This area of Hoon Hay heavily liquefied during the mainshock of the Darfield earthquake.

(a) Sand ejecta at the perimeter of house foundations

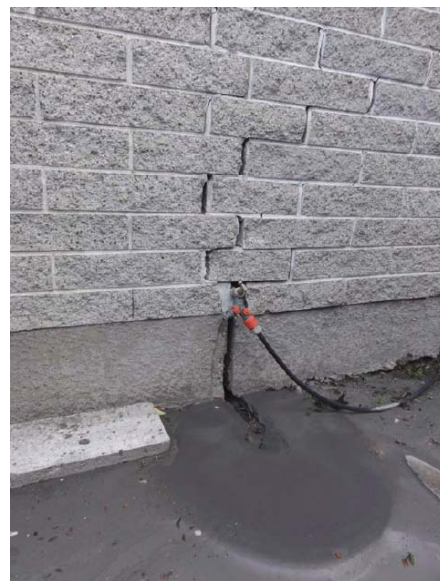
(b) Sand ejecta and damage to foundations (the size of the crack doubled during the re-liquefaction caused by the aftershock)
