Guidelines for the use of expanded foam polystyrene panel systems in industrial buildings so as to minimise the risk of fire

Fire Engineering Research Report 06/1 2006

A project submitted in partial fulfilment of the requirements for the degree of Master of Engineering in Fire Engineering

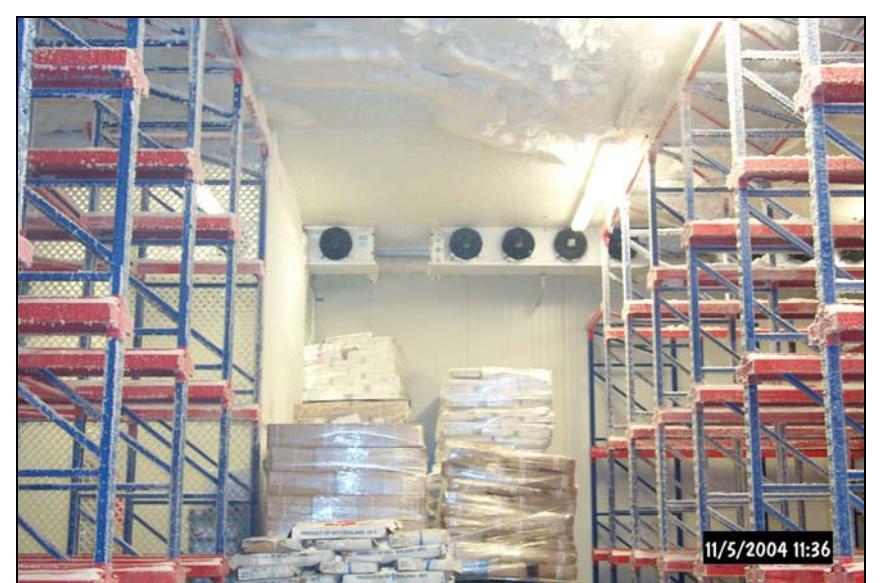
Fig.4.1 Typical cold store with racking from floor to ceiling increasing the risk of fork hoist damage to electrical fittings and to sprinkler heads.

In particular racked storage systems are seen as difficult to sprinkler protect without installing extensive pipework and sprinkler heads which are vulnerable to damage particularly from fork hoists.

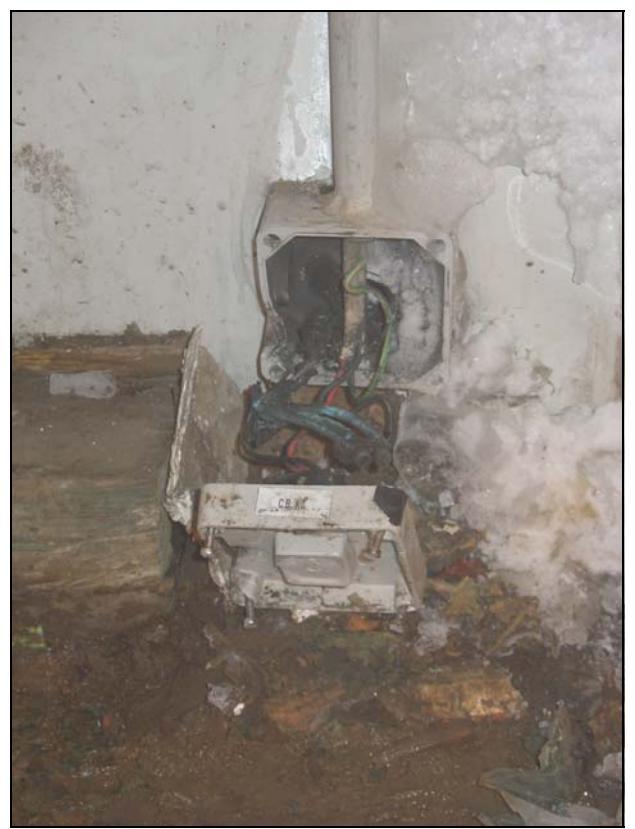
Fig.4.2 Damaged freezer door heater switch that has caught fire.

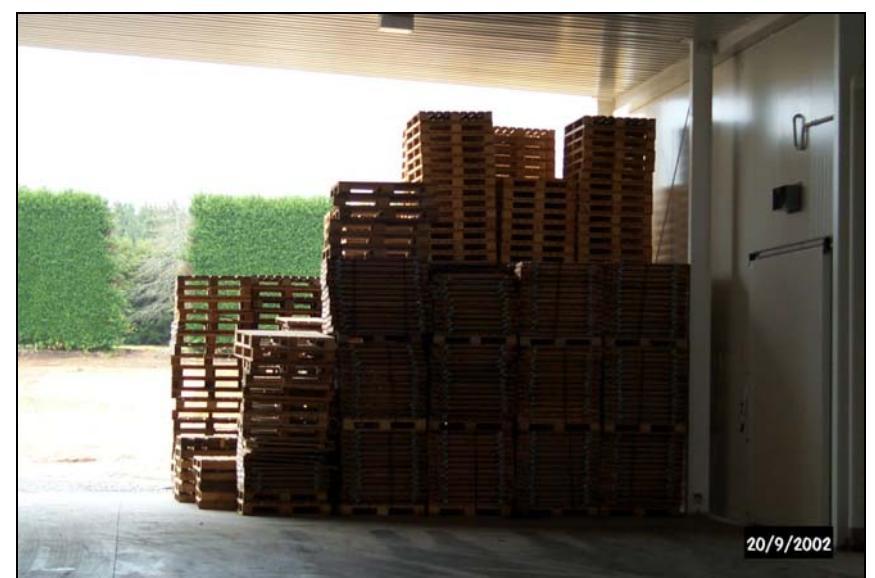
Fig. 4.3 Wooden pallets stacked over 3m high and constituting a greater potential fire load than was envisaged by the designer.

The building industry needs to better recognise the actual end user requirements for such a building, including such factors as off-season storage of combustibles. This needs to be done at the concept design stage. Unfortunately the active fire protection component of a building budget is often a casualty of cost cutting or value engineering exercises.

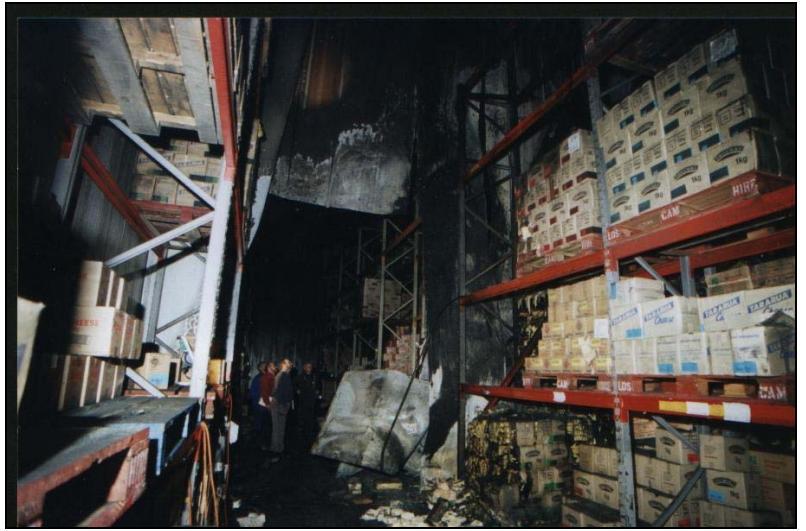
Fig. 7.1 Scene of fire in doorway between cold stores.

After an intensive investigation, the cause of the fire was attributed to an electrical fault in the trace heating around the insulated door. Several theories were postulated as to the actual ignition mechanism. The most popular one being that some form of arc tracking had occurred in the wiring to the trace heating element where the wires were pinched where they pass through the door frame by damage caused by fork hoist impact. (Fig.7.2). It was also suggested that damage may have caused a hot spot in the heating element.

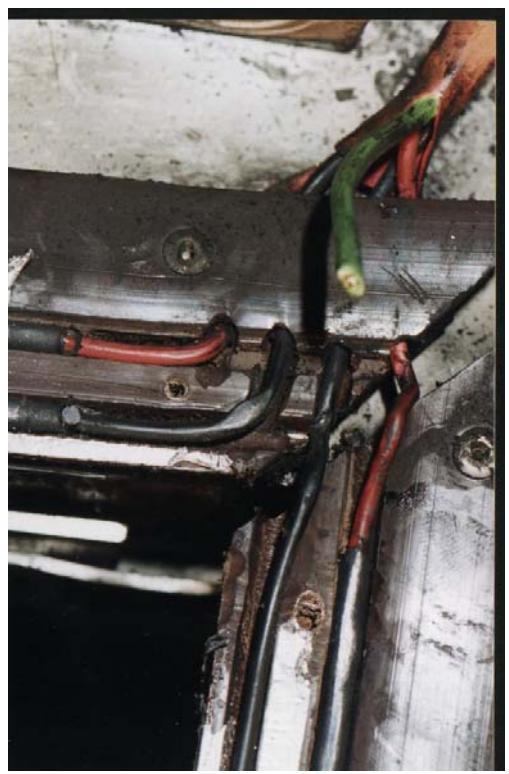
Fig. 7.2 Corner of door frame with capping removed showing where wiring has been pinched.

A contributing cause was that the temperature of the store had been raised from -20° C to $+4^{\circ}$ C. At the higher temperature trace heating was not required, but due to an oversight it had been left on.

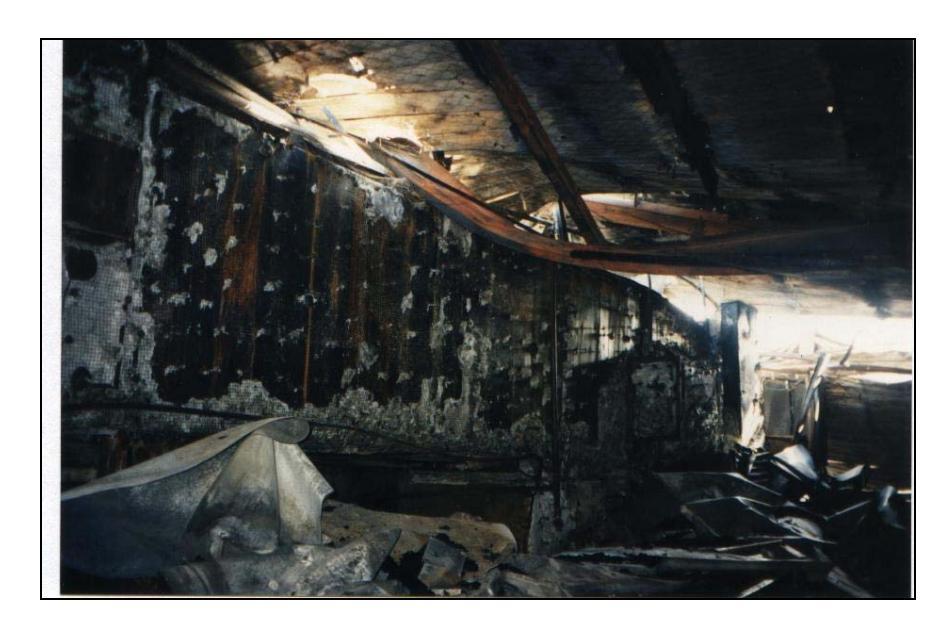
Fig. 7.3 Side of bread oven exposed by failure of EPS wall and ceiling panels.

A polystyrene panel wall and ceiling separated the oven from the working area and provided some protection to workers from the radiant heat of the oven which operated at 240°C. (Fig.7.3).

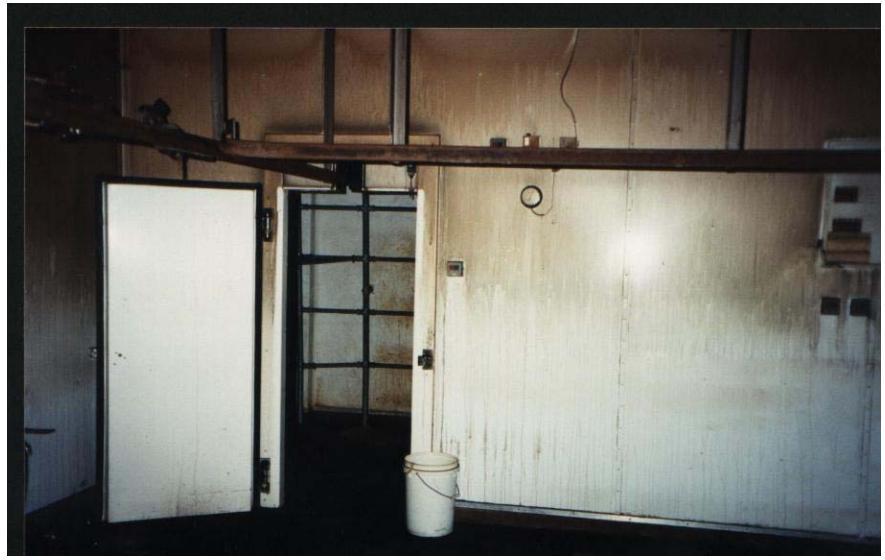
The chillers and freezers were built from two different types of materials, reflecting their different ages. The fire was external to them, but within the main building, The two types of enclosures within the main building behaved quite differently in the fire. The older type appeared to be constructed from a solid plaster, but in fact the walls were of a hollow construction. This part of the building was erected in the late 1960s before EPS was commercially available. Insulation was provided by multiple hollow reflective panels of aluminium foil separated by battens and protected on the outer surfaces by timber framing and a fibrous plaster painted finish. The inner surfaces were either plaster on cement or timber sarking. The most common brand name for this form of insulated wall at that time was "Sisilation." These cool rooms were internally undamaged by the fire and did little to aid the fire spread although painted gypsum plaster board surfaces suffered heat damage from the fire. (Fig.7.4).

Fig. 7.4 Older type of cold room exterior with minimal damage

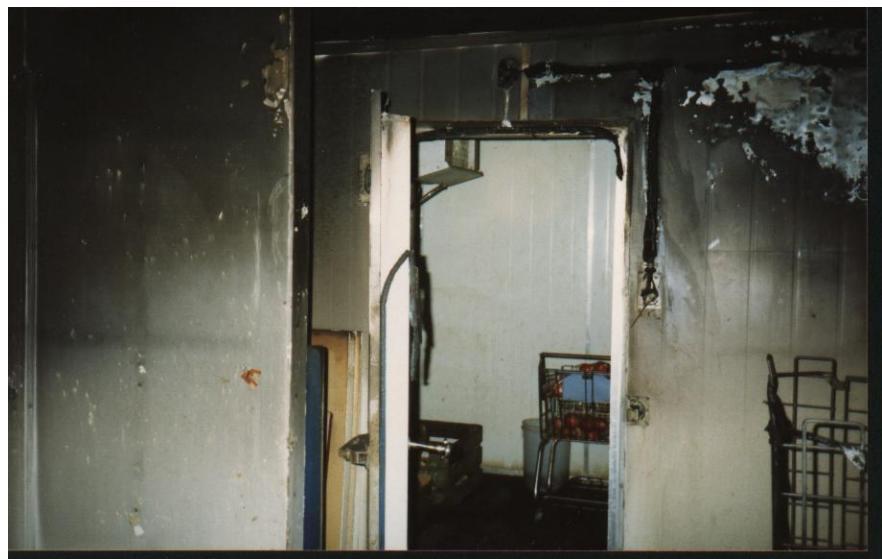
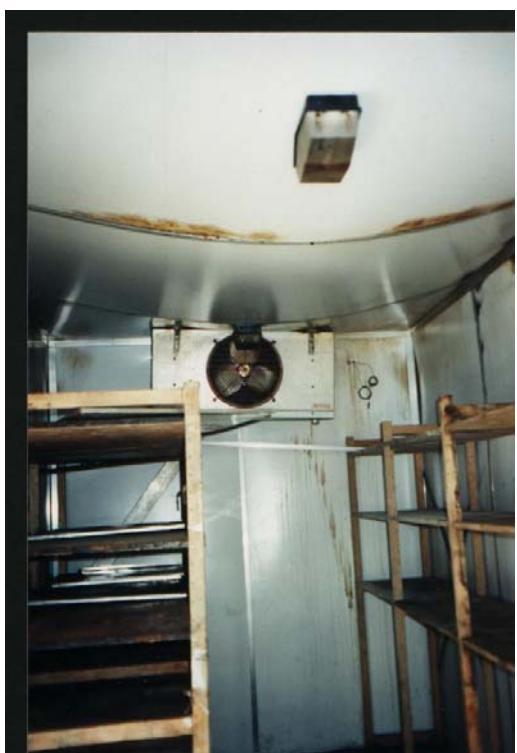
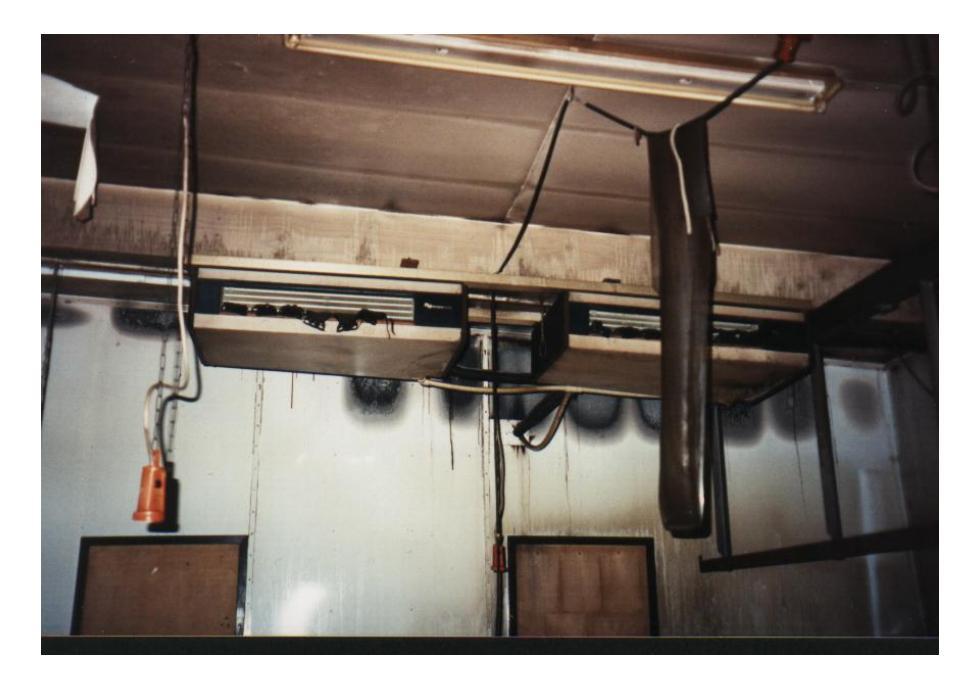
By contrast, a newer ham chiller and two meat freezers in the basement was constructed using 100mm thick EPS. The chiller suffered loss of structural stability of the ceiling although there was no noticeable load on it, and the freezers suffered from high heat flux in the upper areas of the walls so that paint burnt off both the inside and the outside surfaces, indicating a delamination and shrinkage of the polystyrene between the sheet metal outer layers. The meat freezers appeared to have retained their structural integrity only because they contained an internal steel strong-back for the rails that supported the meat carcasses. (Figs. 7.5, 7.6, 7.7)

Fig. 7.5 EPS Cold room exterior

Fig. 7.6 EPS Cold room interior showing ceiling has sagged due to load of evaporator.

Fig 7.7 EPS Cold room interior showing heat affected wall panel behind evaporators where cladding is compromised by services penetrations.

Electrical wiring and refrigerant pipework insulation mounted on the surface of the EPS was destroyed by heat in the upper hot layer, and penetrations were then open to the fire.

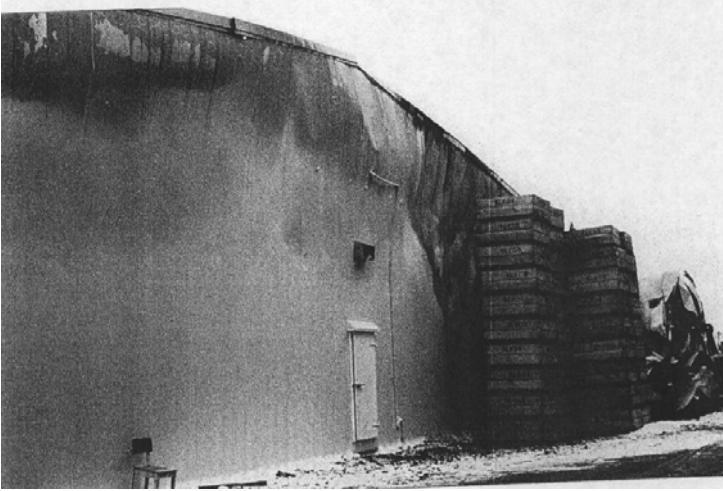
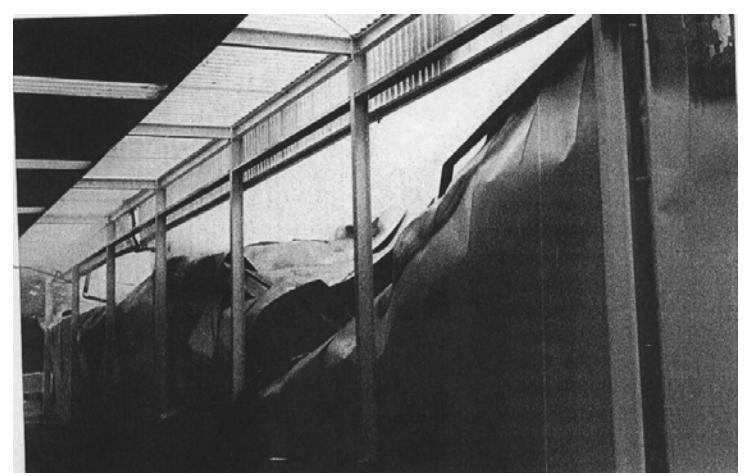
Fig. 7.8 Rear wall of cool store. Note increased fuel load from timber boxes.

Fig 7.9 EPS Panel walls have collapsed inwards towards the fire.

The damage to the buildings and contents was so severe that demolition and debris removal commenced even as the fire was still being bought under control. (Report cover photograph, Figs.7.8, 7.9)

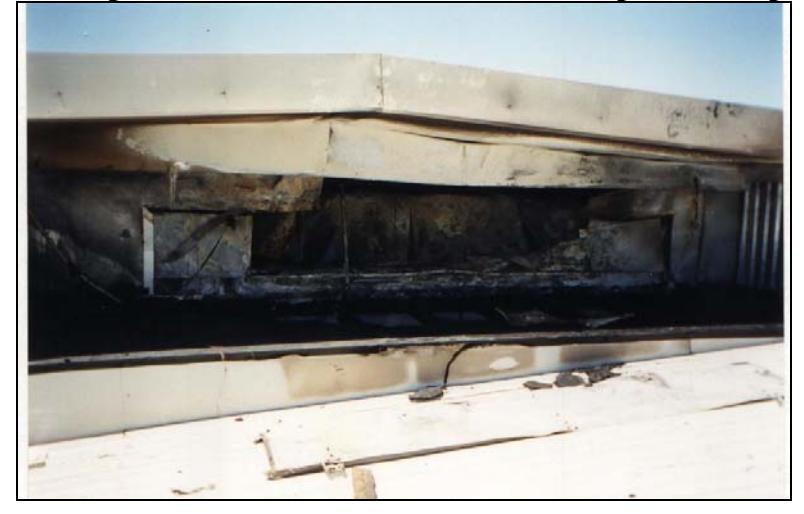
Fig. 7.11 Evaporator room showing effects of the fire.

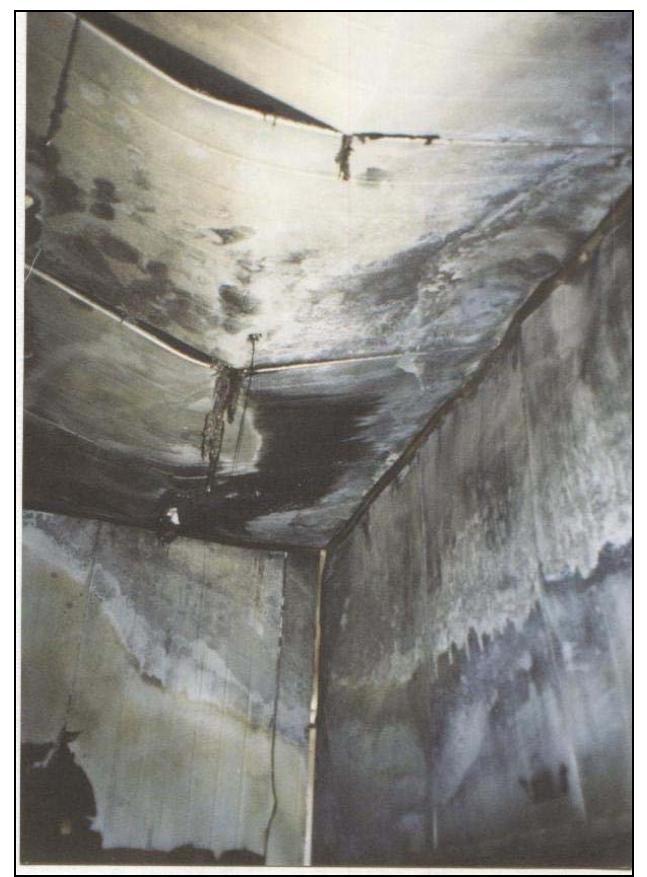
Fig. 7.12 Evaporator room inlet plenum showing failure of 250mm EPS panel caused by fire.

One evening while the store was manned and operating, a heat detector in the ceiling triggered an automatic alarm. The Fire Service contained the fire to the No.3 evaporator room within 30 minutes of arrival, however smoke and products of combustion had circulated through the cold store tainting its contents all of which had to be destroyed.

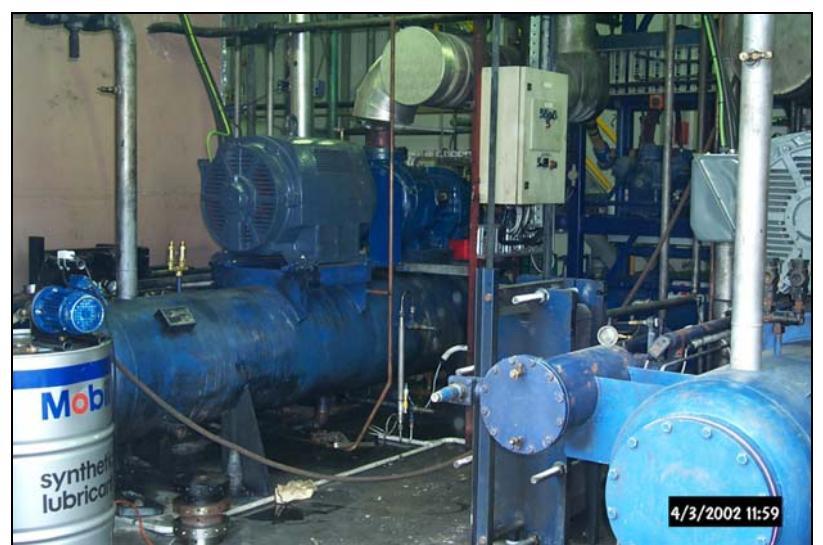
In February 2002, a fire started in the engine room of a meat works in a central North Island town. The room contained the refrigeration compressors that maintained blast freezers and cold rooms and chillers containing beef carcasses and boned beef boxes. The building was seven years old and not sprinklered. (Fig.7.13)

Fig. 7.13 Engine room where the fire started. Note increased fuel load from refrigerant oil.

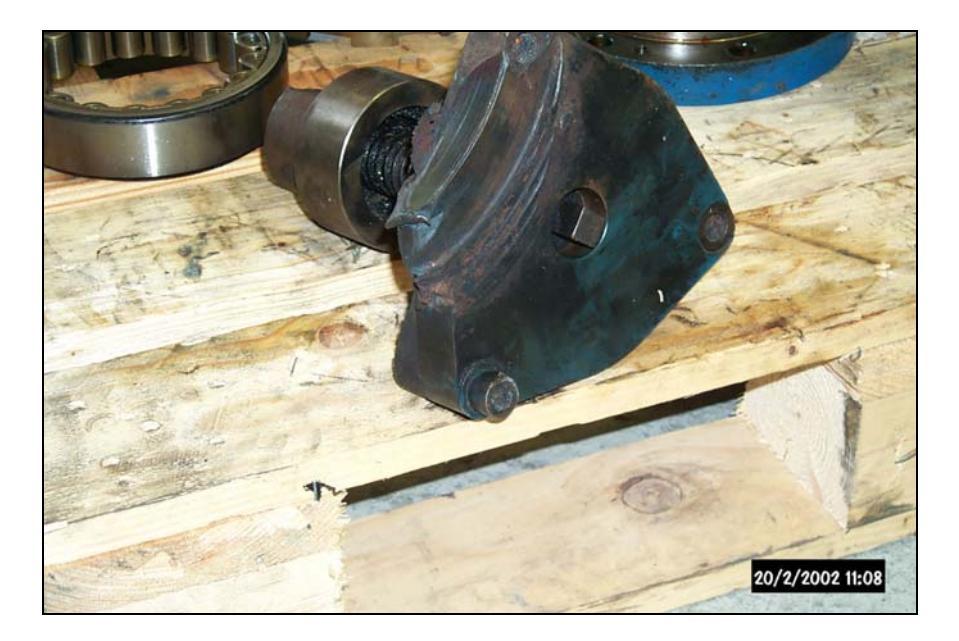
One twin screw compressor set running on Freon R22, and direct driven at 1800rpm by a large electric motor, fractured its cast iron casing. The fractured part was forced against the rotating coupling between the motor and the compressor creating a shower of sparks and heat. (Fig.7.14). Freon gas carrying lubricating oil escaped from the compressor under pressure. The gas was forced through the sparks igniting the oil before spraying it onto EPS panels that formed some of the walls of the engine room.

Fig. 7.14 Damaged compressor component "machined" by coupling causing sparks and heat.

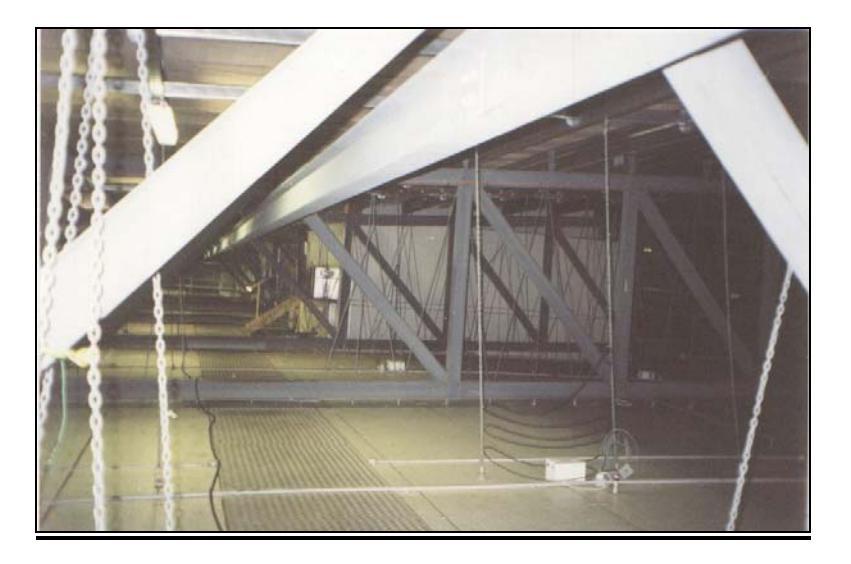
Fig. 8.5 Roof space above cold store

Keep roof spaces clear of unnecessary combustible material such as spare filters.

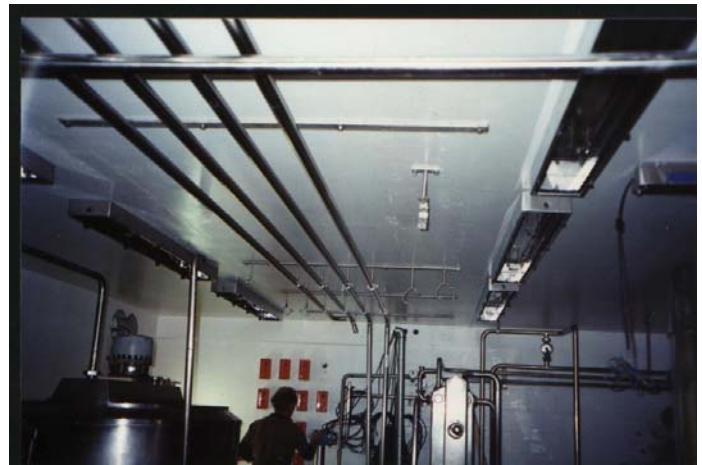
Fig.8.7 Ice-cream manufacturing room. Note surface mounted lights and pipework.

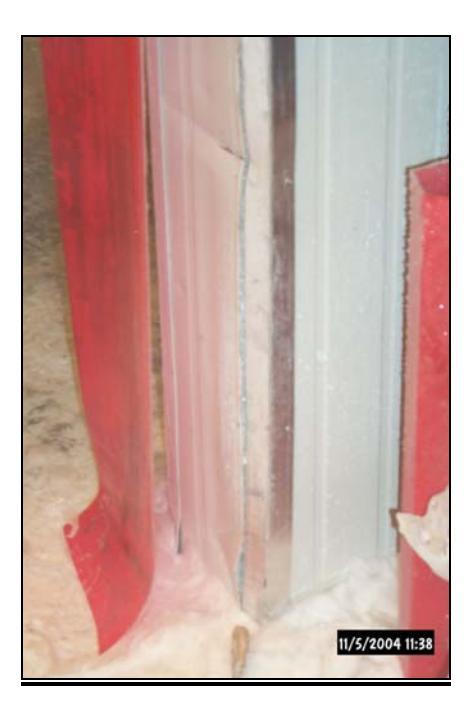
Fig. 8.8 Freezer wall showing fork hoist damage and exposed polystyrene.

Repair promptly, even if by temporary patching using sheet steel and pop rivets. This is preferable to waiting for an opportunity to carry out a more permanent repair. It is more important from a fire safety perspective, to cap and seal the exposed polystyrene, than to make it look hygienic or by hiding the damage from view.

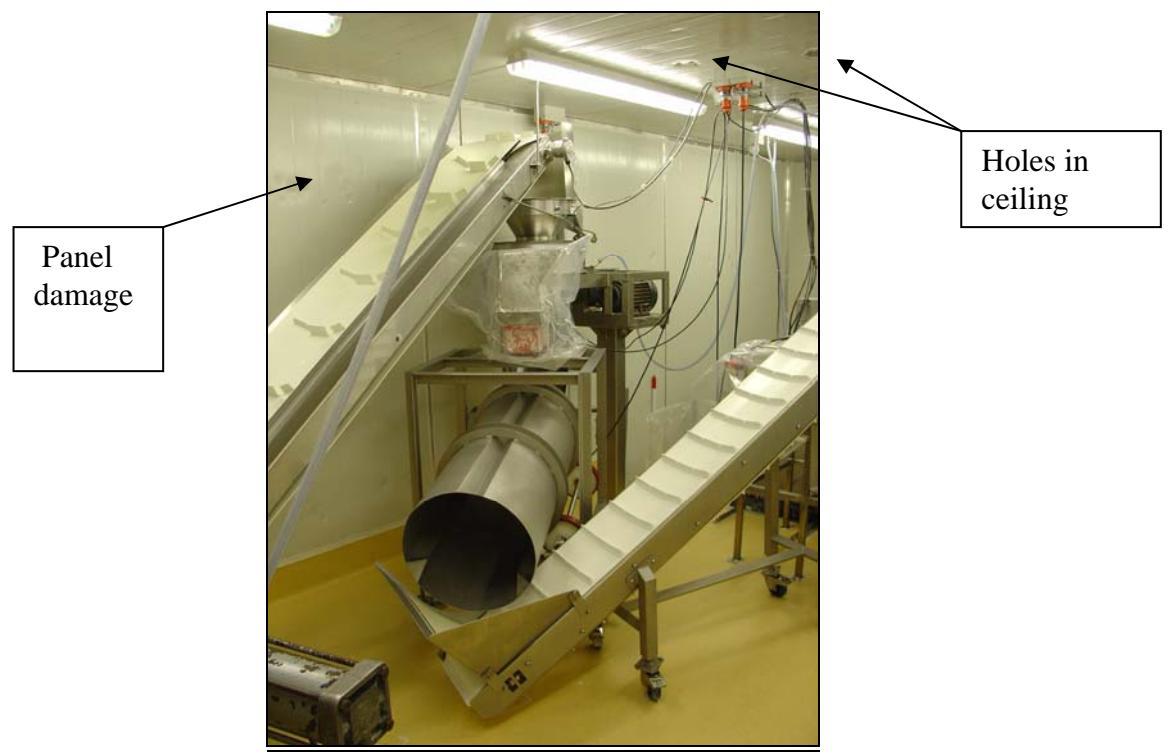
Fig. 8.9 Cheese grating room showing panel damage and old holes not sealed up.

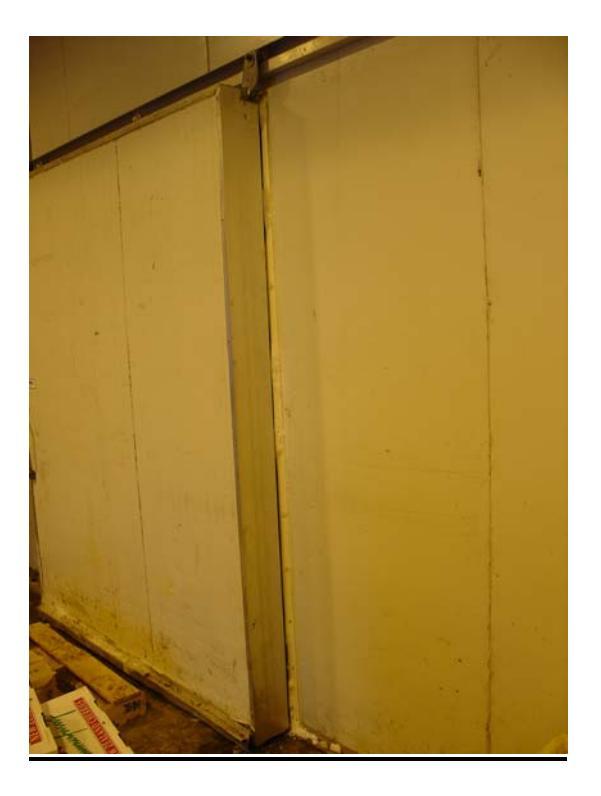
Fig. 8.10 Typical EPS freezer door showing damage to bottom edge
