FULL-SCALE FIRE TESTS OF POST-TENSIONED TIMBER BEAMS

ABSTRACT: This paper describes a series of full-scale furnace tests on loaded post tensioned LVL beams. Each beam was designed to exhibit a specific failure mechanism when exposed to the standard ISO834 fire. In addition to the beams a number of steel anchorage protection schemes were also investigated. These included wrapping the ends in kaowool, using intumescent paint, covering the anchorage with fire rated plasterboard and covering the anchorage with timber (LVL). The results of the full-scale tests cover temperature distributions through the timber members during the tests, the temperatures reached within the cavity and those of the tendons suspended within the cavity, the relaxation of the tendons during the test, the failure mechanisms experienced, and a summary of the anchorage protection details and their effectiveness. Recommendations for the design of both post-tensioned timber beams and associated anchorages are also provided.

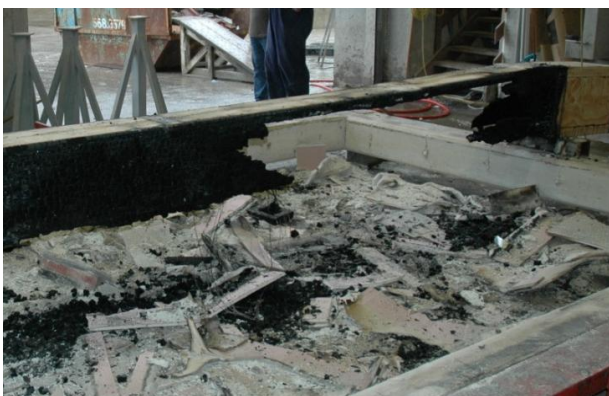
A large portion of one end of the beam burnt through, as a direct result of the extra time it took to remove the loading frame. The remaining end showed two cracks in one of the webs. One crack ran along the bottom corner of the beam, where a shear failure had been predicted. The other crack was higher in the web approximately 3-5 cm below the top flange. Figure 17 shows the failure shape of in an un-deflected state. Figure 18 shows Test 1 after the beam had been removed from the furnace. The immediate aftermath of the test is shown in Figure 19.

Figure 18: Test 1 beam after the test

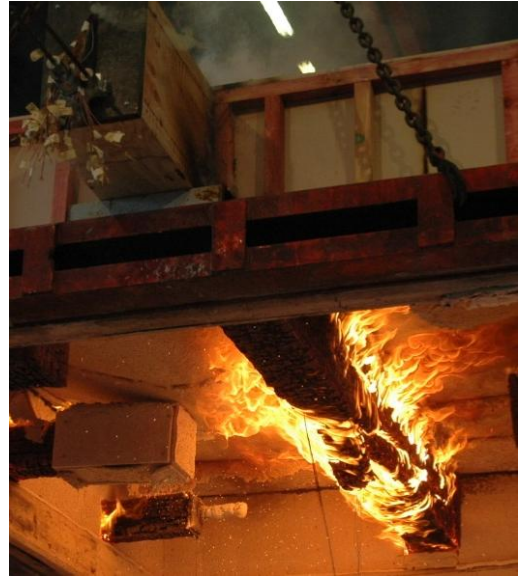
Figure 19: Test 1 shortly after test

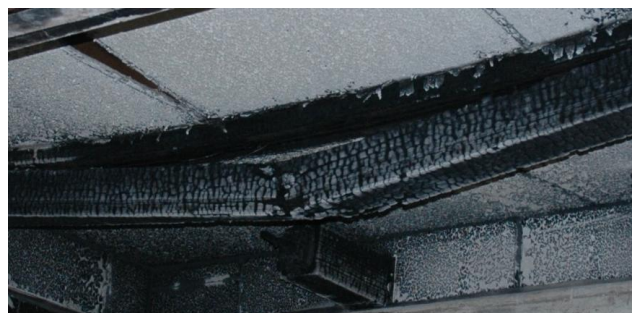
Test 2 failed unexpectedly early. The top flange detached from the webs along most of the length of the beam. One end of the beam remained intact whereas at the other end the flange detached all the way to the end of the beam. The bottom section of the beam formed a channel which crushed near the mid-span of the beam, due to the post-tensioning compression and the compression due to bending. This formed a plastic hinge at the mid-span of the beam which meant only the weaker top flange was capable of carrying any load, causing the beam to fail. This plastic hinge resulted in localized buckling of the web, forcing the webs outward. Figure 20 and Figure 21 show Test 2 after failure. The premature failure of Test 2 led to design method improvements which incorporated the effect of axial loads on a deflected member more accurately.

Figure 21: Test 2 beam after the test.

Test 2 failed earlier than expected. This led to improvements in the design approach. The design methodology before Test 2 did not sufficiently consider the additional moment due to the effect of axial loads on an already deflected beam.

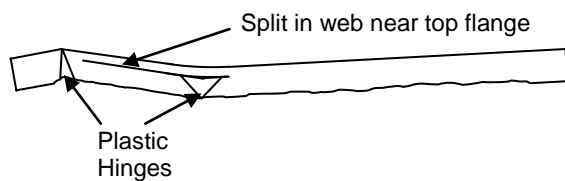
Under one of the loading points in Test 3 a plastic hinge formed in the bottom channel of the section. This was again accompanied by a splitting of the web near the top flange. However, during this test the split was far more localized and did not split down the entire length of the beam. This plastic hinge exhibited some localized buckling in the web as shown in Figure 23.

A second plastic hinge formed near the vertical support closest to the bending failure. This point experienced no, or very low, bending moments due to the loading, however it did experience the maximum bending moment due to the post-tensioning. A hogging plastic hinge formed. Figure 22 and Figure 23 show the beam in Test 3 after failure.

Figure 22: Failure shape of Test 3.

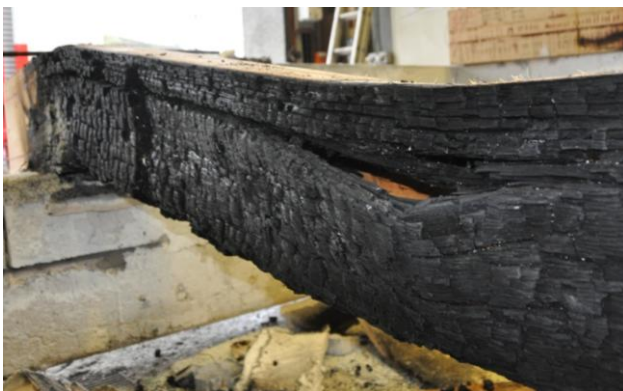
Figure 23: Test 3 beam after the test.
