Considerations on the seismic performance of pre-1970s RC buildings in the Christchurch CBD during the 4th Sept 2010 Canterbury earthquake: was that really a big one?

S. Pampanin, W.Y. Kam, A.S. Tasligedik, P. Quintana Gallo, U. Akguzel

University of Canterbury, Christchurch, New Zealand.

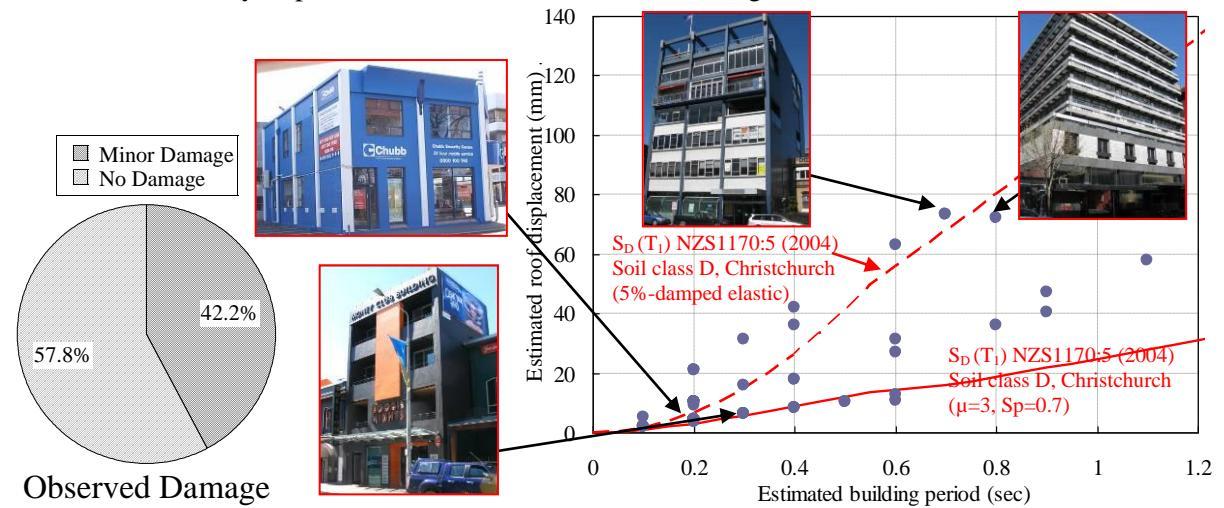
Figure 2 shows a plot of the estimated building period (based on the building height and type of lateral resisting system) versus the estimated roof displacement (based on the observed damage including structural and non-structural components e.g. infills and glazing). While it is apparent that taller buildings lead to higher roof displacement, the trend in Figure 2 indicates that the more flexible buildings underwent higher displacement demand and suffered more damage. Stiff buildings with multiple walls (RC or infills) seem to perform relatively well. Nevertheless, the initial positive contribution of masonry infill walls on the pre-1970s RC buildings could have been negated if the infill panels had deteriorated.

Figure 2. a) Percentage of damaged (minor to moderate) buildings in the surveyed pre-1970s RC buildings stock, b) Plot of estimated building period versus estimated roof displacement. The spectral displacement demands from the NZS1170:5 (2004) for Christchurch soil class D is shown as comparison.

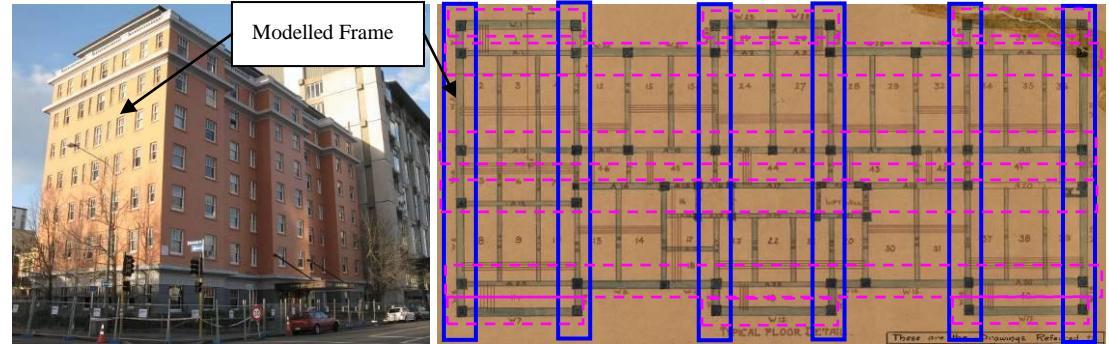
The case study St Elmo Court building (Figure 5a) is a seven-storey non-ductile RC frame building with heavy masonry infill panels and exterior veneers. In the transverse direction (North-South orientation), the lateral resisting system consists of six five-bay RC frames, two of which had infill masonry. In the longitudinal direction (East-West orientation), six one-bay infilled RC frames and four seven-bay interior RC frames provide the lateral capacity of the building. For this study, only the transverse RC frame is considered.

Figure 5. a) The South-West view of the St Elmo Court building; b) Typical floor plan of the St Elmo Court. Dark solid boxes and the light dashed boxes are the lateral load resisting elements in the transverse (N-S) and longitudinal (E-W) direction respectively.

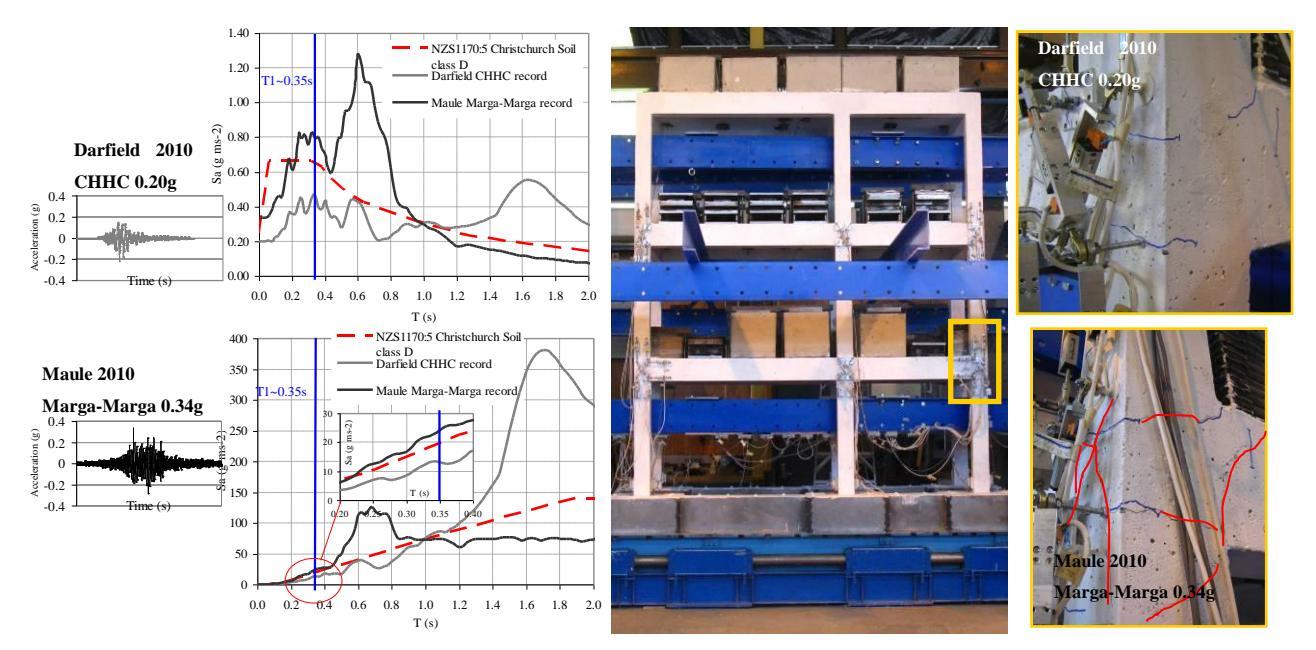
The test result clearly highlighted the brittle 'on-off' (e.g. either elastic behaviour or brittle failure) seismic behaviour of the non-ductile pre-1970s building. Under the Darfield CHHC input (PGA=0.22g, distance = 35km), the recorded inter-storey drifts were less than 1% in all floors, with near elastic response. Minor flexural cracks were observed in the beams and columns (Figure 7c top). Under the Maule Marga-Marga input (PGA=0.34g, distance = 290km), severe damage was observed at the 1st floor beam-column joints. Maximum recorded inter-storey drifts of 4.0%, 2.5% and 1.0% were observed in the 1st floor, 2nd floor and 3rd floor respectively.

Figure 7. Shaking table test of three-storey non-ductile pre-1970s RC frame building (Quintana-Gallo *et al.* 2011). a) Input motion and response spectra in the model domain; b) The front elevation of the test frame model; and c) top: First storey beam-column joint after the scaled Darfield CHHC record, and bottom: First storey beam-column joint after the scaled Maule Marga-Marga record.

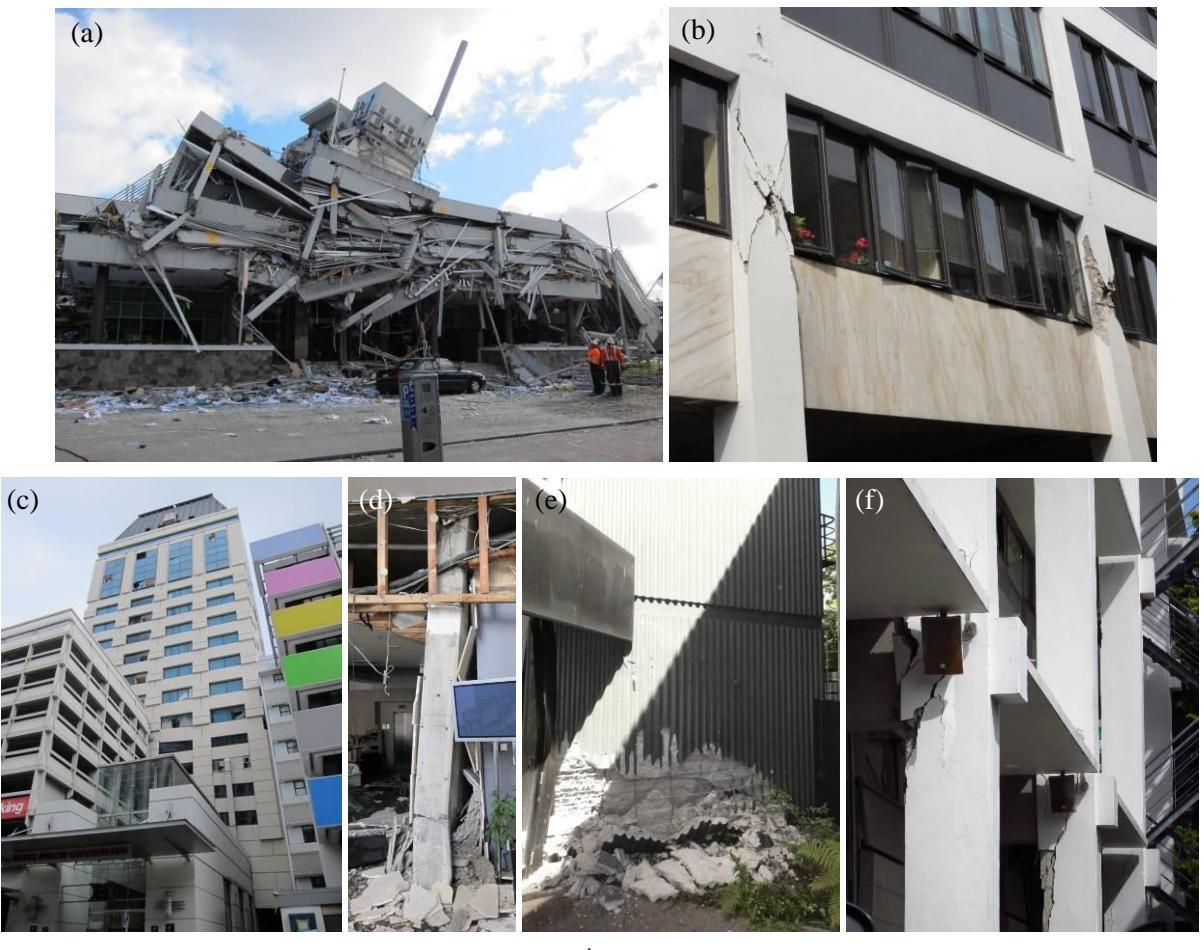
Note: at the time of writing and review of this manuscript, the 22^{nd} Feb 2011 M_w 6.3 Christchurch earthquake has occurred approximately 10km from the Christchurch CBD region. Unlike the Darfield earthquake, this lower magnitude but significantly higher intensity of ground shaking has resulted in severe damage/collapse of RC buildings. In particular, a 1960s building consisting of RC frames and core-wall has fully collapsed (Figure 8a), resulting in loss of human lives. Severe column, beam-column joints, walls and beams damage have been observed in RC buildings built in the 1950s to the 1980s (Figure 8b-f). While it is premature to make any significant conclusion of the observed structural failures and damage in the 22^{nd} Feb event, these high-impact consequences of this catastrophic event have unfortunately reaffirmed the conclusions above (stated and written prior to the 22^{nd} Feb earthquake).

Figure 8. Preliminary observations from the 22^{nd} Feb 2011 M_w 6.3 Christchurch Earthquake: a) The collapse of the 1960s Pyne Gould Corp building; b) Column and joint shear damage at a 9-storey RC building; c-d) Failure of critical wall and column elements resulting in significant tilt of the Grand Chancellor building; e) Compressive crushing failure of shear wall; and f) Beam-column joint failure at the 1st floor connections.
