## The Demountability, Relocation and Re-use of a High Performance Timber Building

T. Smith, R. Wong, M. Newcombe, D. Carradine, S. Pampanin and A. Buchanan.

*The University of Canterbury, Christchurch, New Zealand.*

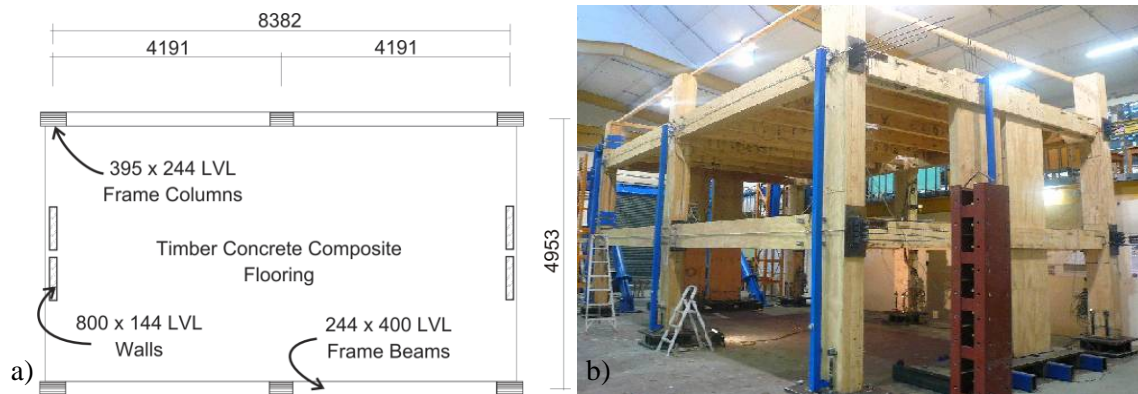
The two storey Pres-Lam test building was a frame and wall open plan structure as shown in Figure 1. The building consisted of a lateral resisting post-tensioned timber frames in one direction and post-tensioned coupled shear walls in the opposite direction. The floor of the structure, which was of area  $41\text{m}^2$  on two levels (i.e. a total area of  $82\text{m}^2$  of the building), was a timber concrete composite flooring system developed at the University of Canterbury, consisting of LVL joists and 50mm of topping concrete connected with notch and coach screw discrete couplers (Yeoh 2010). Due to the structure being a research specimen the floors spanned in two different directions.

**Figure 1.** Pres-Lam Test Building a) Floor Plan and b) Constructed Test Building

Post tensioning tendons were placed inside the beams and walls providing moment connections and thus lateral resistance. Additional moment capacity and energy dissipation was provided by two types of non-prestressed reinforcement. The first was a fused type bar/dissipater attached externally, developed for use in concrete (NZCS, PRESSS Design Handbook, 2010) and adapted to timber. These devices were placed across interfaces between the beam-column and column-foundation. The second solution was given by U-shaped Flexural Plates (UFP) (Kelly et al., 1972) placed in the gap between the two wall elements and being activated by the relative movement of the adjacent walls during the rocking mechanism. Diaphragm action was achieved through the concrete topping which was attached to couplers connected to edge beams which were screwed to the frame and wall members. More information on the test building and its performance can be found in Newcombe et al. (2010a,b).

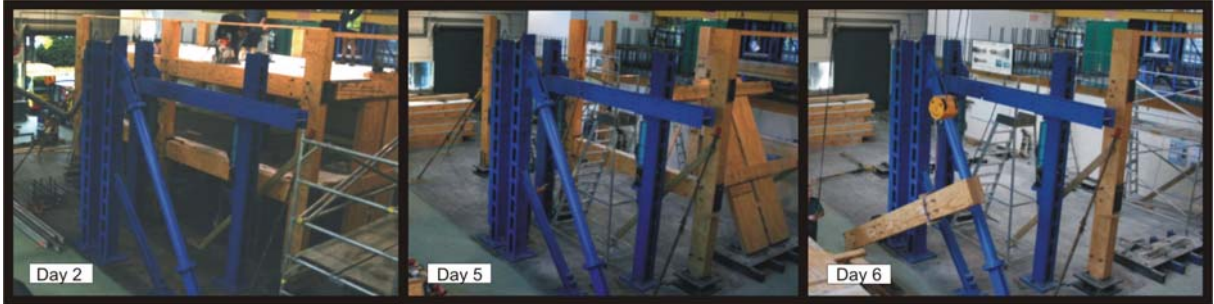
The first stage deconstruction was performed by Mainzeal Construction Ltd, the same contractor that assembled the Pres-Lam test building. Members were then demounted by University technical staff after the floors were decoupled and the tendons released. The major aim of the deconstruction was the removal of all members safely with minimal damage. Structural consultants were engaged before the deconstruction to ensure that reconstruction would be efficient. A major concern was the removal of the floor system and the consequent loss of diaphragm action provided by the concrete topping. This would have to be recreated in the reconstructed building. The deconstruction sequence is displayed in Figure 2. More information on the deconstruction can be found in Wong (2010).

Figure 2. Deconstruction Sequence of Pres-Lam Test Building (Wong 2010)

The deconstruction process took a total of 122 manhours to complete (Wong 2010). Most of the onsite work was performed by two labourers with more required during certain stages. 6 days were needed to completely dismantle the structure. While little time was spent dismantling the structural elements the removal of the floor was time intensive. This was due to the use of discrete connectors from the floor to the frames or edge beams within the slab to provide load transfer between each floor unit. This choice meant that considerable labour was required to decouple the slab from the beam and edge-beam members. The remaining time was spread evenly amongst the other structural elements. The total estimated cost of the deconstruction was \$NZD 10,420 (Wong 2010). This was 15% of the total cost of the building and half the cost of the original construction. All other costs were evenly distributed among the other elements. In practical application it is envisaged that this cost will be more than offset by the sale of the building members or money saved in materials for a new structure.

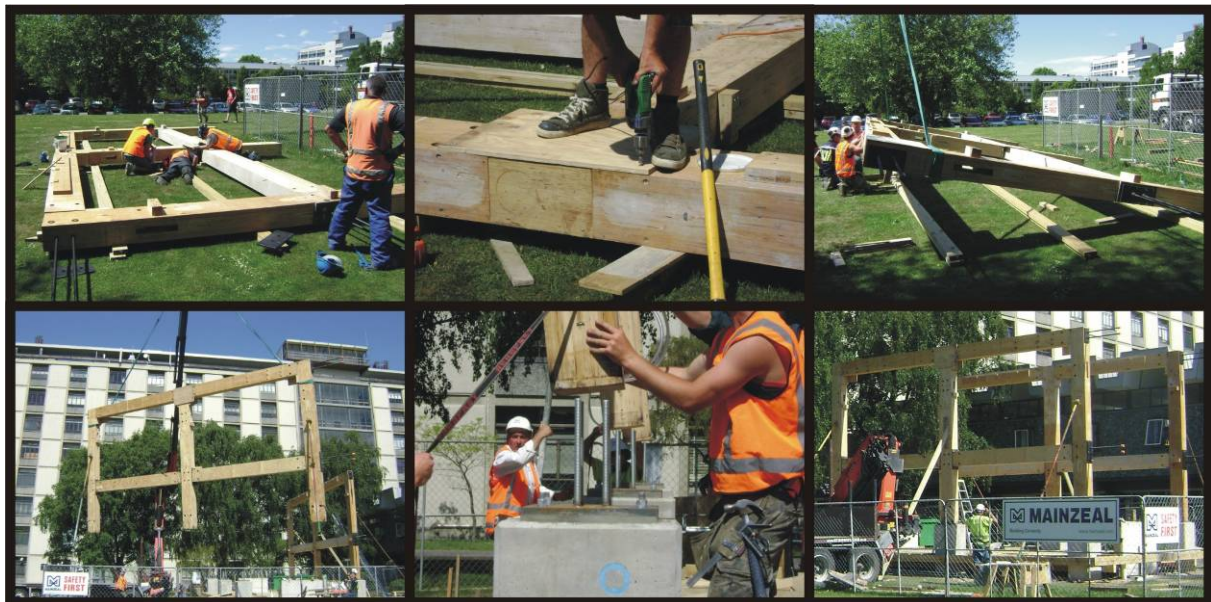
The erection of the post tensioned timber frame was begun on the 16<sup>th</sup> of November, 2010. The frames were assembled on the ground, MacAlloy bars were hand tightened and then frames were lifted into place. Once in position, adjustable props were placed and secured. The total time of erection for the first frame was 3 hours. Of this time approximately 1 hour was spent on each of the tasks of; the frame assembly, hand stressing/plumbing and the erection/securing with propping. The assembly of the second frame was performed on the ground beside the structure and then lifted into place in the same manner as the first frame. Less time was required for the second frame erection as workers became familiar with the necessary procedures. The frame was assembled on slightly uneven ground demonstrating the versatility of the building system and the way it can be adapted easily to onsite conditions. Pictures displaying frame erection are shown in Figure 5. During the erection of the frames a total of 8 workers were used onsite. A total of 40 man hours were used in the erection of both Post Tensioned Timber Frames.

**Figure 5.** Erection of Second Post Tensioned Timber Frame

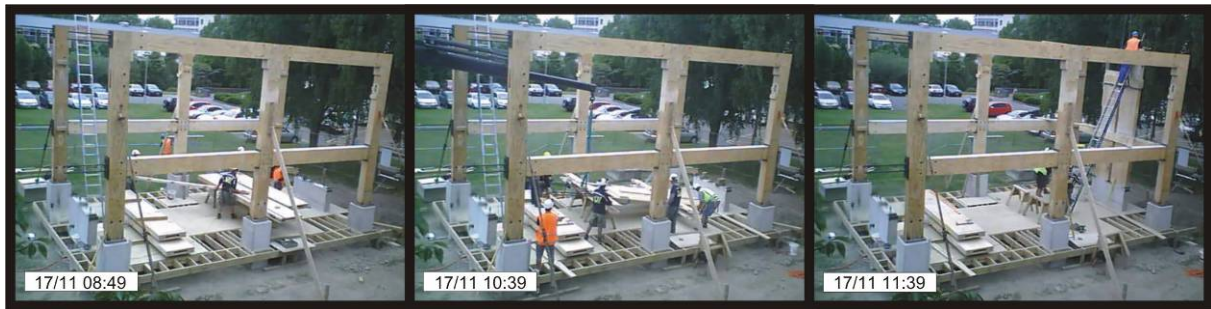
Erection of the walls took place one day after the erection of the timber frames. The two parallel walls were placed on trestles, the edge beams were attached and the whole end section was lifted into place and secured. External props were not used as the walls were supported by temporary braces attached to the frames along with the hand tightened MacAlloy Bars. The total time taken to assemble the first set of walls was 3.5 hours. The assembly of the second set of walls was more rapid than the first set (2.75 hours) as the workers became more familiar with the necessary procedures. The erection

sequence and time of the erection of the wall systems are shown in Figure 6. A total of 37.5 man hours were required for the erection of the two walls.

**Figure 6.** Erection of Post Tensioned Timber Walls

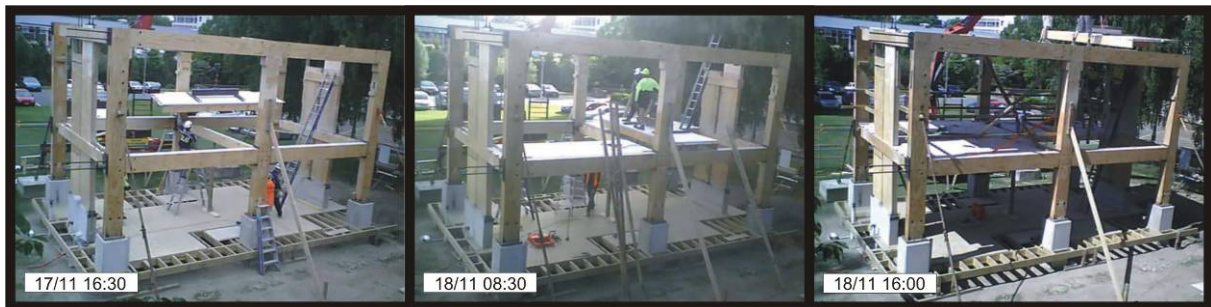
Immediately upon completion of the structural frames and walls, work commenced on the placement of the 1<sup>st</sup> floor primary beam which would act to further increase the stability of the structure. Once the primary beam was placed the flooring units were lowered into position. The floor units were placed on the already existing top mounted joist hangers before the face mounted joist hangers were installed on site. Figure 7 shows the placement and time required for the floor units.

**Figure 7.** Placement of Floor Units

During the placement of the floor units handrails were nailed to column members on the first floor to comply with site safety requirements. The placement of the first floor took a total of almost 5 hours. As with the frames and the walls the second part (i.e. Level 2) took less time, requiring only 3.5 hours.

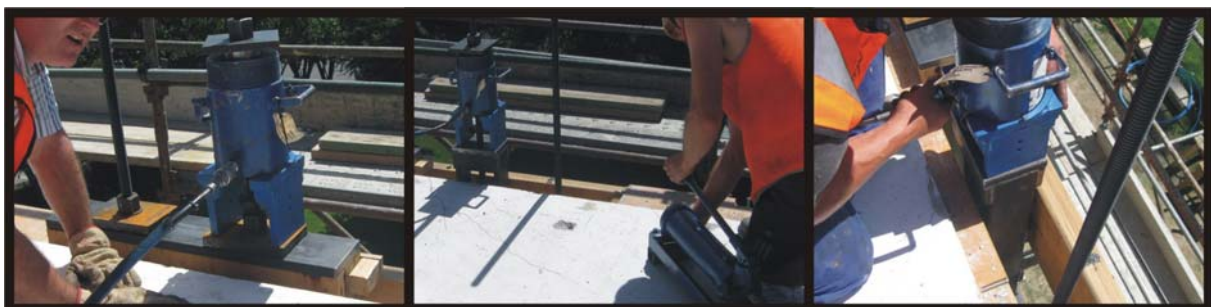
The post tensioning of the frame and wall elements took place on the 26<sup>th</sup> of November. Three workers were required and the recently erected scaffolding was used to access the building. The time taken to post tension the two frames and four walls was approximately two hours. To apply the post tensioning to the shorter walls, a steel extension was fabricated giving the jack adequate space to pull the bar from above while the nut was tightened. The post tensioning of the wall is shown in Figure 8, with the extension used for the shorter wall shown on the far right. 3 workers were required for the safe application of the post tensioning.

**Figure 8** Post Tensioning of the Wall

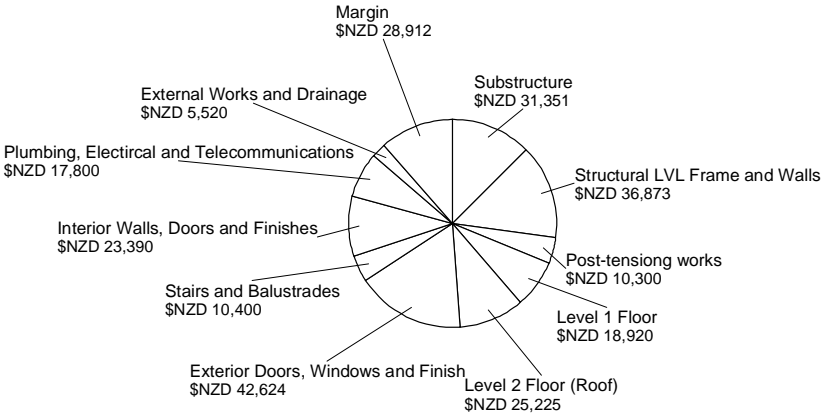
The total cost of the reconstruction of the test building (Figure 9) was estimated before construction commenced to be \$NZD 250,000 (3,000 \$NZD/m<sup>2</sup> of floor area) which included the \$NZD 42,000 cost for the original structure and a 13% margin (intended to cover additional risk in the project cost and set at the current standard rate) but did not include the reworking of the members necessary for their new application (performed at the University of Canterbury free of charge). This estimation was made from a combination of quotations from suppliers and the Rawlinsons Construction Hand Book (Rawlinsons & Co. 2009).

**Figure 9.** Estimated Cost of EXPAN Office Building

It can be seen above that the structural system (substructure, frames, walls, post-tensioning, Levels 1 and 2) makes up \$NZD 122,000 (1,470 \$NZD/m<sup>2</sup> of floor area) which is approximately 50% of the total cost of the structure. Of this, the foundation makes up \$NZD 31,000 (26%), slightly less than the frames and walls which cost a total of \$NZD 37,000 (30%). The level one and two floors are estimated at \$NZD 19,000 (16%) and \$NZD 25,000 (20%) respectively. The post tensioning works cost \$NZD 10,300 including materials, a significant portion (70%) of which is the cost of materials. The remaining cost was for architectural components such as cladding and interior finishes.
