Liquefaction ejecta clean-up in Christchurch during the 2010-2011 earthquake sequence

M. Villemure, T.M. Wilson, D. Bristow & M. Gallagher

**2012 NZSEE
Conference**

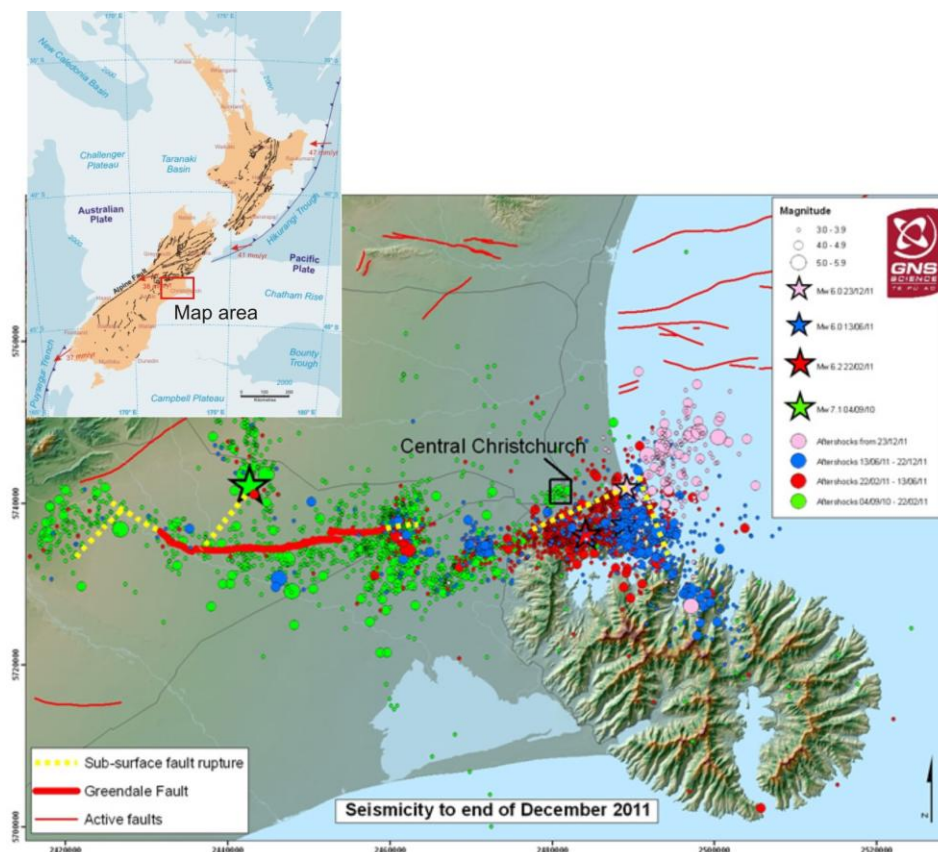
Figure 1: New Zealand tectonic setting and aftershock map showing epicentre locations of significant earthquakes of the 2010-present Canterbury earthquake sequence (source: GNS Science)

New Zealand is located on a convergent plate boundary where the Australian and the Pacific plates move obliquely relative to each other (Walcott, 1998) (Fig. 1). This movement is mostly accounted by the Alpine Fault (70-75 %) and the Marlborough Fault zone (Howard et al. 2005), but it is also transferred to the surrounding region such as the Canterbury plains. These faults present a significant and poorly understood hazard that requires further research (Pettinga et al. 2001).

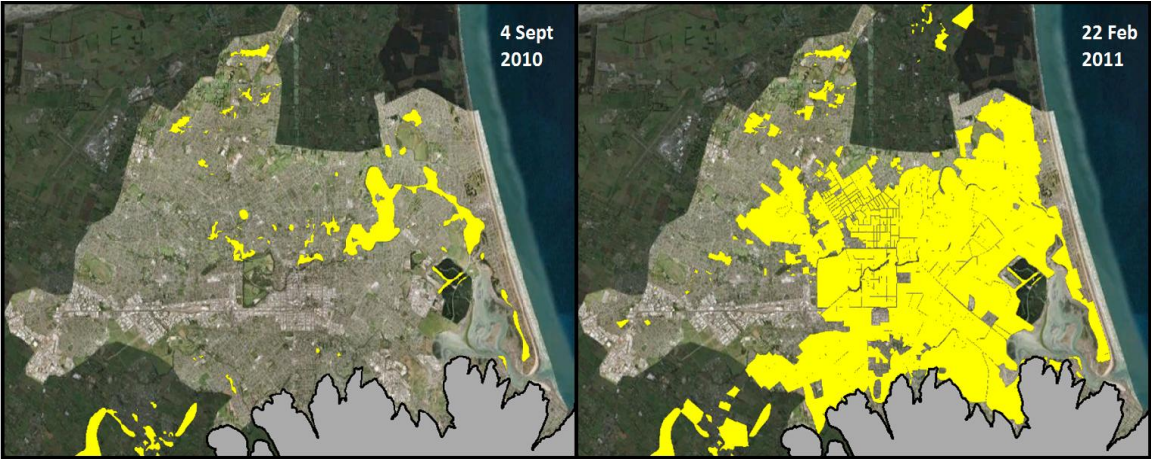
Figure 2: "Observed liquefaction overview map" in Christchurch for 4 Sept 2010 and 22 Feb 2011 earthquakes Yellow areas show observed liquefaction (source: EQC and Tonkin and Taylor Ltd).

Gubrinovski, 2011). These regions are built upon soft, saturated and uncompacted (Kaiapoi or Tai Tapu) soils (Recent and Recent Gley Soils respectively) which act to amplify the effects of ground shaking and are highly susceptible to liquefaction. The areas that experienced the greatest liquefaction included many low-lying eastern suburbs with a concentration along the Heathcote and Avon rivers (Fig. 2).

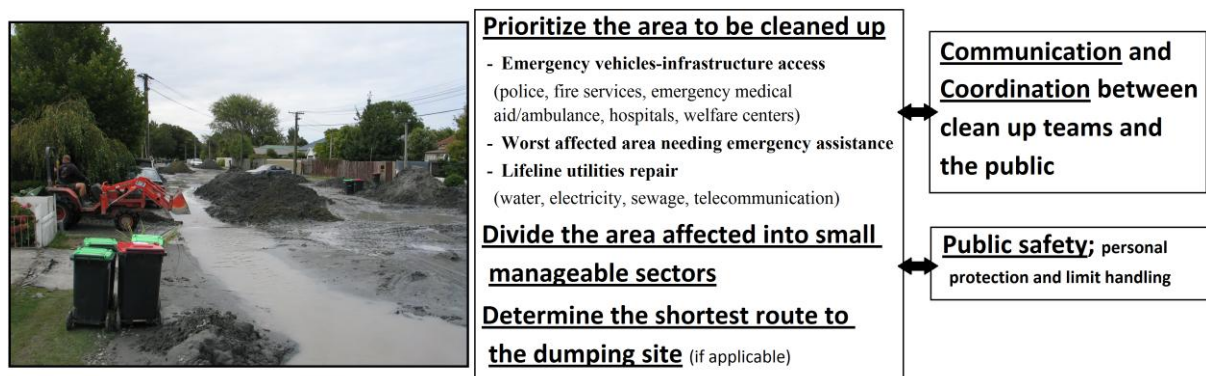
Figure 3: General strategy for Christchurch liquefaction clean-up. Photo: piles of liquefaction ejecta cleaned from residential properties and roads, ready for removal by heavy earth moving machinery at Bracken Street in the suburb of Avonside following the 22 Feb 2011 earthquake (Photo credit: Jarg Pettinga)

The optimal liquefaction clean-up process was found to include the following five steps (McDonald pers comm., 2011, Scott pers comm., 2012):

- 1) Contractor undertakes an initial inspection, defines small working zones on the basis of volume of sediment and local conditions, and identifies priority zones.

- 2) Contractor undertakes an initial silt removal from the street and pathways to facilitate transport - typically using heavy earth moving machinery.

- 3) Contractors, volunteers and property owners/residents remove silt by hand (i.e. shovel and wheelbarrow) from difficult to reach areas that machinery can't reach, including private properties, areas around vehicles, gardens, driveways and schools (Fig. 3). Material is accumulated in the street away from the curb (for easy pick up by diggers or loaders) and away from drains (to avoid sediment ingestion into waste water networks).

- 4) Silt is collected by contractors with machinery and either a) transported to disposal site at Burwood Resource Recovery Park (former city landfill) (Figs. 4, 5b) or b) stored in a temporary strategic location, prior to transport to disposal site (Fig. 5a).

- 5) Final cleaning via water-carts (truck mounted water tank and sprinkler system) to suppress windblown silt from the roads and to clean the silt possibly left into the storm water system.

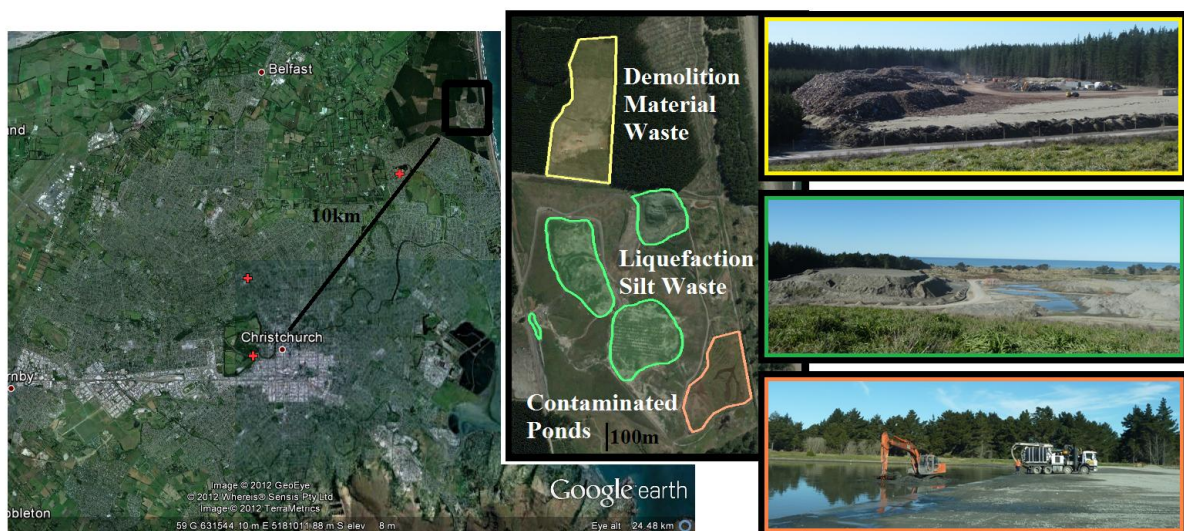
Figure 4: Burwood Resource Recovery Park location to Christchurch centre and simplified map of staging areas for different type of waste. Photo: staging areas on 25 August 2011.

The severity of road damage following the February quake and the huge volumes of silt led to stock piles being created in strategic locations in the city before being transported to Burwood (Fig. 5a) (Harris; Hautler pers comm. 2011, Scott pers comm. 2012). In addition, small quantities were disposed of by Fulton Hogan at their quarry in Pound Road due to proximity (Hautler pers comm. 2011). Future uses for liquefaction ejecta have been suggested for construction of concrete blocks or bricks, and engineering fill for levelling ground for sports fields and parks, however, to date the final uses have not been determined.

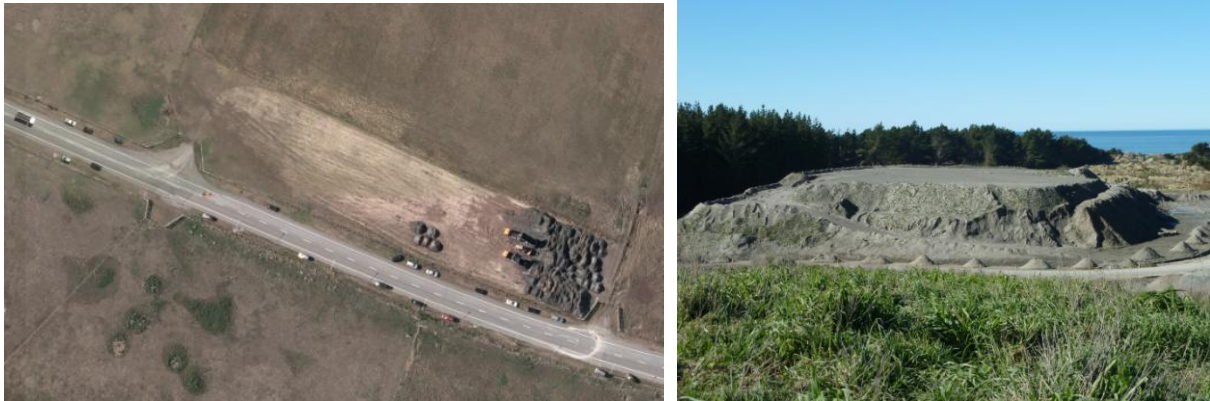
Figure 5a: Aerial Photo 655 Breezes Road Bexley, showing temporary storage area for liquefaction silt 25/02/11 (Source: Koordinates 2011); Figure 5b: Estimated >500,000 tonnes of liquefaction silt removed from the Christchurch urban area after the 22 February 2011 earthquake at the Burwood landfill disposal site.

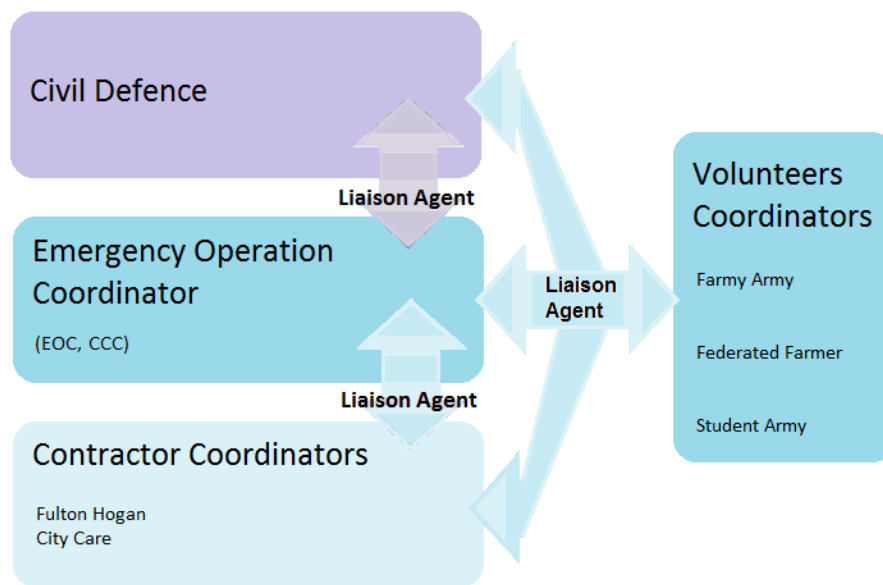
Figure 6: Emergency Clean-up Chain of Command from Christchurch liquefaction clean-up
