Seismic Performance Assessment Of Inadequately Detailed Reinforced Concrete Columns

A. Boys, D. K. Bull and S. Pampanin

University of Canterbury, Christchurch, New Zealand

2008 NZSEE
Conference

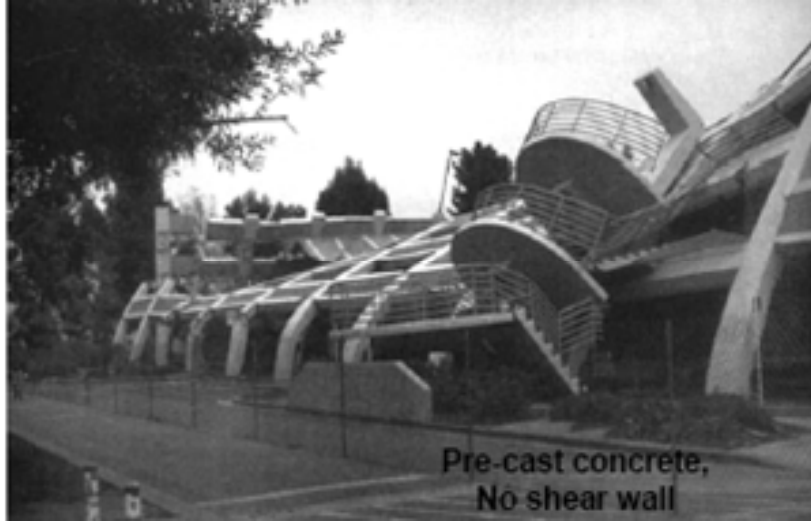
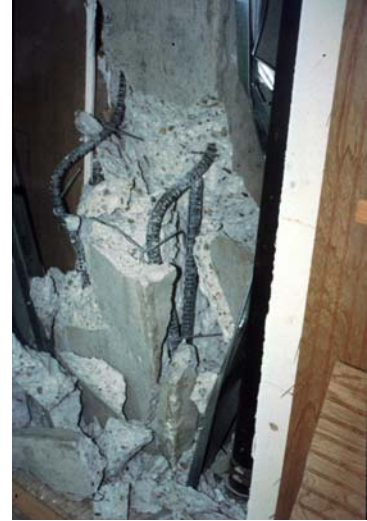
a) Parking Building, California State University,
Northridge, 1994

b) Indian Hills Medical Centre,
Northridge, 1994

Figure 1: Previous Inadequately Detailed Column Failures

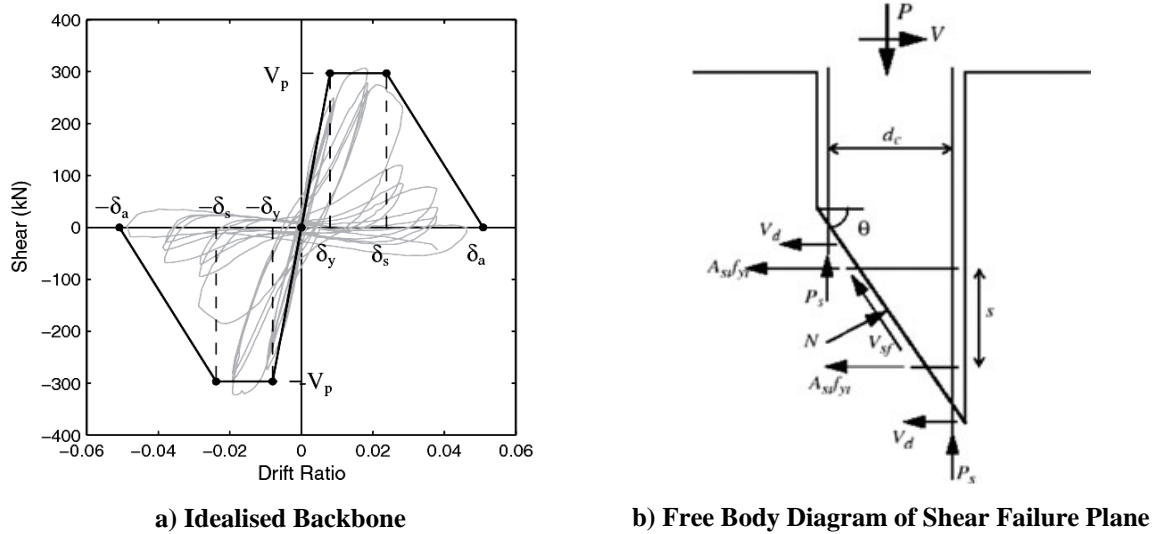
Figure 2: Idealised Backbone Model and Shear Failure Plane (Elwood and Moehle 2006)

The most significant failure mechanism inherent in the inadequately detailed gravity columns is the loss of axial load carrying capacity. Elwood and Moehle (2006) recently proposed an idealised backbone model for the capacity of these columns. The model developed is empirical in nature and as such is applicable only to columns with appropriate details and test configuration (Elwood and Moehle 2005a). Figure 2 a) below illustrates the backbone capacity model developed compared with results from an experimental test. The model has a shear capacity equal to the plastic capacity of the column (as determined by moment-curvature analysis). Detailing dependent drift levels are calculated for the yielding of the section, shear failure (indicated by a reduction of capacity to below 80% of maximum); and post shear-failure loss of axial load carrying capacity.

Axial failure of the columns is dependent on prior shear failure and force equilibrium at the shear failure plane (see Figure 2 b)). Force equilibrium is used in conjunction with experimental data to derive the following relationship for drift at axial failure (Elwood and Moehle 2005b):

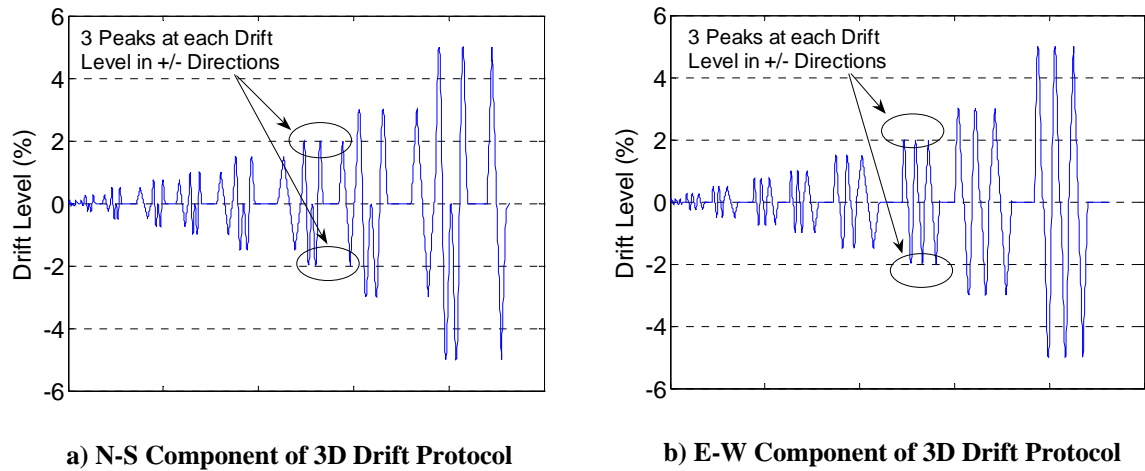
Figure 5: Components of the 3D Displacement Protocol

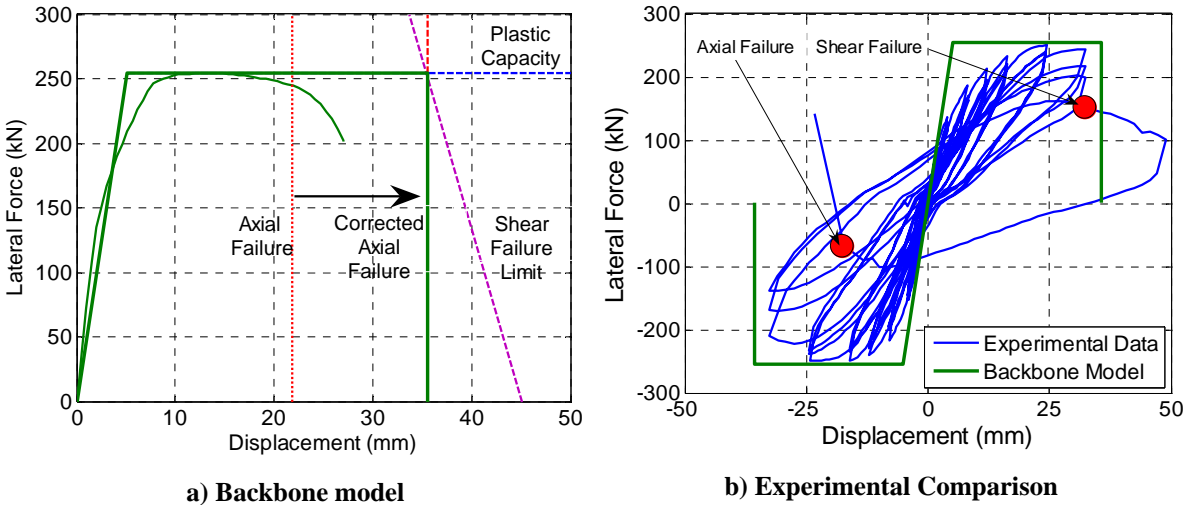
Figure 8 Backbone Model and Experimental Comparison for Specimen 24L-300-2D

The backbone model for the 24L-300-2D specimen is shown below in Figure 8 a). Included in the figure are: section force-displacement capacity; shear failure limit; and the drift at loss of axial capacity. From the model shear failure is calculated to occur at a drift of 35.5 mm where the section capacity and the shear failure limit intersect. In the model as axial failure is assumed to follow the shear failure. However Figure 8 a) illustrates the calculated drift at axial failure occurs prior to the shear failure drift limit, and therefore the drift limit for axial failure is increased to match the drift at shear failure.

Figure 8 b) compares the backbone model with the experimental data for the test specimen. It is evident that the model captures the behaviour adequately with shear failure occurring on the first cycle to +3.0% drift just prior to the modelled drift limit. Although the column exceeds the shear drift limit the capacity is significantly reduced below the 80% of maximum at which shear failure is deemed to occur. While the loss of axial capacity did not occur immediately following the shear failure it occurred after minimal additional demand.

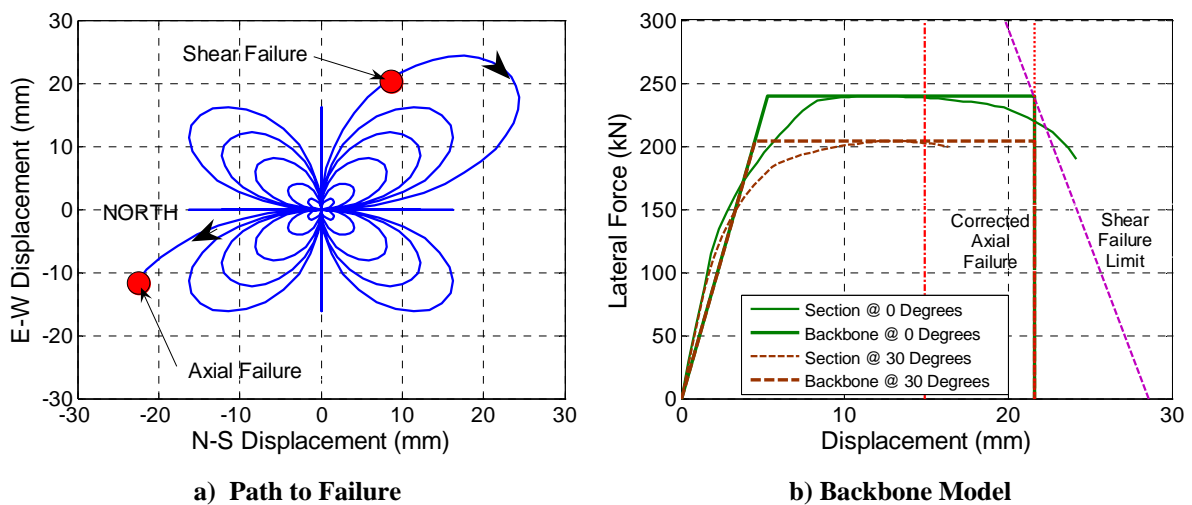
Figure 10: Loading Path to Failure and Backbone Model

Figure 10b) develops the backbone model for the test specimen. Both the shear limit and the drift capacity at axial failure were calculated for a 45 degree applied force (resolved to component at zero degrees). Forty-five degrees corresponds to the minimum effectiveness of the transverse reinforcement to restrain the shear failure plane. The shear failure drift (and the corrected drift at axial failure) are found at the intersection of the backbone capacity for a lateral force applied at zero degrees, as this corresponds to the maximum uni-axial displacement. In addition Figure 10 b) illustrates section

capacity (resolved into the component at zero degrees) for a lateral force applied at 30 degrees (the maximum displacement in each 'leaf' occurs at a 30 degree angle to the corresponding axes). Resolving the capacities and limits into components allows direct performance comparisons between uni- and bi-direction demands.

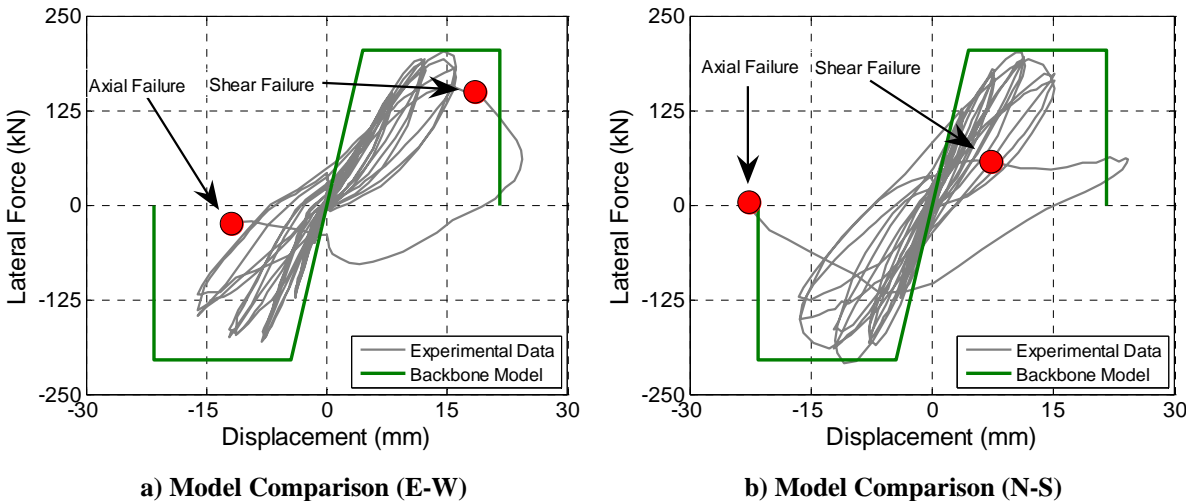
Figure 11 Backbone Model and Experimental Comparison for Specimen 24L-300-3D

Figure 11 a) and b) illustrate the experimental results compared to the 30 degree backbone model for the E-W and N-S directions respectively. Comparisons to the 30 degree backbone are made as the first four excursions to maximum in each direction occur during the ‘leaves’ of the protocol and cyclic degradation makes it unlikely that the uni-directional capacity will be reached in the later cycles. Shear failure occurred in the first ‘leaf’ of the 1.5% cycles as illustrated in Figure 10 a) above. At this point the displacement in the E-W direction was moderately less than the modelled shear failure displacement of 21.6 mm. Post shear failure the stiffness in the N-S direction is negative, and essentially is zero in the E-W direction. Axial failure then occurred on the subsequent ‘leaf’ after minimal additional displacement demand.
