Seismic Sustainability Assessment of Structural Systems: Frame or Wall Structures?

T.Z. Yeow, G.A. MacRae, R.P. Dhakal & B.A. Bradley

University of Canterbury, Christchurch, New Zealand

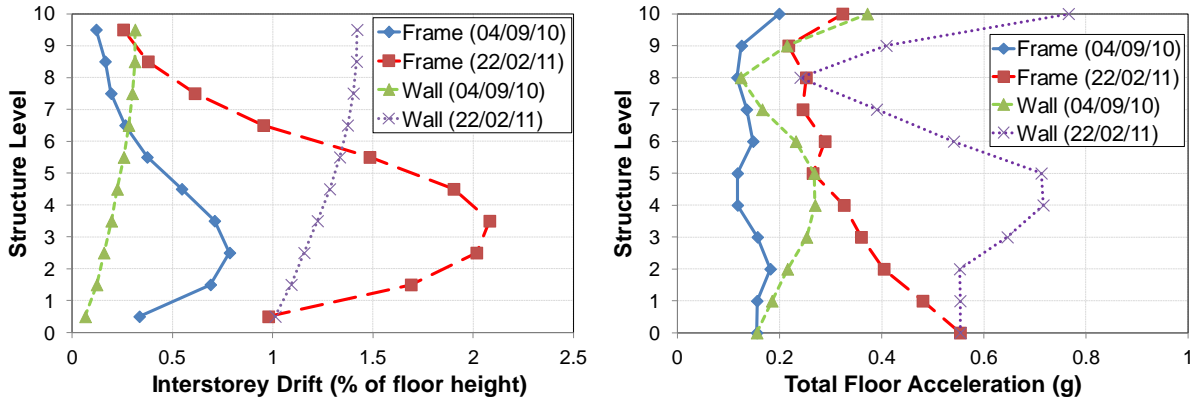
(a) Maximum Inter-storey Drift Profiles

(b) Maximum Total Floor Acceleration Profiles.

Figure 4.1 Maximum response of frame and wall structures subjected to selected ground motion records for scenario loss assessment

Figures 4.1a and 4.1b show respectively the maximum inter-storey drift profiles and the maximum total floor acceleration profiles of the frame and the wall structures subjected to the two ground motion records.

From Figure 4.1a, the following trends can be observed for both the 4th September and the 22nd February scenarios:

- The frame structure’s peak maximum inter-storey drift occurred between the second and the third level, and the third and the fourth level of the structure and decreased towards the top of the structure.
- The wall structure’s maximum inter-storey drift increased with the height of the structure.
- The peak maximum interstorey drifts were smaller in the wall structure than in the frame structure (1.4% for the wall structure and 2.1% for the frame structure).

From Figure 4.1b, the total floor acceleration for the wall structure is larger than that of the frame structure in both scenarios. This is expected as the wall structure is stiffer than the frame structure, which results to a greater amplification of high-frequency ground motion.

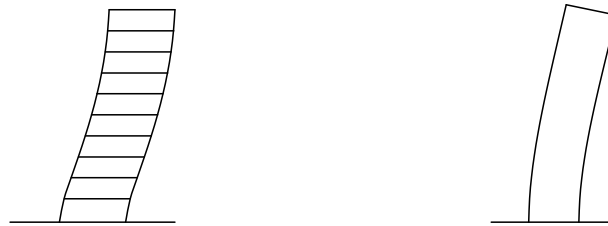
(a) Frame Structure

(b) Wall Structure

Figure 4.2 General deflection shapes for frame and wall structures

The trends can be explained by observing the expected deformation shape of the two structures. Figure 4.2 shows the general deflection shapes of the frame and wall structures. For the frame structure, it can be seen that the interstorey drifts are larger at the bottom half of the structure compared to the top half. For the wall structure however, the interstorey drift is largely governed by the rotation of the wall and therefore increases with height.

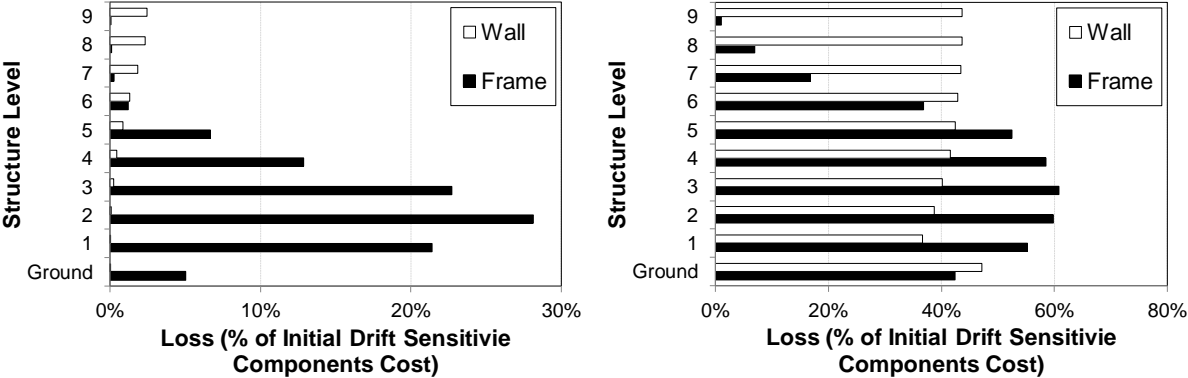
(a) 4th September 2010 scenario (b) 22nd February 2011 scenario
Figure 5.1 Distribution of drift induced losses (structure and non-structural) for each storey level

Figure 5.1 shows the losses from damage to structural and drift-sensitive non-structural components for each level of the structure as a percentage of the initial cost of all drift sensitive components present on the particular level.

From Figure 5.1a, it can be observed that the frame structure exhibits significantly larger drift losses (a maximum value of 28%) compared to the wall structure (a maximum value of 2.5%) in the 4th September scenario. However, the wall structure has larger drift induced losses on the top four floors. This is expected as the inter-storey drifts of the wall structure exceed that of the frame structure on the upper floors. It is also interesting to note that the wall structure drift losses increases with height of the structure while the frame losses peak at the 2nd floor. These observations can also be correlated to the inter-storey drift profiles of the two different structures in Figure 4.1a.

Similar trends can also be observed in Figure 5.1b for the 22nd February scenario. However, the percentage of drift losses for the wall structure is more prominent (a maximum value of 47%) when compared to the frame structure (a maximum value of 61%). Even more significant is the fact that the wall structure sustains large drift losses throughout the height of the structure, while the drift losses for the frame over the top three floors is small in comparison.

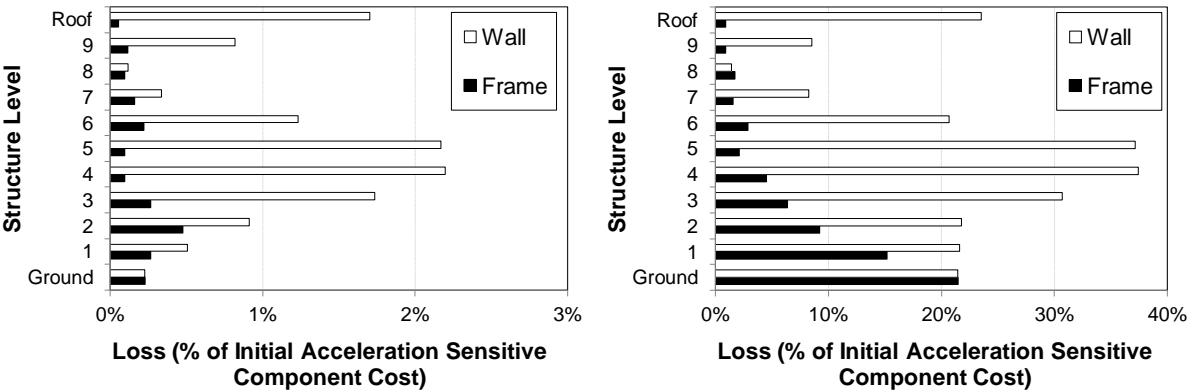
(a) 4th September 2010 scenario (b) 22nd February 2011 scenario
Figure 5.2 Distribution of acceleration induced losses for each storey level

Figure 5.2 shows the non-structural acceleration sensitive component losses for each level of the structure as a percentage of the initial cost of all non-structural acceleration sensitive components present on the particular level. Generally, the wall structure has larger acceleration losses than the frame structure in both scenarios. This is to be expected as the total floor accelerations of the wall structure were generally higher than that of the frame structure as shown in Figure 4.1b.

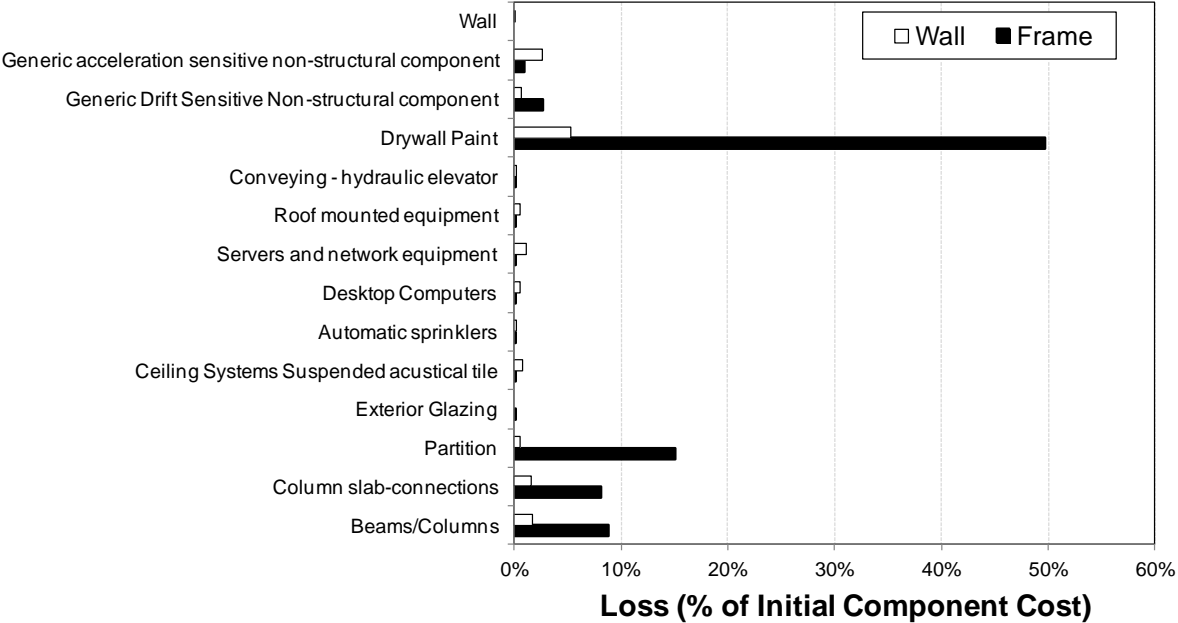
(a) 4th of September 2010 scenario

Figure 5.3 individual component losses

Figure 5.3 shows the losses for each individual component (i.e. partitions, sprinklers) as a percentage of the component’s total initial cost. As expected for the 4th of September scenario, the losses associated with drift sensitive components is higher in the frame structure than the wall structure, while the opposite is true when considering losses associated with damage to acceleration sensitive components.

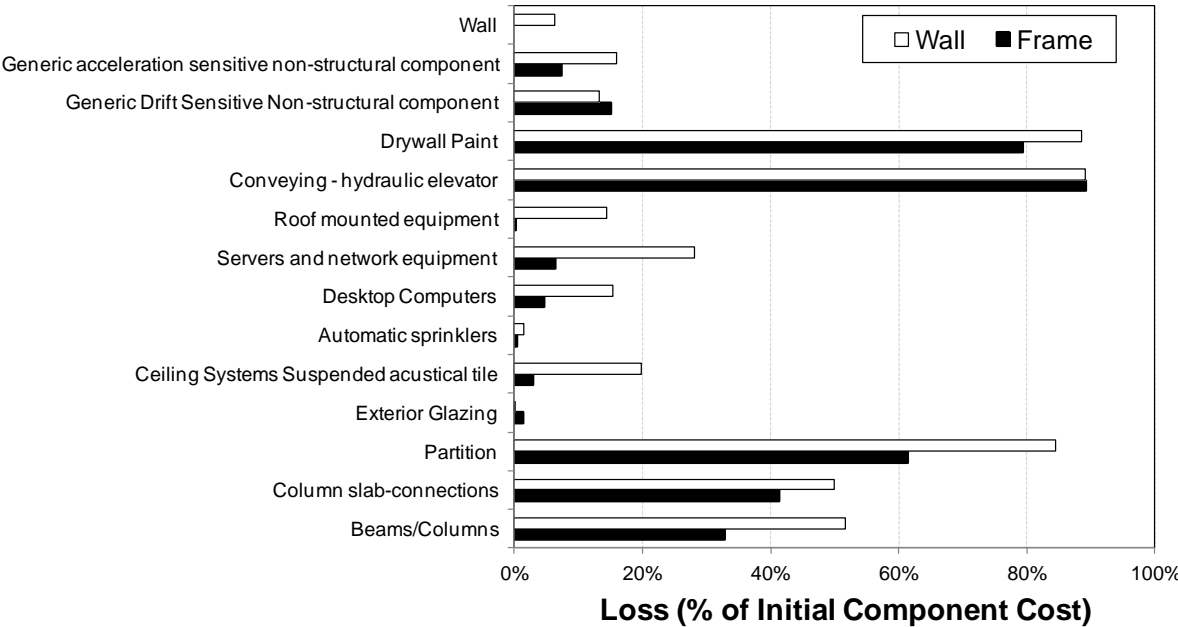
(b) 22nd of February 2011 scenario

In the 22nd February scenario, higher losses are observed in almost all components in the wall structure than in the frame structure. This is expected for acceleration sensitive components as the wall had consistently higher total floor accelerations than the frame structure. However, it is interesting that the same trend has occurred for the drift induced losses as well, despite the frame structure exhibiting larger values of interstorey drift. However, this can be explained by closely examining the losses of particular drift sensitive components.

Table 5.3 shows the damage states, the median interstorey drifts which causes the respective damage states, and the median cost of repair for each damage stage for the partitions considered in this study. The median interstorey drift which causes damage state 2 is 0.85%. Observing the 22nd February scenario drift profiles in Figure 4.1a, it can be seen that the wall structure exceeds this interstorey drift on all floors; while the frame structure only exceeds this interstorey drift in the bottom 7 floors. This would mean that, on average, all of the partitions in the wall structure fall into damage state 2 while only those in the bottom 7 floors of the frame structure are likely to do so. Therefore, the losses in the wall structure due to partition damage will be much higher, which is as observed in Figure 5.3b. Note however that the partition loss is not 100% in the 22nd February scenario. This is because the interstorey drift which causes the onset of damage state 2 is not fixed, but rather it is an uncertain value. Therefore, a small percentage of partitions would not have reached damage state 2. Similar observations can be made with other drift sensitive components. This explains why the wall structure generally had larger drift losses compared to the frame structure.

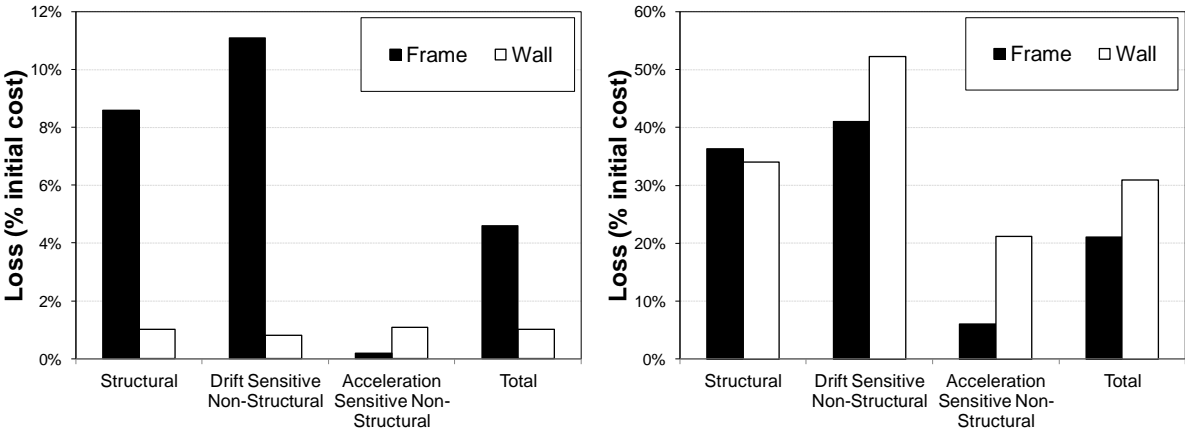
(a) 4th September 2010 scenario (b) 22nd February 2011 scenario
Figure 5.4 Loss for each component group (percentage of component group’s initial cost)

Figure 5.4 shows the losses of each component type (structural, non-structural drift sensitive and non-structural acceleration sensitive) as a percentage of the initial cost of the respective component type. As previously observed, the frame structure obtains larger drift losses in the 4th of September scenario while the wall structure obtains higher acceleration losses. It can be seen from Figure 5.4a that the frame structure has larger total losses (when expressed as a percentage of the total cost of the structure) compared to the wall structure.

From Figure 5.4b, the losses due to non-structural damage are far greater for the wall structure than for the frame structure. However, the structural loss of the frame structure is slightly higher. This is

because most of the damage to the wall occurs at the base of the wall. This causes a large rotation at the base of the wall, resulting in sizeable inter-storey drifts throughout the height of the structure. Therefore, although there are large drift losses on non-structural elements and non-lateral load resisting elements, the losses from the wall damage are small (9% as shown in Figure 5.3b), resulting in slightly smaller structural losses than for the frame structure. Note that if the damage at the base of the wall is large, it could mean that the structure has to be replaced and hence 100% loss of the building could be incurred. Overall, the wall structure performed worse than the frame structure in the 22nd of February scenario.
