# **Review of the impact of the February 22<sup>nd</sup> earthquake on the Canterbury health care system**

A thesis

Master of Science in Geology

University of Canterbury

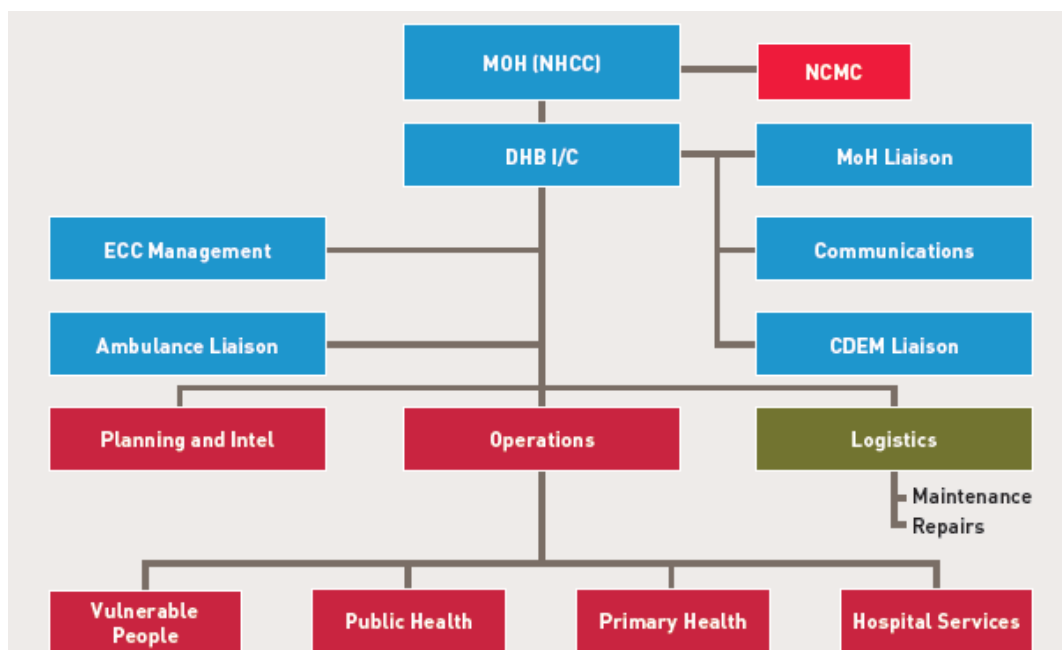
**Figure 2.1: The health emergency response organizational structure including; NHCC (National Health Coordination Centre), NCMC (National Crisis Management Centre), DHB I/C (Incident Controller), EOC (Emergency Operations Centre), ECC (Emergency Control Centre) and the CDEM (Civil Defence Emergency Management) (McColl 2012).**

The Canterbury District Health Board organisational structure is presented here as an example. The CDHBs emergency response structure is conceptualised in Figure 2.1, the base levels of the organizational structure consists of; Vulnerable people, Public health, Primary health and Hospital services. All the base levels are independent, during the disaster they are coordinated in unison from “Operations” with support from “Logistics” and “Planning and Intel”. “Operations” is supported by the local District Health Board (DHB) and Ministry of Health, the response is structured as so to insure the higher levels provide resources at the request of the lower levels which coordinate the response. The structure is implemented for all health crisis, whether they be sudden onset disasters or slow onset pandemics.

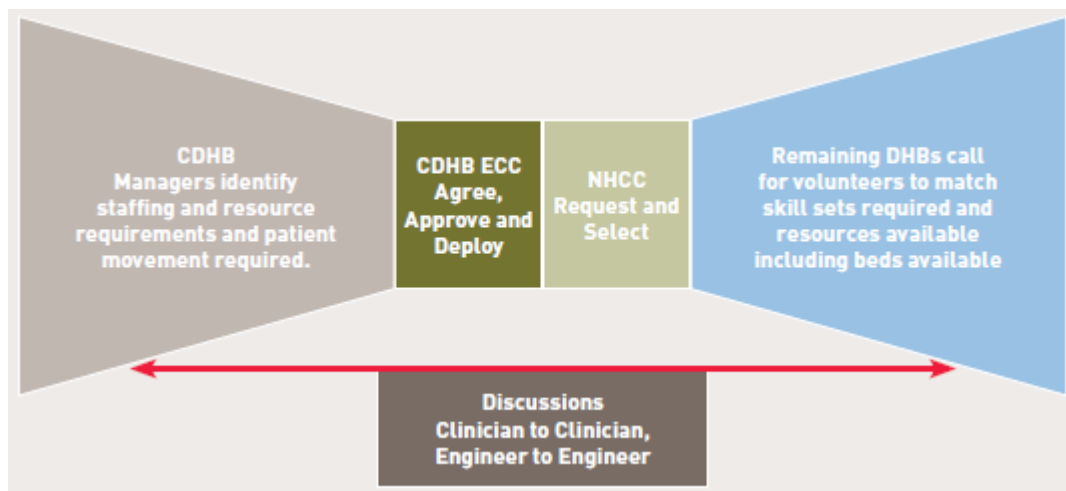
**Figure 2.2: The CDHB resource control and co-ordination process (McColl 2012).**

The flow chart in Figure 2.2 provides a description of the process for patient transfers following a sudden onset disaster. The process of patient transfers is dependent upon local DHB managers identifying the required patient transfers and the resources required. The patient transfers are then approved by the local DHB and the ECC, the NHCC request beds and resources from within the afflicted hospital network and the broader hospital network that is not affected by primary earthquake damage at the request of the local CDHB and ECC. The NHCC operates at a national level by providing support for the regional DHB at the DHBs request. The NHCC sources bed space and resources from other DHBs, while clinicians and engineers within the afflicted DHB communicate directly with other DHBs.

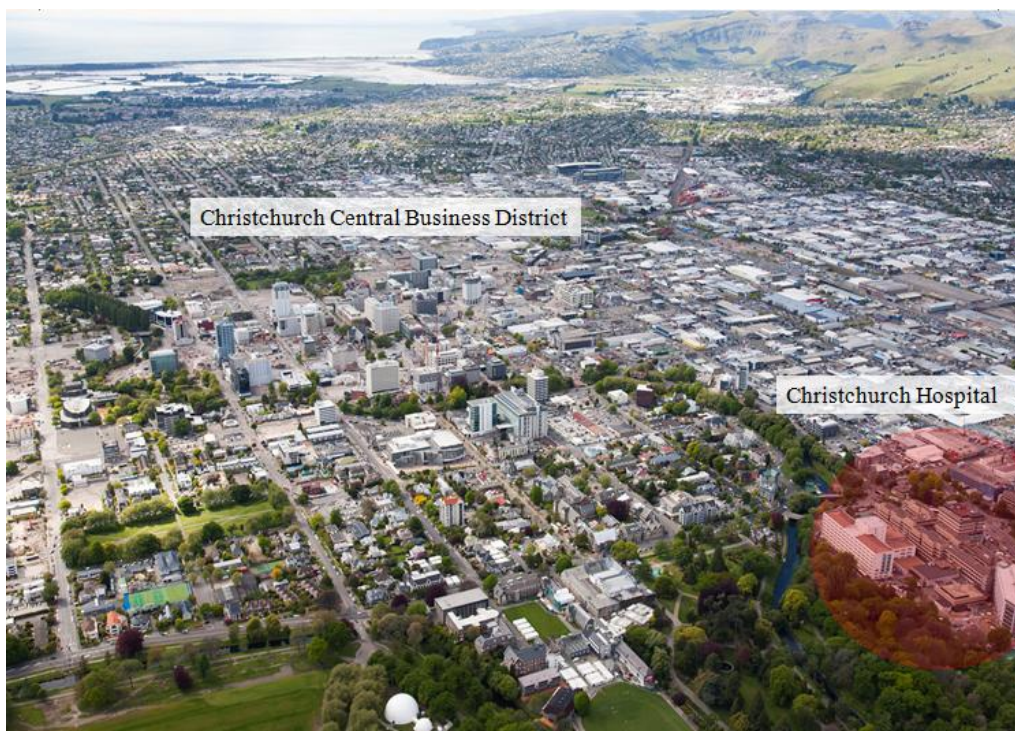
**Figure 3.3: Christchurch Hospital in the lower right corner adjacent to the CBD and the Avon River, October 2012 (Photo is taken looking SE) (Christchurch City Council).**

Christchurch Hospitals buildings (Figure 3.2& 3.3) were constructed during different time periods using a variety of construction methods including concrete-shear-wall or reinforced-masonry which are further defined for each building in Chapter 4 (Table 4.4).The buildings include the Riverside Building (built in the 1970s), Parkside Building (built in late 80s to early 90s), the Diabetes Centre (built in late 1950s and early 1960s), the Christchurch Women’s Hospital (built in 2005) and the

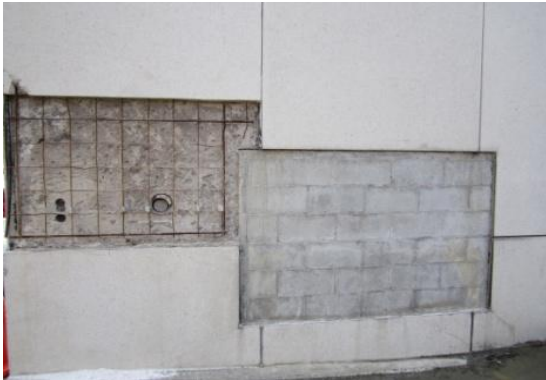
Minor structural damage was also evident in the Riverside Building when shear wall cracking was discovered some of the cracks went all the way through the wall (Figure 3.5). However, these were fixed relatively easily with epoxy resin. In the Riverside building critical structural weaknesses were identified in three of the structures that make up the Riverside building. The buildings only met about 40 per cent of the building code, which was introduced May 2012 (Stylianou 2012). All clinical buildings suffered roof damage; however the damage did not warrant closures. In some cases the separation joints of between 100mm and 150 mm were not large enough to accommodate the displacement and were damaged. Each of the seven stairwells in the Parkside building had to be taken

**Figure 3.5: Damaged shear wall panels Riverside building, Christchurch Hospital.**

out of service for significant repairs, as well some structural walls and floors in the Parkside buildings needed to be injected with resin (Stylianou 2012).

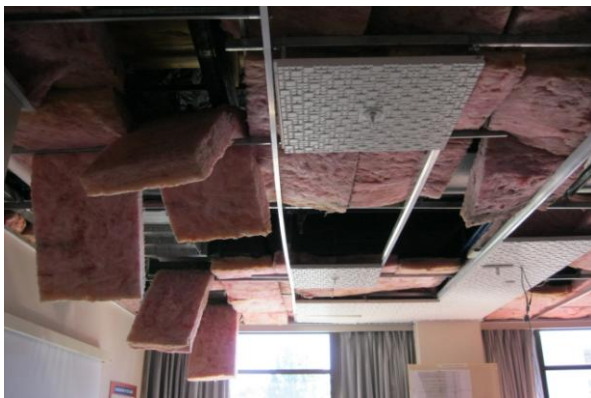
designed to protect life but not be functional after 475 year return period earthquake. The nonstructural damage to internal and external roof coverings and roof top water tanks caused water to flow into the 5<sup>th</sup> and 6<sup>th</sup> floors of the Riverside building. Precast concrete panels were also damaged throughout the building and have caused disruption during the recovery phase. The water damage caused the evacuation of five adult medical wards in the Riverside building. The wards on the 5<sup>th</sup> and 6<sup>th</sup> floors had no horizontal egress so the patients had to be evacuated via the stairwells as explained below in Section 3.5. The loss of clinical space in the Riverside building has been the only permanent loss of capacity at Christchurch Hospital (Section 3.3.1).

**Figure 3.6: Damage to nonstructural ceiling tiles in Christchurch Hospital.**

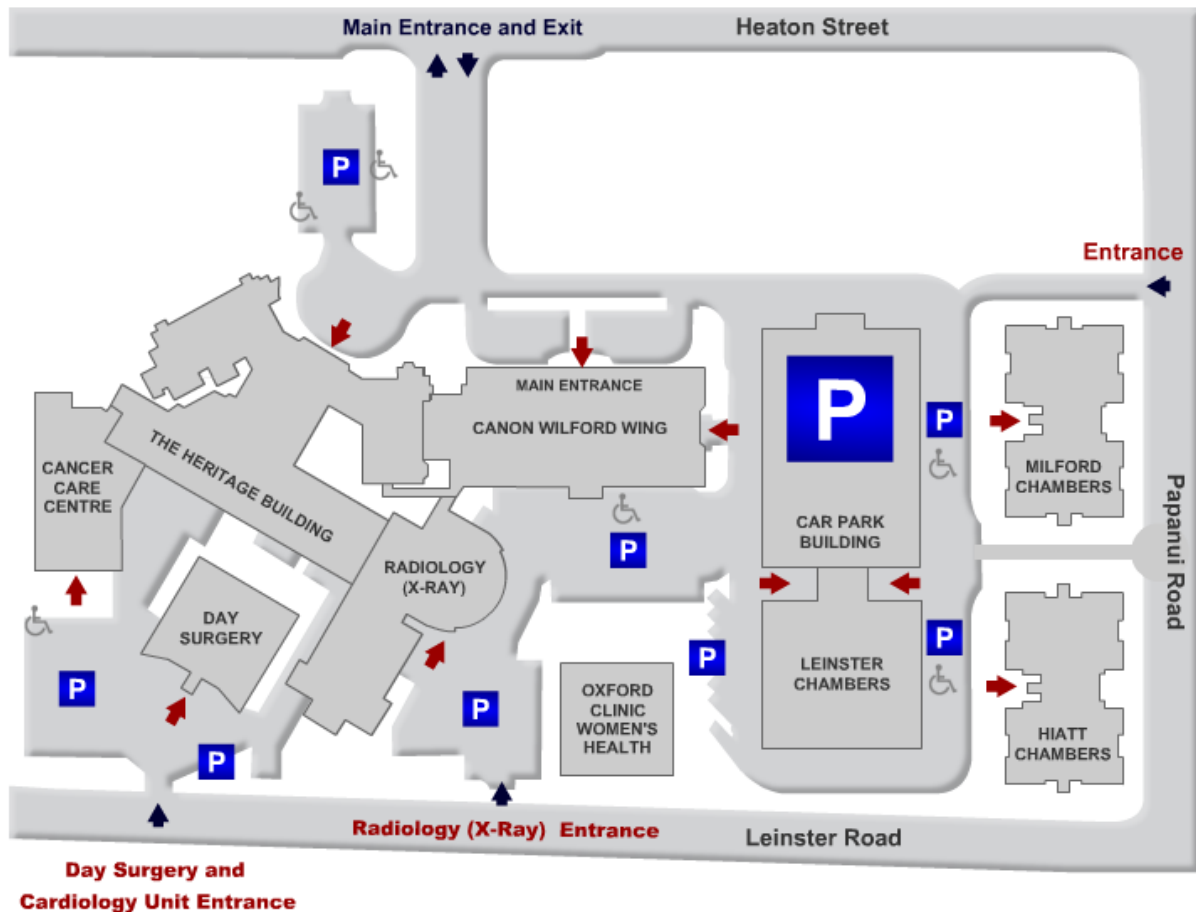
**Figure 3.8: Map of St George’s Hospital, the Maternity building is labeled as the Heritage building (St Georges)**

St. Georges Hospital (Figure 3.1& 3.13) dominantly performs elective surgery, Cancer treatment and maternity care. The hospital was closed completely from the 22<sup>nd</sup> of February, 2011 till the 7<sup>th</sup> of March, 2011 due to structural damage to the reinforced masonry maternity ward, nonstructural damage to the surgical wards and the loss of services. The Maternity building which has subsequently been demolished (Figure 3.10) also housed all the hospital's administrative functions. The medical records kept in the administrative area of the maternity building were damaged when air conditioning units dislodged and fell through the roof. Water from earthquake damaged pipes came in through the holes made by the dislodged air conditioning units.

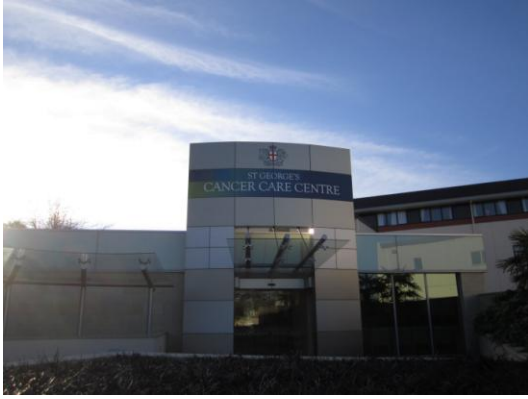
**Figure 3.9: St George's Hospital Cancer Care Centre**

The Cancer Centre (St Georges Hospital) (Figure 3.14) was damaged when liquefaction induced the unbalanced and insufficiently anchored structure to tilt. The liquefaction (Figure 3.11) also caused damage to the buildings foundations and the lowest floor to flood. The unbalanced mass was a result of a 1.5 meter thick concrete ceiling required for the Linear accelerator located in the basement of the building. This disproportionally weighted the buildings mass on one end of the building and caused the building to behave asymmetrically.

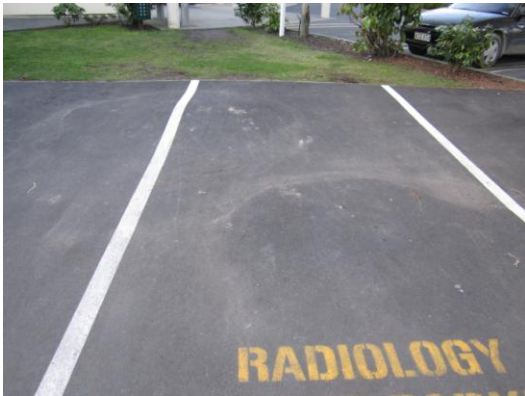
**Figure 3.11: Liquefaction induced blistering in the Radiology car park**

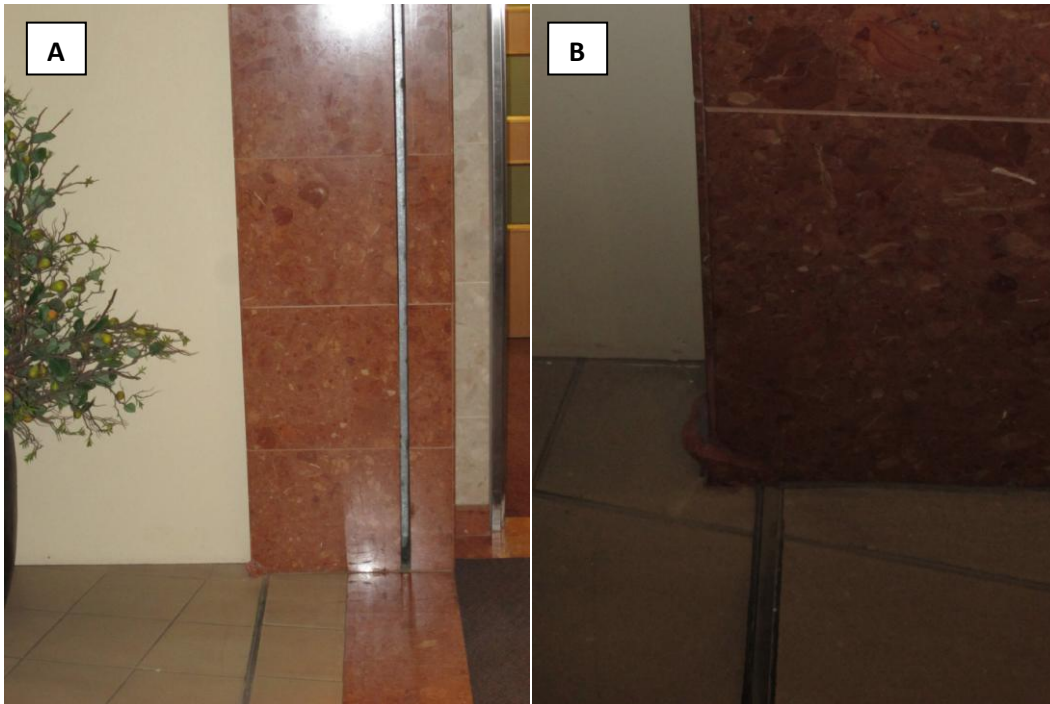
**Figure 3.12: (A) Separation Joint in the Canon Wilford wing adjacent to lift shaft. (B) Cosmetic damage to columns adjacent to a vertically displaced separation joint**

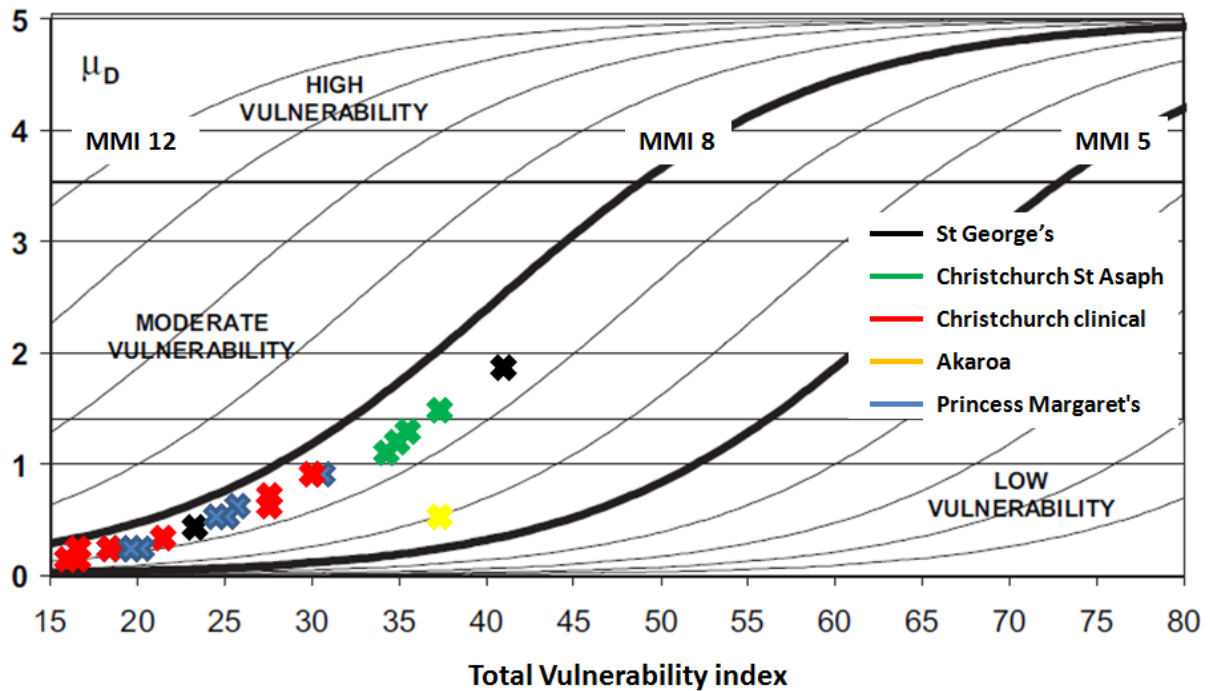
**Figure 4.1: Expected damage grade and vulnerability vs total vulnerability index of Canterbury Hospitals for the GNS felt report weighted average (minimum) MMI data (WHO 2006).**

The predicted levels of damage are outlined in Table 4.2. All but 45 St Asaph Street (Christchurch hospital) and St Georges Hospital maternity building were classed as having “Low damage” the two exceptions were both classed as having “moderate and high damage respectively”. Analysis of the results suggests that the methodology underestimates the Canterbury hospital network earthquake hazard. This is evident because Akaroa Hospital and St George’s Cancer centre sustained damage rendering the facilities inoperable during the Canterbury earthquakes. However, Akaroa Hospital was closed as a result of the delayed identification of structural damage most likely caused by the Christchurch earthquake, and exacerbated by all the major aftershocks during 2011

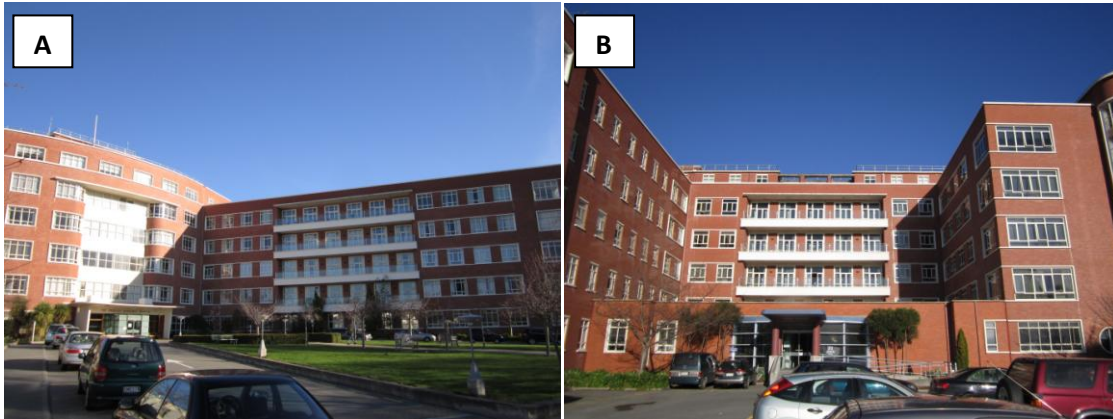
**Figure 4.2: (A) Princess Margaret's Hospital Main Ward -A,B,E,F,H &J. (B) Princess Margaret's Hospital K wards**

- Princess Margaret's Hospitals Main Wards A,B,E,F,H&J (Figure 4.2) , the Maintenance building and the Recreation Hall.
- Christchurch Hospitals Parkside building, Riverside building and the Food services buildings.
- St Asaph Streets 33, 41 and 45 buildings.
- And the 235 Antigua Street building.

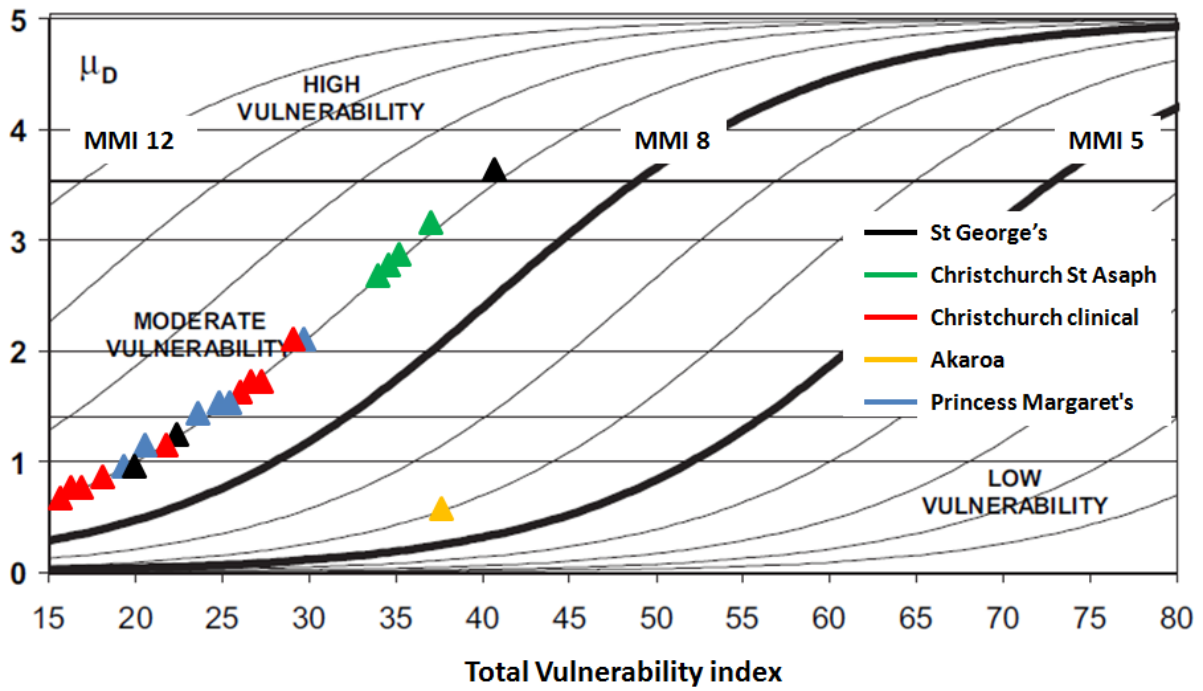
Figure 4.3: Expected damage grade and vulnerability vs total vulnerability index of Canterbury Hospitals for the USGS (maximum) MMI data (WHO 2006).

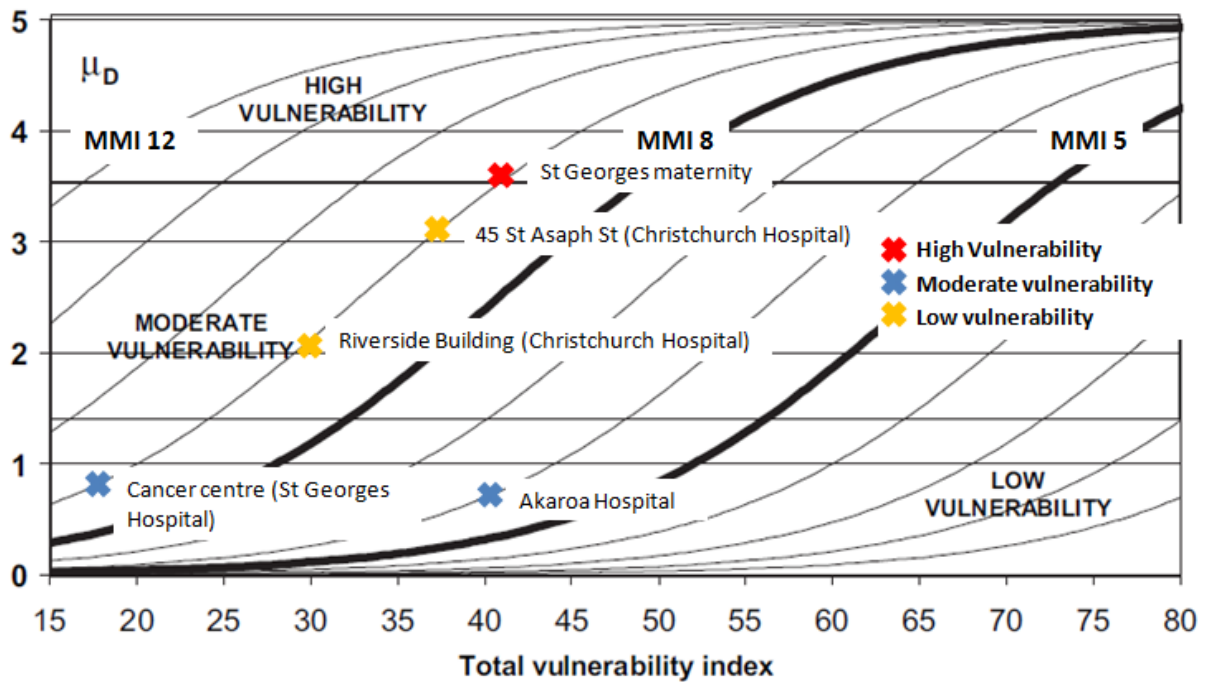
**Figure 4.5: The expected damage grade and vulnerability vs total vulnerability index of the structural damaged hospitals in the Canterbury Hospital network for the maximum USGS MMI data (WHO 2006).**

The St Georges Cancer centre was built with two of its three stories beneath ground level, it was severely disrupted when soft sediment liquefied and flooded the lowest floor. The liquefaction combined with the buildings disproportionately balanced mass caused the building to tilt (Section 3.2). The Soil modifying indice in the WHO (2006) Structural assessment does not define separate categories for the depth buildings storeys are situated in soils classed C (soft). In some cases facilities had un-determinable modifiers; St Georges Hospital Radiology building which contains the radiological services has areas with soft stories.

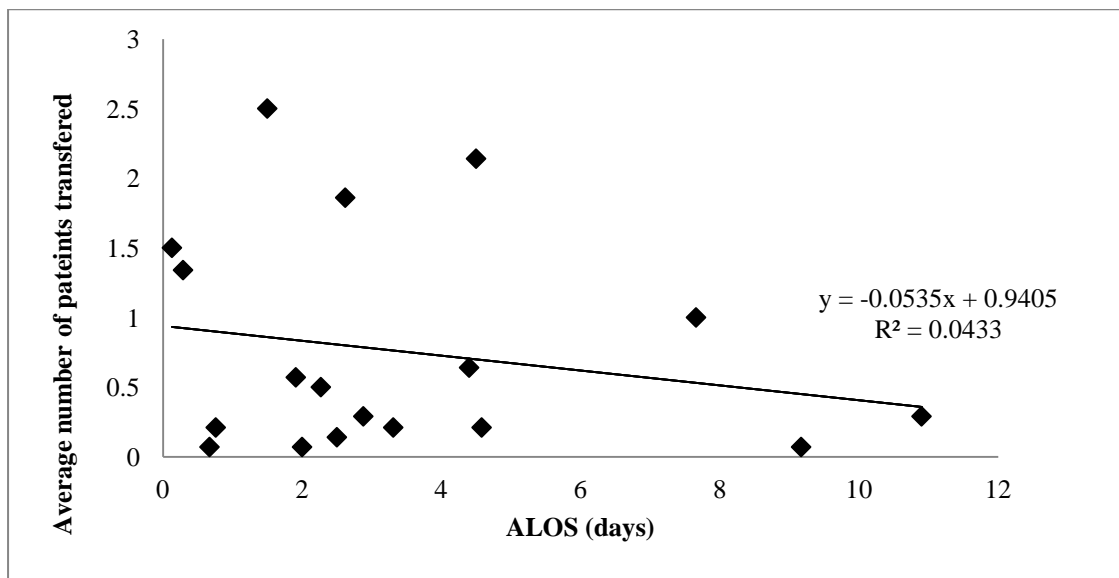
**Figure 5.2: The ALOS (days) for individual wards compared with the average number of patients transferred from that individual ward at Christchurch Hospital in the two weeks following the Christchurch earthquake.**

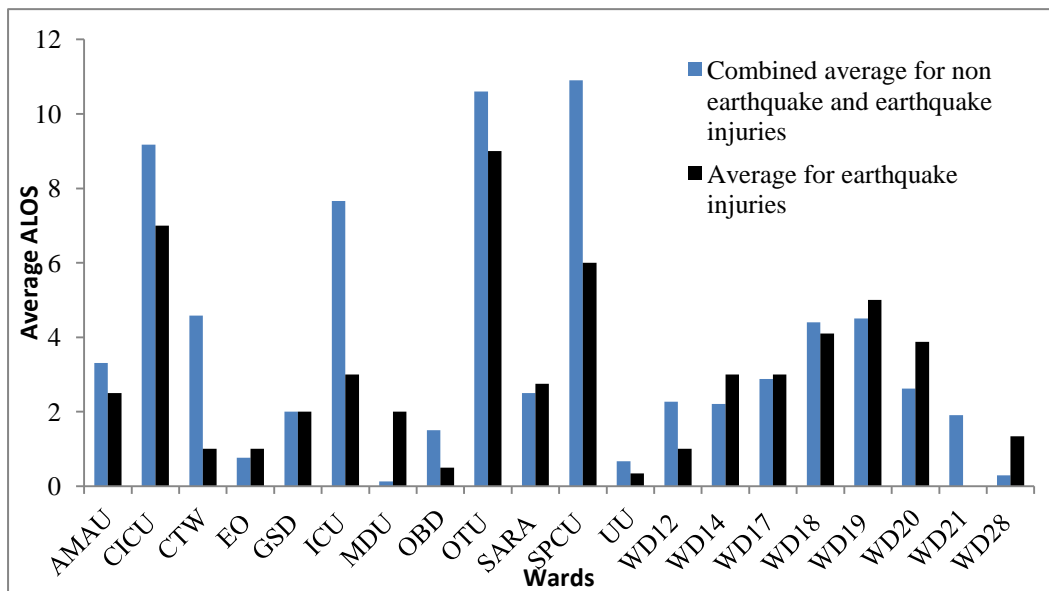
**Figure 5.3: The ALOS (days) for earthquake injuries and the combined ALOS (days) for all the patients in the hospital for the two weeks following the Christchurch earthquake (Appendix L & N).**

The ALOS for patients during the two weeks following the Christchurch earthquake at Christchurch Hospital is collated in Appendices M and N for all the patients at the hospital (Appendix L) (Presented in Figure 5.3) and for earthquake patients (Appendix M). The data in Appendix L is for all the individual wards in Christchurch Hospital. Appendix M just depicts the ALOS for earthquake related injuries (Presented in Figure 5.3), the wards the patients were treated in and the number of transfers from those wards. A comparison of the ALOS for the earthquake casualties and for all the patients in Christchurch Hospital is presented in Figure 5.3.

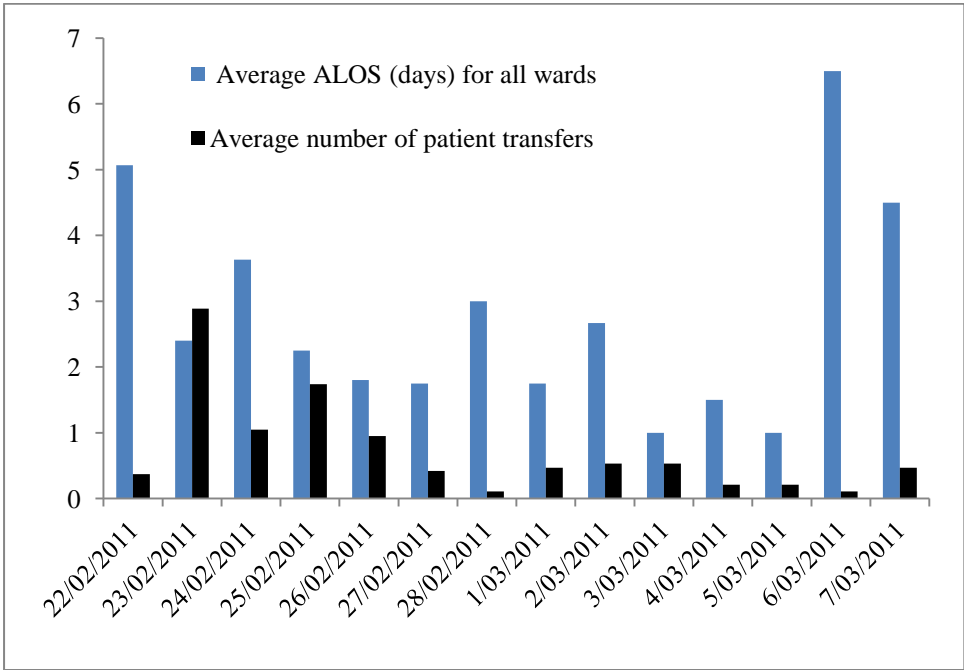
**Figure 5.5: The daily ALOS for earthquake patients and the daily average number of transfers from Christchurch Hospital (all wards) during the two weeks following the Christchurch earthquake for earthquake casualties only (Appendix M).**

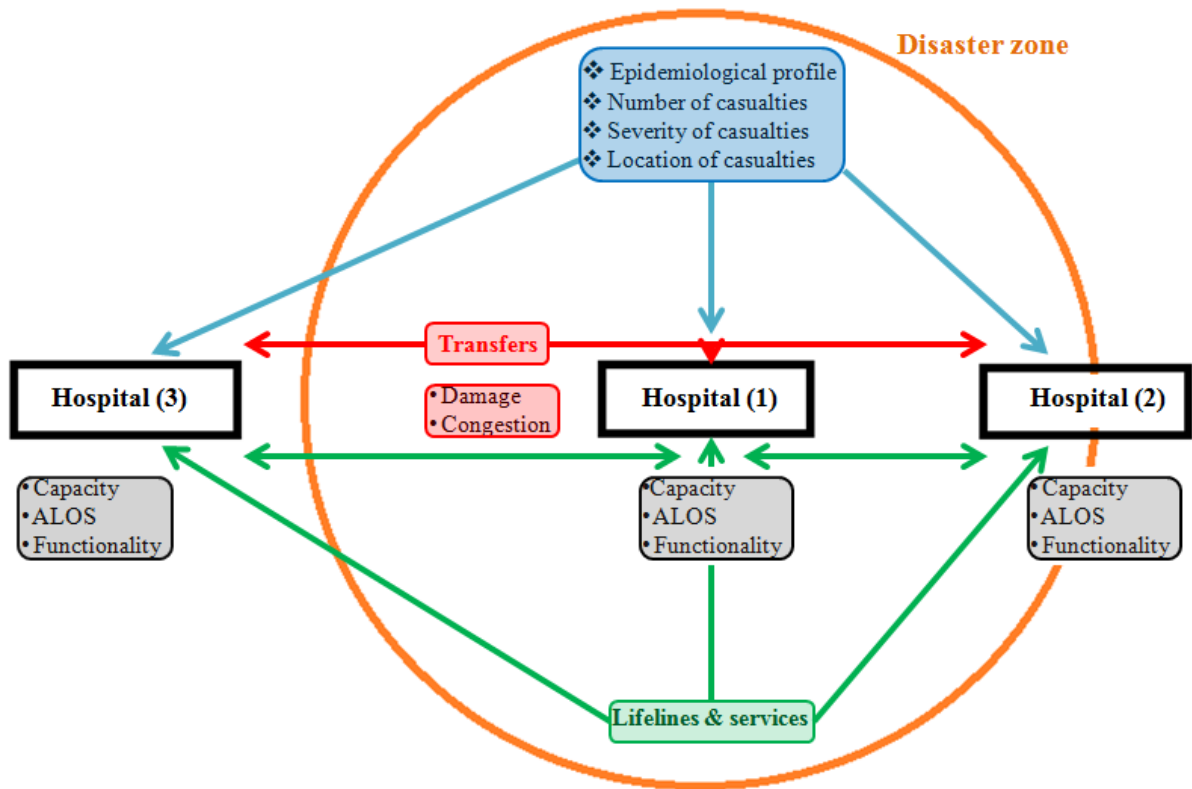
**Figure 5.9: Holistic model for hospital networks following a local disaster**

Models for complex integrated systems like hospital networks are rare because of the extensive data requirements that are needed to generate outputs (Section 4.4). The purpose of Figure 5.9 is to define the connections between the components necessary for the assessment of the network wide inter-hospital transfer process. The spatially extensive transport network (road, air and sea transport networks) respond in a unique way geographically to seismicity and traffic congestion. Therefore, predicting how the transport network will be impeded depends on the characteristics of the underlying land, how the seismicity interacts with the land, the built environment (seismic performance of the system), the rate which damage can be repaired and the likely flow of people within the transport network (the demand on the system and the redundancy of the system).

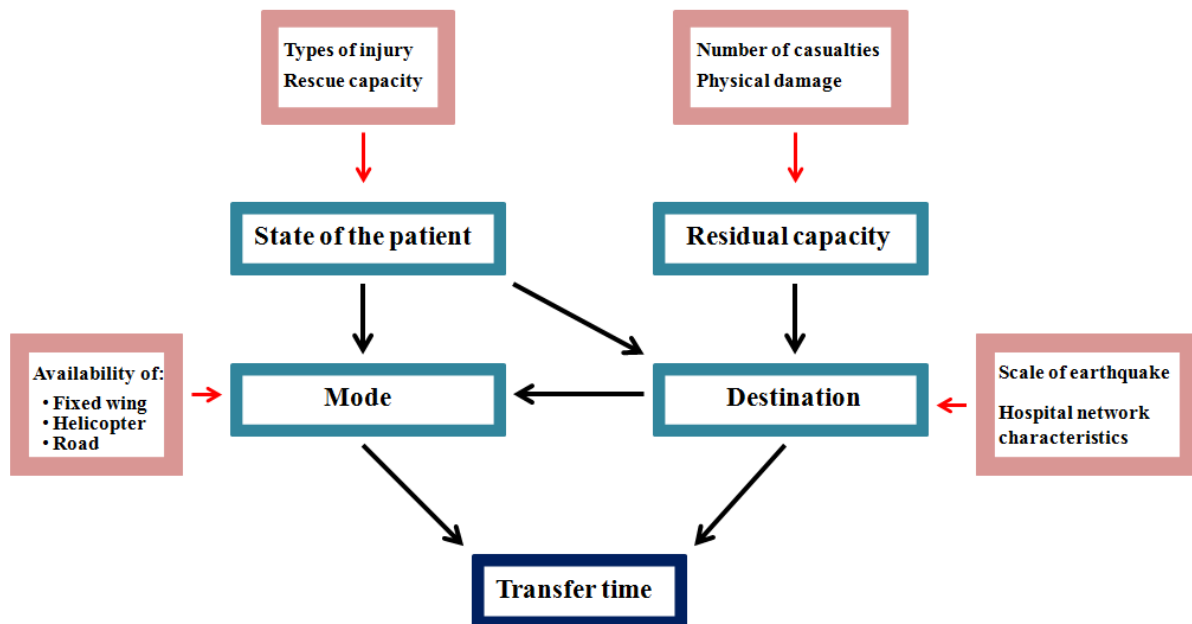
**Figure 5.10: The components that determine transfer time; the state of the patient, residual capacity, destination, mode and the factors that influence the components.**

The distance to the hospital chosen for transfer is the main variable (destination). It is modified by the availability of capacity in the network (residual capacity). The road condition is vital in determining the time of transfer for road transfers. However the state of the patient and destination determines the mode of transfer (road, fixed wing or helicopter). The state of the patient modifies the mode of transfer because patients in a severe state are most likely to be transferred by the fastest means such as helicopter or fixed wing. The connections between the factors described above are summarized in Figure 5.10.

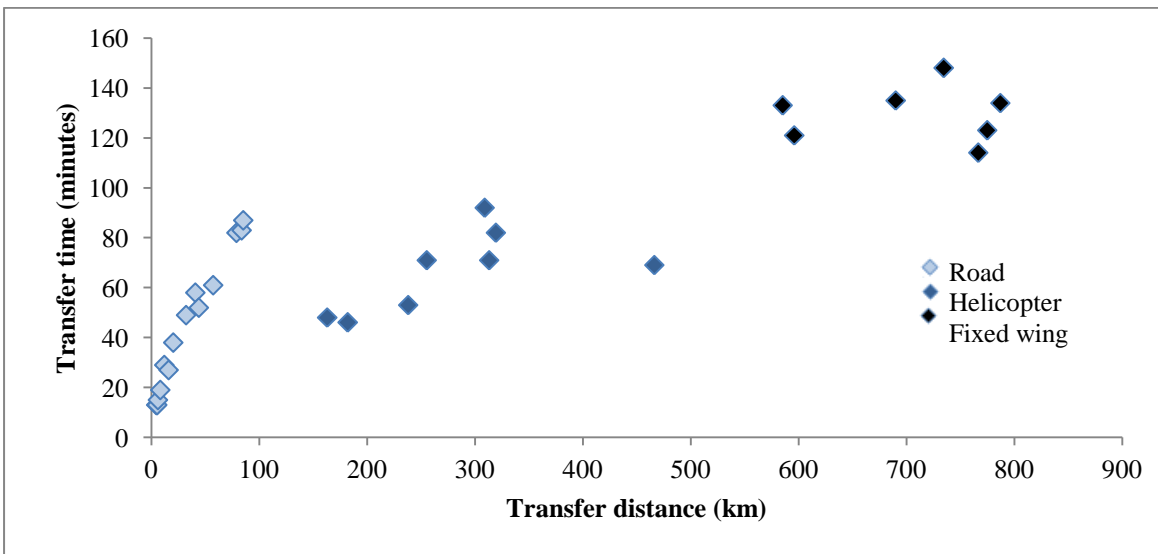
**Figure 5.12: The transfer time versus transfer distance for the patient transfers by Road, Fixed wing and Helicopter.**

The data in Appendix O, Table 5.6 Table 5.7 incorporates travel time data for road, fixed wing and helicopter flights to the more distant hospitals. The travel times by road for transfers to hospitals outside of Christchurch were calculated using Google Earth. The quickest mode of transfer was assumed if the mode of transfer was not known (Table 5.5). Plotting the travel time verse travel distance (Figure 5.12) shows that there are three distinctive groups for transfers by road (Table 5.7), helicopter (Table 5.6) and fixed wing (Table 5.5).
