INTRODUCTION

This poster presents preliminary results of ongoing experimental campaigns at the Universities of Auckland and Canterbury, aiming at investigating the seismic residual capacity of damaged reinforced concrete plastic hinges, as well as the effectiveness of epoxy injection techniques for restoring their stiffness, energy dissipation, and deformation capacity characteristics.

This work is part of wider research project which started in 2012 at the University of Canterbury entitled "Residual Capacity and Repairing Options for Reinforced Concrete Buildings", funded by the Natural Hazards Research Platform (NHRP). This research project aims at gaining a better understanding and providing the main end-users and stakeholders (practitioner engineers, owners, local and government authorities, insurers, and regulatory agencies) with comprehensive evidence-based information and practical guidelines to assess the residual capacity of damaged reinforced concrete buildings, as well as to evaluate the feasibility of repairing and thus support their delicate decision-making process of repair vs. demolition or replacement.

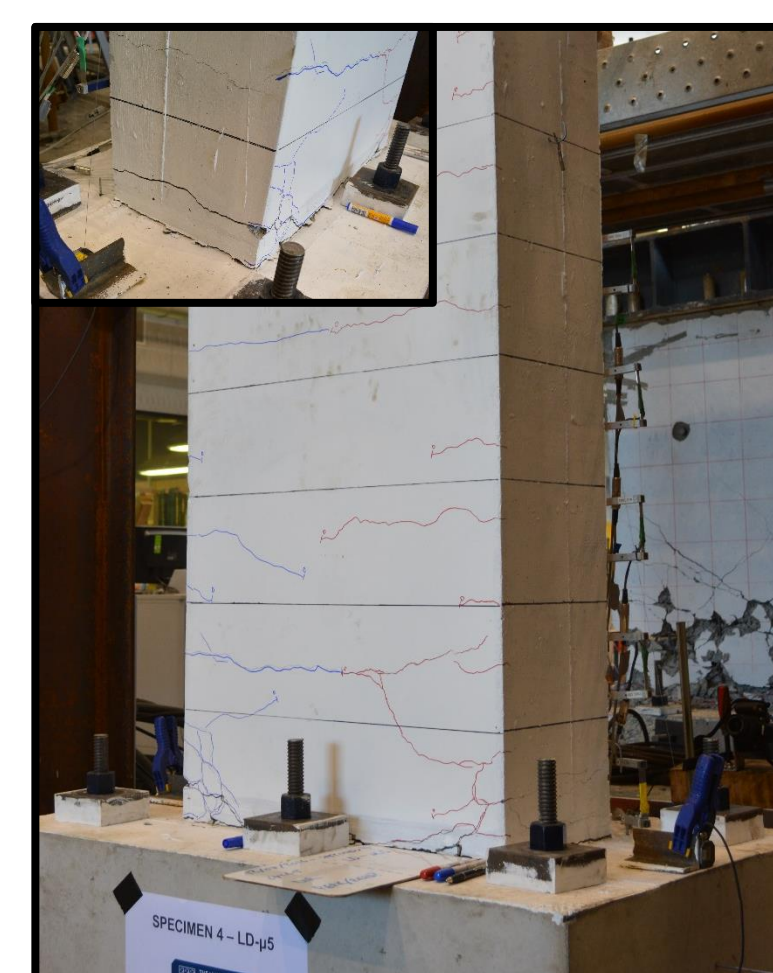
Figure 3: Damage state following dynamic long duration EQ loading to ductility 5, with close up of primary and bond splitting cracks in inset.

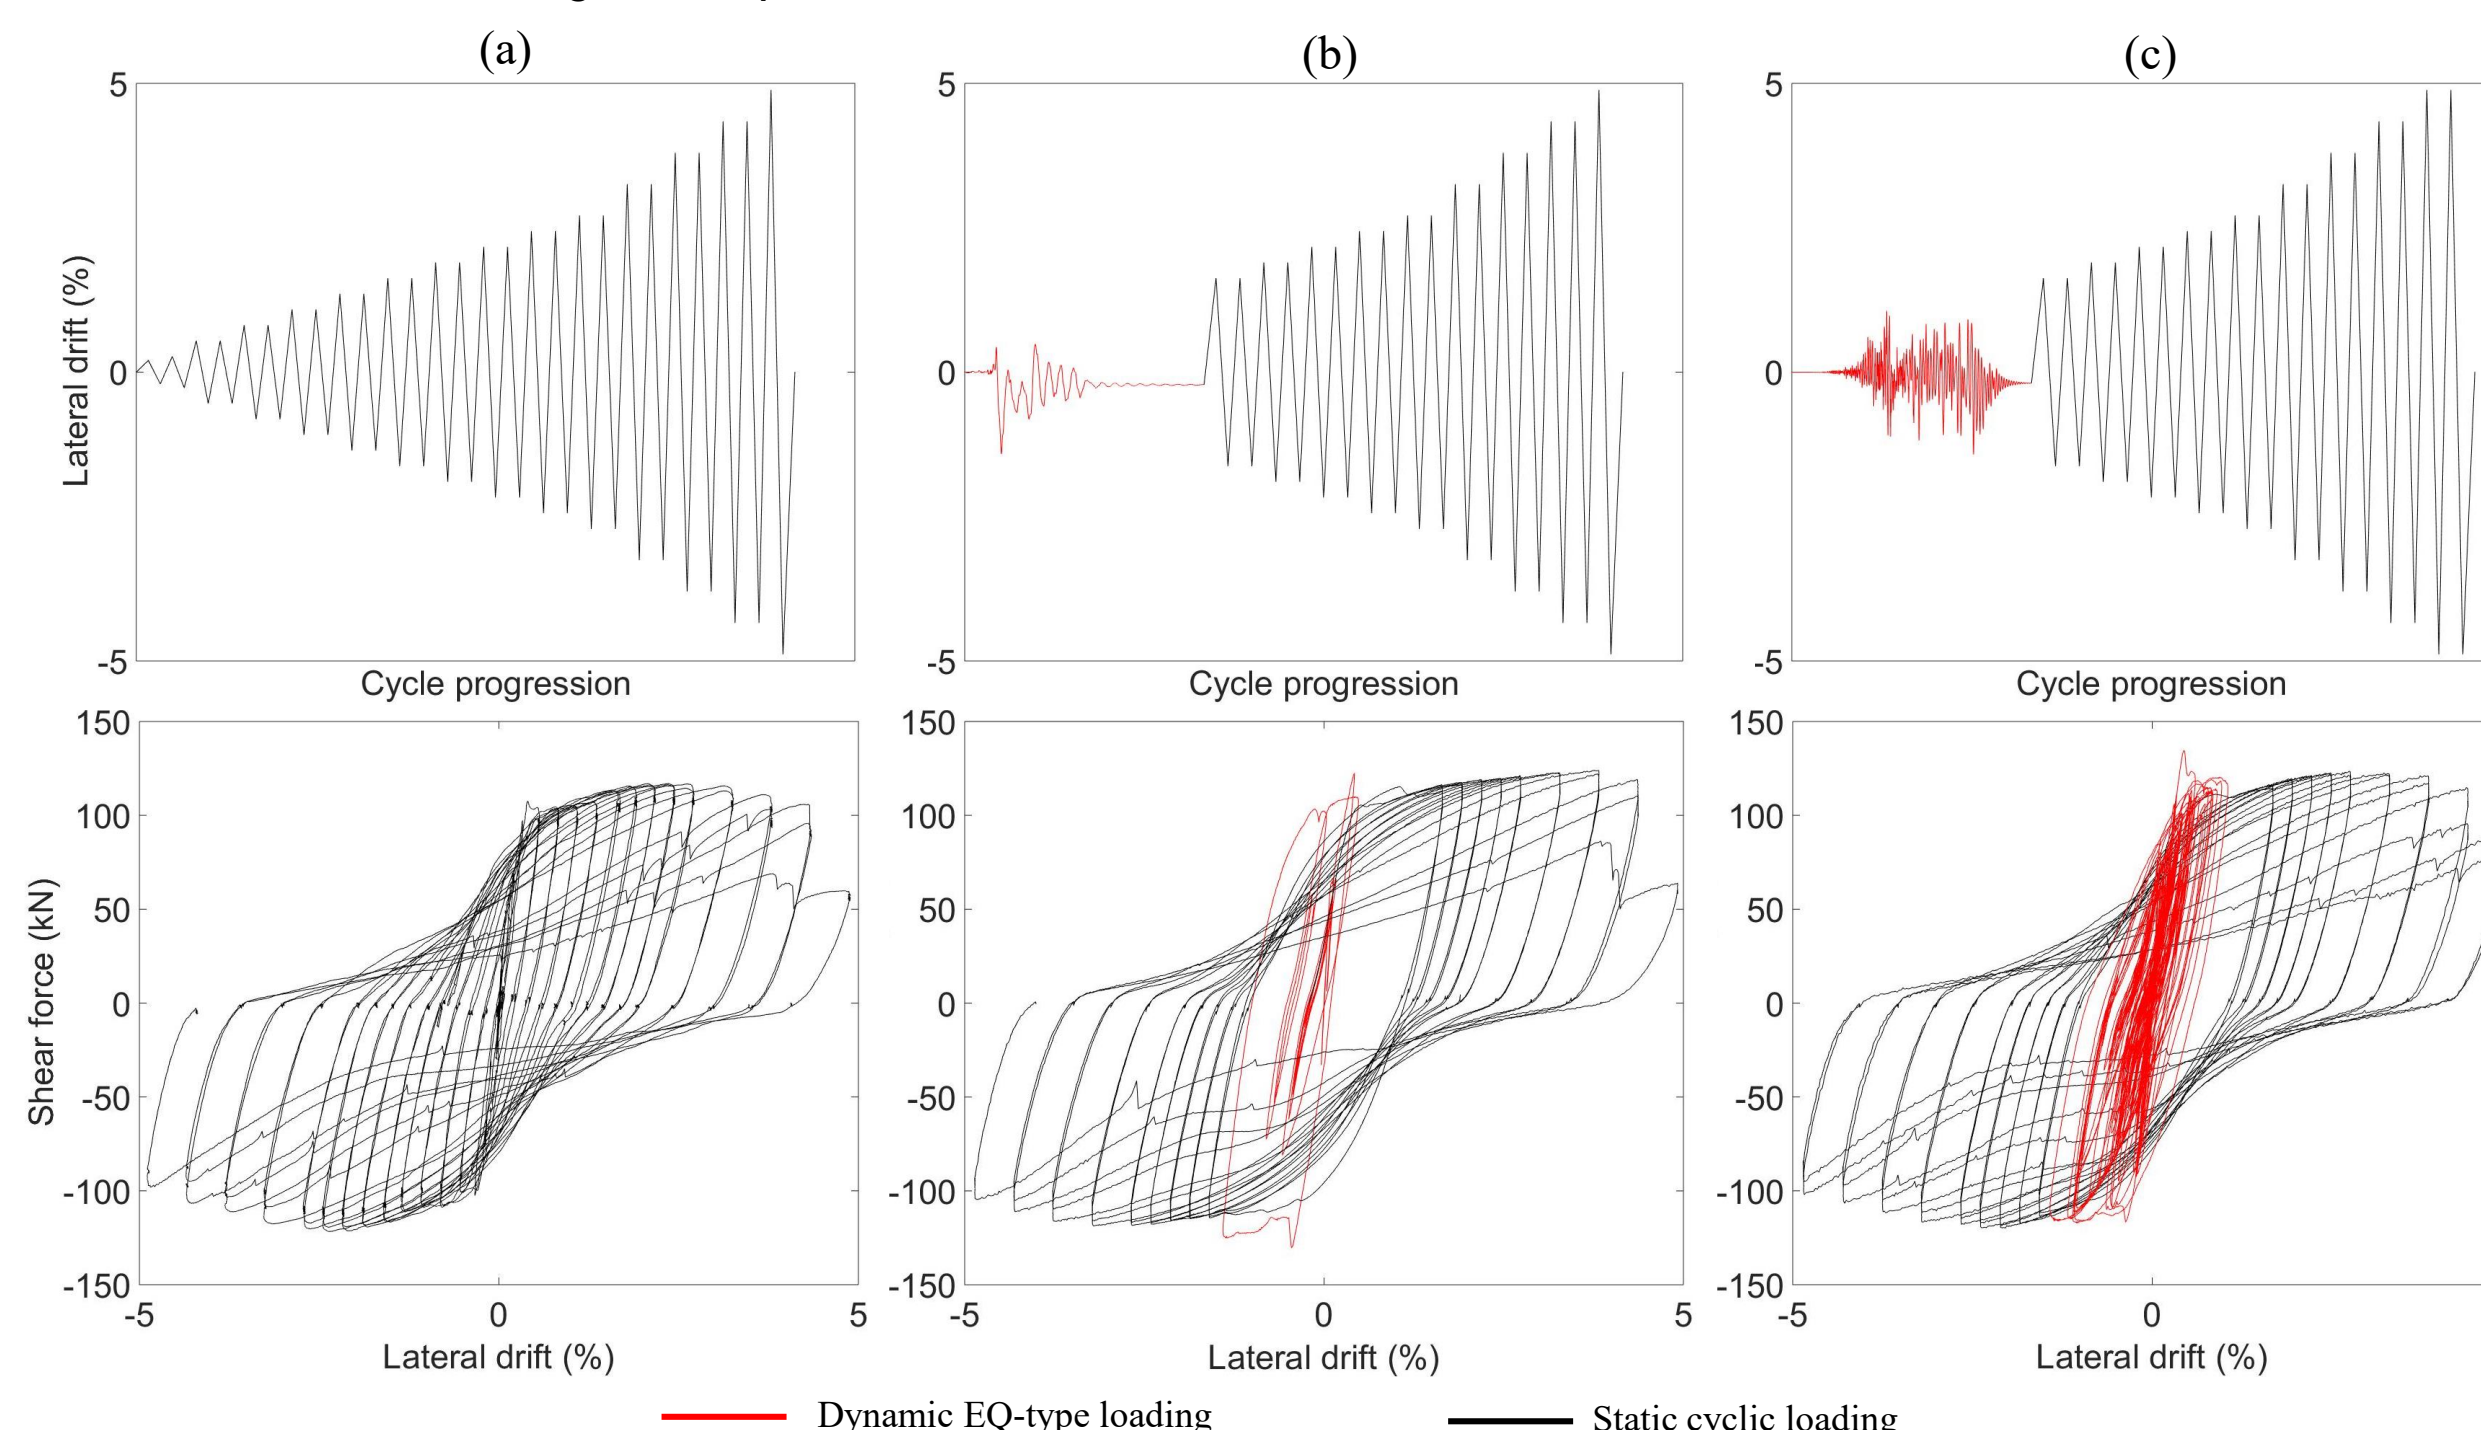
Figure 4: Loading protocol and hysteresis for three completed tests, showing: (a) static cyclic test (b) dynamic pulse-type EQ loading to ductility 5 followed by static cyclic loading (c) dynamic long duration EQ loading to ductility 5 followed by static cyclic loading.

- For low-to-moderate ductility demands, the loading rate and characteristics of the damaging earthquake have limited effect on residual energy dissipation and displacement capacities (see Figure 4).

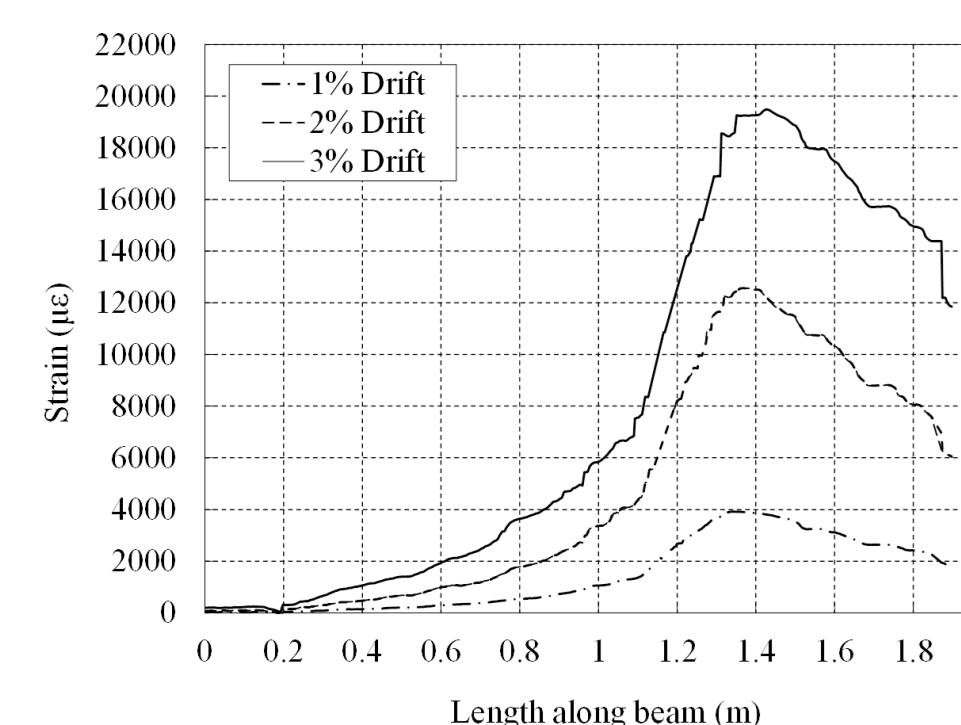
Figure 6: strain profiles measured in tensile reinforcement.

The preliminary measured strains from the embedded bonded fibres on the reinforcement plotted against length along the beam for the beam experiment are shown in Figure 6. The strain values increase from almost zero at the tip of the beam to the peak value at the datum exactly above the steel block level which is a representative of a fixed end support

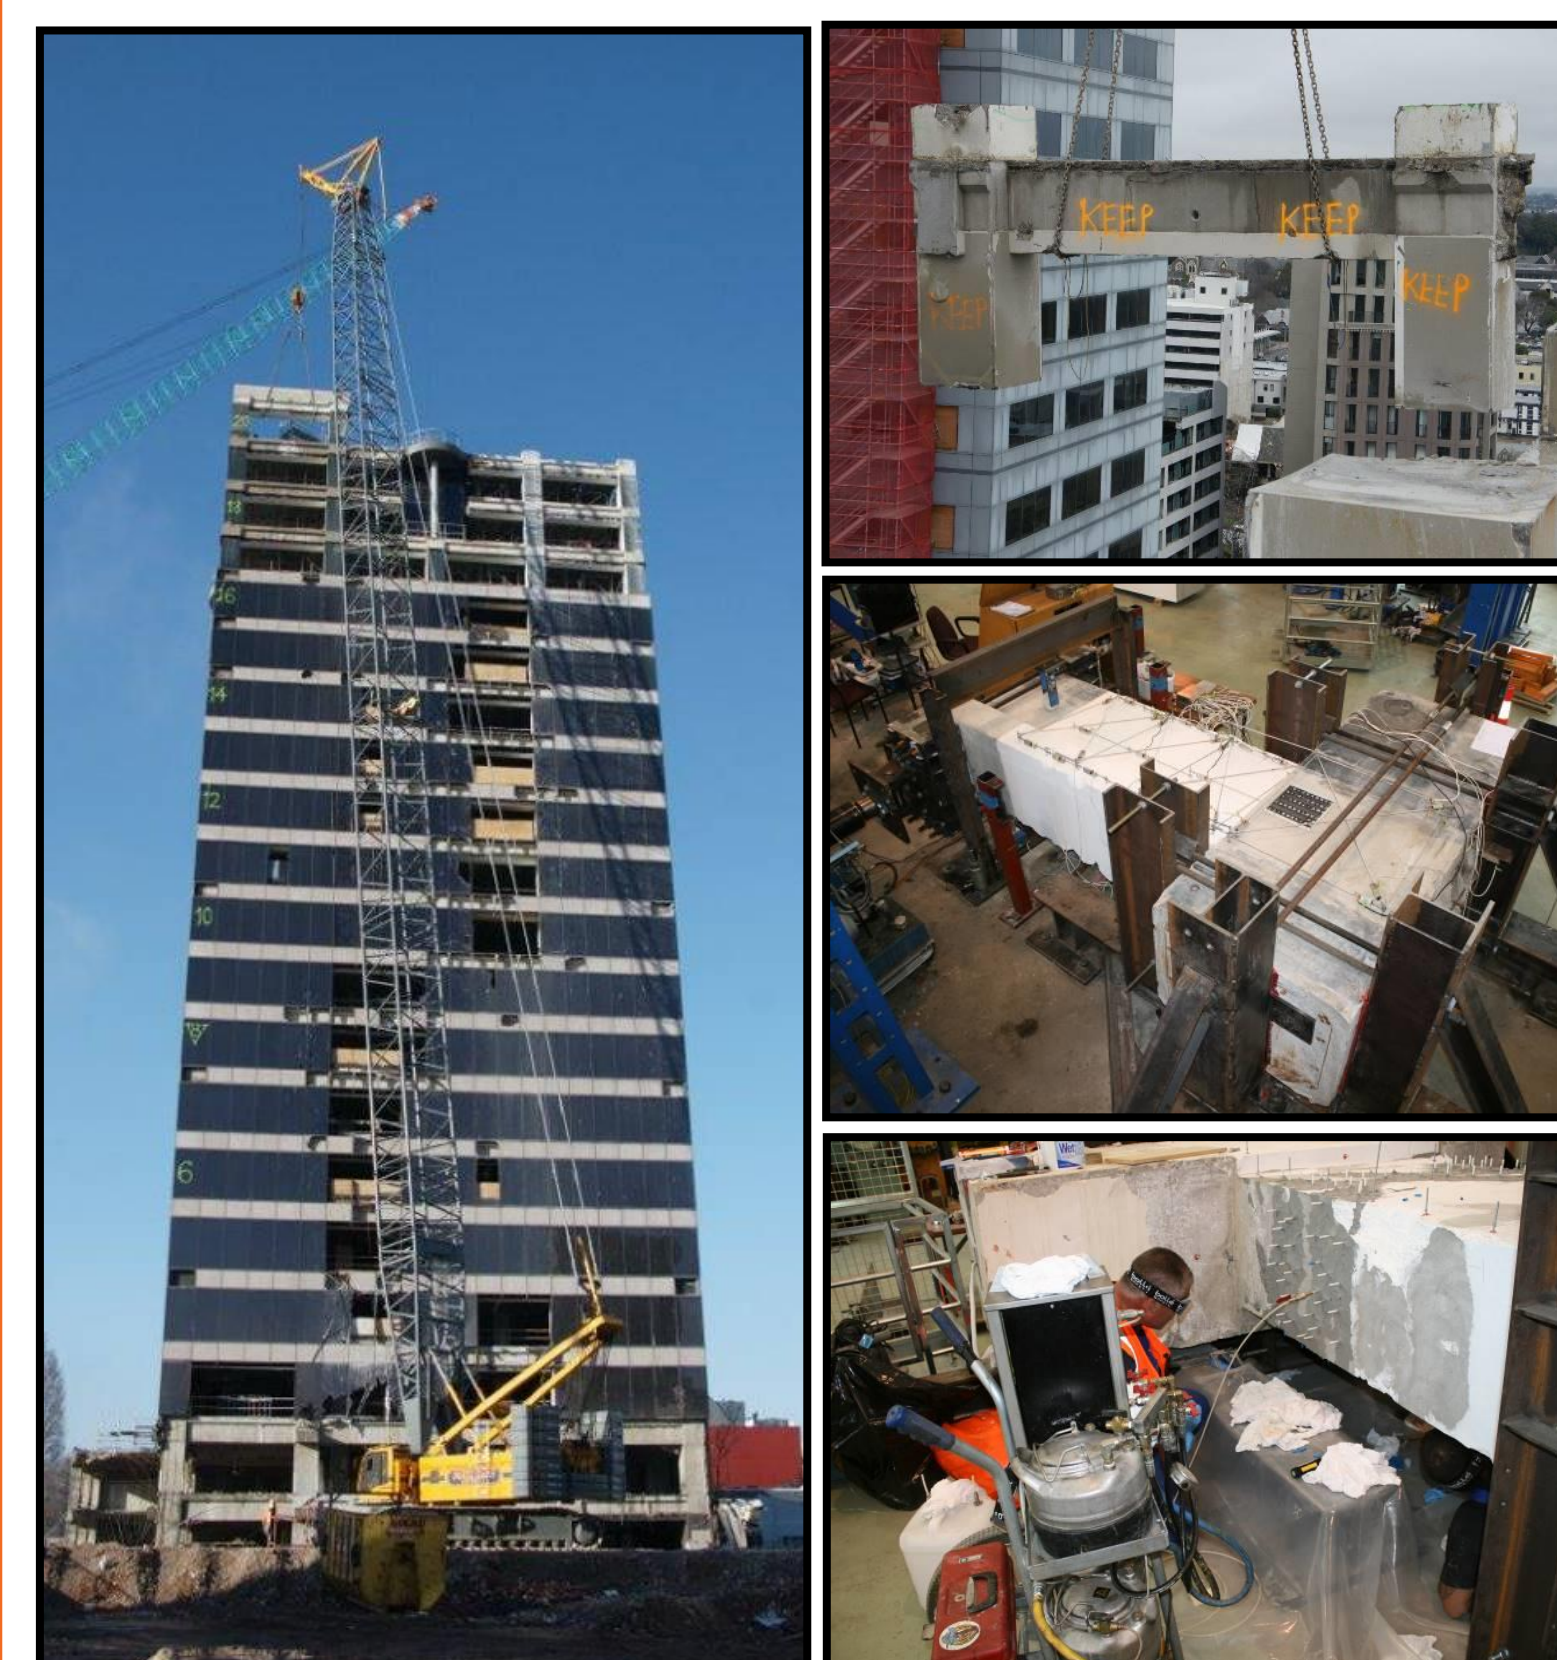
Figure 7: Elevation of the PWC building during the deconstruction process (left); extraction of one of the "H" frames (upper-right); test setup (middle-right); and resin injection of cracks (lower-right).

- Beam-column joint subassemblies were extracted from a 22-storey PWC building constructed in late 1980s at the Christchurch's CBD area, damaged and demolished after the 2010-2011 Canterbury earthquakes sequence (see Figure 7).
- The building was designed following capacity design principles. The beams were provided with plastic hinge relocation details at both beam-ends, aiming at developing plastic hinges away from the column faces (see Figure 8).

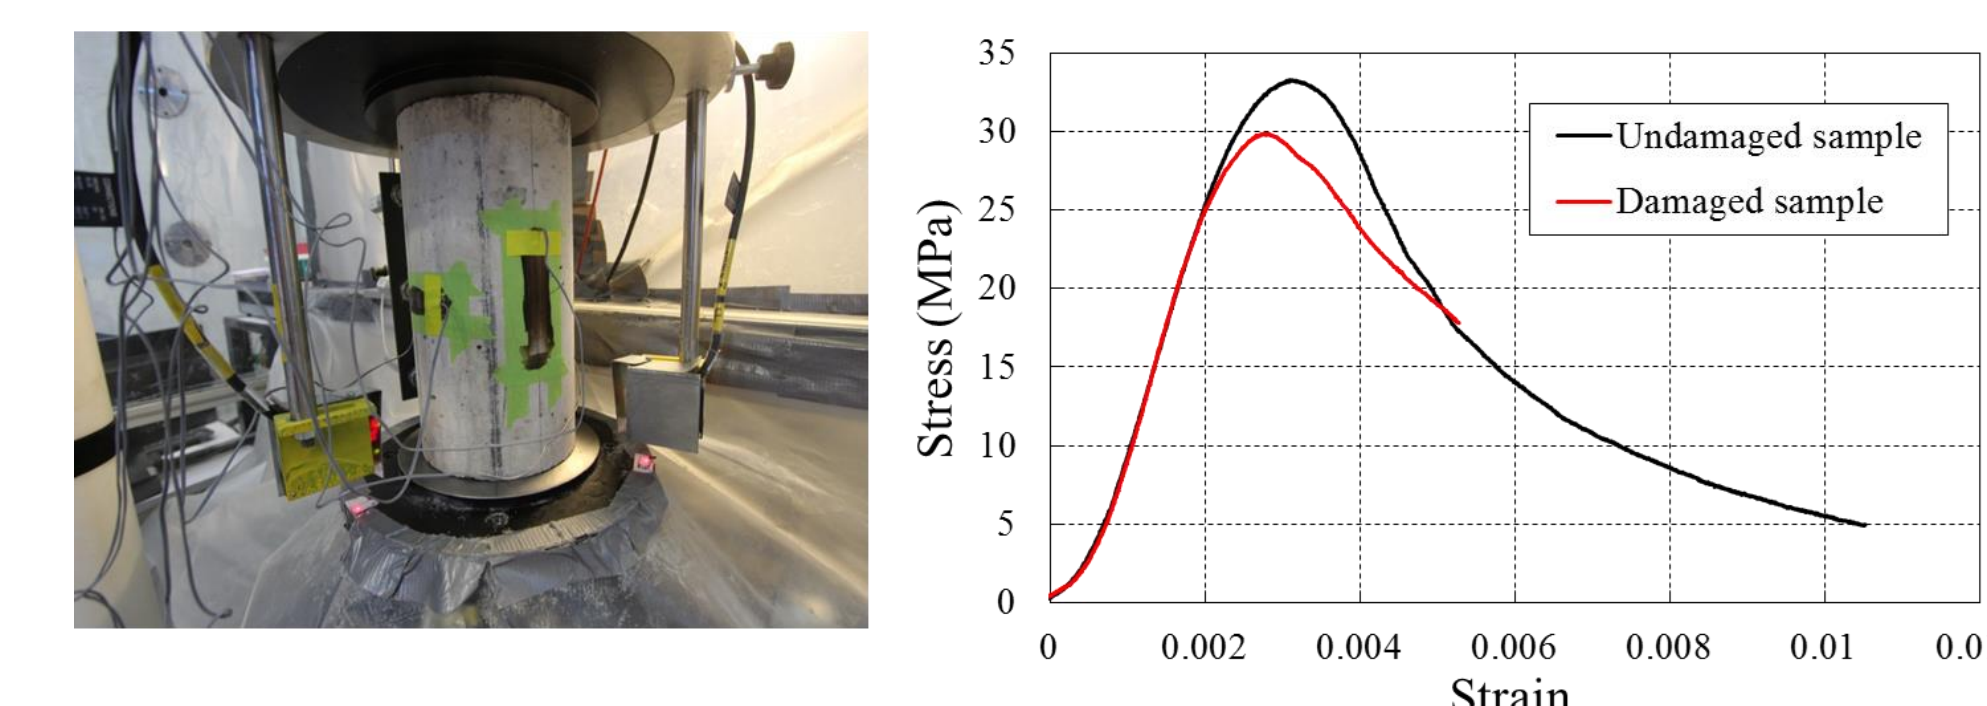
Figure 11: Test specimen (A) Plain concrete sample (B) Compressive stress-strain behaviour

Laser measuring technique was implemented along with 4 strain gauges to precisely capture post-peak behaviour of damaged concrete. Figure 11 shows test set-up and also monotonic compressive behaviour of both undamaged and damaged concrete samples after applying 90% of the cycles that it can undergo up to failure at stress level equal to $0.9f_c$.
