# EXPERIMENTALLY VALIDATED RETROFIT SOLUTIONS

## Shake-table testing of securing solutions for face-loaded unreinforced masonry walls

Dr D. Dizhur and Prof J. Ingham (Flagship 3, Project No. 16058)

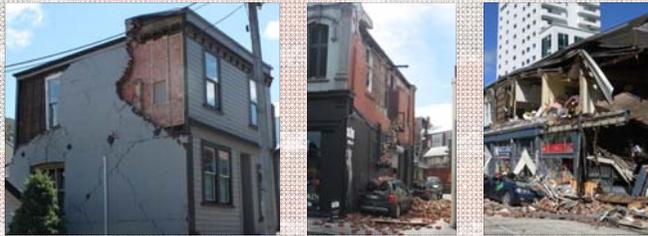
Examples of out-of-plane failures observed after the 2010-2011 Canterbury sequence

One of the most critical deficiencies of historic clay brick unreinforced masonry (URM) buildings [1] is the out-of-plane failure mechanism induced by lateral earthquake loads [2-4]. This failure mechanism is inhibited via the addition of adequate wall-diaphragm and wall-to-wall connections. However, in high and moderate seismic zones the sudden and unstable out-of-plane failure of walls mainly located at the upper building levels can result in extensive damage and potentially catastrophic collapse, posing a significant life-safety hazard to both building occupants and nearby pedestrians.

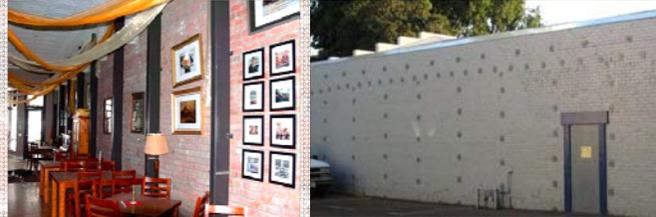
Examples of out-of-plane wall retrofit adopted in New Zealand

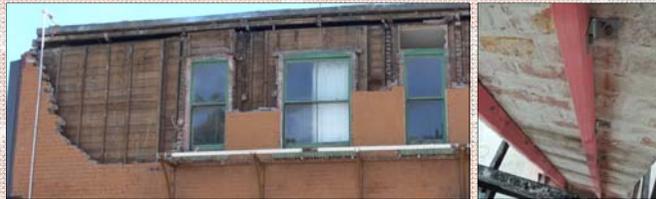
The first retrofit technique that will be tested consists of innovative system of strong-backs. In particular, the vertical framing that is typically a non-structural support of the inner wall lining will be used as retrofit solution and fixed to the wall with steel brackets and mechanical screw-ties in order to form a strong-back.

Retrofit technique using timber strong-backs

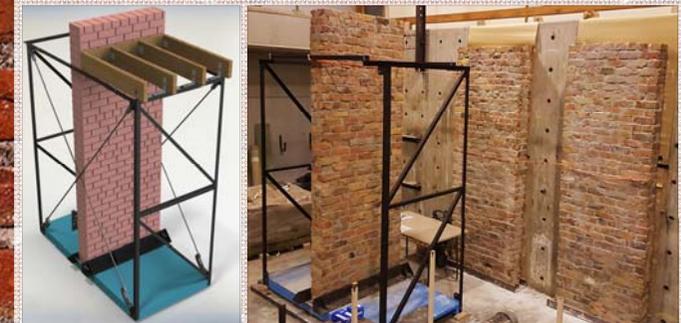
Solid brick double-leaf walls are H3300 × W1200 × T220 mm and closely simulated in-situ conditions. To reproduce the low compressive strength of original lime-based mortar a 1:3 (lime:sand) mortar mix was used.

The test set-up was designed to replicate common in-situ boundary conditions for a single-storey wall portion of an upper storey perimeter load-bearing solid-wall fixed at the base for continuity with the lower walls or foundation and allowing rotation and vertical displacement at the top based on typical seating arrangements observed at the roof level.

Test set-up and wall construction

Harmonic motion will be applied with acceleration increasing every 15s and constant amplitude at 50 mm. Each test will be conducted up to the point of wall cracking, and the initiation of rocking will be considered to correspond to the onset of wall instability. A second non-instrumented test will be then performed up to collapse of the wall.
