Cobden wetlands īnanga habitat assessment and recommendations for future management

Mike Hickford and Shane Orchard

Marine Ecology Research Group
University of Canterbury
May 2017

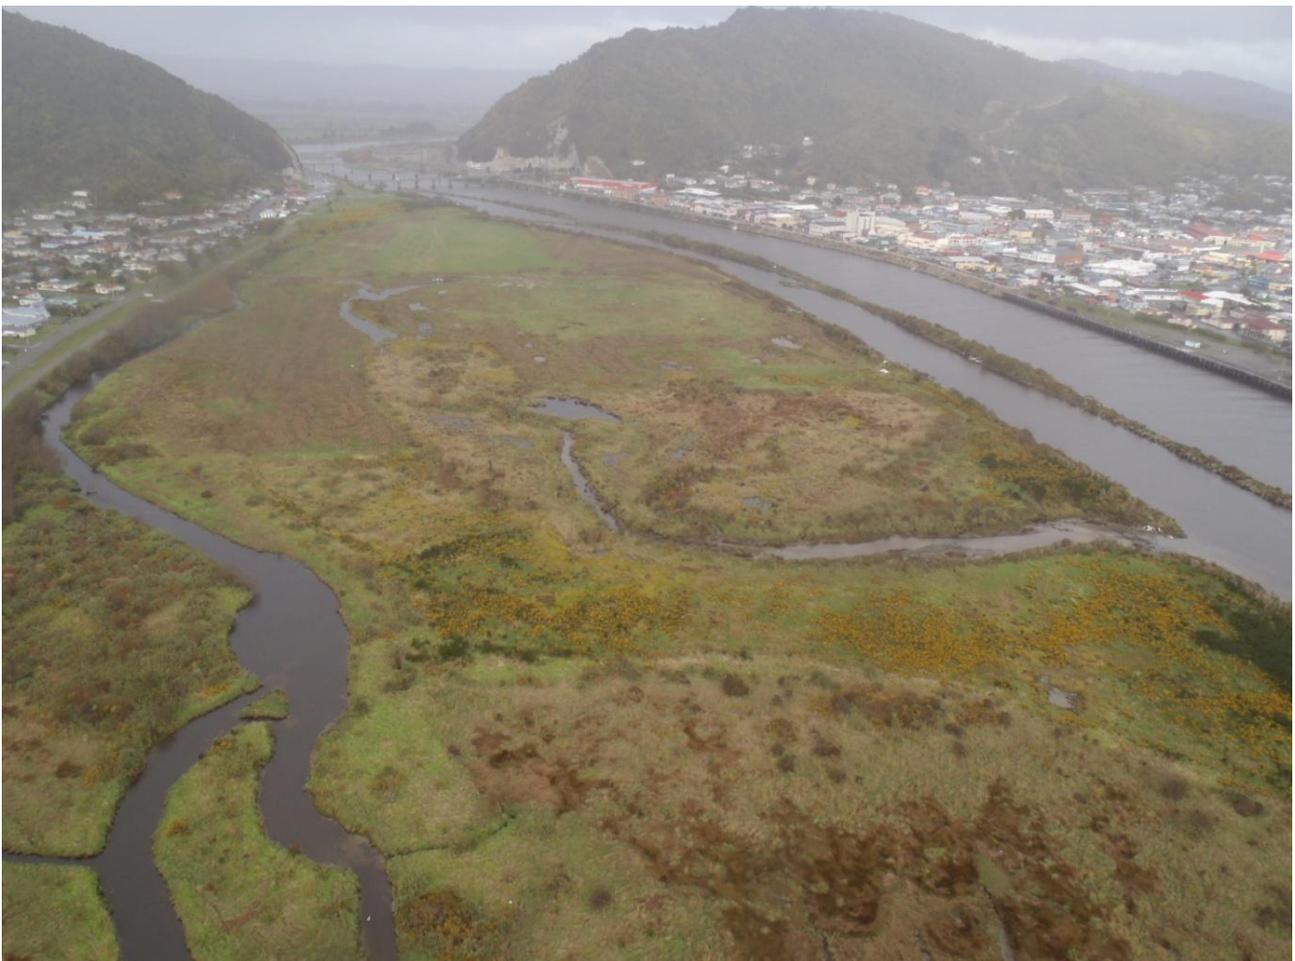
Figure 1. Grey River and Cobden Island floodplain, September 2011 (pre-restoration). (Henk Stengs, DOC).

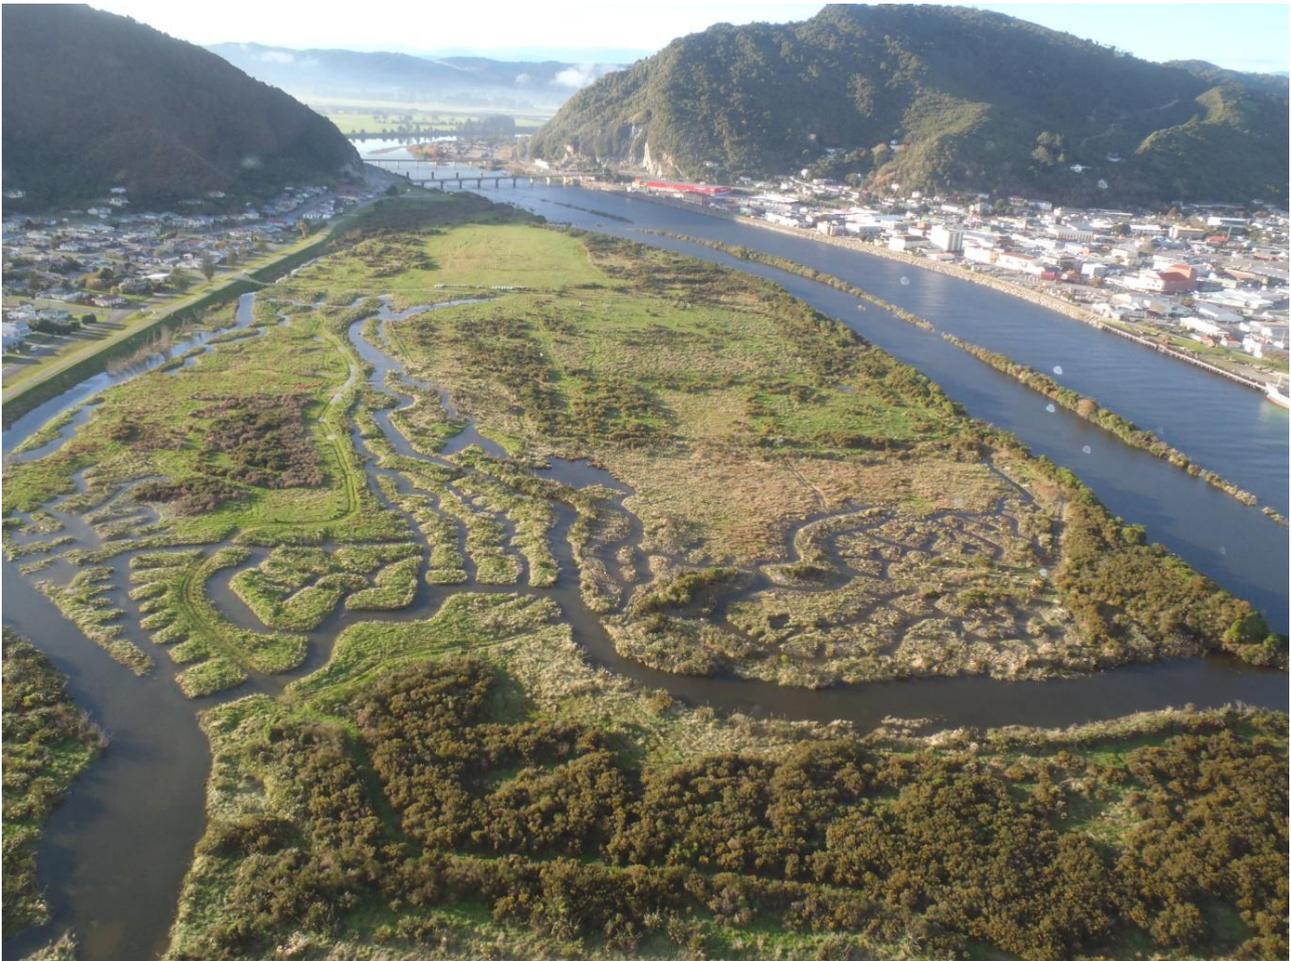
Ecological restoration of Cobden wetlands commenced in 2013 with the first of four annual stages of channel excavations on Cobden Island (Figures 1 and 2). The aims were to provide restored habitat for īnanga including improved spawning habitat in areas inundated on spring high tides. Over 10,000 flaxes and other indigenous species have been planted by volunteers beside the channels in order to provide shade, habitats for indigenous birds, and for aesthetic reasons. Volunteers have also carried out the more difficult task of removing gorse and broom from waterway margins in order to ensure the establishment of riparian plant communities known to support īnanga spawning.

Figure 2. Grey River and Cobden Island floodplain restoration site, June 2016. (Henk Stengs, DOC).

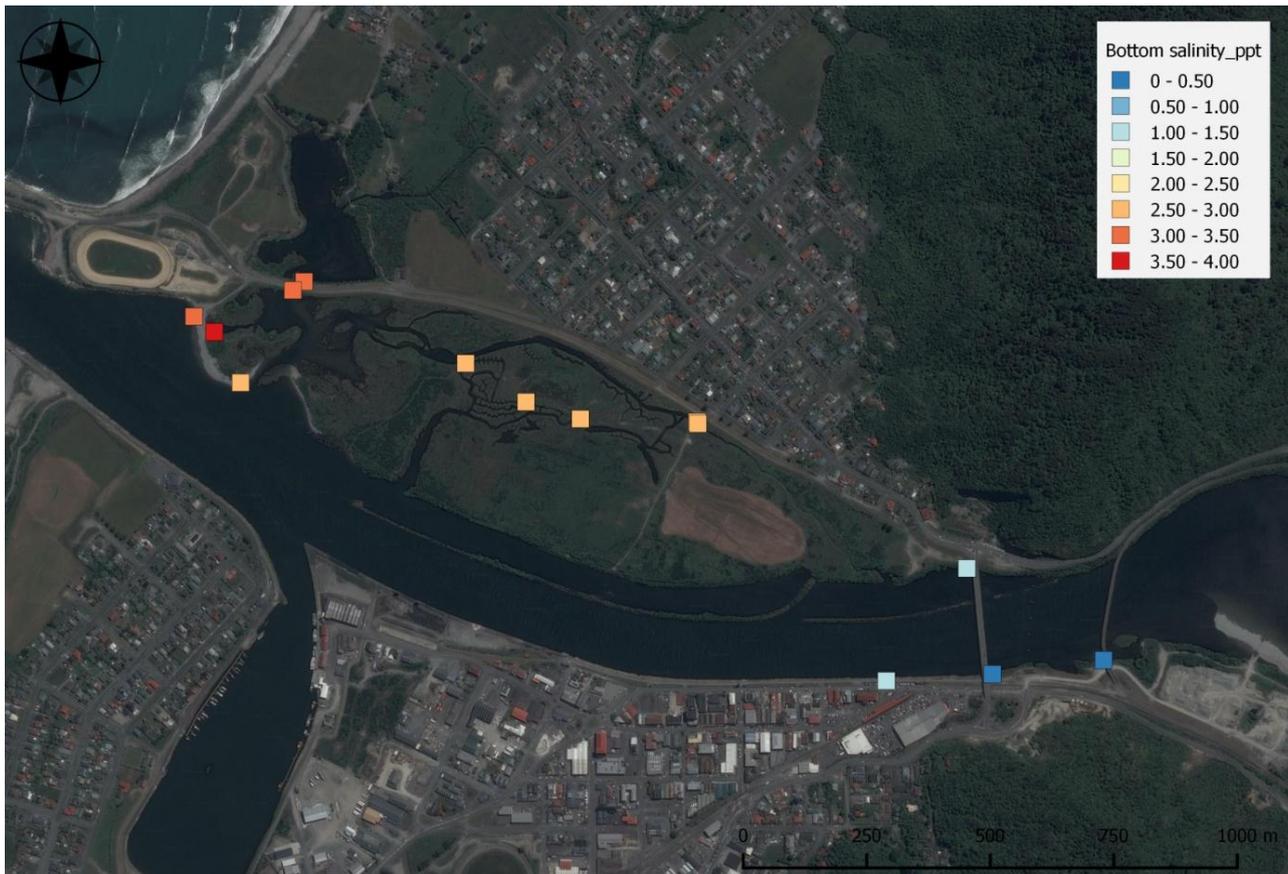
14. The search for eggs on Cobden Island at the place where milt was observed on 30 March was unsuccessful. It is very likely that any resulting eggs would have already hatched.
15. Most channels retain water at low tide. This greatly enhances their habitat value for maturing adults.
16. Surveys in late February-early March 1990 yielded two spawning sites on Cobden Island (Taylor, Buckland & Kelly 1992). The northernmost of those was searched in 2017 but no eggs were found.
17. Salinity is within the range suitable for īnanga spawning (Figure 3).

Figure 3. Bottom (maximum) salinity measurements recorded 1 May 2017 on the tidal peak (3.2m high tide @ 3.11pm)
