Antarctic Aviation: Accidents and Safety Policy

Mike Chilton

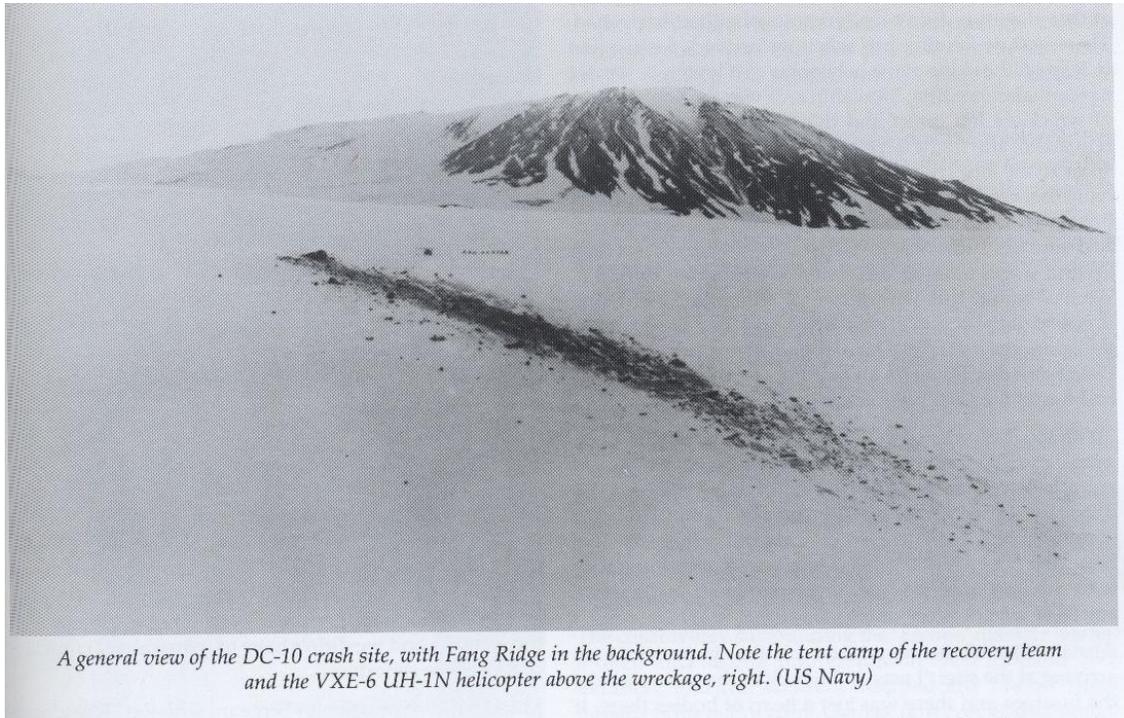
horizon lay before them. What in fact existed beyond the illusion was the lower slope of Mount Erebus, Fang Ridge.

The aircraft was destroyed upon impact. Flight data and cockpit voice recorder tapes indicated that the crew up until that moment had no idea of the approaching terrain before them. Air New Zealand submitted that such phenomena was rare, however the head of the Royal Commission of Inquiry, Justice Mahon, visited the area and experienced the same conditions. He was told by local operators that in fact such conditions were not unlikely and those experienced by Justice Mahon that day were nearly identical to that which deceived the flight crew of TE901. The false horizon illusion coupled with the compelling effect of what they expected to see was considered a major contribution to the 1979 accident.³

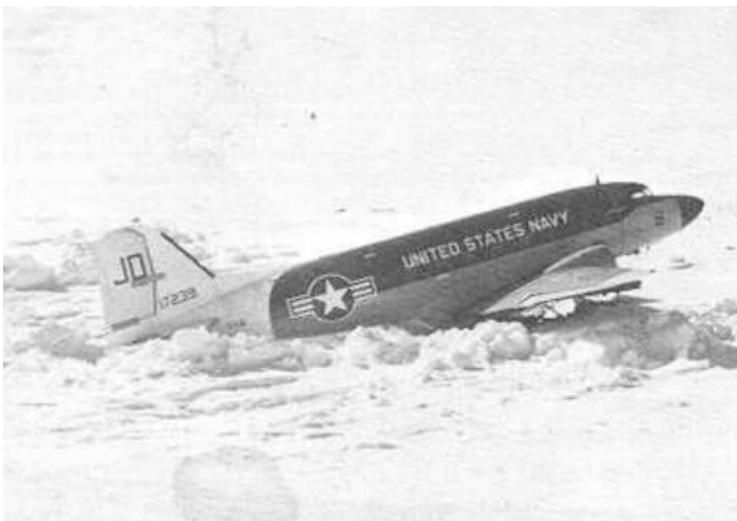
In the Deep Freeze operations of 1965 the Squadron lost seven aircraft. A LC-47J Bu No 50778 was on its rollout on the skiway, when one of its skis struck a large sastrugi, and in turn striking its propeller, tearing off the port engine and twisting its fuselage. On October 6 a LC-47H Bu No 17239 crashed on the Ross Sea Ice Shelf, while practicing open field

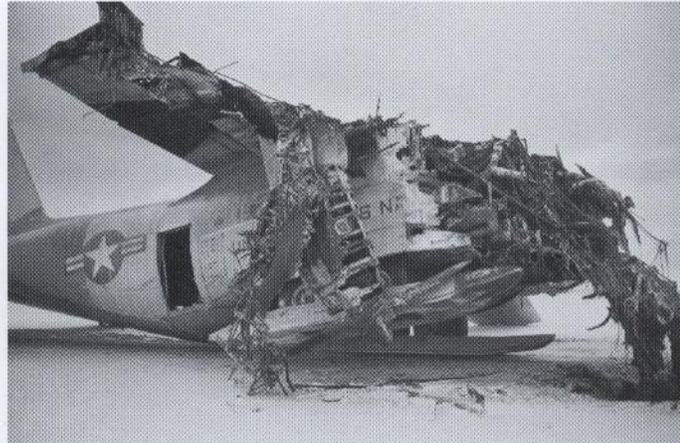
The Navy lost their first C-130F Hercules named 'City of Christchurch' in a taxing accident. The Hercules had just taken 7000 gallons of fuel for the return trip to Christchurch, but burst into flames, as it was taxiing around a building. Its left ski went over a five and half foot snow bank; its right wing hit the ground and broke between the two starboard engines. The fire fed by fuel and high winds soon engulfed the aircraft.

The burnt out remains of the VXE-6 LC-130F (BuNo 148318) "City of Christchurch" at McMurdo in February 1971. (US Navy)

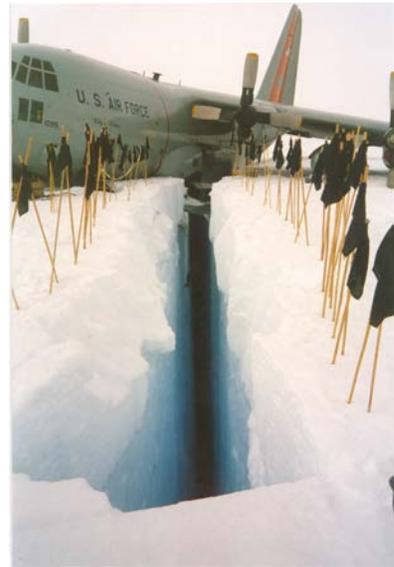
The Air National Guard had their first C-130 # 10295 incident late in 1998, when the aircraft's portside ski-equipped undercarriage lodged down a 38 metre deep crevasse, whilst preparing to take off from a remote West Antarctic science field camp 130 km south-west of Siple Dome and 1000km from McMurdo. After partly filling the crevasse with snow, engineers used airbags and a special harness developed by Air New Zealand's Engineers to pull the C-130 free. Once free engineers working in sub zero conditions replaced an engine and two propellers, before being flown back to Air New Zealand Engineering Services in Christchurch.

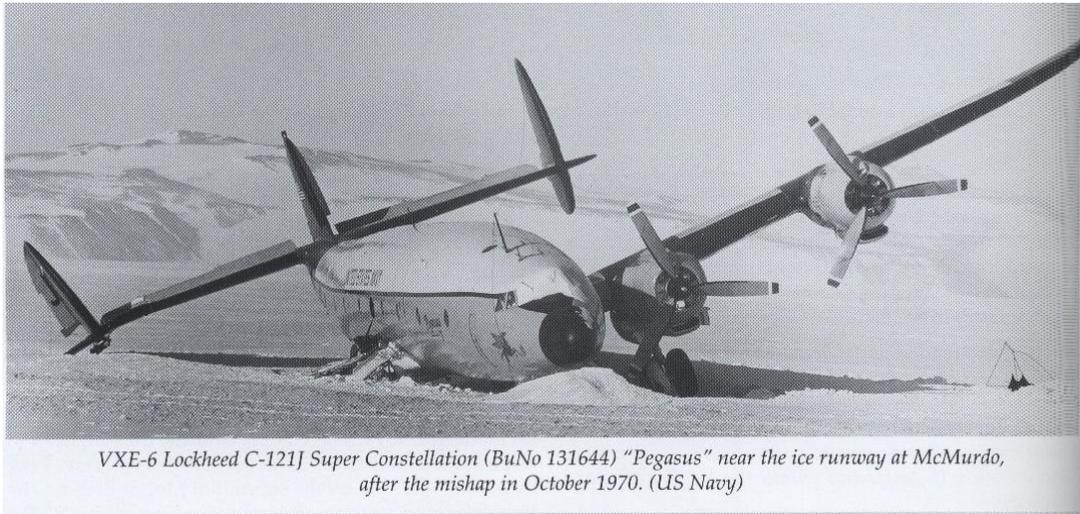
With no other alternative airfield, and the aircraft low on fuel, the pilot made several low-level radar controlled approaches, all unsuccessful. On the last attempt, and with almost no fuel left, he landed, veered off to the right of the runway. The C-121 was seriously damaged, without any injuries.

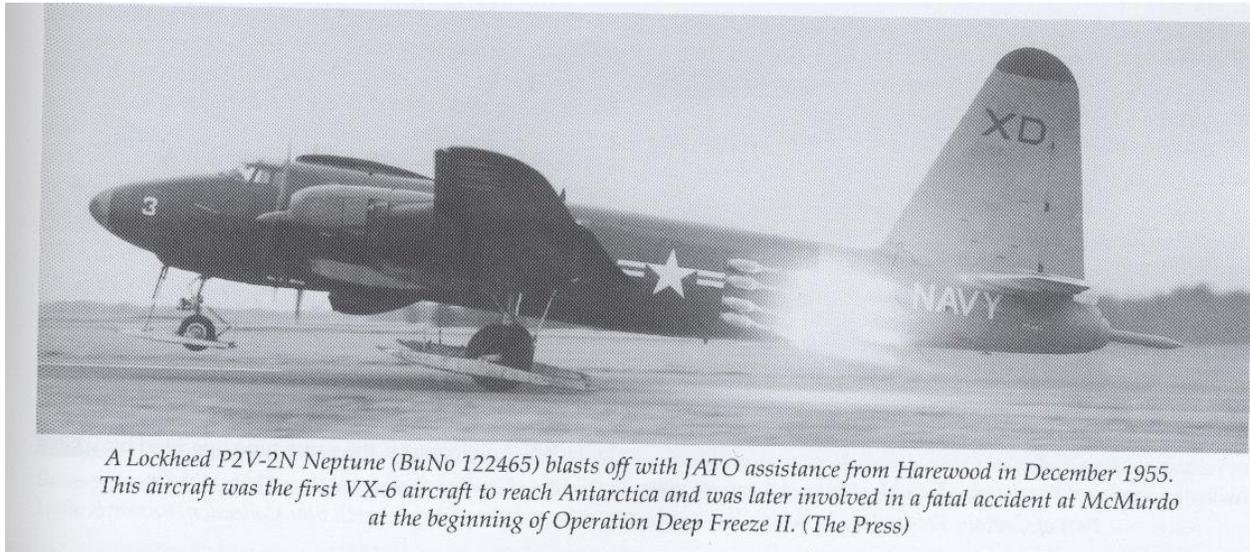
The extreme environment and high surface altitudes on which the aircraft operate necessitates unusual measures to assure adequate performance. The use of JATO (jet assisted take-off) rockets have a dramatic effect on take-off performance. The rockets are attached to the fuselage and fired in banks near take-off speed to provide thrust augmentation. The use of such devices in

the Antarctica began during “Operation High Jump 1” (1946-47).¹¹ The operation was a large US Navy deployment led by the now *Admiral* Byrd consisting of 4700 men. The JATO rockets were initially used for carrier aircraft RD4¹²(C-47) deployment, of the naval ship the *Philippine Sea*.

JATO rockets were instrumental in the successful completion of the first aircraft to land at the geographical South Pole On October 31, 1956 an the R4D named "Que Sera Sera" (what will be, will be).¹³ The aircraft was sitting on the ground subject to -50°C temperatures compounded by a 10-15 knot wind. After approximately 50 minutes the decision was made to leave. However, the R4D's skis during the landing heated a few degrees from the friction causing the snow to melt, subsequently freezing to the skis. At 9,200 feet, the engines had insufficient power to ‘unstuck’ the skis. Consequently, fired all the JATO bottles were fired in order to avoid an unscheduled and potentially fatal stay at the pole.

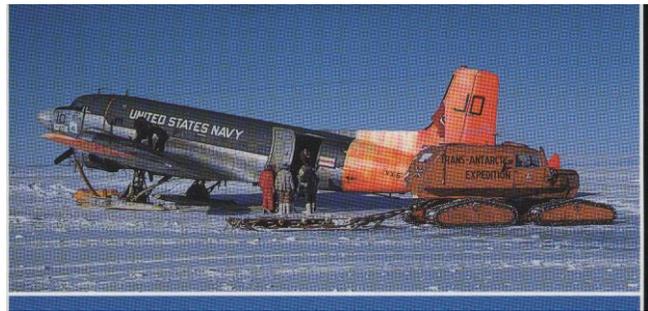
Since then the use of JATO bottles became commonplace but not without their associated accidents. A LC-47H Bu No 50777, while making a jet assisted take-off at Davis Glacier, was written off after a JATO bottle was released prior to it being extinguished hitting the aircraft's propeller. On October 22 19%% a LC-47H Bu No 12407 crashed when one of its JATO canisters was inadvertently fired while being jettisoned. Striking the left prop, the aircraft was a total loss

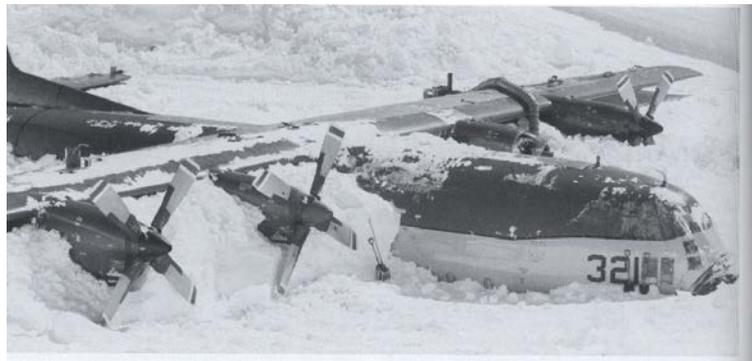
In “Deep Freeze 72”, VXE-6 lost their second C -130F Bu No 148321 landing in an open ice field to supply a French traverse team participating in the International Glaciological Project. After unloading, the C-130F made the usual JATO take off before

returning to McMurdo 750 nautical miles away, however when the pilot had reached 50 feet, two of the bottles separated from the left hand side, striking the left inward engine and prop. The aircraft sustained serious damage on impact with the ice.¹⁴
