# **EROSION SOURCES AND SEDIMENT PATHWAYS TO STREAMS ASSOCIATED WITH FOREST HARVESTING ACTIVITIES IN NEW ZEALAND**

Prepared for the New Zealand Forest Owners Association

June 2017

## Project Final Report

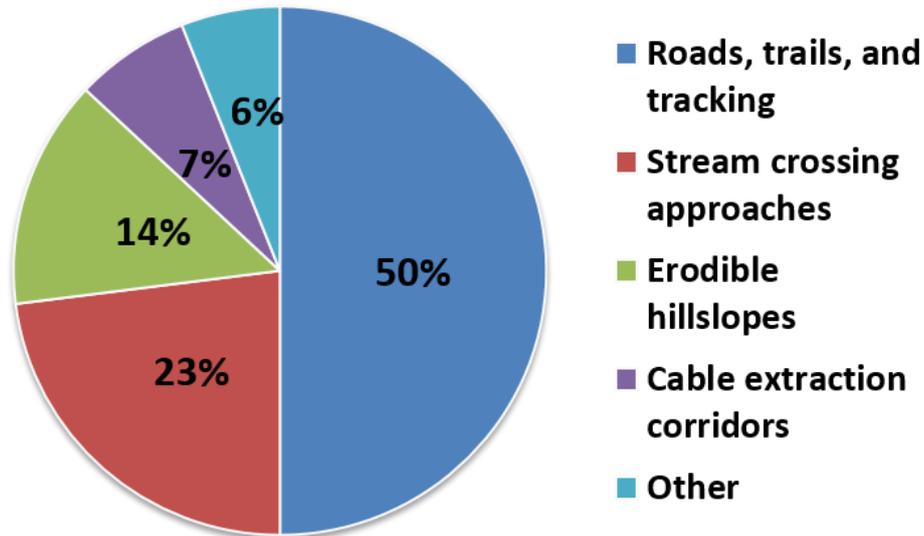
Figure 1. Breakthrough sources and their relative frequency. N = 53 for ‘Roads, trails, and tracking’, 24 for ‘Stream crossing approaches’, 15 for ‘Erodible hillslopes’, 7 for ‘Cable extraction corridors’, and 6 for ‘Other’.

Half of the breakthroughs found in this study were caused by concentrated runoff from roads, skid trails, or machine traffic disturbance on the hillslope (Figure 1). An additional 23% of breakthroughs occurred where roads and trails crossed streams. Thus, 73% of breakthroughs were associated with roads, trails, and machine tracks on the hillslope.

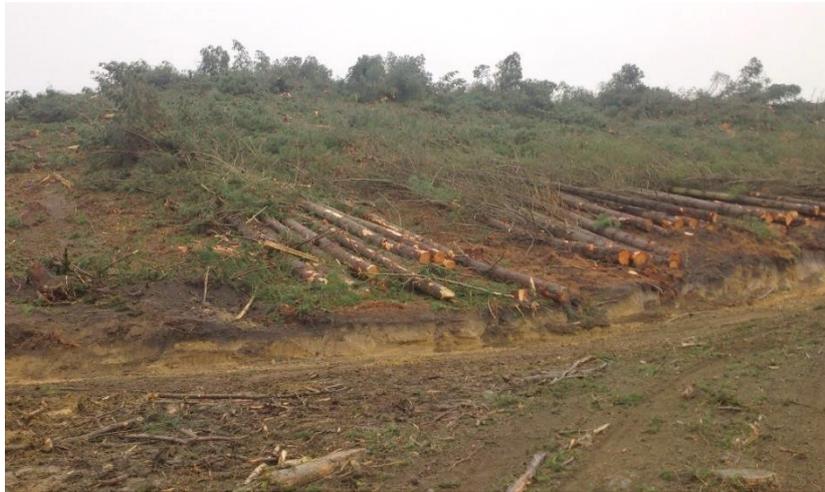
Figure 3. Bunched stems next to a skid trail awaiting extraction from a grapple skidder.

An example of minimising tracking associated with ground-based harvesting is to use shovel logging. Less tracking is required because stems can be shovelled to a skid trail and bunched in preparation for extraction (Figure 3).

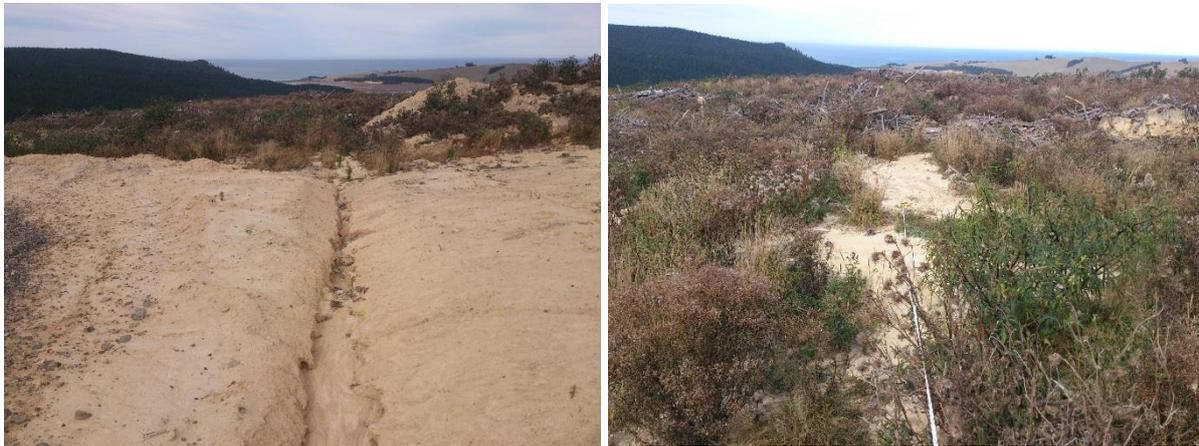
Figure 5. Left: At a road curve, a cut-out moves water from the ditch into an area in the cut-over with flat topography and high surface roughness, ideal for trapping sediment. Right: Sediment is trapped and stored in the cut-over.

emphasis on controlling water in small amounts and reducing surface runoff velocity can help to reduce the occurrence of sediment breakthroughs, or at least mitigate their impacts on water quality. When it comes to road surface runoff, think “Slow it down and spread it out” (Figure 5). This can be achieved by spacing water control structures (e.g. cross-drain culverts, cut-outs, or water bars) according to road gradient and soil erodibility. As road gradient or soil erodibility increases, road drainage structures need to be spaced at shorter intervals.

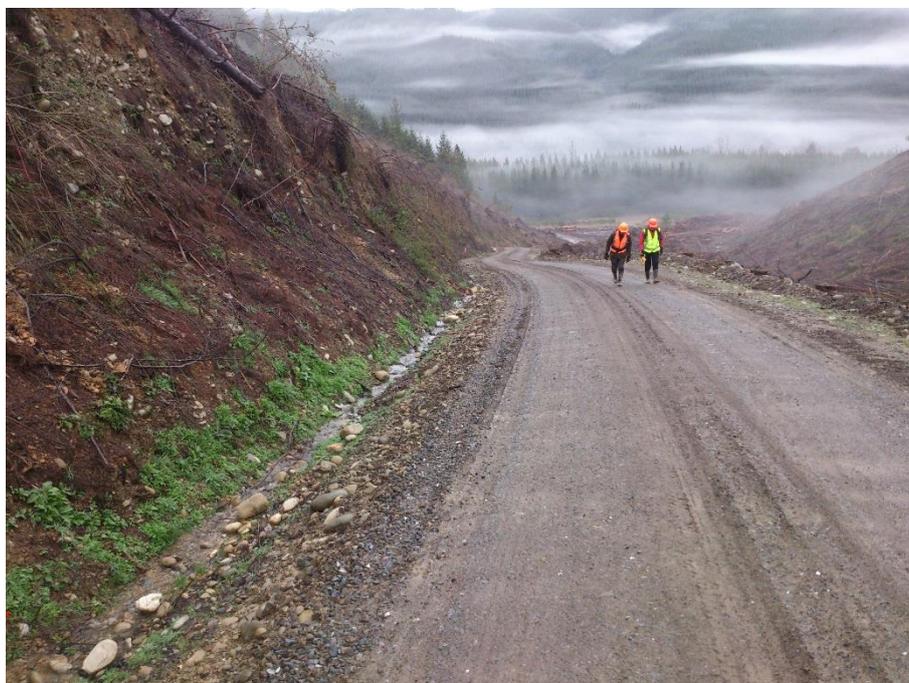
Figure 6. A secondary forest road with a good shape (crown), which moves half of the road surface runoff to the inside ditch and half to the fillslope (outer) side of the road. Water in the ditch drains to a series of cross-drain culverts, while surface runoff from the outer half of the road is relieved by a series of cut-outs. Note that the ditch also concentrates subsurface flow

from the hillslope above the road, which may have a much larger catchment area than that of the road surface itself. The spacing of road drainage structures needs to take this into account.

In addition to appropriate spacing of road drainage structures, the shape of the road profile is important for reducing runoff volume and velocity. For example, a crowned road sheds half of the road surface runoff to the inner and half to the outer sides of the road. (Figure 6).

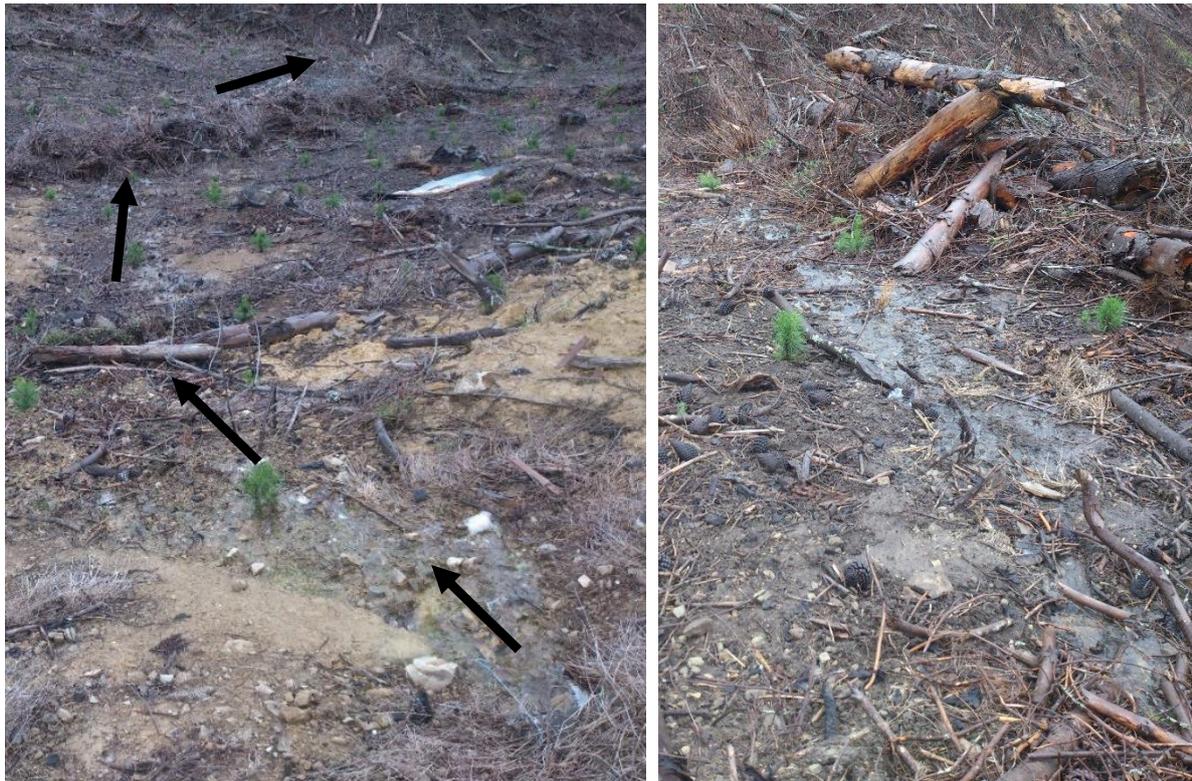
Figure 7. Left: Runoff flowpath on the hillslope below a cross-drain culvert. The slope is moderately steep (21 degrees) and surface cover is low after root raking and replanting, but surface runoff must travel 95 meters on the hillslope and pass through a slash windrow on its way to the stream. Right: Concentrated surface runoff reaches the stream, but it is flowing clean.

Locating road drainage structures to avoid discharging surface runoff directly or indirectly (e.g. through ephemeral gullies) to stream channels is also important to reduce road-to-stream hydrologic connectivity. A cut-over with an intact forest floor is a good example of a desirable receiving environment because its stability, roughness, and high infiltration capacity improve infiltration of runoff and trapping of sediment. Other desirable characteristics for receiving environments include gentle slopes, lack of convergence, and some distance between the drainage outlet and the stream (Figure 7).

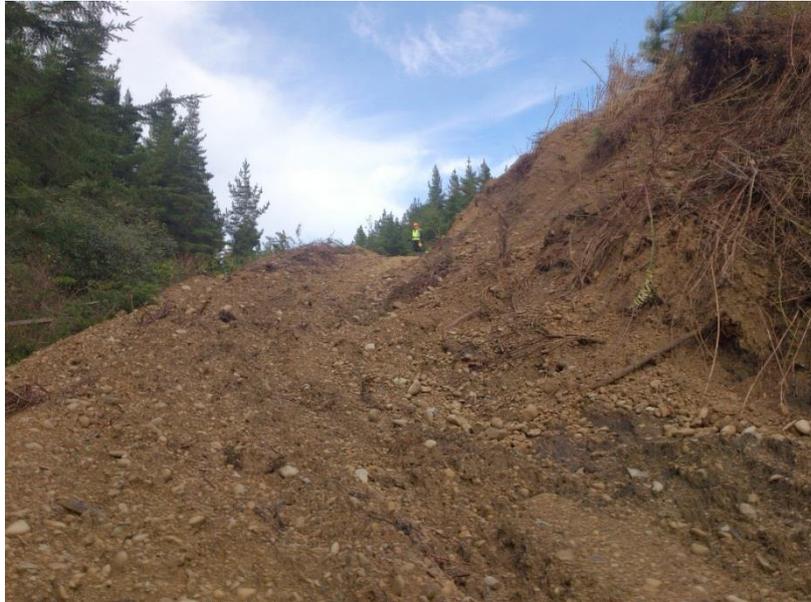
Figure 8. This temporary stream crossing approach was steep (33% slope), with no water control, and poor surface cover (20% cover). The potential erosion rate was estimated at 204 tonnes/hectare/year.

While just 10 of 35 skid trail approaches to stream crossings contributed to sediment breakthroughs in this study, the ones that lead to breakthroughs did so in a big way (Figure 8). For example, the median potential erosion rate for skid trail approaches that led to breakthroughs was 71 tonnes/hectare/year versus 1.6 tonnes/hectare/year for the surfaces of log truck roads. Closure of bladed trails at stream crossings should include drainage structures, such as water bars, plus some type of surface cover (Figure 9).

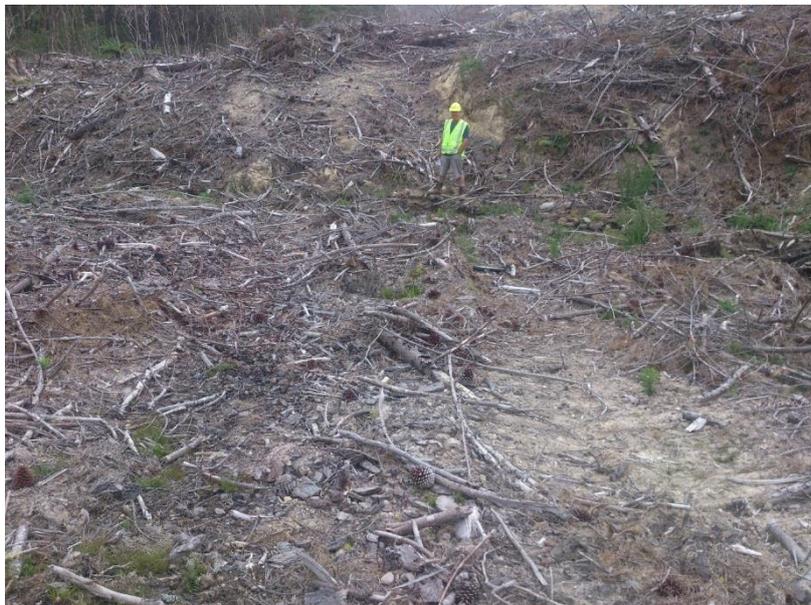
Figure 9. This temporary crossing has gentle approaches to the stream, slash barriers were used to disrupt concentrated surface runoff, and logging slash was used to provide surface cover.

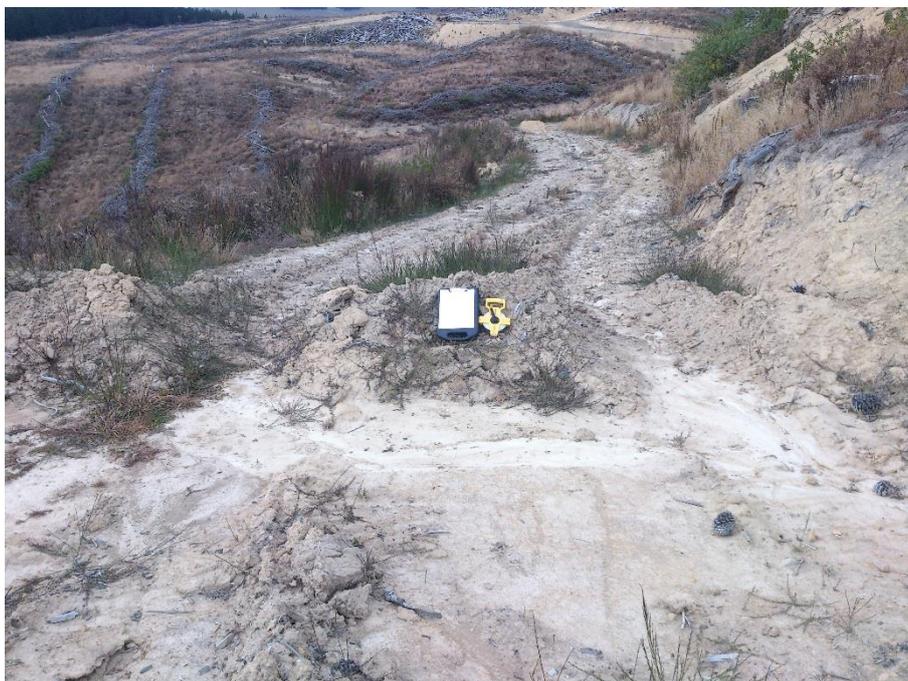
Figure 10. Surface runoff passes through this water bar because it has been compromised by traffic.

For skid trails and other temporary tracks, water bars, cut-outs, and other erosion control practices need to function for about two years post-harvest (Figure 10). By then, harvested sites have revegetated and exposed soil has become less erodible (i.e. easily transported sediment has been washed off). Therefore, it is important to audit the implementation and functioning of erosion and sediment control practices prior to machines moving off site, as well as periodically thereafter (e.g. following heavy rainfall events).

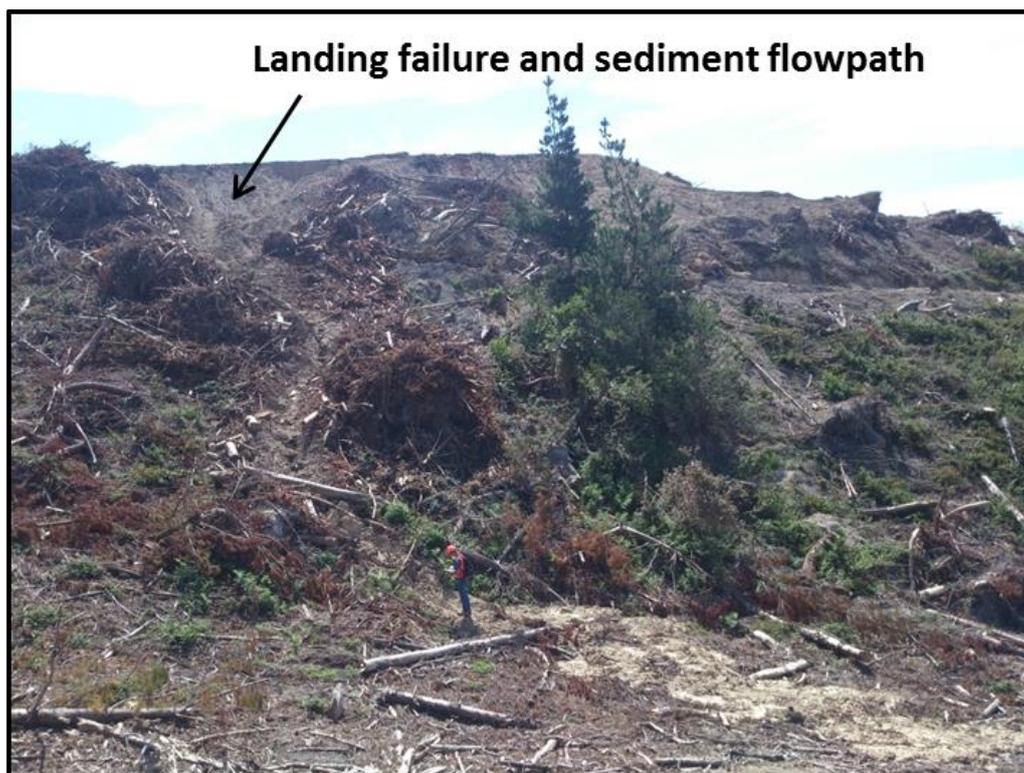
Figure 1. Example of a sediment breakthrough to an ephemeral stream channel. This breakthrough resulted from a landing failure. Photo: Kristopher Brown.

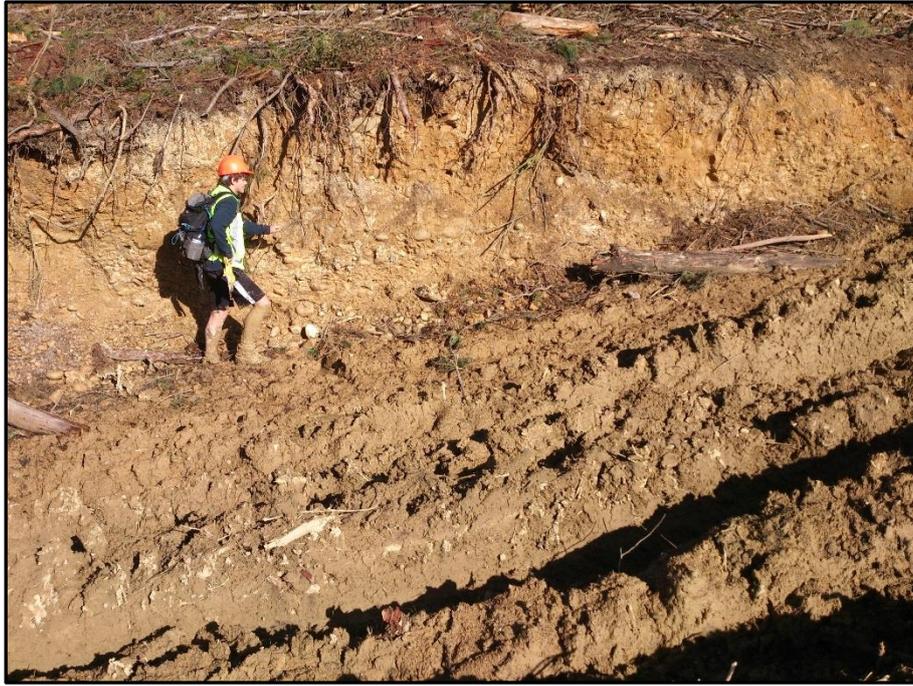
Figure 2. Photo depicting a badly rutted skid trail post-harvest. Photo: Kristopher Brown.

crossing constructed in highly erodible silty loam soils. An additional 10 breakthroughs resulted from naturally-occurring erosion features (i.e., many small land slips, rills and one gully) with no obvious connections to harvesting or road construction activities. At the other problem site, most of the breakthroughs were associated with deep rutting from skid trails and machine traffic near the stream with no provisioning of surface cover during site closure (Figure 2).

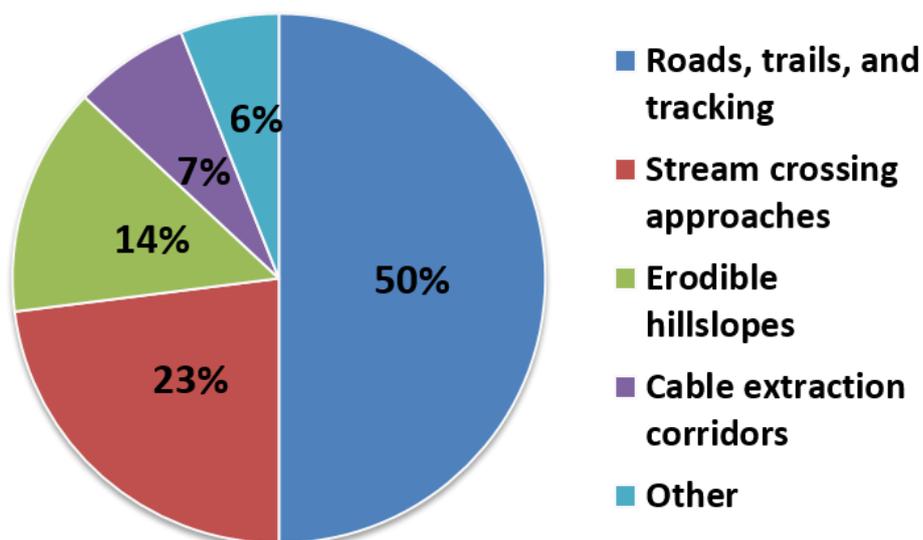
Figure 3. Breakthrough sources and their relative frequency. N = 53 for 'Roads, trails, and tracking', 24 for 'Stream crossing approaches', 15 for 'Erodible hillslopes', 7 for 'Cable extraction corridors', and 6 for 'Other'.

Most breakthroughs (50%) were caused by concentrated runoff from roads, skid trails, or machine traffic disturbance on the hillslope (Figure 3). An additional 23% of breakthroughs occurred where roads and skid trails crossed streams. Thus, 73% of breakthroughs were associated with roads, trails, and machine tracks on the hillslope. These findings reinforce the importance of pre-harvest planning efforts to minimise earthworks, locate roads and stream crossings to avoid steep gradients, and maintain a buffer (e.g., an SMZ or slash barrier) between disturbed soil and streams. Such practices should reduce the occurrence of road-related sediment breakthroughs and reduce the severity of impacts to water quality. Furthermore, road-stream crossings represent easy targets that can be identified during the planning stage and BMPs can be prescribed for water and erosion control.

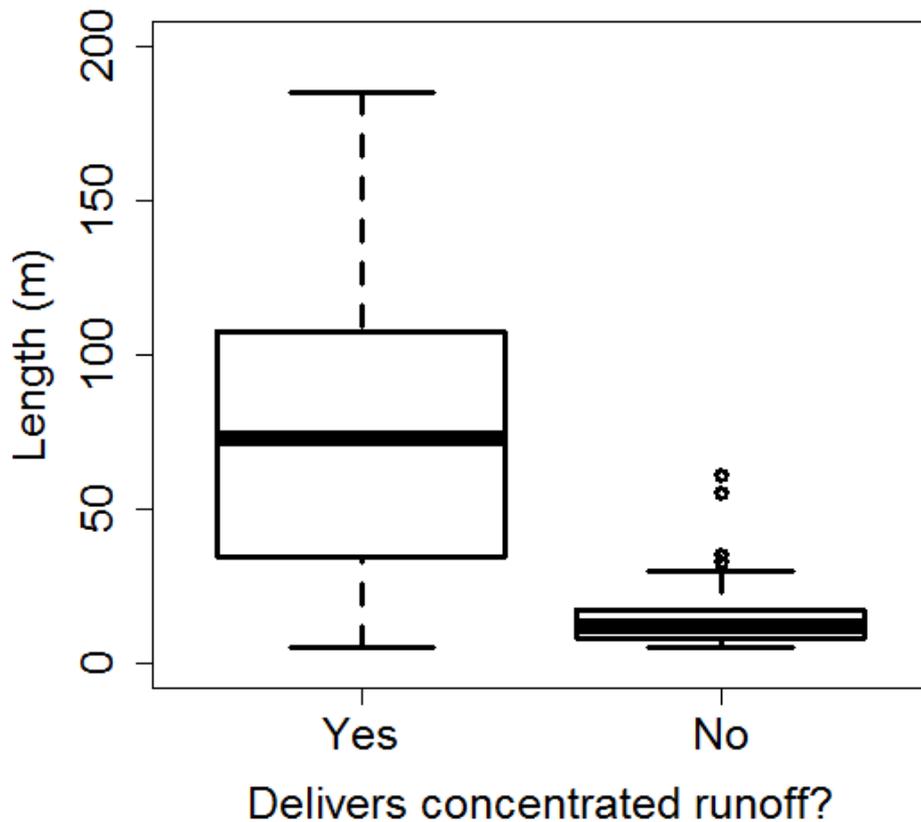
Figure 4. Box and whisker plots (showing the 5<sup>th</sup>, 25<sup>th</sup>, 50<sup>th</sup>, 75<sup>th</sup>, and 95<sup>th</sup> percentiles) of stream crossing approach length (m) in relation to whether or not the approach delivered concentrated surface runoff to the stream (n = 27 for 'Yes' and n = 29 for 'No'). Approach length was defined as the distance from the stream to the nearest road drainage structure (e.g. water bar, turnout, or culvert cross-drain) or topographic feature that moved surface runoff away from the road.

The distance from the stream to the nearest water control structure was important for understanding road-to-stream hydrologic connectivity. Median drainage length for road-stream crossings that led to breakthroughs was 73 m, ranging from 5 to 185 m (Figure 4). Conversely, median drainage length for road-stream crossings that did not lead to breakthroughs was 12 m, ranging from 5 to 61 m. These findings suggest that while it may be difficult to eliminate connectivity from log truck roads at stream crossings (due to their inherently compact design), the severity of water quality impacts can be managed by adding water control structures to reduce the drainage length. Sessions (2007) recommended reducing the drainage length at road-stream crossings to approximately 20 m. Of the 21 truck road approaches to stream crossings measured in this study, only 4 had a drainage structure within 20 m of the stream. For skid trail crossings, connectivity could be reduced by using overland (not bladed) skid trails where slope steepness allows, as well as installing cut-outs for water control and using slash or mulch for surface cover during road closure.

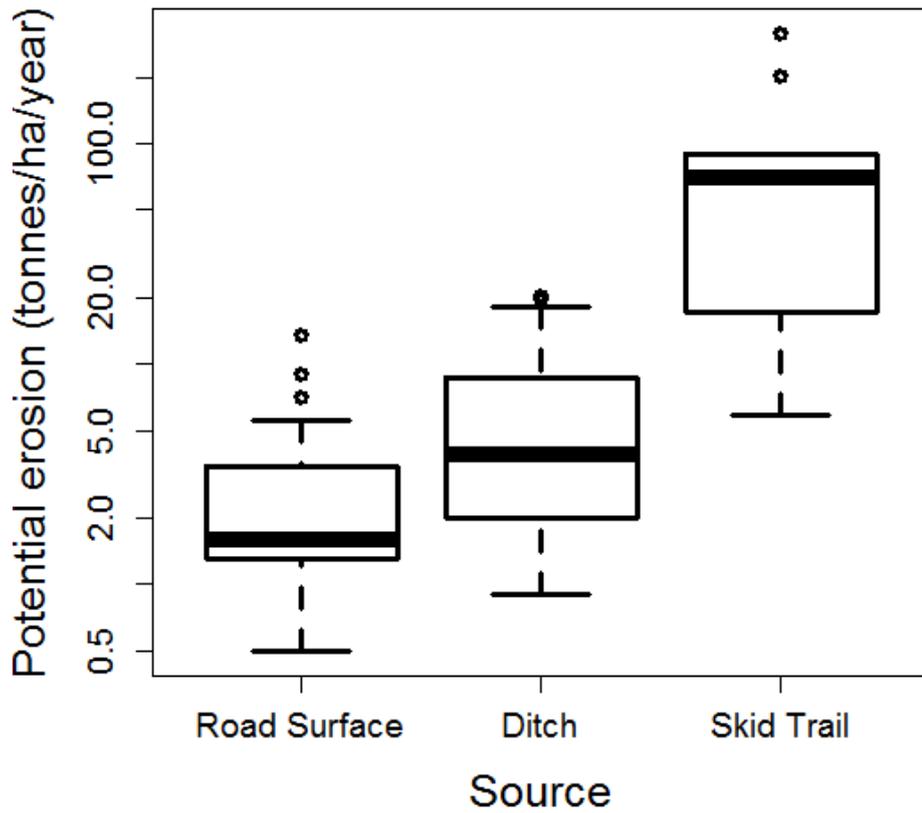
Figure 5. Box and whisker plots (showing the 5<sup>th</sup>, 25<sup>th</sup>, 50<sup>th</sup>, 75<sup>th</sup>, and 95<sup>th</sup> percentiles) of potential erosion rates of log truck and skid trail stream-crossing approaches (n = 17, 14, and 10, respectively, for truck road surfaces, truck road ditches, and skid trails). Each of these approaches contributed to a breakthrough.

Erosion estimates ranged from 0.5 to 13.4 tonnes/ha/yr for truck road surfaces, 0.9 to 20.1 tonnes/ha/yr for truck road ditches, and 5.9 to 314.8 tonnes/ha/yr for skid trail surfaces (Table 2). The median potential erosion rate for skid trails was 44 times greater than truck road surfaces and 18 times greater than truck road ditches (Figure 5) because skid trails that led to breakthroughs were steep (median = 16.5% slope) with 0 to 30% surface cover. This finding highlights the importance of closing skid trails properly, especially at stream crossings. Several studies have demonstrated the sediment-reduction efficacy of skid trail closure techniques, such as water bar installation, plus slash or mulch application (Sawyers, Bolding, Aust, and Lakel 2012, Wade, Bolding, Aust, and Lakel 2012, Vinson 2016).

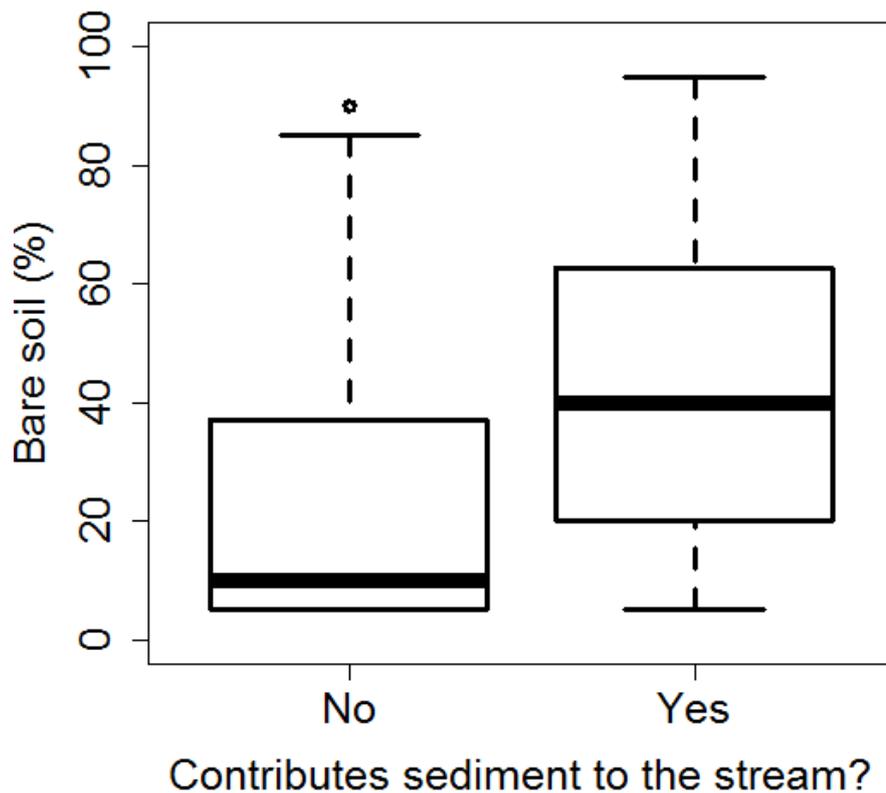
Figure 6. Box and whisker plots (showing the 5<sup>th</sup>, 25<sup>th</sup>, 50<sup>th</sup>, 75<sup>th</sup>, and 95<sup>th</sup> percentiles) of bare soil percentage for upslope contributing areas that did ( $n = 77$ ) and did not ( $n = 267$ ) lead to a breakthrough.

Excluding stream crossing approaches, breakthrough likelihood of occurrence increased with increasing bare soil percentage ( $Z=5.2$ ,  $p<0.001$ ) (Figure 6). Hillslopes with no roads, skid trails, or machine traffic disturbance ( $Z=-2.4$ ,  $p=0.02$ ) or only machine traffic disturbance ( $Z=-2.8$ ,  $p=0.004$ ) decreased the likelihood of a breakthrough. Median bare soil percentage for upslope areas contributing to breakthroughs (40%) was 4 times higher than that of those that did not (10% bare soil).
