## Practical Application of Joule Heating to the Sterilization of *Pinus radiata* Logs

A research and development study carried out by the EPECentre for the Stakeholders in Methyl Bromide Reduction (STIMBR) Primary Growth Partnership (PGP) in 2012, under project section 1.5.2.

WJB Heffernan, Electric Power Engineering Centre, University of Canterbury, February 2013

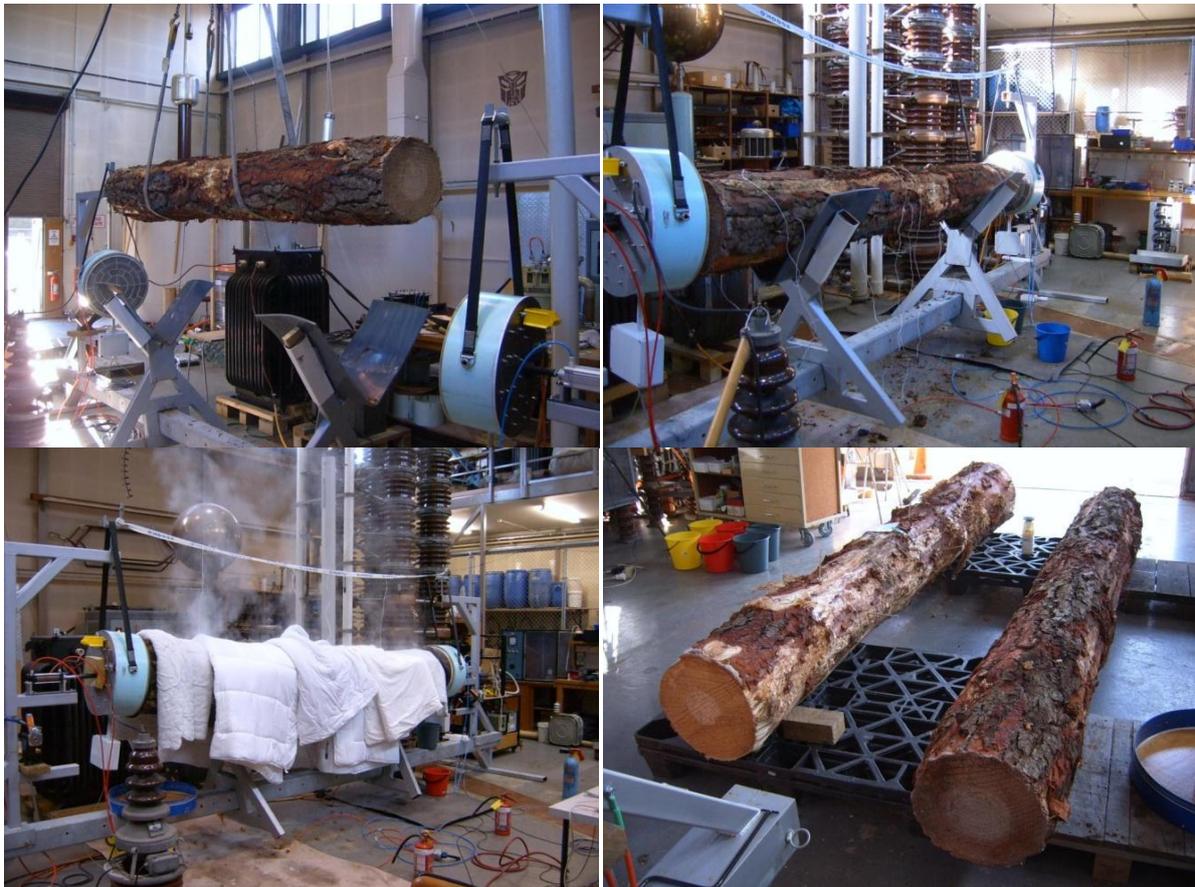
Joule heating process (clockwise from top left): Log being lowered into place; Thermocouples inserted into log; Power applied to log (note covers to reduce heat & moisture loss to ambient); Pair of logs after sterilization (note lack of apparent damage to end of logs).

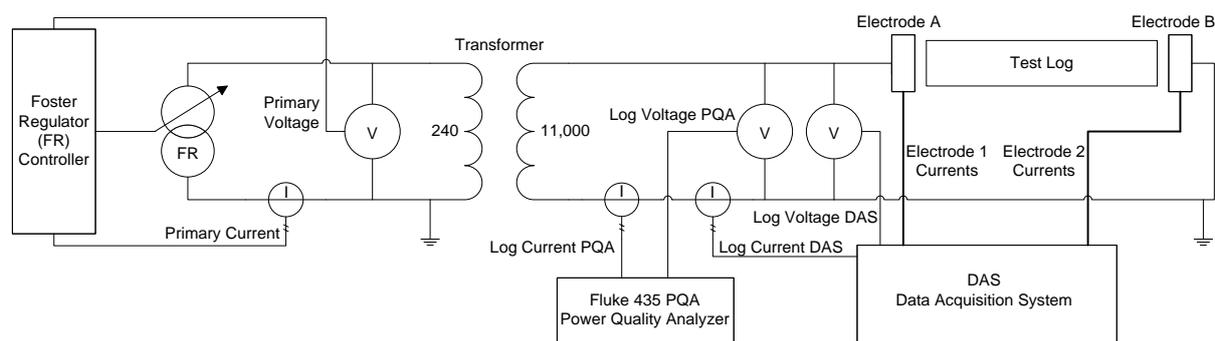
**Simplified system schematic diagram, showing Foster Regulator, Transformer, Electrodes and related instrumentation.**

The diagram below shows the simplified schematic diagram for the full system.

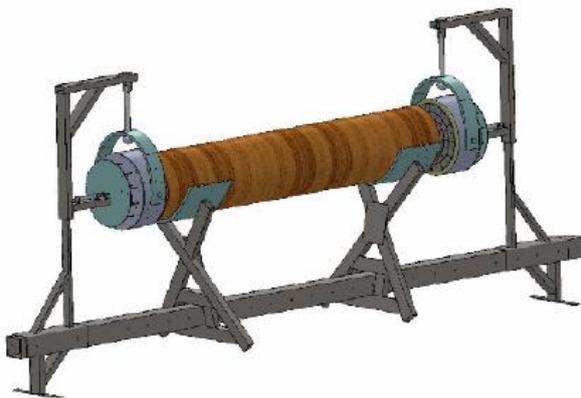
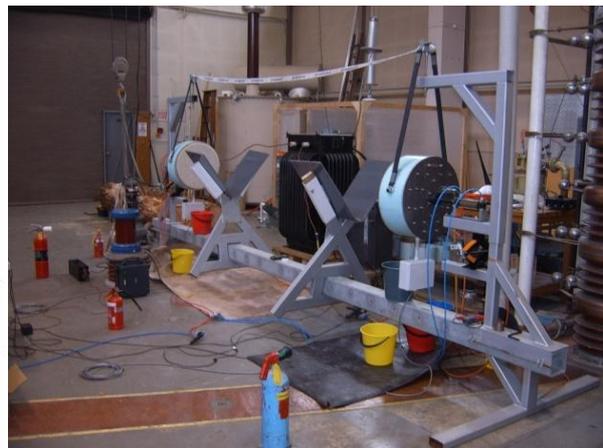
**Adjustable Test Fixture (left to right): Conceptualization; Realization - note PVC insulators, coarse length adjustment, electrode height adjustment and pneumatic rams.**

Due to space constraints in the HV laboratory this was designed to hold logs up to about 3.5m in length, rather than 6m. It could be extended later if necessary. The fixture includes a mounting arrangement for the electrode assemblies and a compressed air driven system for applying the electrodes to the log ends with controlled, adjustable pressure. This fixture was designed by Luke Tough, a 3<sup>rd</sup> professional year student, working under the direction of David Healy (the Department of Electrical Engineering workshop manager) and the author. The fixture is constructed from galvanized steel, with PVC insulated log supports, capable of withstanding 33kV. It incorporates coarse log length adjustment (electrode “gibbets” are movable), height adjustment for electrodes (depending on log diameter) and pneumatic rams to apply the electrodes to the log ends with controllable pressure.

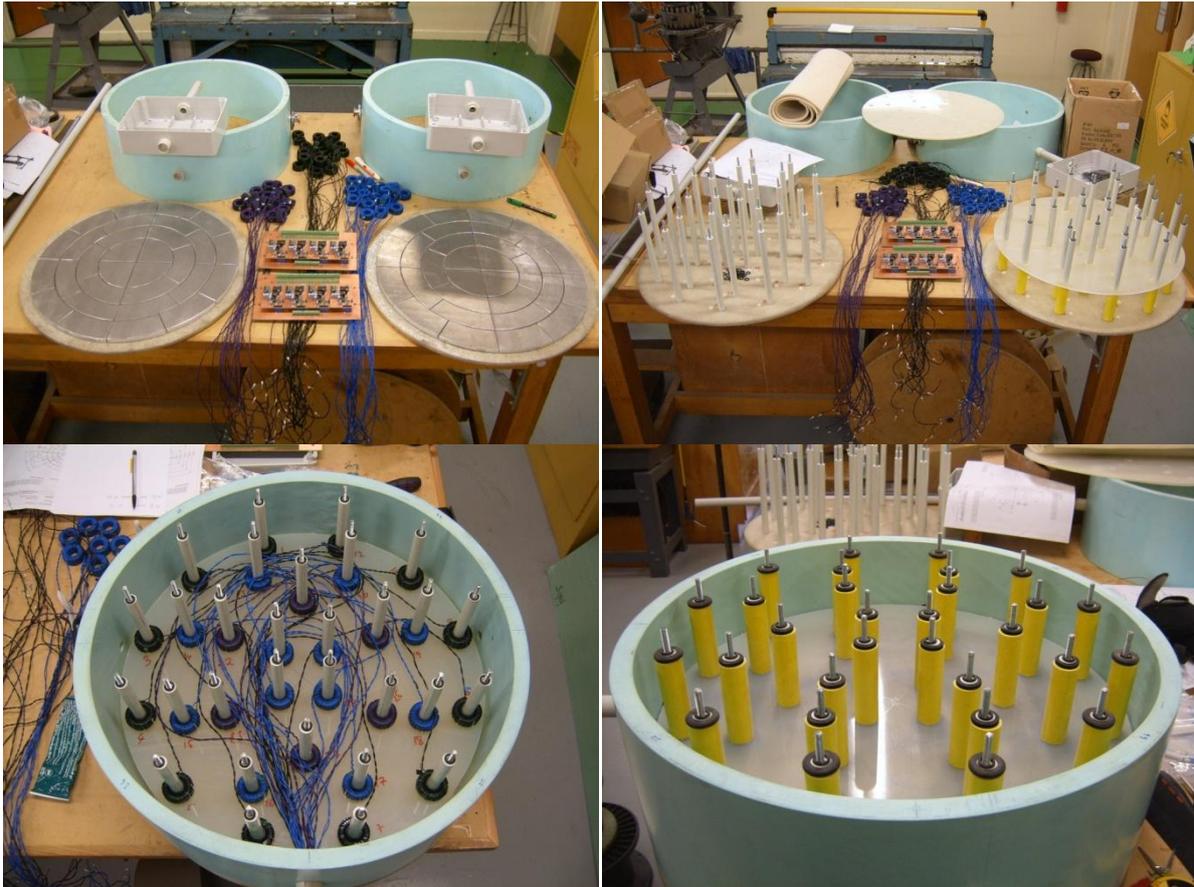
**Electrode assembly (clockwise from top left): Components (note segmented electrodes); Part assembled (note GRP insulators and insulating trays); CTs inserted; insulating spacers fitted, prior to back contact plate attachment.**

The assemblies incorporate 30 contact segments and current transformers (CTs) to allow individual segment current monitoring. This helps to provide evidence of a good log contact and some data regarding current distribution at each end of the log. A considerable design and test effort (including a 3<sup>rd</sup> professional year student project by Luke Tough, further input from David Healy and input from Jac Woudberg and Professor Pat Bodger) went into the design of the electrodes and CTs, resulting in a design capable of withstanding in excess of 33kV AC rms, in a laboratory environment. (In a real industrial application a test voltage of around 1.5 to 2 times the rated voltage would be required, but the current electrodes should be reliable with a 33kV centre ground system). Each electrode has 30 equal area segments arranged to monitor current in different sections of the log end and is designed for log diameters up to 500mm.

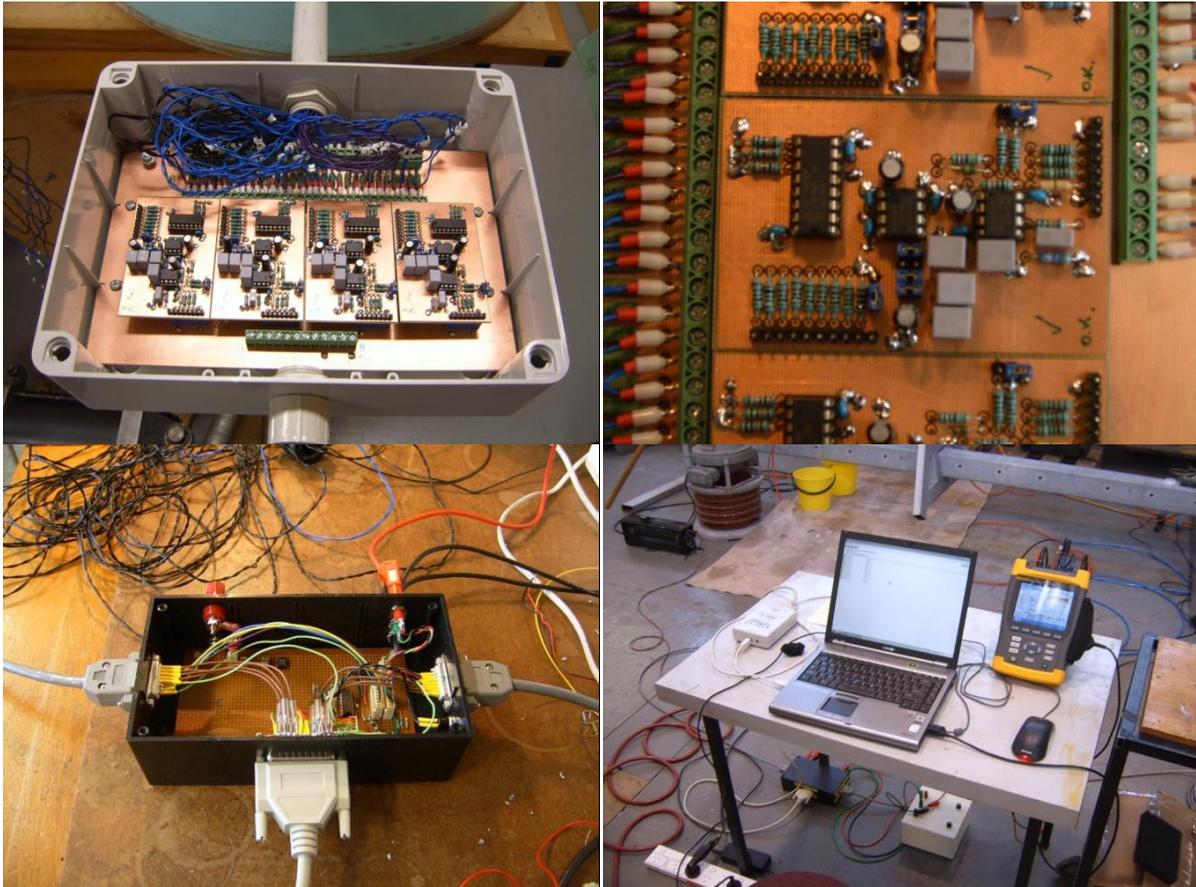
**Data Acquisition System (clockwise from top left): CT Amplifiers/Multiplexers in electrode extension housing; single Amplifier/Multiplexer board; Multiplexer Address Generator/Concentrator; Data Acquisition System in situ (ADC to left of laptop)**

This had to handle inputs from 60 CTs and log the real-time data to a host computer during the tests. The resulting data could then be synchronized with the overall power and energy readings. Each electrode has four amplifier/multiplexer boards, hosted by a mother board. Each amp/mux board takes up to 8 CT inputs and passes a true rms dc representation of the measured current to the address generator/concentrator which passes this and the address data to the analogue to digital converter (ADC). The Full Scale Range (FSR) of the ADC is 2.5V. The CT amplifiers have two gain settings: 1V/A (i.e. FSR is 2.5A) or 0.5V/A (i.e. FSR is 5A). Digital data from the ADC are logged by software running on a host laptop computer. The address generator/concentrator was also fitted with true rms circuits for both total log current and electrode potential difference. The former accepts an input from a 10mV/A Fluke CT, while the latter is fed by the output of an ABB 33kV:110V Potential Transformer (borrowed from Connetics). The current circuit feeds the ADC with a signal of 100mV/A (i.e. FSR of 2.5V represents 25A AC rms of total log current). The voltage circuit feeds the ADC with a signal of 200mV/kV (i.e. FSR of 2.5V represents 12.5kV AC rms across the electrodes).

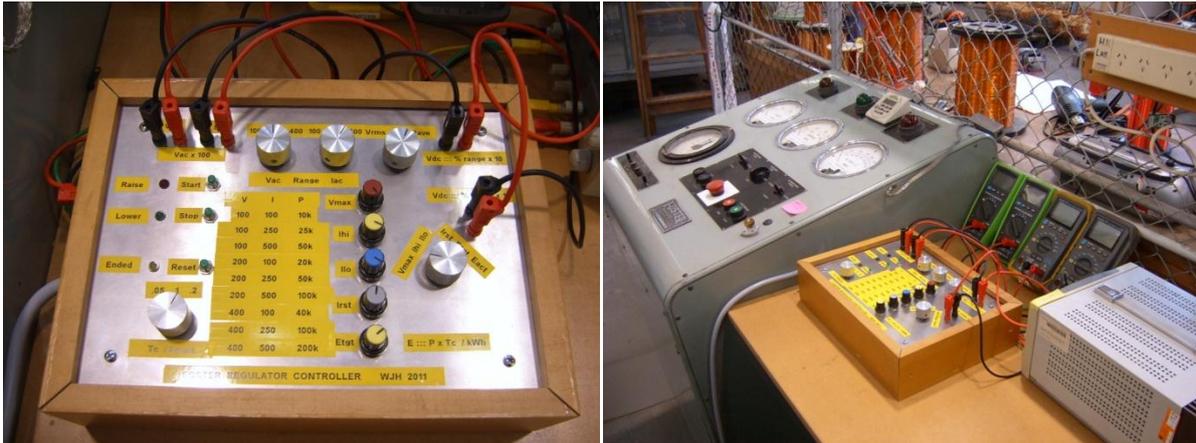
**Foster regulator controller (left to right):** Close-up showing current and voltage range selectors, voltage, current and energy set-point adjusters, integration time selector etc. Controller in situ with FR (to left) and meters for voltage, current, power and energy.

The various ranges of voltage and current allow maximum real powers between 10kW and 200kW to be catered for. The various integration time constant ranges allow total energies between 0.5kWh and 40kWh to be injected in a single application (of course, multiple consecutive applications allow this to be increased indefinitely).

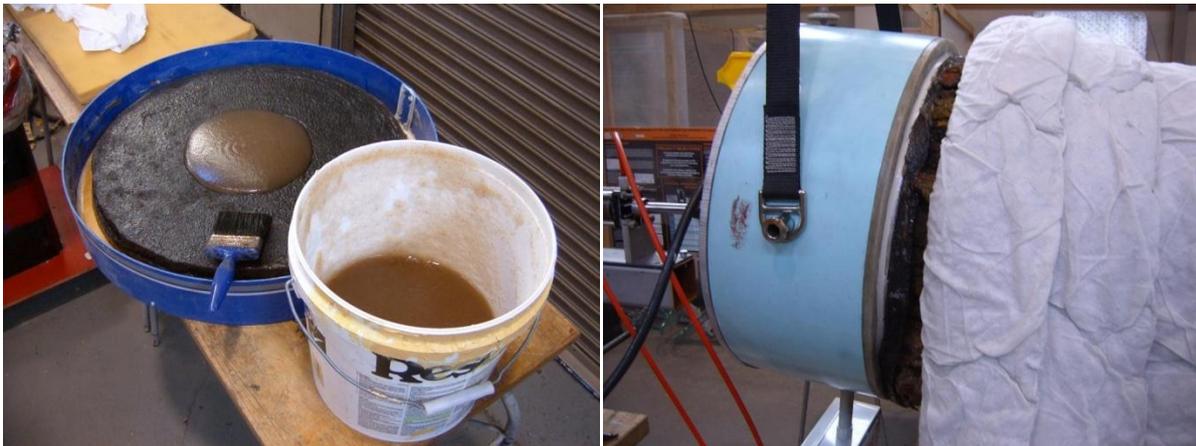
**Conductive Pad system (left to right):** Foam pad in “paddling pool” with “synthetic sap” (not made by Resene!); Pad in situ between electrode and log.

Ideally the foam would be conductive in the longitudinal direction only. This will be tried in future tests by segmenting the foam in the same pattern as the electrodes. At this stage though the impregnated foam is equally conductive in all directions, allowing some cross-conduction between segments.

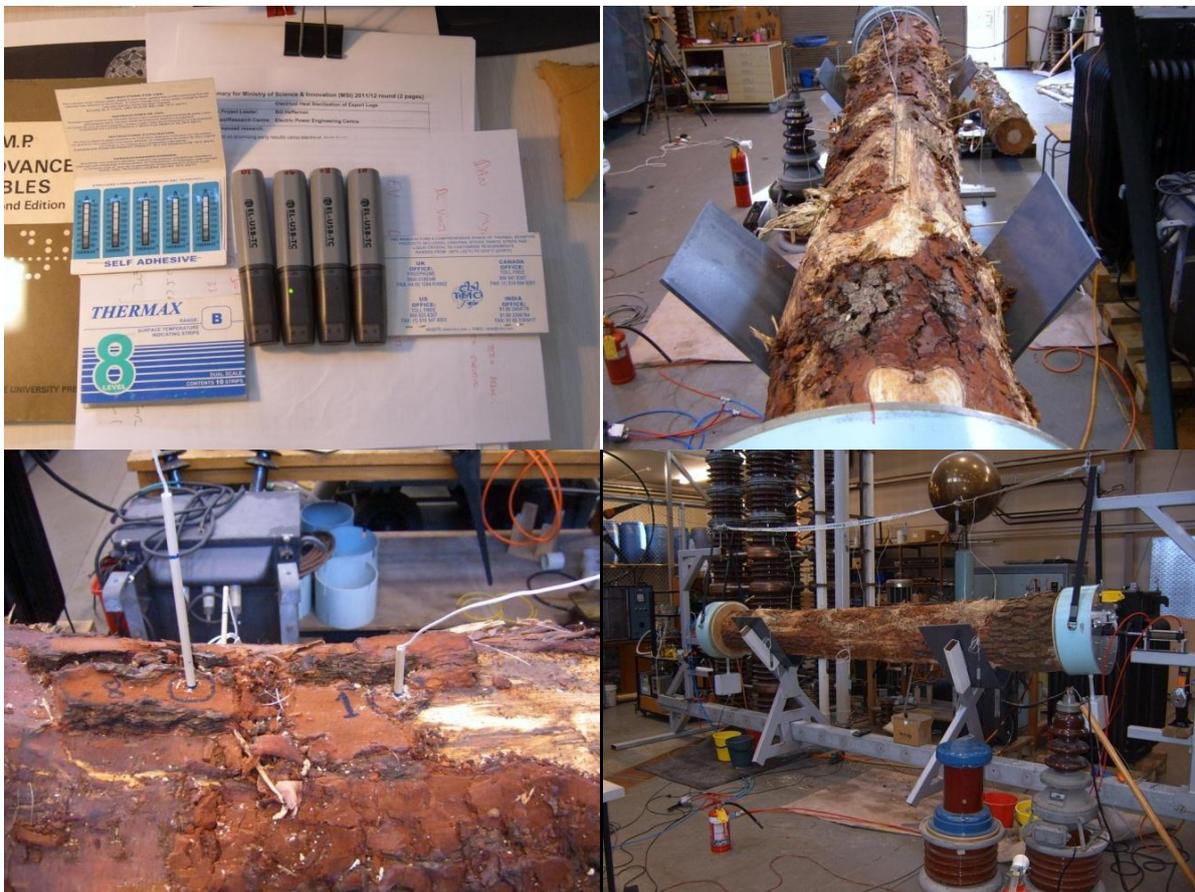
**Thermocouple Instrumentation (clockwise from top left): 4 of the 10 USB loggers; test log showing thermocouple locations (after successful sterilization); close up of two thermocouples at different depths; arrangement used to keep thermocouples and loggers isolated from each other during testing.**

It was desired to be able to record the temperature at various locations within the log, both during application of power and in the equilibration and cool down period afterwards. Ideally a wireless system would have been employed to allow real-time viewable data to be captured (each temperature sensor is at a different, hazardous voltage during power application and must therefore be isolated from everything else). In the absence of a budget for this, 10 low-cost USB thermocouple data loggers were purchased, with Type K thermocouples. These were capable of recording time-stamped temperatures every second, enabling the real-time temperature distribution to be reviewed after the fact, but not live during the test. This was a major limitation of the instrumentation. Each logger is powered by its own battery and the thermocouples were inserted in Alumina thermo-wells to insulate the metallic thermocouple from the wood. 20 of these thermo-wells were supplied as free samples from the UK, but are normally around \$90 each. As it proved impossible to retrieve them from the logs after testing a low cost alternative, based on heat forming our own thermo-wells from high temperature thermoplastic tubing, was devised. At this point such thermo-wells have been made but not yet tested.

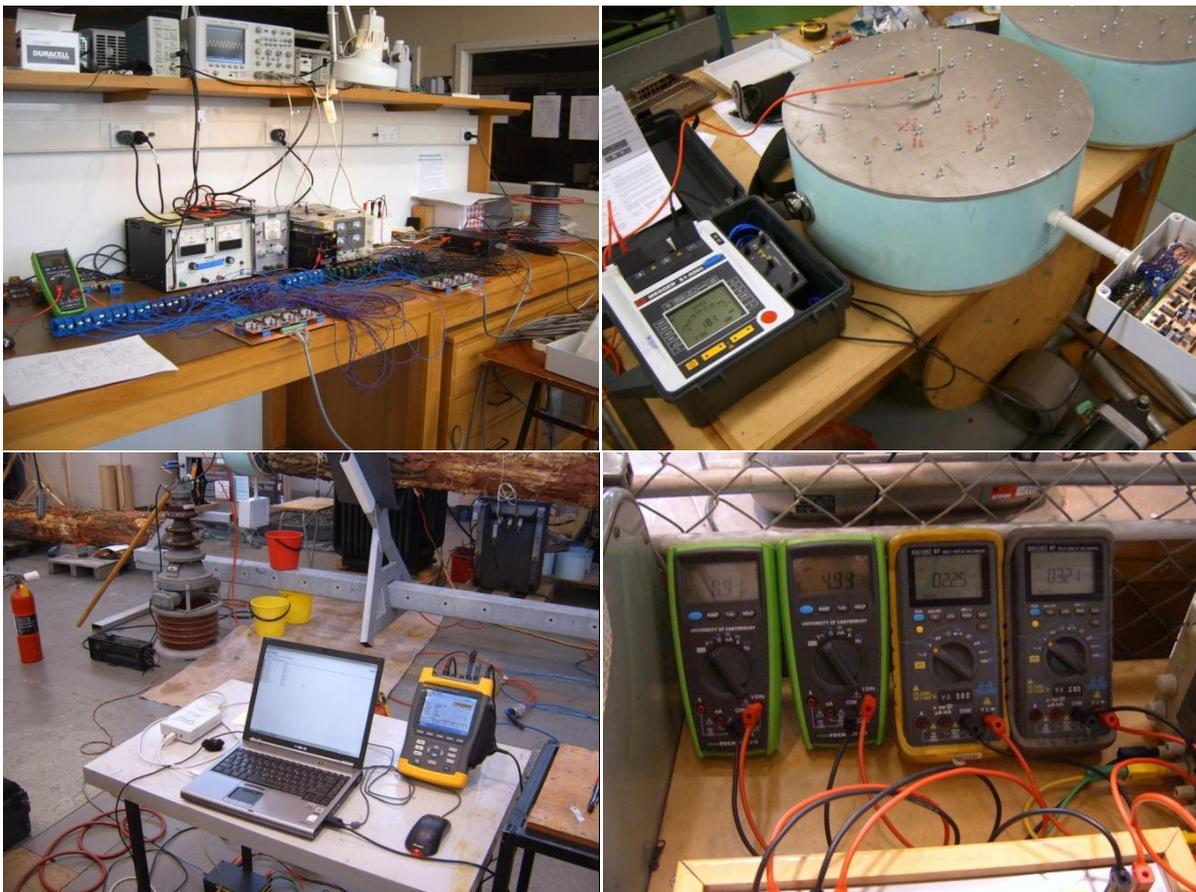
**Test & Calibration of instrumentation (clockwise from top left): Bench calibration of CTs and amplifiers at 1A; Hi-Pot testing of electrode assembly at 5kV; Calibration of Fluke 435 versus DAS; Calibration of FR controller**

The electrodes have been designed to withstand flashover to above 33kV AC rms. Nevertheless it is prudent to test the insulation resistance and leakage current of the whole unit after assembly before putting them into service. Tests at 5kV AC rms showed a leakage current of around 20nA (insulation resistance of about 250G $\Omega$ ).

The readings of the total log current sensor and electrode potential sensor in the DAS were measured against the readings from a Fluke 435 Power Quality Meter with independent sensors (Fluke CT and Tektronix 1000:1 'scope probe). This was carried out for electrode potential differences between 1kV and 11kV and for secondary currents between zero and 11A. All results were within  $\pm 2\%$  of reading. The readings from the meters attached to the FR controller were also calibrated against reference primary voltage and current instruments. However their absolute accuracy is not critical to the results, as the HV side measurements (directly applied to the log) are always used, whereas the LV side current measurements include transformer magnetizing current and are just used to set desired test parameters.

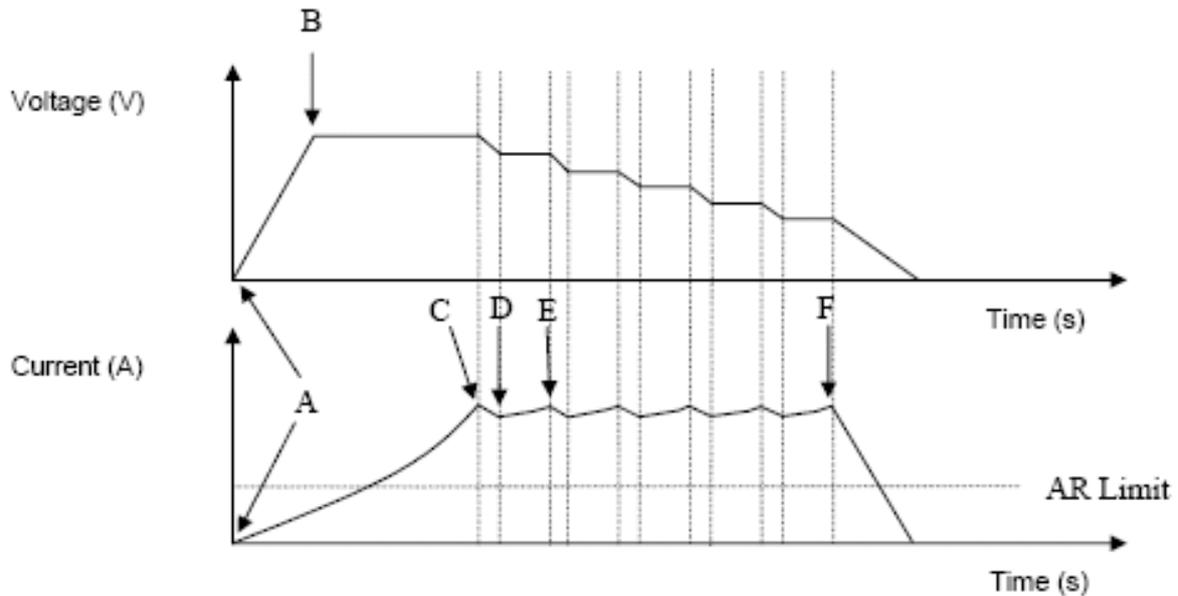
Example Voltage and Current profiles, versus time, for a typical log. Point A: Test begins, with controlled voltage ramp-up; Point B: Voltage reaches maximum setpoint, while current continues to rise; Point C: Current reaches top of dead-band, triggering Voltage ramp-down; Point D: Current reaches bottom of dead-band, halting Voltage ramp-down; Point E: Same as Point C etc.; Point F: Integrated Energy ( $\Sigma V.A.t$ ) reaches preset limit, causing Voltage ramp-down to zero and end of test.

As the log heats up it becomes more conductive and the current increases until it reaches the maximum setpoint. At this point the FR controller automatically reduces the applied voltage until the current reaches the lower setpoint (maximum value minus dead-band). The log continues to heat, current increases again and the cycle repeats, as shown below. All the while the FR controller measures the applied real power and integrates it to keep a tally of the injected energy total. When this reaches the preset value, the FR controller quickly reduces the applied voltage to zero and the test is complete. (Note that the FR controller could be modified to follow a maximum voltage, constant power scheme, rather than the maximum voltage, constant current scheme used, provided the maximum FR current of 500A is not exceeded and the maximum HV winding current of 18A is not exceeded. However in this case, with maximum power of 100kVA, we were up against the 500A FR limit most of the time).

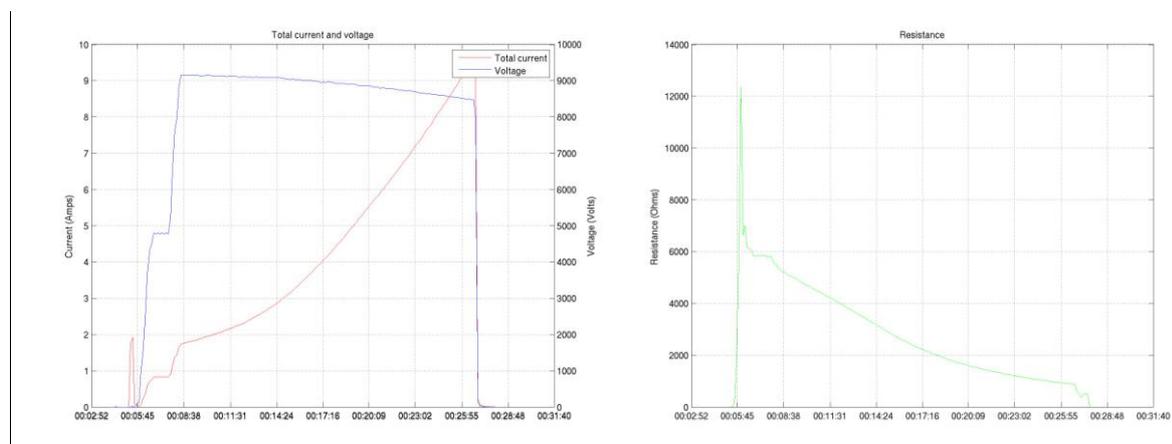
Log Voltage, Total Current and Resistance versus time, plotted from DAS measurements, Log 1 initial test

Initial log voltage was about 9.3kV – a step at about 5kV is seen in the DAS results, due to the operator checking that all was well at the lower voltage before enabling full voltage. Once full voltage was established, initial log current was about 2A, rising to about 10A after about 20 minutes. The power being delivered increased from about 20kW to 90kW over the same period. The log voltage fell to about 8.5kV as the current increased, due to increasing voltage drop across the transformer and cable impedances at higher currents. After 20 minutes about 14kWh had been delivered to the log and the test was terminated, although the current set point had not yet been reached. Had more energy been supplied to the log, current control would have kicked in. The reason for the increase in current and hence power delivered, over time, is that the log's resistance falls as it heats. In this case, once the voltage has reached its full value, the resistance falls from about 6kΩ to about 1kΩ. These measurements from the DAS are shown in the graphs below.

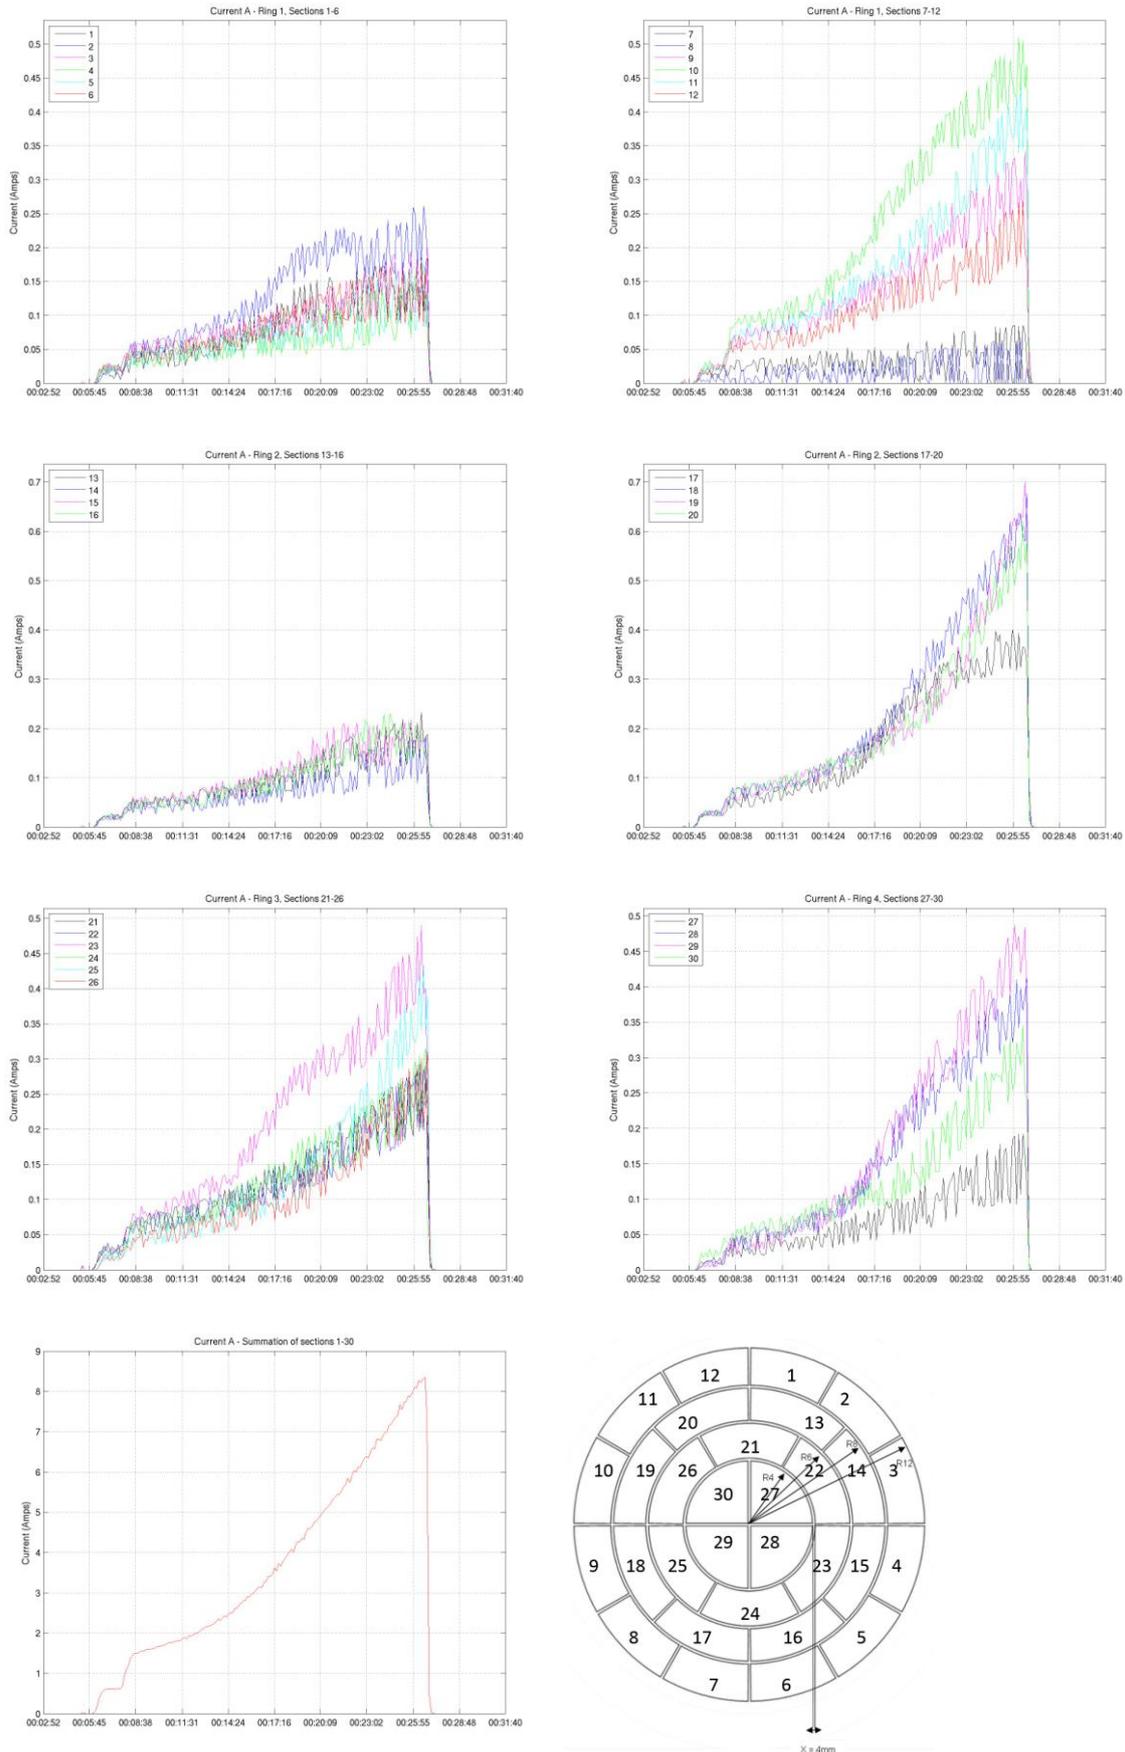
**Individual Segment Currents for Electrode A (HV), with summation & numbering scheme, Log 1 initial test**

The individual currents for each of the 30 segments of Electrode A (HV) and Electrode B (Ground), together with a summation are shown below, along with the segment numbering scheme.

The segments in each electrode are numbered from 1 to 30 and are arranged in concentric rings as shown. The numbering is as viewed from the log (front) side. If the electrodes are pushed together the current flows directly between Electrode A segment 1 and Electrode B segment 12 and so on.

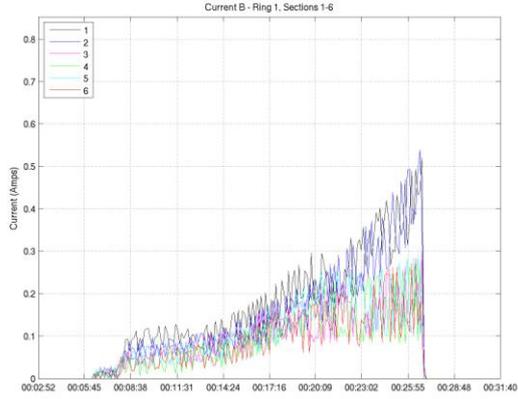
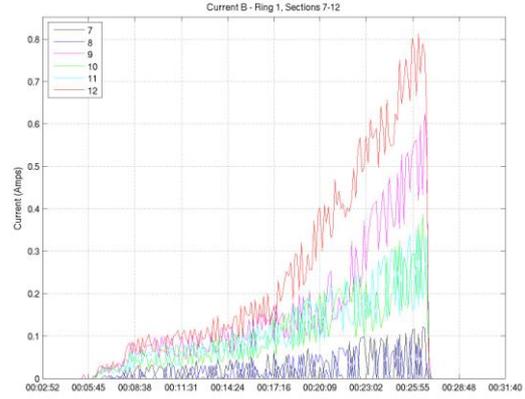
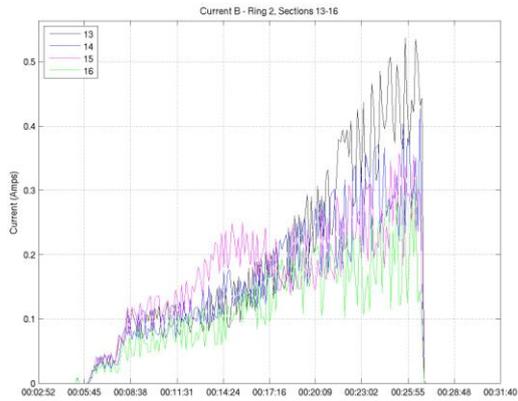
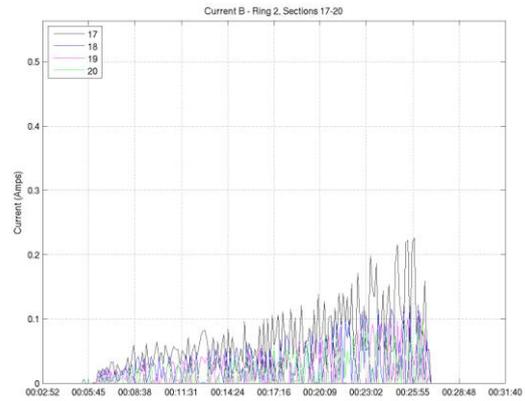
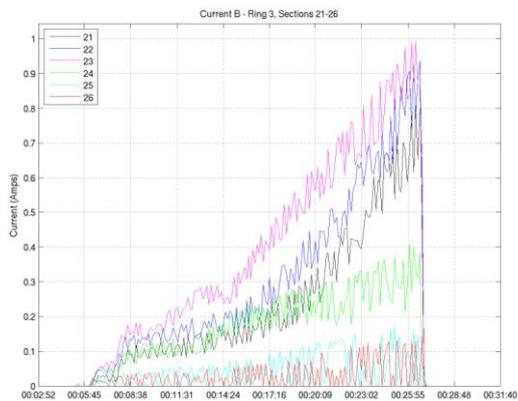
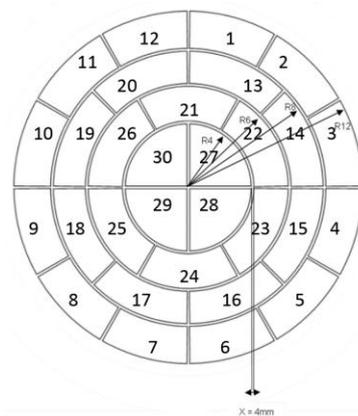
**Individual Segment Currents for Electrode B (Ground), with summation & numbering scheme, Log 1 initial test**

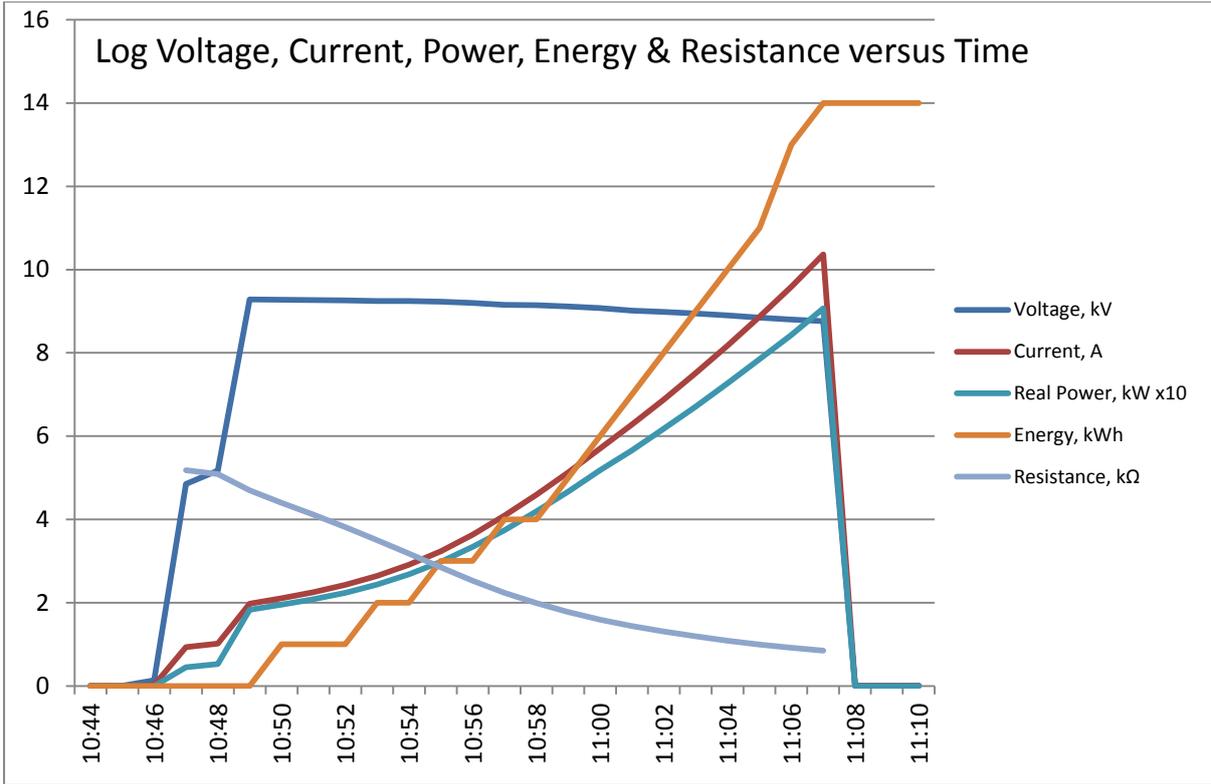
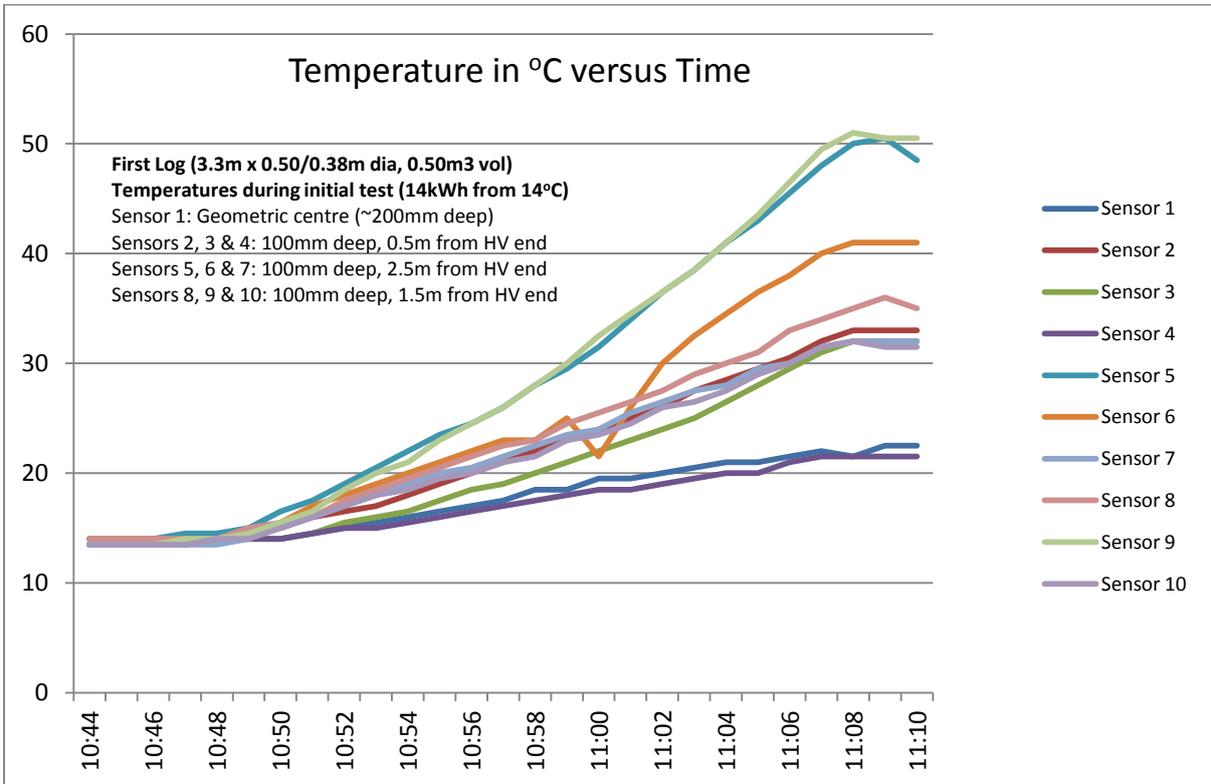
PQA measured Voltage, Current, Power, Energy & calculated Resistance, with corresponding temperature readings, during Log 1 initial test

The temperature logging continued for about 6 hours after the removal of power, the overall temperature results also being shown below.

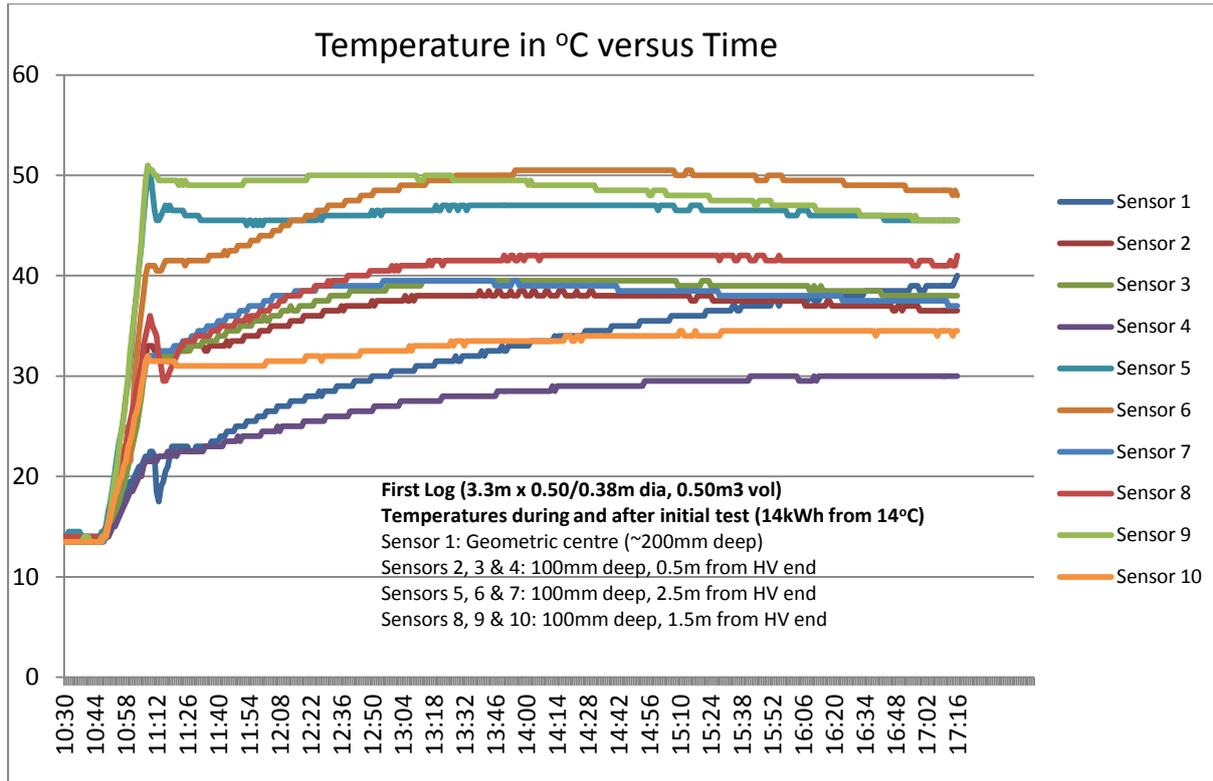
#### Temperature readings during and after Log 1 initial test

Clearly the temperature rise of approaching 50°C expected with the injected energy of 14kWh has not been achieved – average temperature rise is more like 25°C, with the centre only experiencing a 16°C rise. However the calculated energy does not take into account the large convection and radiation losses and the moisture losses occurring from the log, into the cold ambient air, during the 20 minutes of the test and the 5 hour equilibration period. In the previous, fence-post sized tests, the power to volume ratio was at least an order of magnitude higher, such that heating occurred in about 1 minute, resulting in far lower losses. This is a feature of being restricted in power level (about 100kW, rather than the 1MW calculated in the earlier MAFBNZ report [2]) by the available equipment. In subsequent tests an attempt to alleviate the problem was made by covering the logs with duvets, but this was only partially successful. Earlier, using a length of suitably sized plastic sewer pipe cut in half longitudinally as a thermal casing had been considered, but was not implemented due to cost considerations<sup>1</sup>. Nevertheless, despite these limitations, the general trend of temperature rise is encouraging.

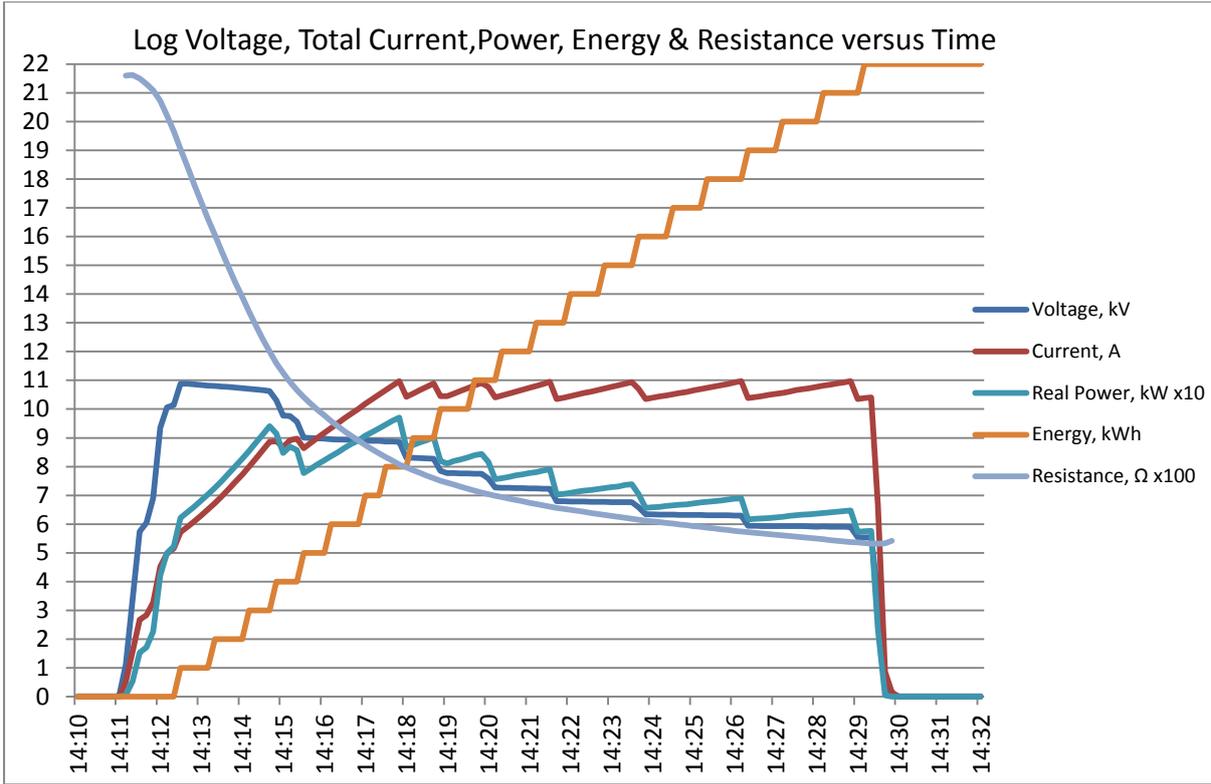
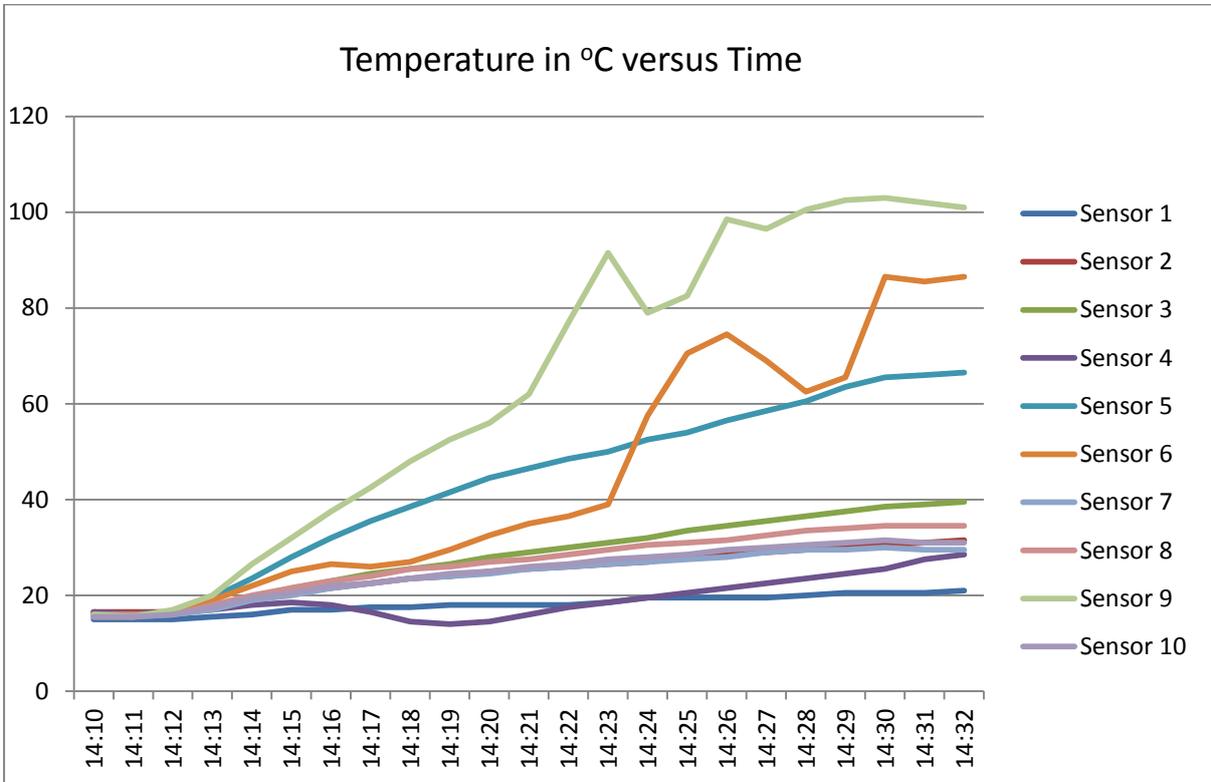
**PQA measured Voltage, Current, Power, Energy & calculated Resistance, with corresponding temperature readings, during first energy injection stage of Log 1 sterilization test**

The results from the PQA, shown below, clearly demonstrate the action of the current dead-band control and its effect on the log voltage and power. As discussed above, the initial limiting factor is the maximum transformer secondary voltage of 11kV (corresponding to 240V on the primary), followed by the maximum FR current rating of 500A (corresponding to 10.9A on the secondary). Although the log power does not quite reach the 100kW power limit, the equipment is nevertheless being used at its voltage and then current limits, demonstrating its limitations.

Over a period of about 19 minutes 22kWh of energy is injected into the log, which this time is wrapped in duvets to attempt to reduce heat and moisture loss. The 22kWh figure was an estimate based on the temperature rise results of the initial 14kWh test and the anticipated effect of the duvet lagging. Over the duration of the test, log resistance falls from just over 2k $\Omega$  to just over 500 $\Omega$ . It is interesting to note that this is lower than in the initial test, even though the log is only about 2 $^{\circ}$ C hotter at the start this time (16 $^{\circ}$ C versus 14 $^{\circ}$ C)<sup>1</sup>.

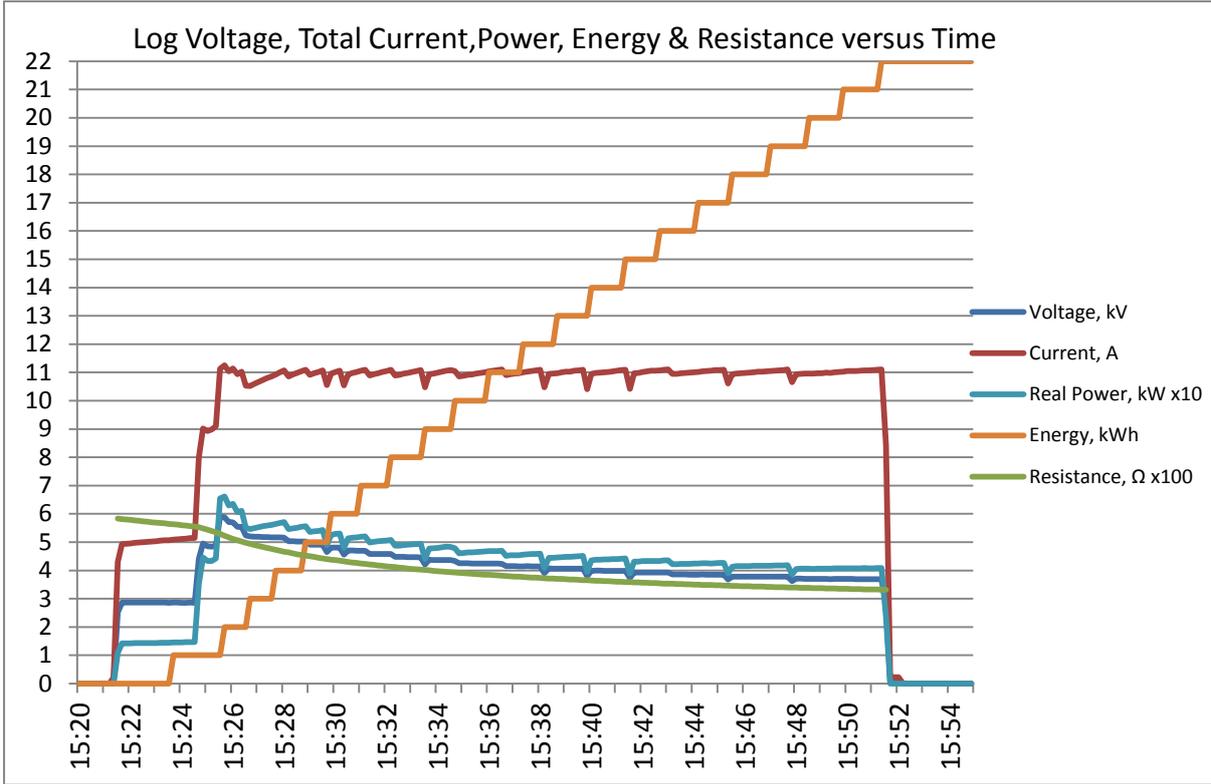
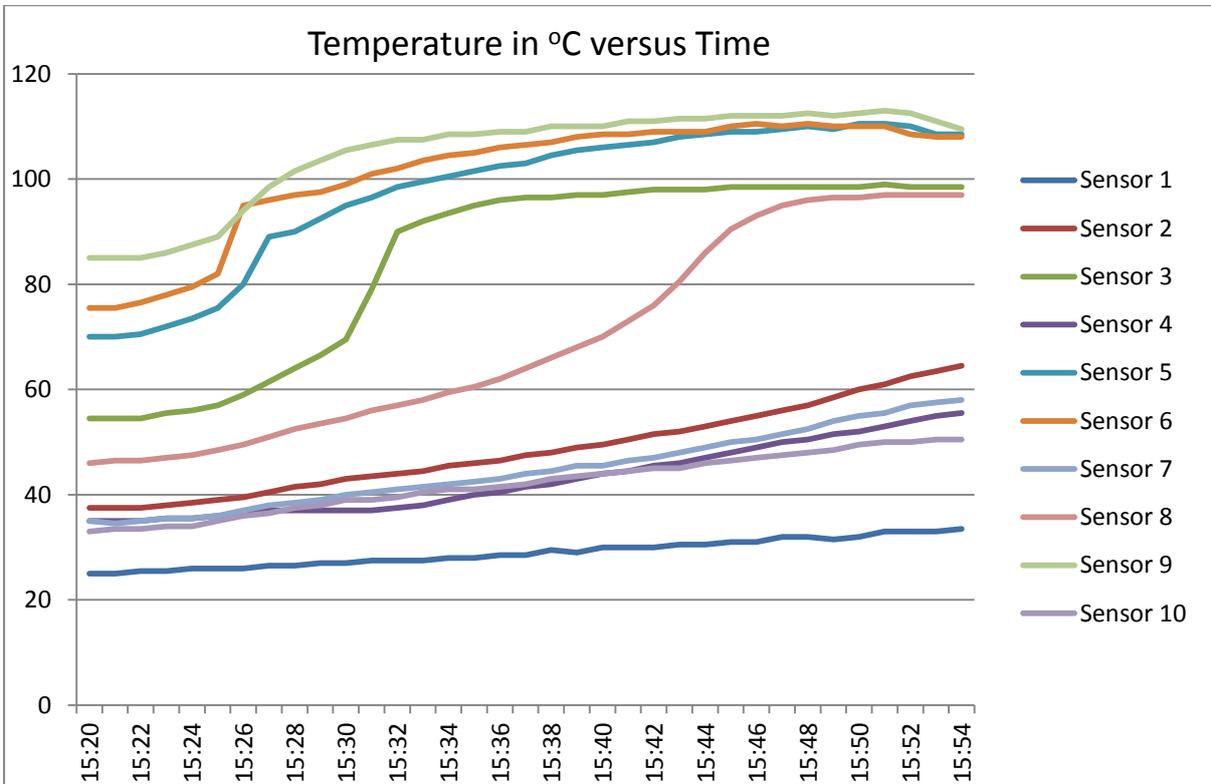
**PQA measured Voltage, Current, Power, Energy & calculated Resistance, with corresponding temperature readings, during second energy injection stage of Log 1 sterilization test**
