## Practical Application of Joule Heating to the Sterilization of *Pinus radiata* Logs

A research and development study carried out by the EPECentre for the Stakeholders in Methyl Bromide Reduction (STIMBR) Primary Growth Partnership (PGP) in 2012, under project section 1.5.2.

WJB Heffernan, Electric Power Engineering Centre, University of Canterbury, February 2013

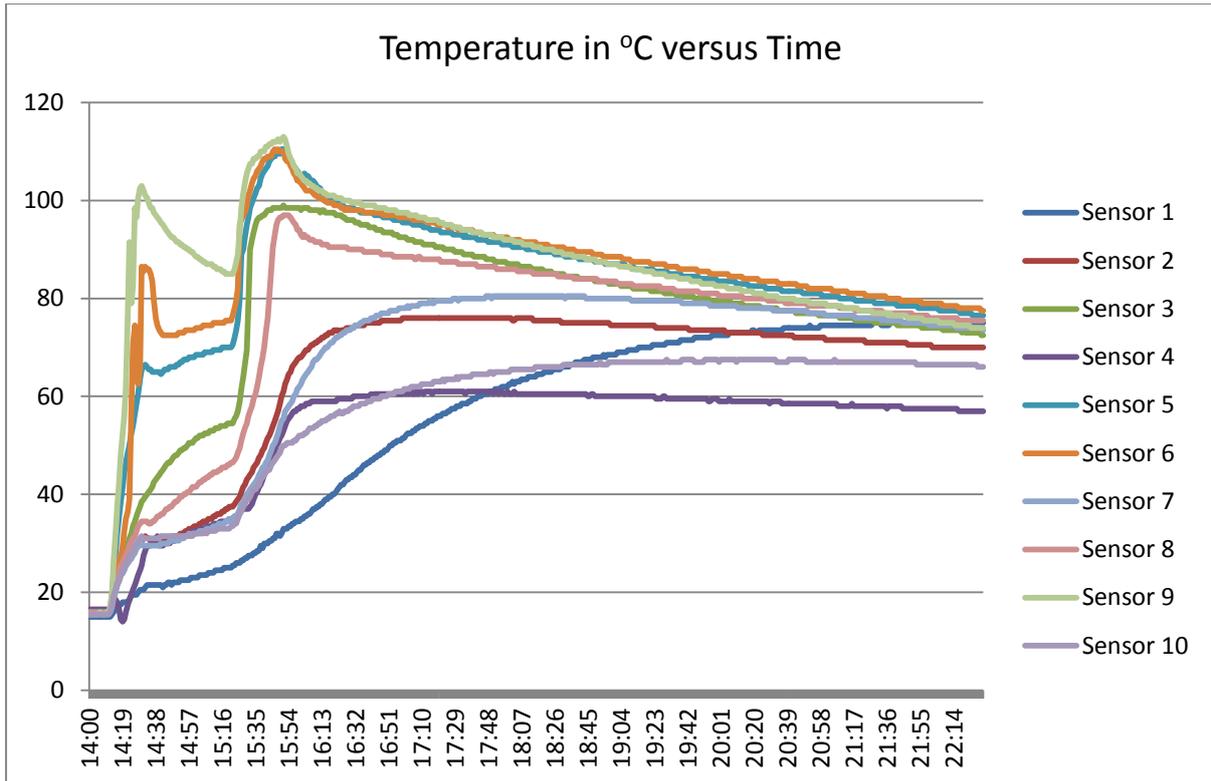
#### Temperature readings during and after Log 1 sterilization test

The second heating stage causes the hottest 5 sensor locations to reach excessive temperatures (especially 9, 6 & 5 again) with all but the very centre of the log being within reach of meeting ISPM-15 conditions by the end of the application of power. The temperatures recorded as above 100°C are regarded with concern, as such a condition would require either localized superheating or a pressure increase to around 1.5 atmospheres. Further investigation is needed.

It is clear that the sterilization has been somewhat overdone! However, at the time, it was hard to tell, due largely to the unavailability of real-time temperature data. Furthermore, the amount of loss to ambient in the form of radiation, convection and evaporation during the long test periods was not properly accounted for. It would have been good to be able to weigh the log before and after each stage of the testing to determine moisture loss and hence latent heat of vaporization lost. In the future this would be possible by fitting the HV lab ceiling crane with a load cell. It might also be possible to fit load cells into the test rig, providing real-time moisture loss data. And, of course, as stated earlier, some form of insulating enclosure, superior to a few duvets, should be investigated.

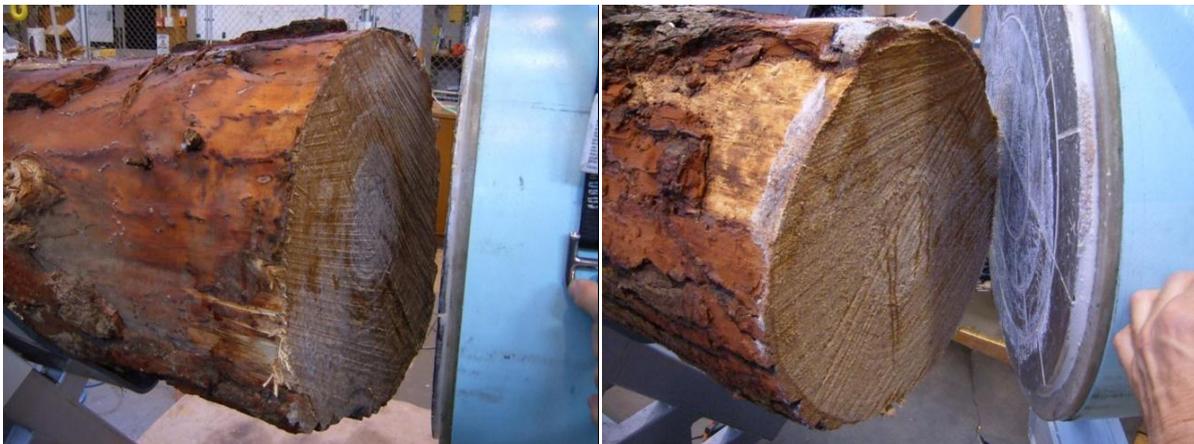
**Log 1 ends after sterilization (left to right): Large (HV) end; small (Ground) end**

This test, therefore, shows that Joule heat sterilization undoubtedly can work. After the test the log appeared to the naked eye to be unchanged and the ends appeared exactly as before, which was the criterion specified in the initial project scope. Photographs of the large (HV) and small (Ground) ends are shown below. (Photographs of both logs after all testing are shown on the summary page at the front of this report and of the whole of Log 1 after sterilization, under “Equipment purchased”).

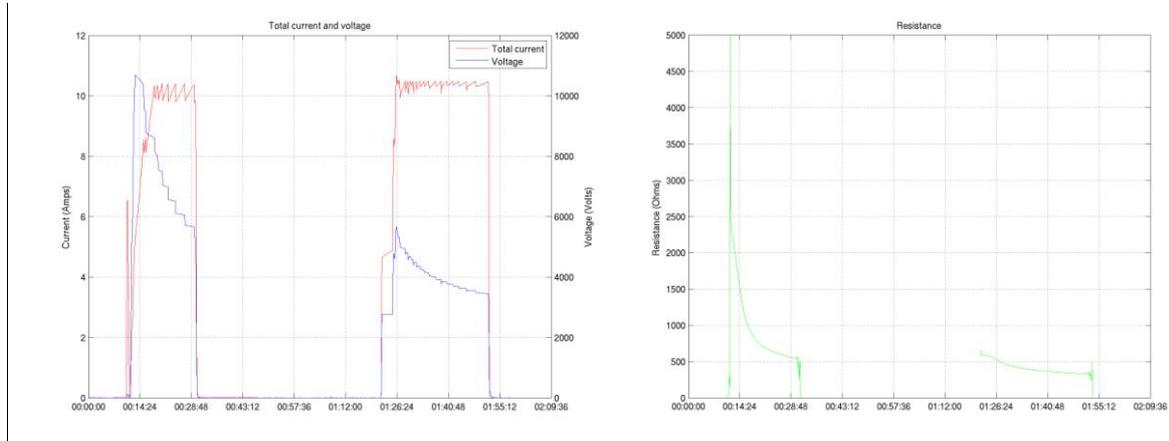
**Log Voltage, Total Current and Resistance versus time, plotted from DAS measurements**

The DAS results for both stages of the test are plotted on a common time axis, and show good agreement with the PQA data<sup>1</sup>.

<sup>1</sup> The current spike seen on the left of the DAS data is due to initially forgetting to remove the earth wand from the HV electrode, leading to high current with virtually zero voltage - this forms no part of the test and has been edited out of the PQA results presented earlier. Additionally the extrapolation of resistance value when the excitation voltage is near zero leads to false results – this has also been edited out of the PQA results.

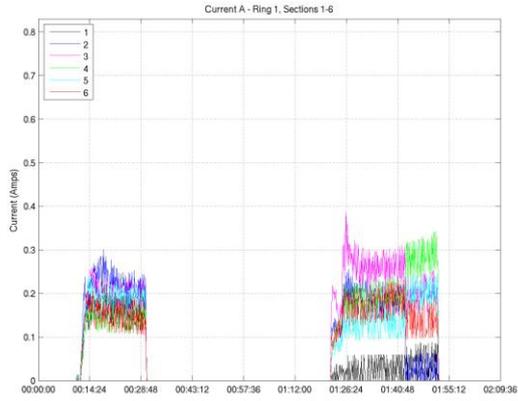
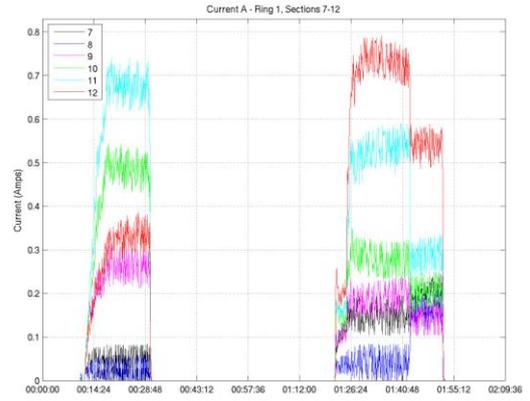
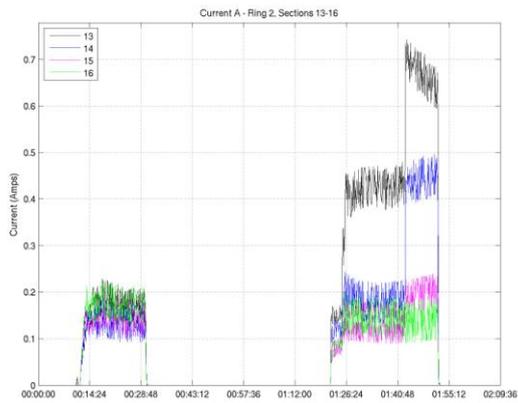
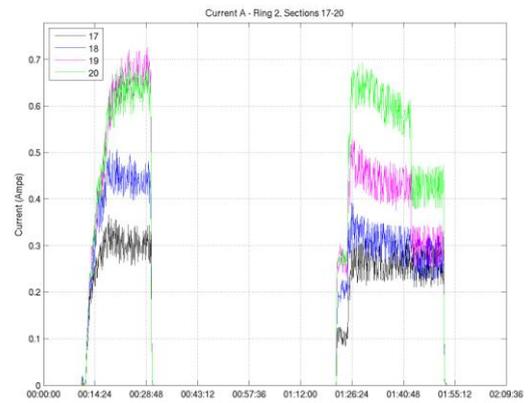
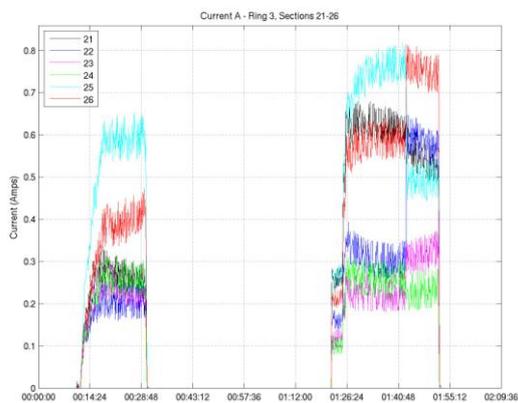
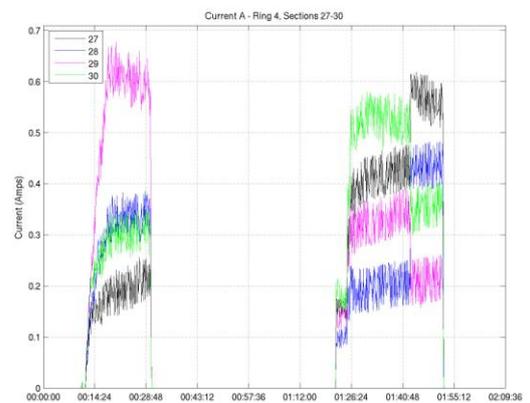
**Individual Segment Currents for Electrode A (HV), with summation & numbering scheme, Log 1 sterilization test**

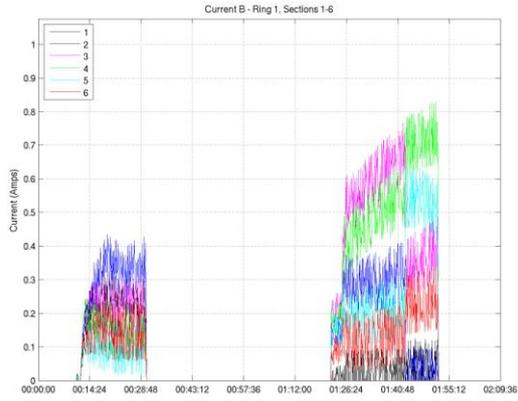
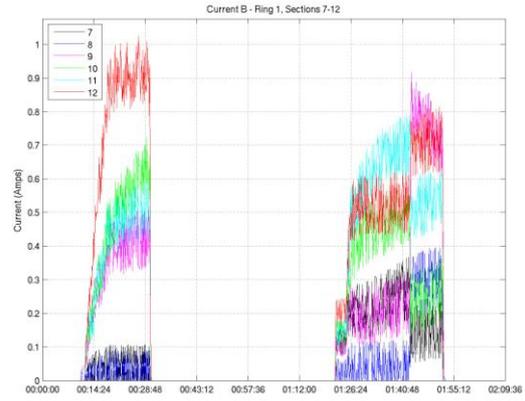
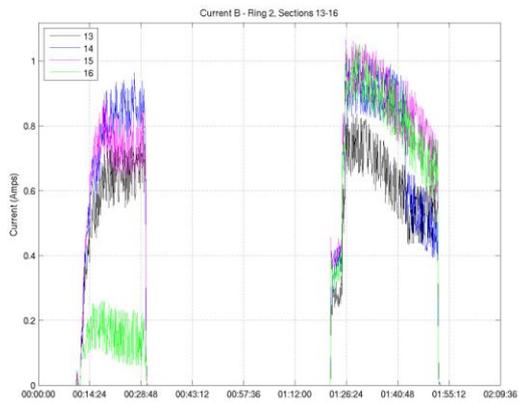
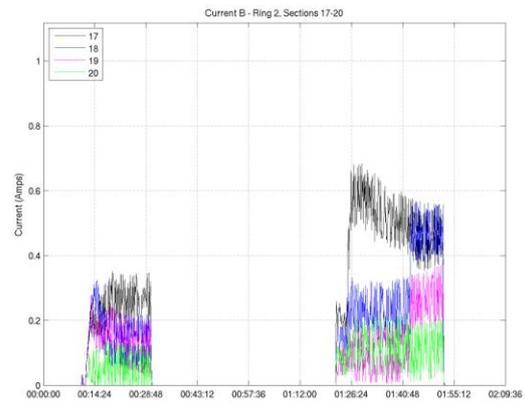
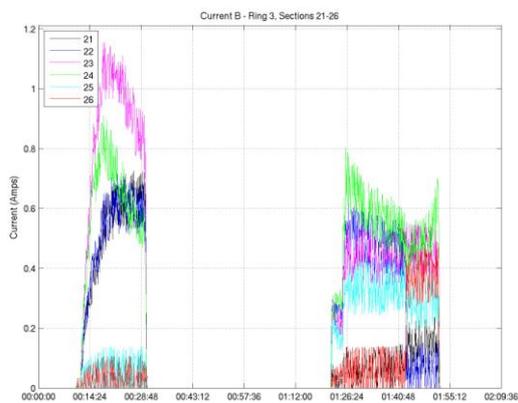
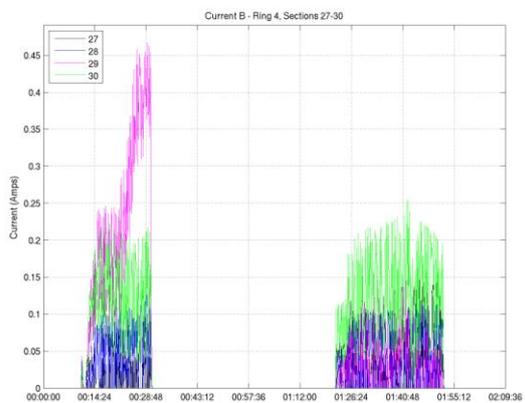
**Individual Segment Currents for Electrode B (Ground), with summation & numbering scheme, Log 1 sterilization test**

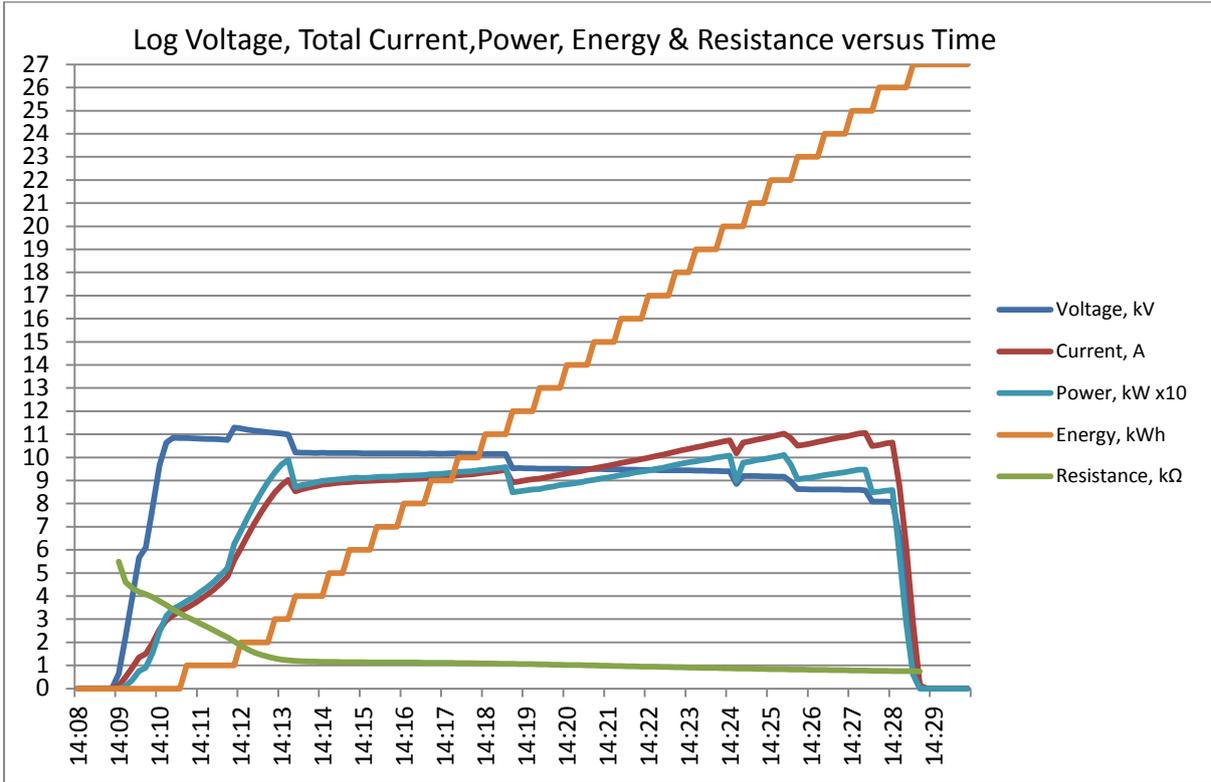
PQA measured Voltage, Current, Power, Energy & calculated Resistance during Log 2 sterilization test

Clearly the amount of energy absorbed by the log was insufficient to meet ISPM-15 requirements, largely due to the significant losses occurring to ambient despite the duvet lagging. Again, without real-time temperature monitoring, it was not possible to determine this until after the fact. Nevertheless the 9 valid temperature traces provide some encouragement that by increasing the energy absorption of the log, either by further injection, or preferably by improved heat/moisture loss control, by about 40%, ISPM-15 could be satisfied. The log resistance fell from about 5.5kΩ to about 750Ω during the test.

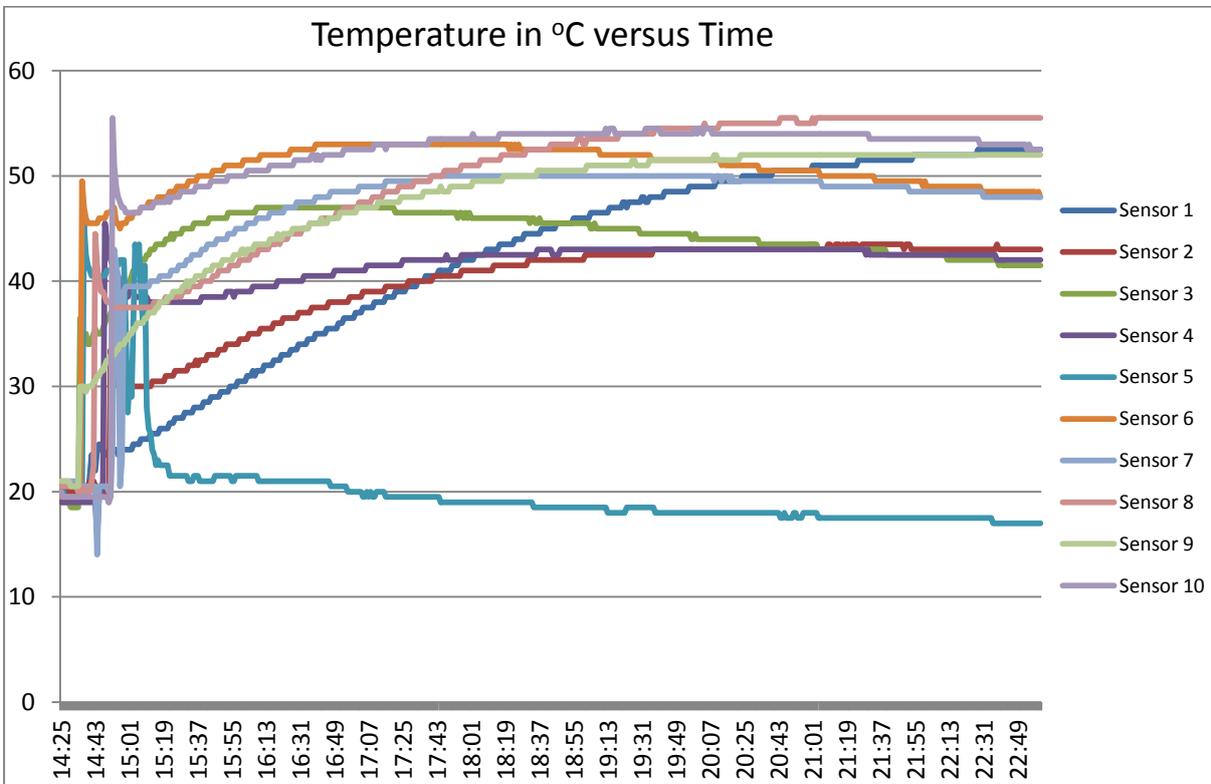
Temperatures logged from immediately after removal of power, following Log 2 sterilization test

Thermocouple sensor 5 was subsequently found to be giving false readings, due to its connector being soaked in sap-filled water – after cleaning and drying out it again became functional – so these readings should be ignored. The other 9 temperatures eventually reach an average of about 48°C for about 5 hours or so, with actual peak temperatures ranging from 43°C to 56°C. As expected, the longest time constant for heat soak is for the centre of the log which is of the order of 5 hours.

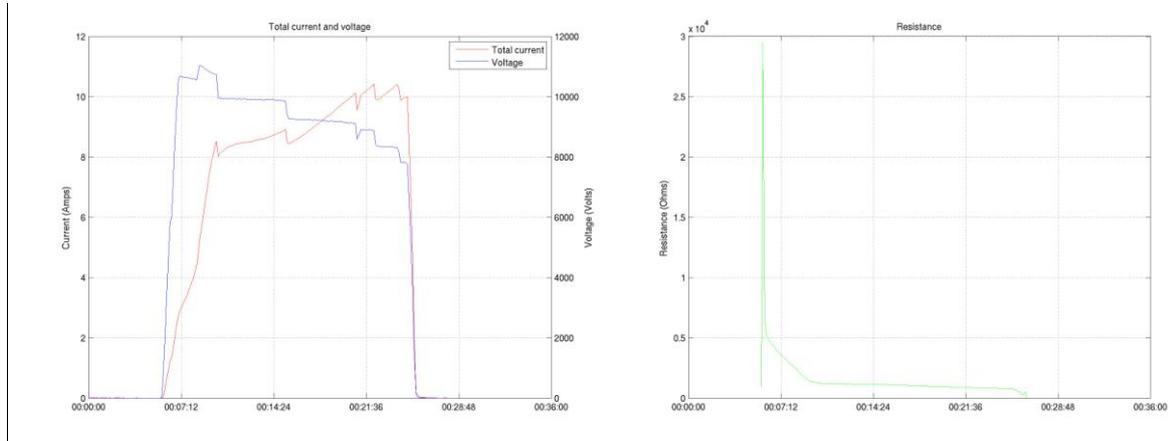
**Log Voltage, Total Current and Resistance versus time, plotted from DAS measurements, Log 2 sterilization test**

The DAS results for the test again show good agreement with the PQA data<sup>1</sup>.

<sup>1</sup> Again the extrapolation of resistance value when the excitation voltage is near zero leads to false results – this has again been edited out of the PQA results.

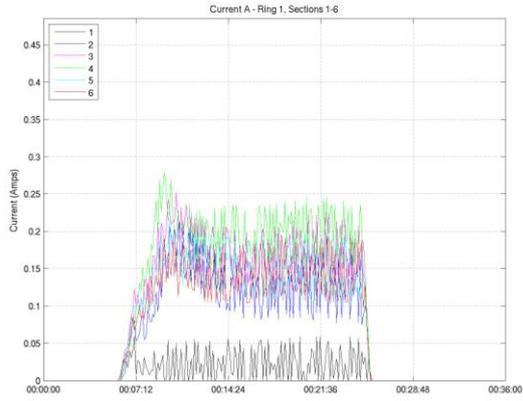
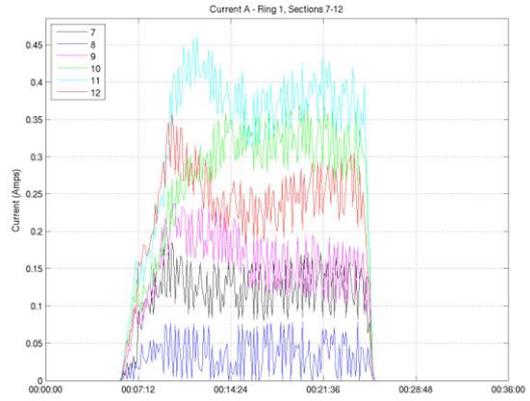
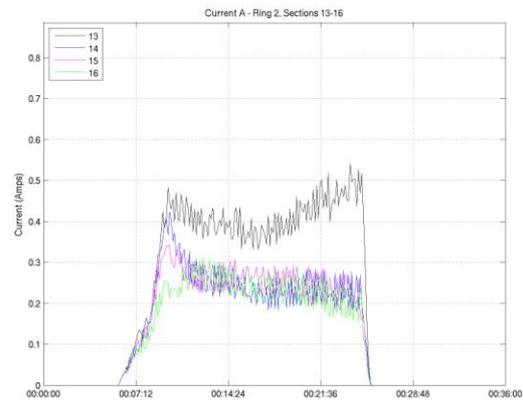
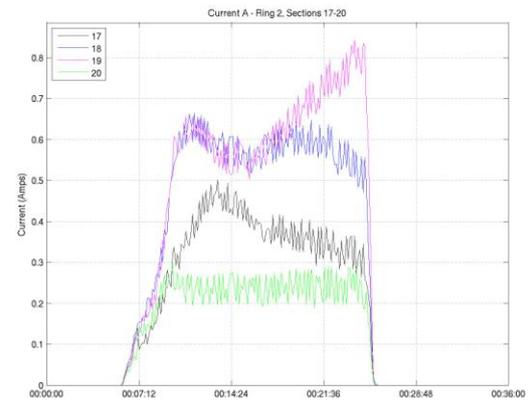
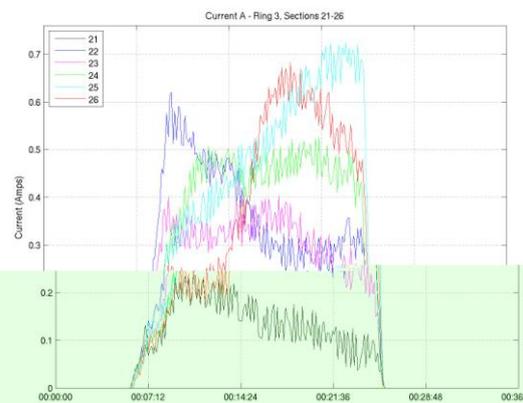
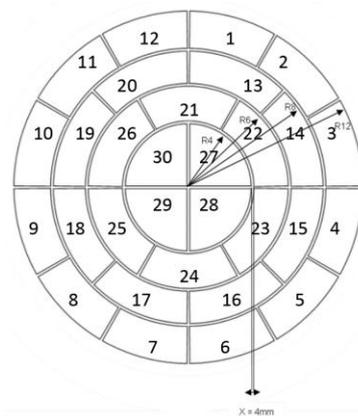
**Individual Segment Currents for Electrode A (HV), with summation & numbering scheme, Log 2 sterilization test**

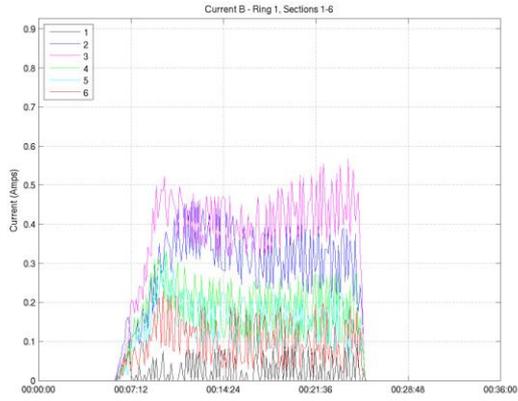
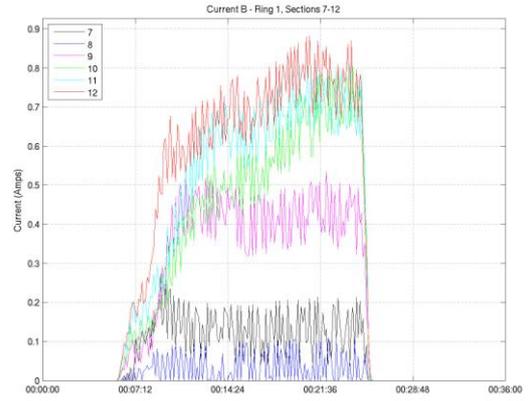
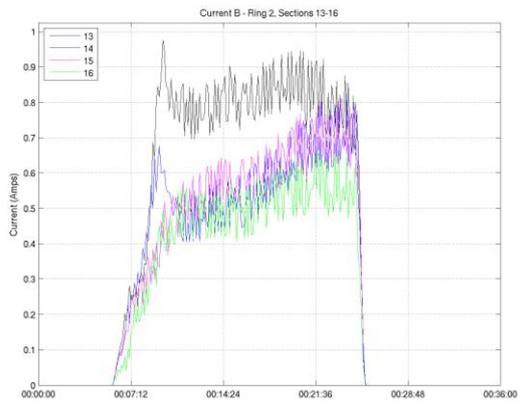
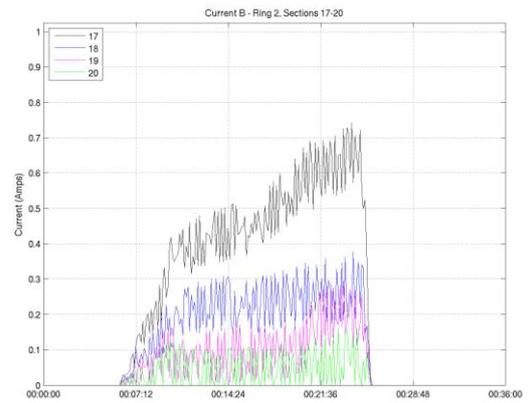
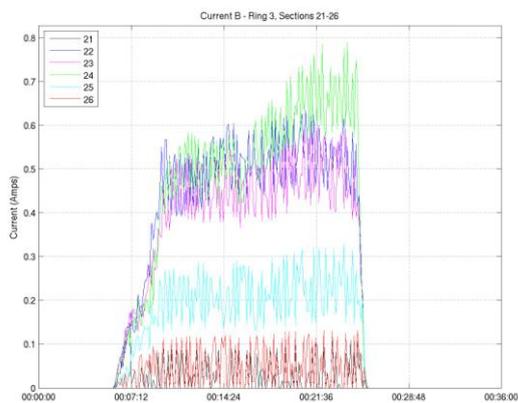
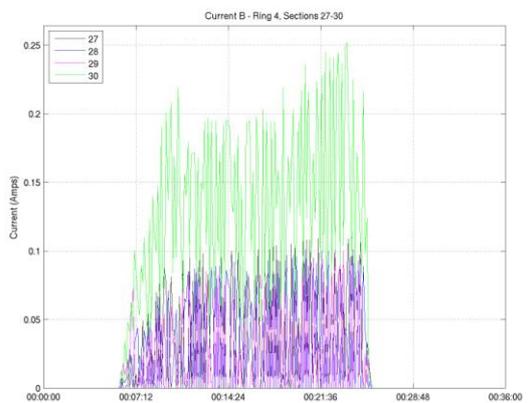
**Individual Segment Currents for Electrode B (Ground), with summation & numbering scheme, Log 2 sterilization test**

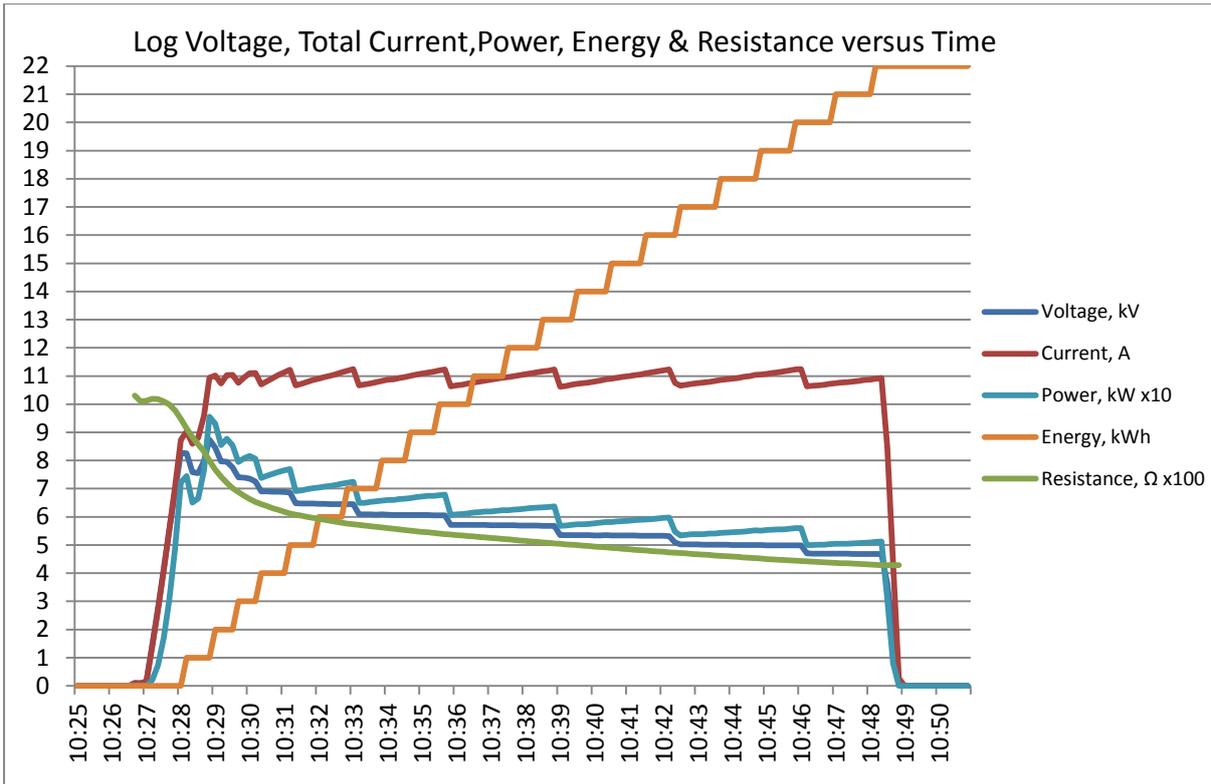
PQA measured Voltage, Current, Power, Energy & calculated Resistance during Log 2 reheating test

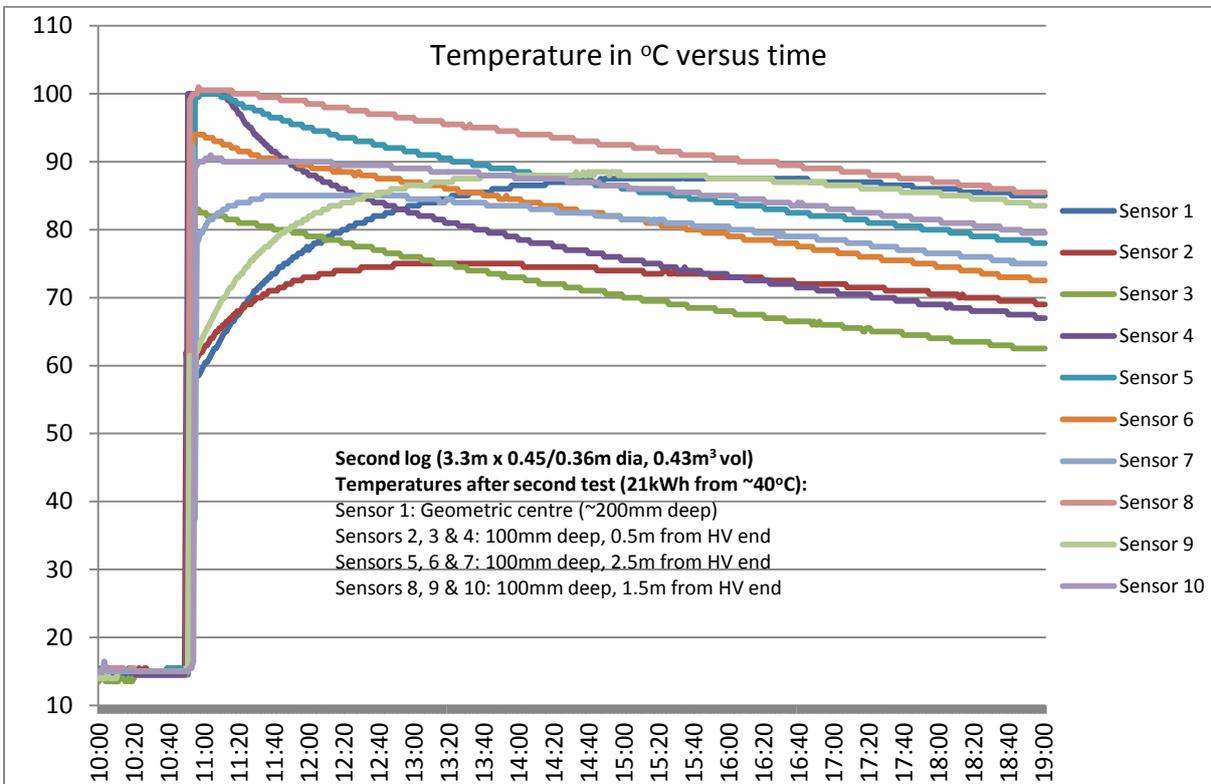
Temperatures logged from immediately after removal of power, following Log 2 reheating test

<sup>1</sup> By 10:15 the following morning (i.e. over 16 hours after removal of duvets) the 10 sensors ranged between 41 °C and 49°C, with a mean of 43.5 °C.

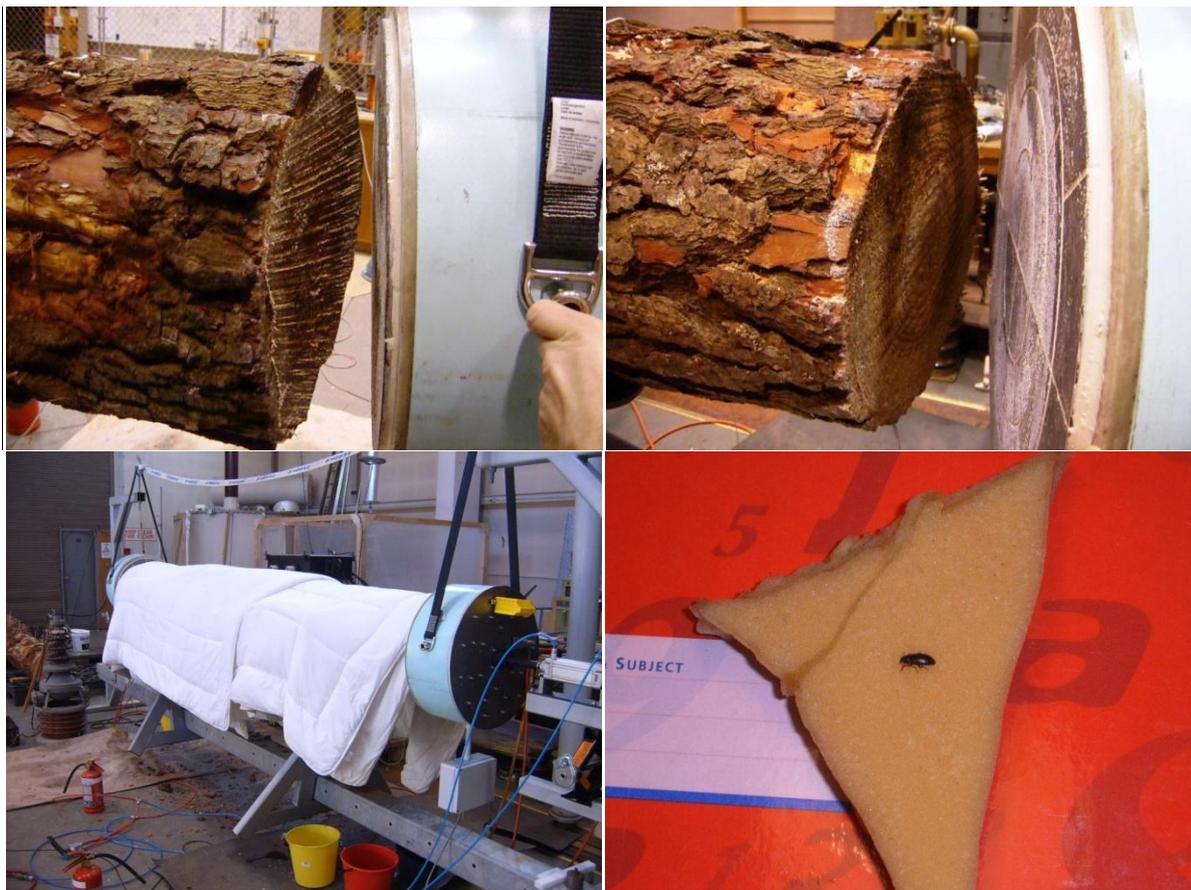
Log 2 after completion of all tests (clockwise from top left): Large (HV) end; Small (Ground) end; log under duvets; dead beetle from bark

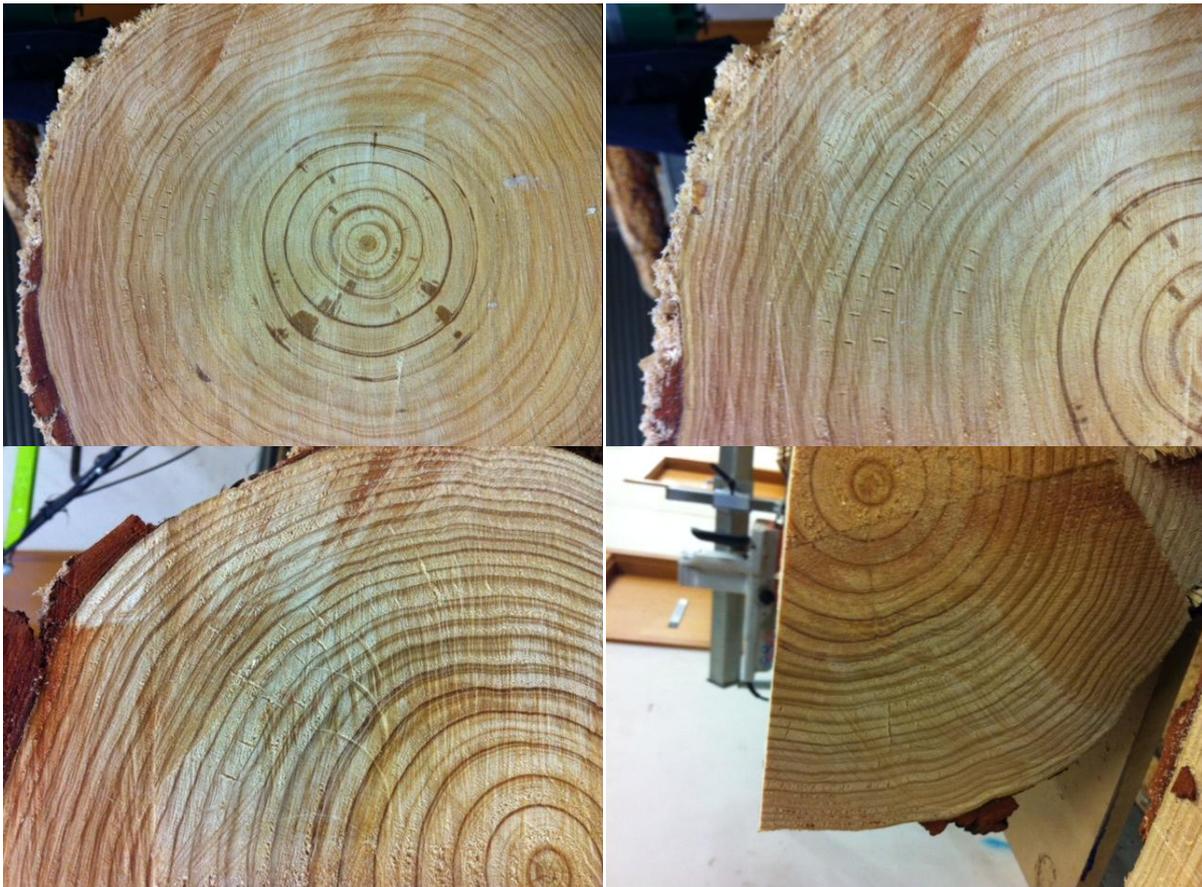
Timber samples milled after completion of all tests (clockwise from top left): Log 1 section close up part way through showing checking; Log 2 crosscut at 1.1m, showing checking; Log 2 slabbing, showing checking

Although beyond the initial project objectives, a brief look at the timber structure after the tests described above was attempted. Each of the two logs was cut into three 1.1m sections. One section of each log was cut into 50mm rounds, one slabbed into 50mm planks and the final one left as a log for future reference. The ends of all logs showed no apparent damage. However, some of the rounds and slabs showed evidence of checking. Unfortunately, without untreated control logs and many more samples to test it is hard to confirm the cause of the checking – checking can occur naturally, particularly in edge of stand trees, such as those from which both of these butt logs came.

It is likely, but beyond the scope here, that localized boiling of parts of the log caused some or all of this checking. Further work, with far more samples will be able to determine this. Additionally more samples, improved instrumentation and real-time temperature monitoring should reduce or eliminate the chances of localized boiling.

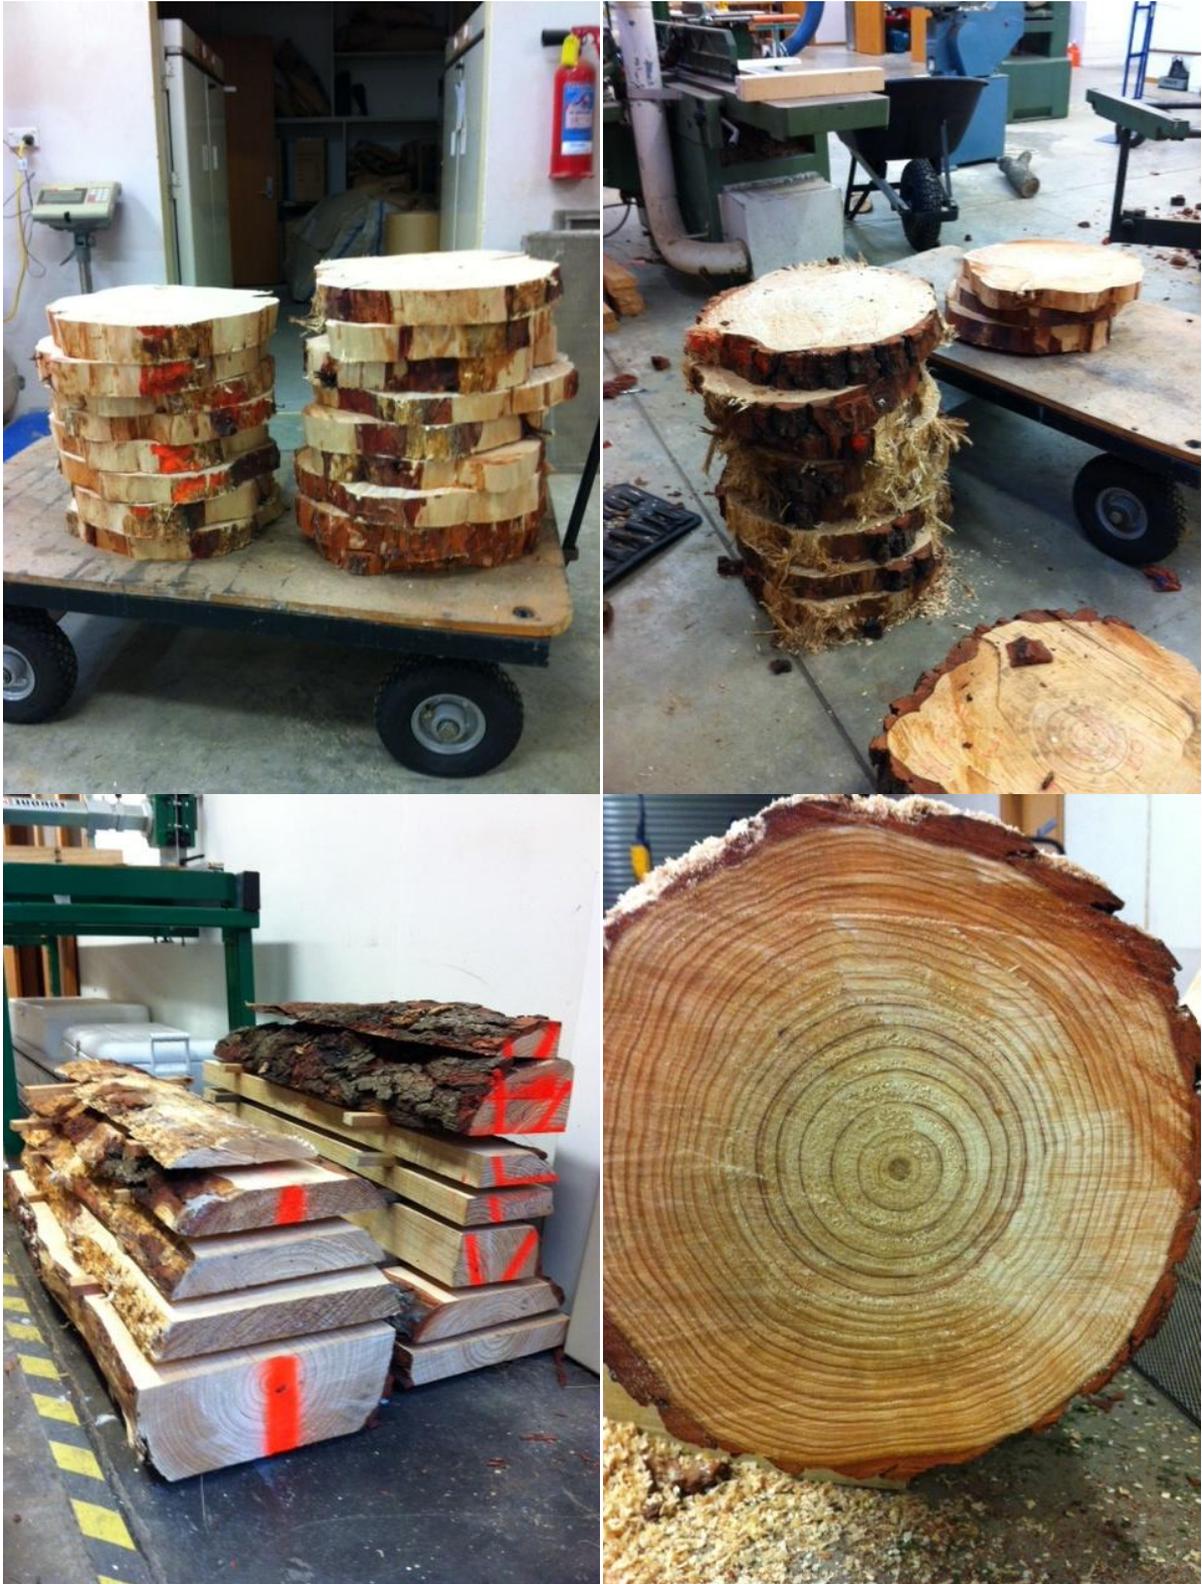
Timber samples milled after completion of all tests (clockwise from top left): Log 1 rounds; Log 2 rounds; slabs; Log 2 small end after removal of initial 25mm
