# Evaluating the potential for sediment delivery at forest road-stream crossings in New Zealand

Kristopher Brown and Rien Visser

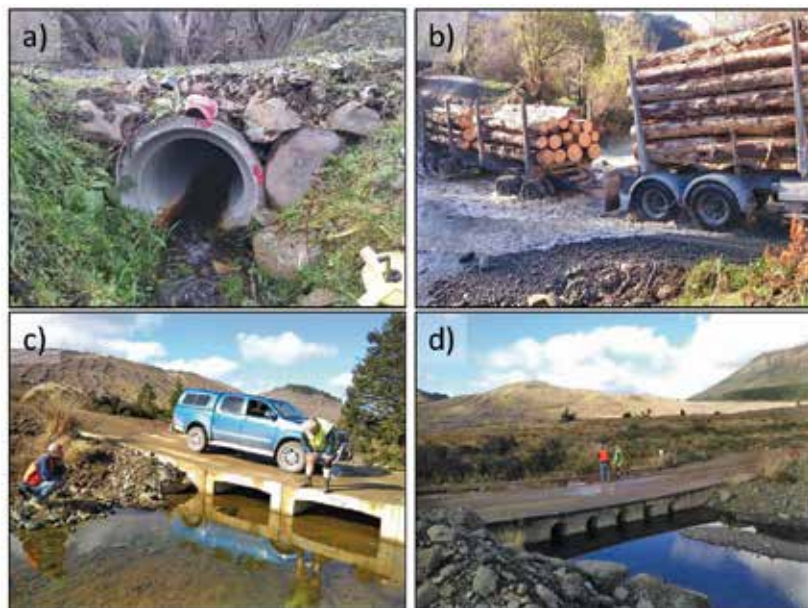
Figure 1: Stream-crossing types included in the field survey of road design, water control and surface cover BMPs: a) single culvert; b) open ford; c) drift deck; d) battery culvert

From April to August 2015, site visits were made to 39 corporate haul road-stream crossings covering six regions in New Zealand. A haul road-stream crossing was classified as any crossing on an arterial, secondary or spur road. Most of the sites (24) were located in the South Island: Southland (3), Otago (3), Canterbury (13) and Nelson–Marlborough (5). Site visits in the North Island (15) included Gisborne (10) and Waikato (5). Crossing types included single culverts (25), open fords (9), drift decks (3) and battery culverts (2) (Figure 1). Drift decks and battery culverts were grouped into the category ‘vented fords’ in accordance with Keller and Clarkin (2007). Using this classification, 64.1% of the crossings surveyed were single culverts, 23.1% were open fords and 12.8% were vented fords.

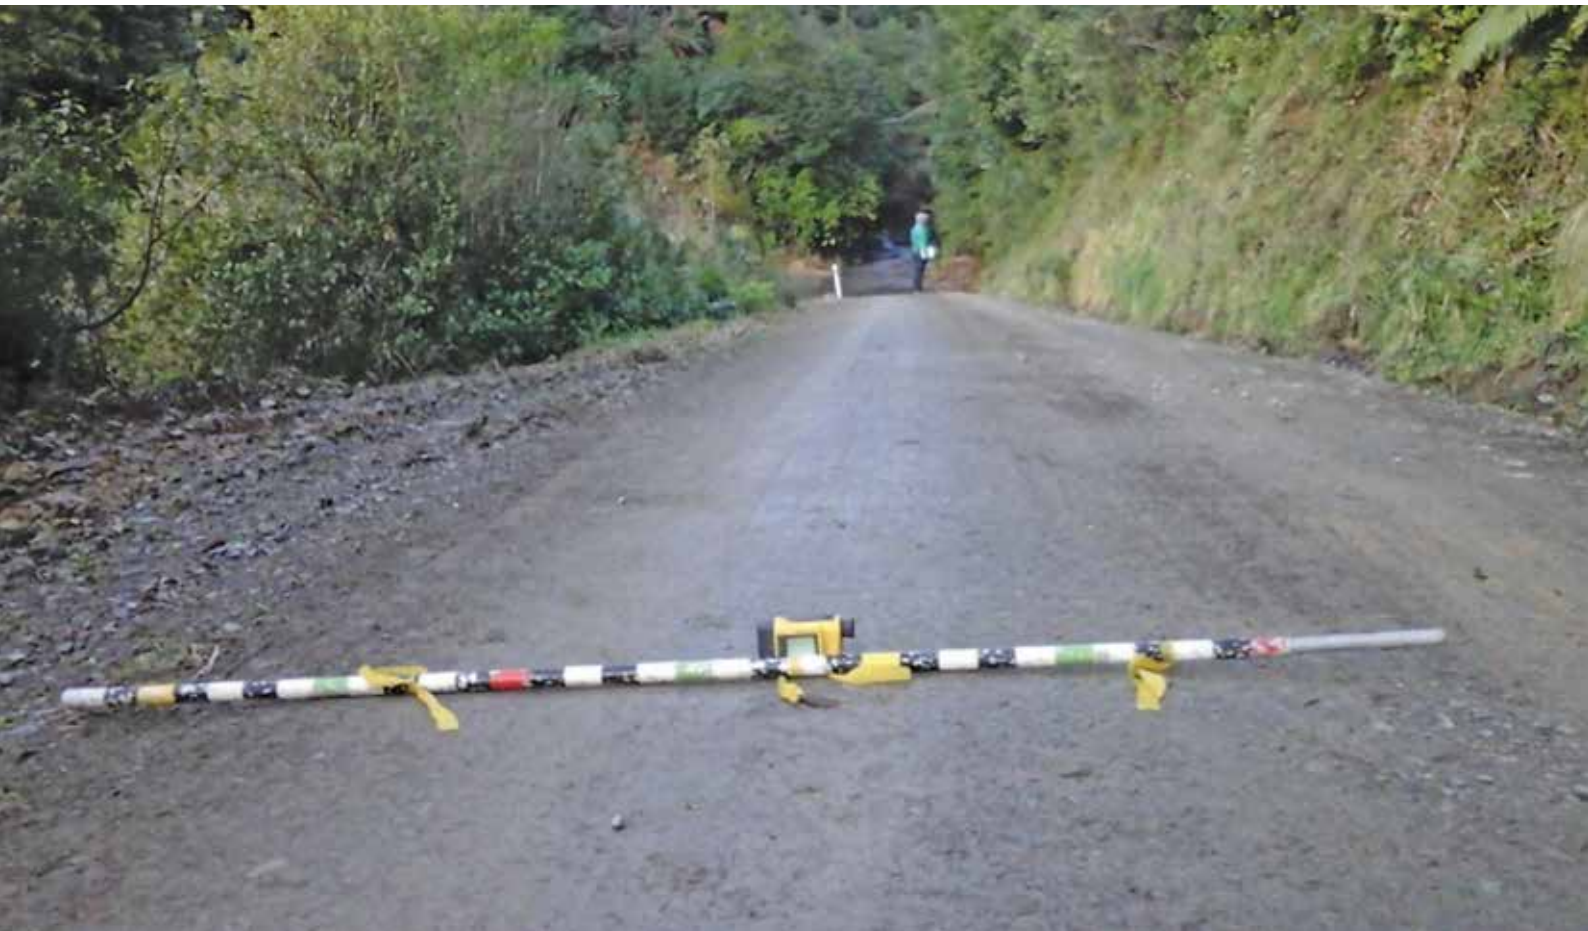
Road camber measurements

On each stream-crossing approach, transects were established perpendicular to the direction of road travel at distances of 5 m, 10 m and 15 m from the stream. Transect length was representative of the road right-of-way or the disturbed area associated with road construction. At each transect, road camber (cross-slope) was measured to characterise the degree to which the road profile (crown, inslope or outslope) shed water from the road surface (see photo). Road camber was measured by laying a metal rod on the road surface and using a laser rangefinder to measure the slope of the road running away from the road centre. A crowned road, for example, might have slopes of -4% on either side of the road centre line. For each transect, mean cross-slope was quantified from the absolute value of road camber measurements.

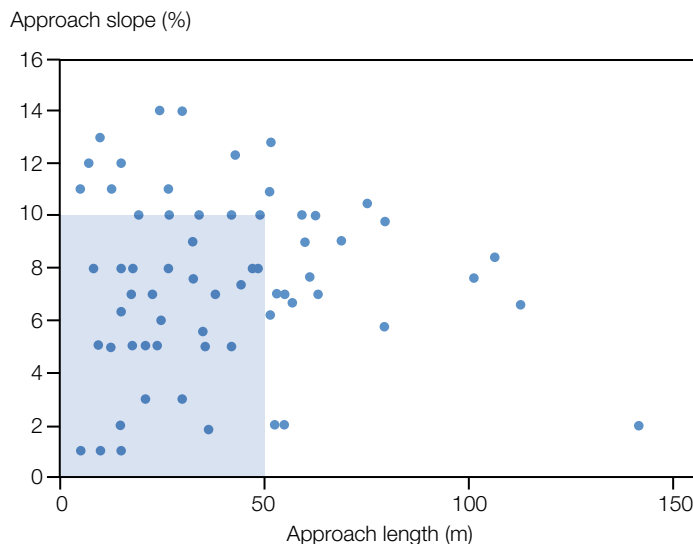
Figure 2: Scatter plot of stream-crossing approach length (m) and slope (%). The grey screen indicates approaches that were ≤50 m long with slopes ≤10%

Mean length and slope of the stream-crossing approaches was 40 m and 7.2%, respectively (Table 1). Approximately three-quarters of the approaches were shorter than 50 m with less than a 10% gradient

(Figure 2). However approach lengths could be shortened further by adding another water control structure. Sessions (2007) states that surface run-off from the road and table drains should be redirected from the road at least 20 m before the stream crossing. In this way, direct hydrologic connectivity could be limited to a 20 m road segment immediately upslope of the crossing, while road run-off originating upslope from the water control structure could be redirected and dispersed over the forest floor before reaching the stream.
