Appendix C. Specimens from AP14a

AP14a-DM1-6-A

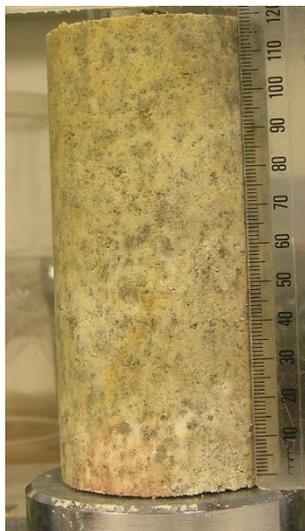
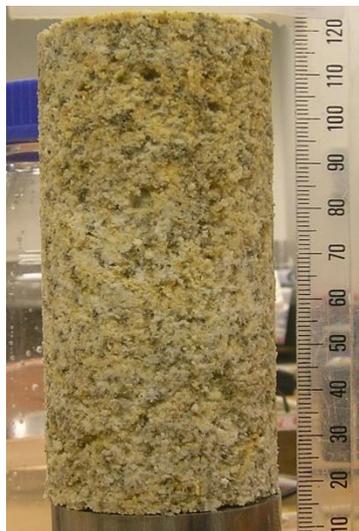
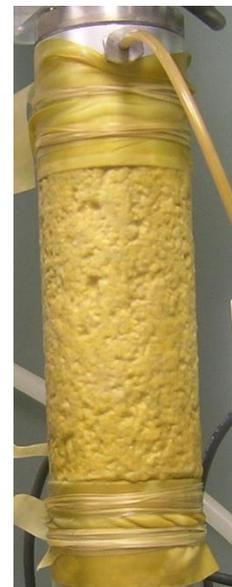
Figure C.1: AP14a-DM1-6A before testing

(a) as extruded

(b) after trimming

(c) mounted in device

AP14a-DM1-6A was noted to feel more weathered (i.e. higher proportion of fine grained material) than the other specimens, though the material still appeared to be slightly cemented (trimmed easily with a sharp knife) and with less of the hard coarse sand material.

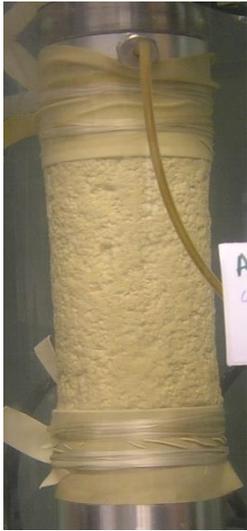
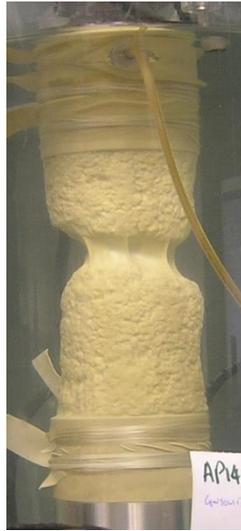
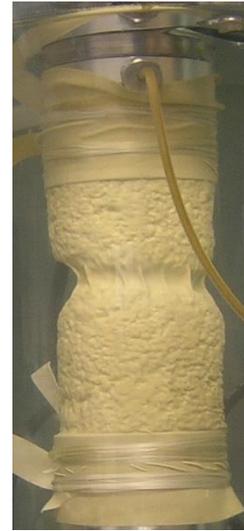
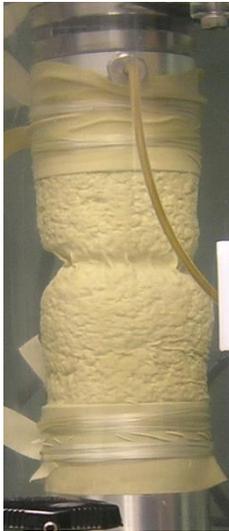
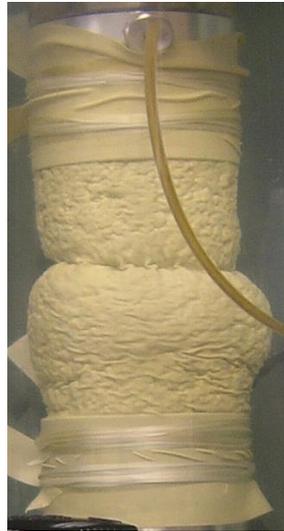
Figure C.2: AP14a-DM1-6A during testing

(a) after consolidation (400kPa)

(b) after cyclic loading

(c) after 7hrs ($\epsilon_a \approx 12\%$)

(d) after 10hrs ($\epsilon_a \approx 17\%$)

(e) end of testing ($\epsilon_a \approx 25\%$)

Following the end of cyclic loading, the “necked” zone of the specimen was relatively large and it was possible that the ultimate failure load would not be reached in the post-cyclic triaxial compression phase of the experiment. Hence, the initial stages of the triaxial compression loading were conducted under load control, before switching to displacement control once a load of 30N had been mobilised (around an axial strain of 4%).

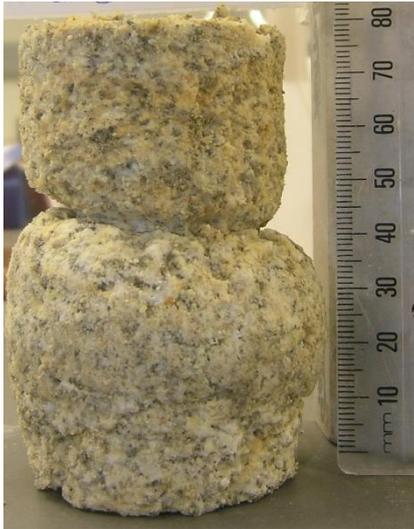
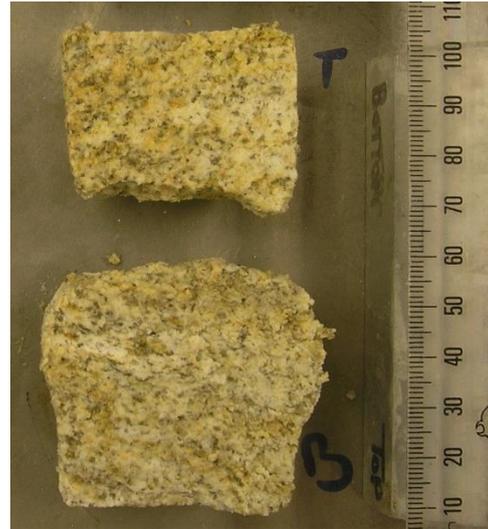
Figure C.3: AP14a-DM1-6A after testing

(a) exterior

(b) interior

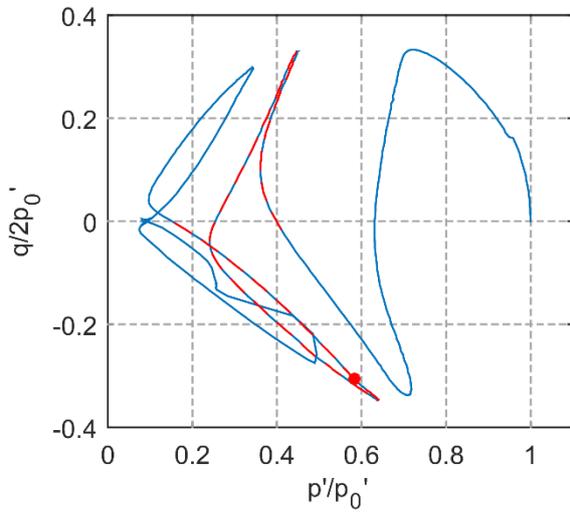
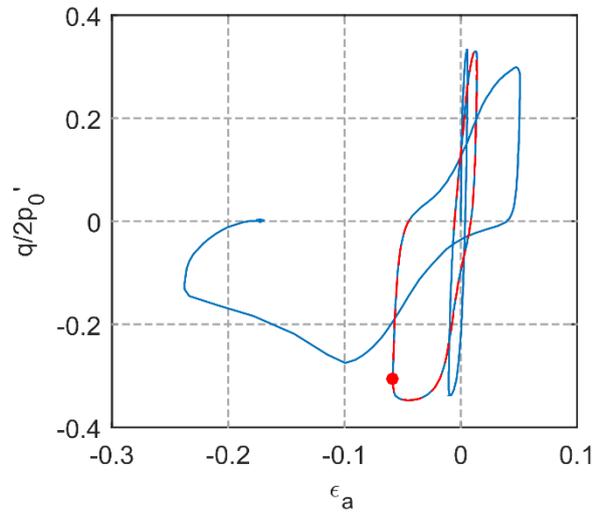
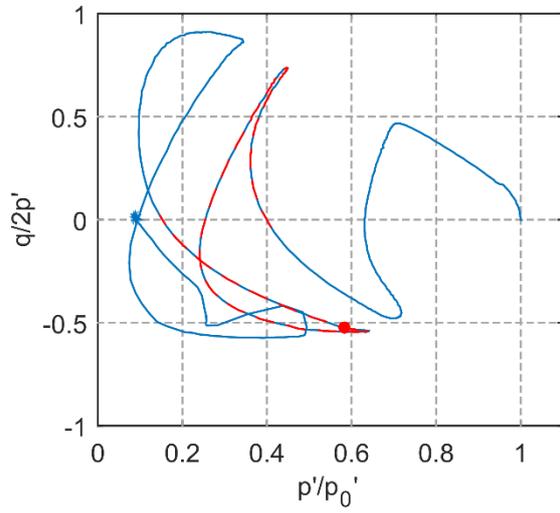
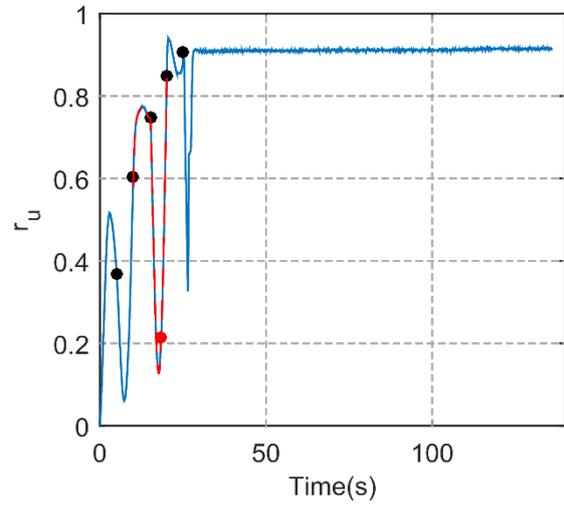
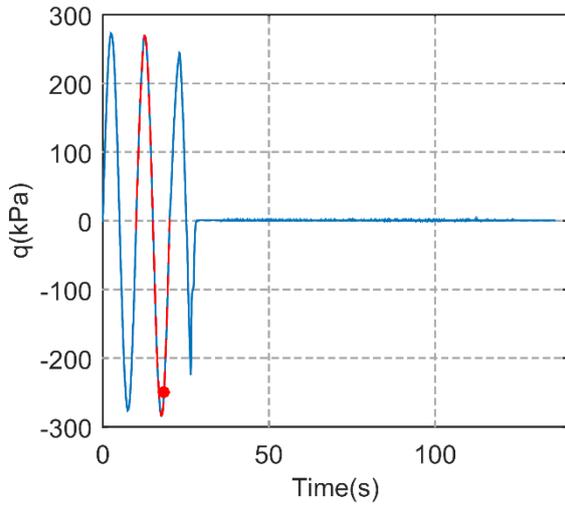
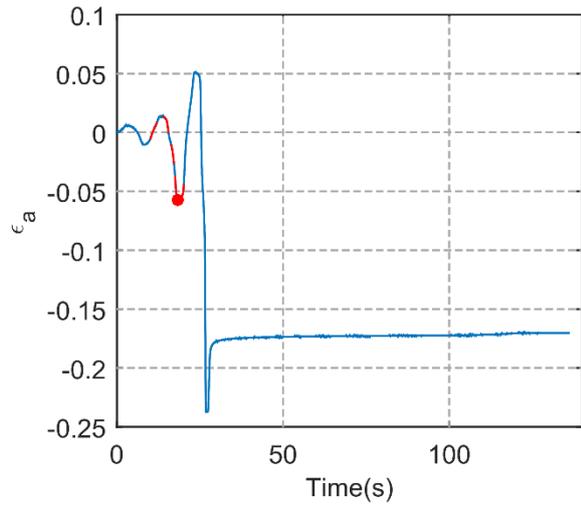
AP14a-DM1-6 A - CTX

$N_{5\%DA} = 2$ cycles

$CSR' = 0.337$

$p_0' = 408.4$ kPa

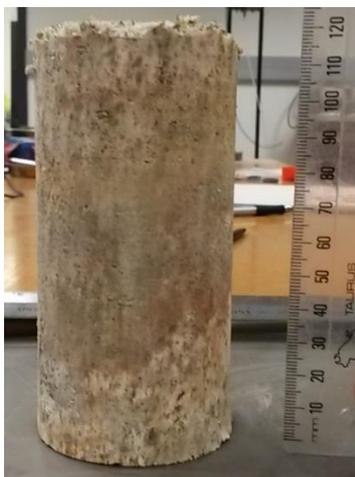
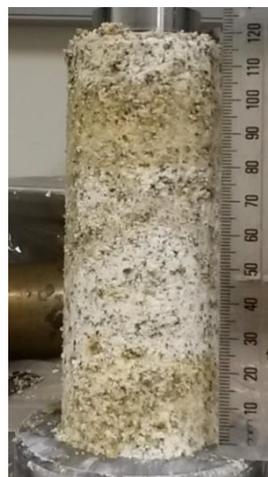
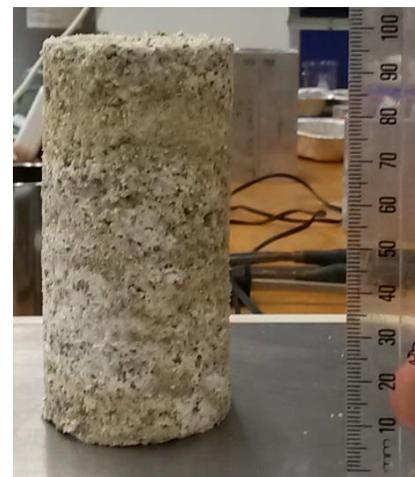
Figure C.4: View of specimen prior to testing

The material captured in specimen AP14a-DM1-6-B consisted of two distinct materials, visible in Figure C.4b. The off-cream material at the top and bottom of the specimen appeared similar to that found in AP14a-DM1-6-A (and other specimens). The white band apparent in the middle of the specimen was an extremely soft material, more similar to a soft clay and is considered different to the majority of the material which has been tested.

(a) as extruded

(b) after trimming

(c) final specimen (after trimming in mitre box)

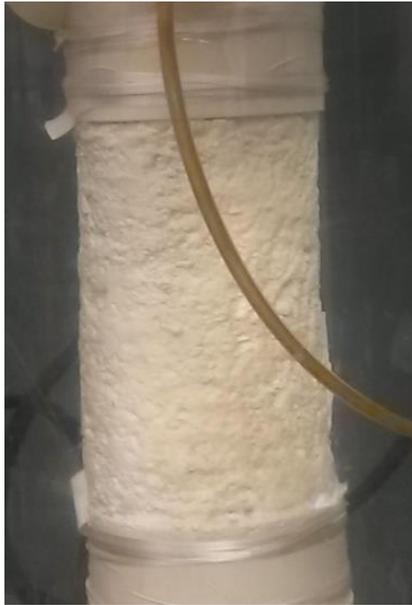
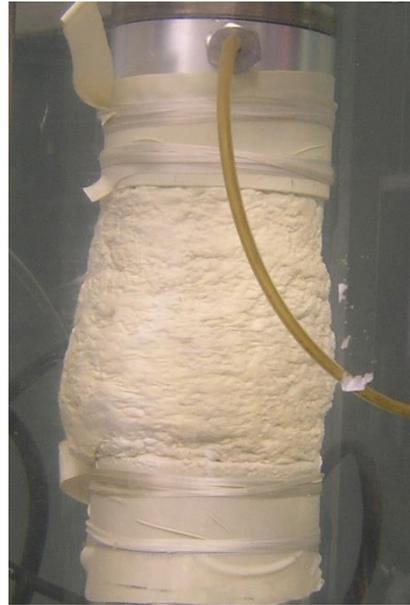
Figure C.5: During testing

(a) after consolidation

(b) at end of testing

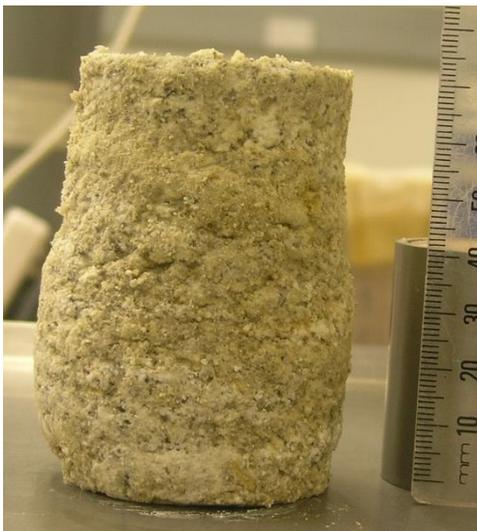
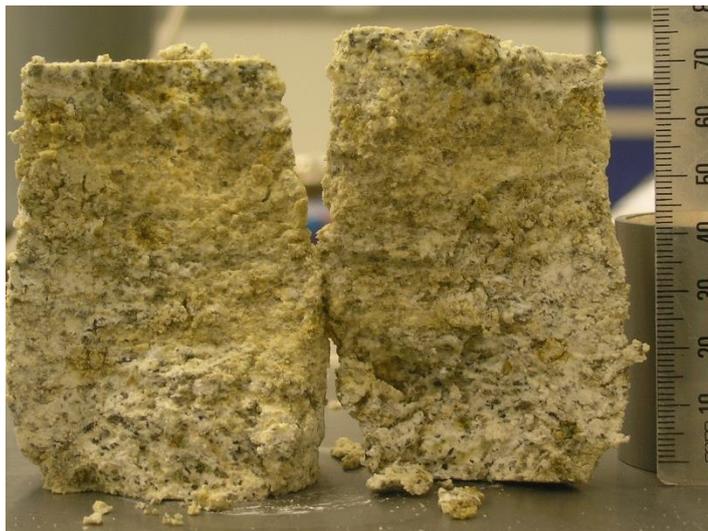
Figure C.6: After testing

(a) whole specimen after testing

(b) view of specimen interior after testing
