SURVEY OF IMPACTS ON THE ANDAMAN COAST, SOUTHERN THAILAND FOLLOWING THE GREAT SUMATRA-ANDAMAN EARTHQUAKE AND TSUNAMI OF DECEMBER 26, 2004.

This report on the Sumatra-Andaman great earthquake and tsunami of December 26, 2004 describes the event and its impacts in southern Thailand. It includes the observations of the New Zealand Society for Earthquake Engineering Reconnaissance Team gathered one month after the event. The report covers the effects of the tsunami on the natural and built environment, and the recovery process in relation to social and economic issues. Lessons applicable to the understanding and potential mitigation of tsunami risk in New Zealand are presented and discussed.

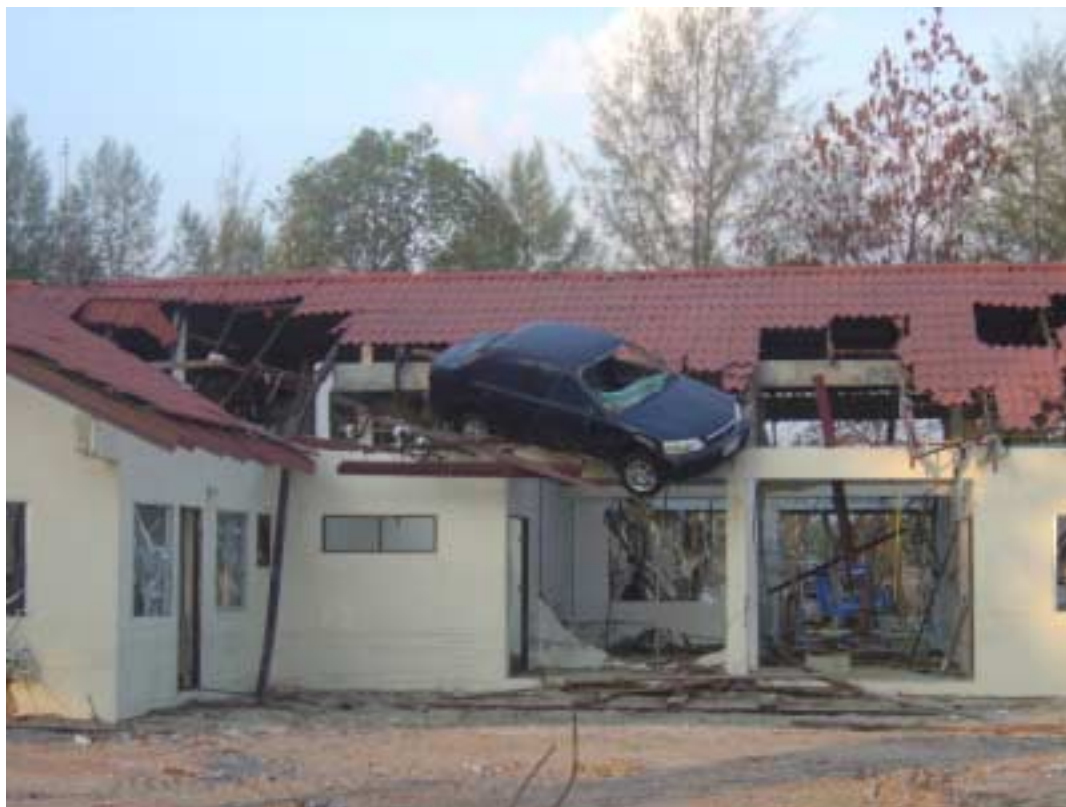
Figure 4. Tsunami wave heights were inferred from strand-lines and watermarks on buildings. In this case a car was lifted above the roofline of a resort in Khao Lak (Photo Thai Meteorological Department).

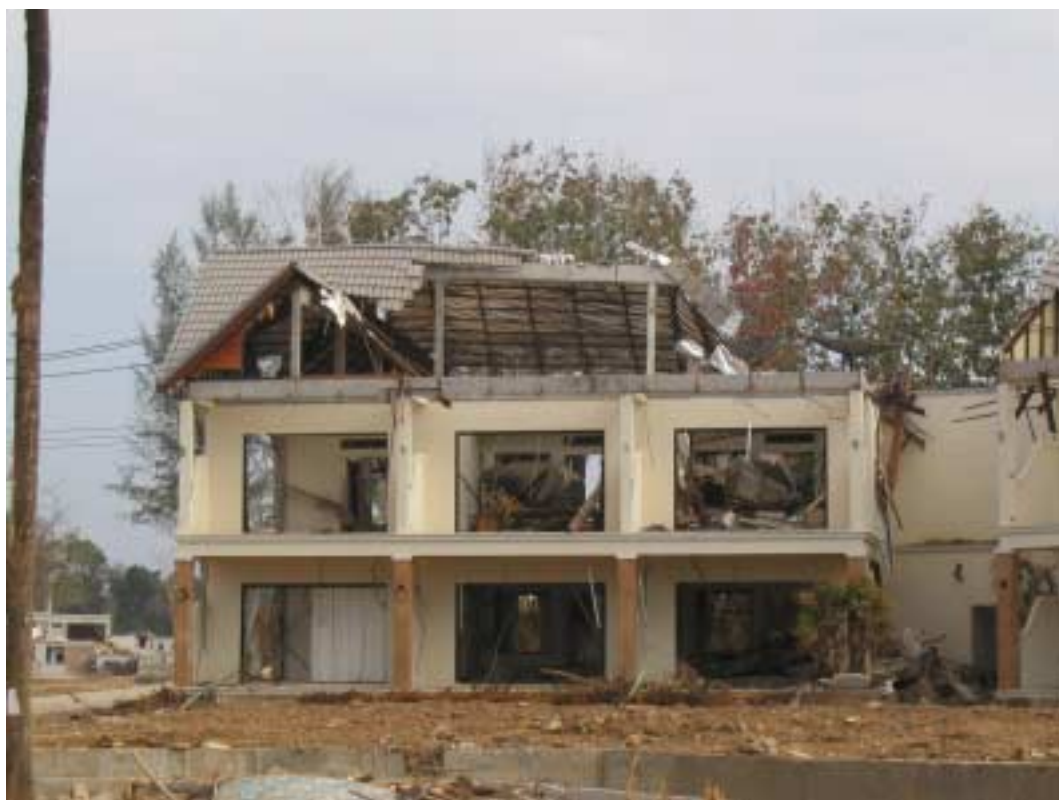
Figure 5. Missing roof tiles indicate the tsunami torrent depth exceeded nine metres at this location in Khao Lak (Photo ED).

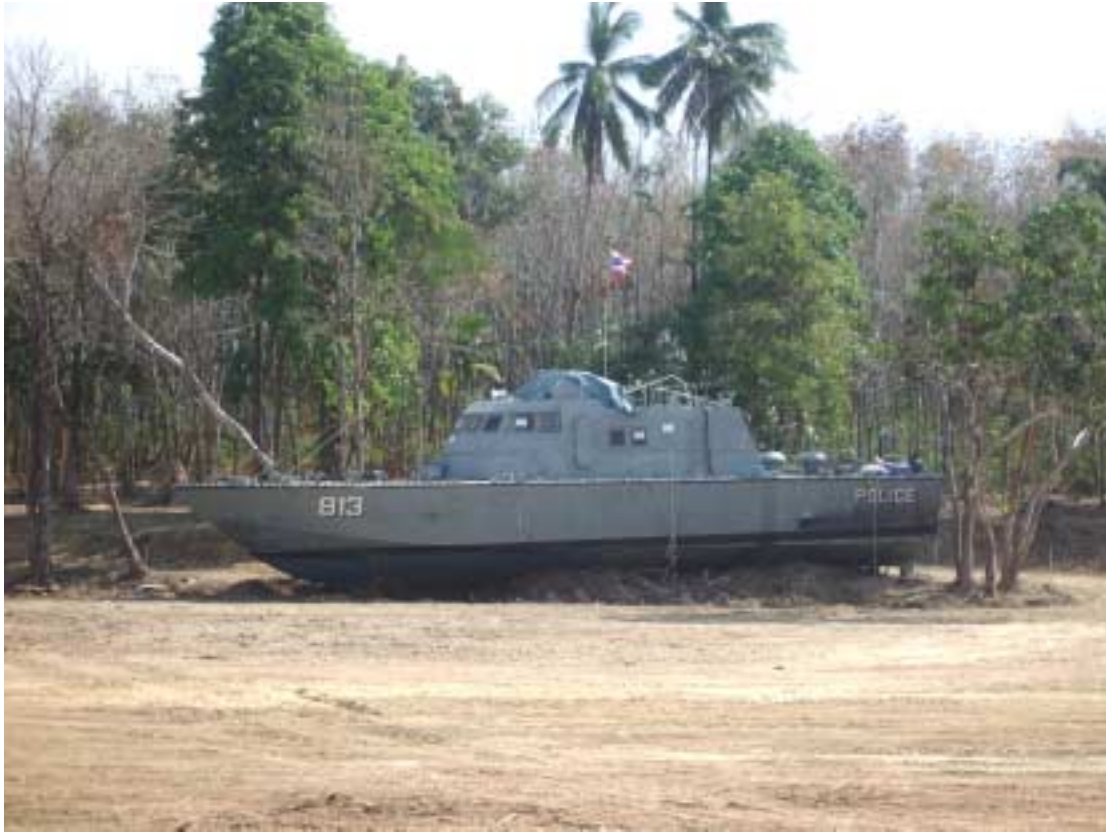
Figure 6. One of two police patrol vessels caught by the first tsunami wave off Khao Lak – this one was carried 1.2 km inland narrowly missing a shopping complex; the other vessel rolled and sank near the coast. (Photo RB).

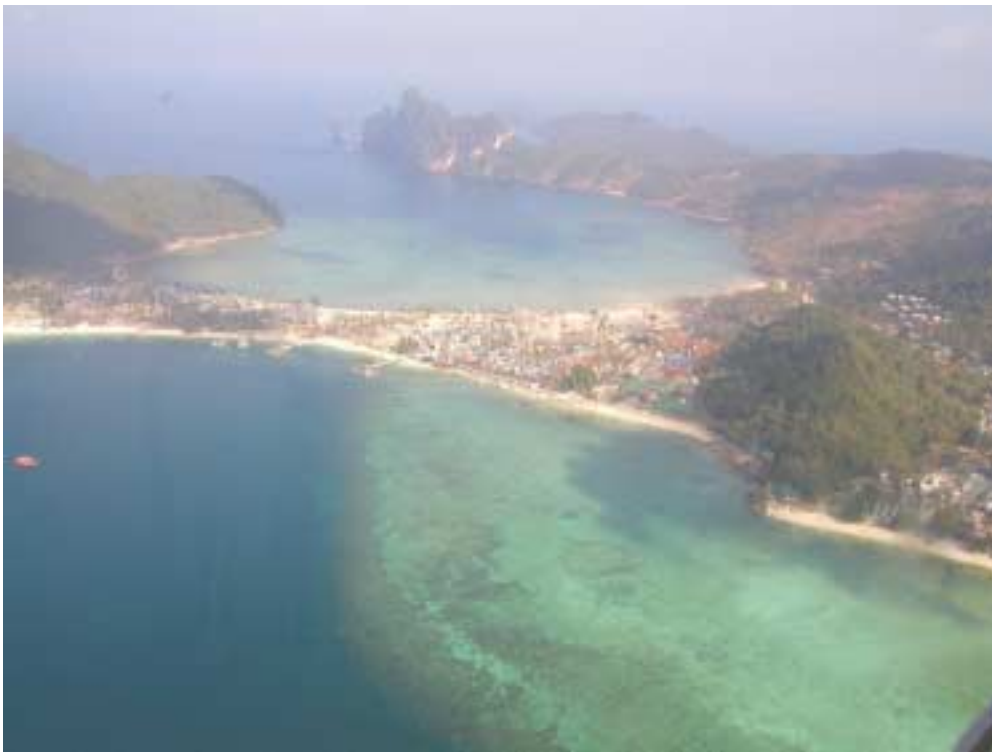
Figure 7. Phi Phi Island viewed from the air as the team approached by helicopter from the southeast. The tsunami wave traversed the sand-spit at depths of up to nine metres, first from the north and a few minutes later again from the south (Photo ED).

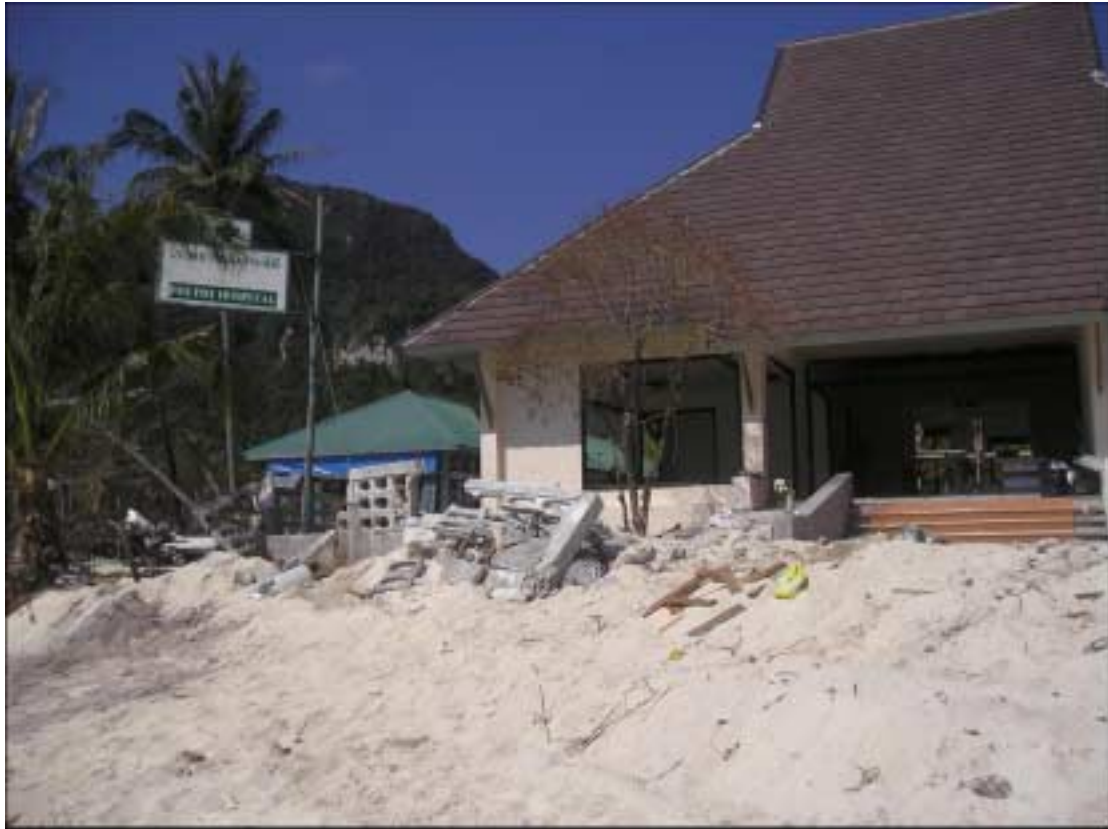
On Phi Phi, about 1,400 resort rooms in 34 facilities were lost or damaged and up to 70% of the island was severely damaged (Guy Carpenter, 2005) as shown in Figure 8. The devastation witnessed at Phi Phi provided a salutary lesson of the vulnerability associated with extensive development on tombolos and sand spits in areas exposed to tsunami hazard.

Figure 8. The hospital on Koh Phi Phi was set back from the shore but situated close to sea-level. It was rendered inoperable by the tsunami, highlighting the critical need to locate such facilities outside potential inundation zones (Photo LY).

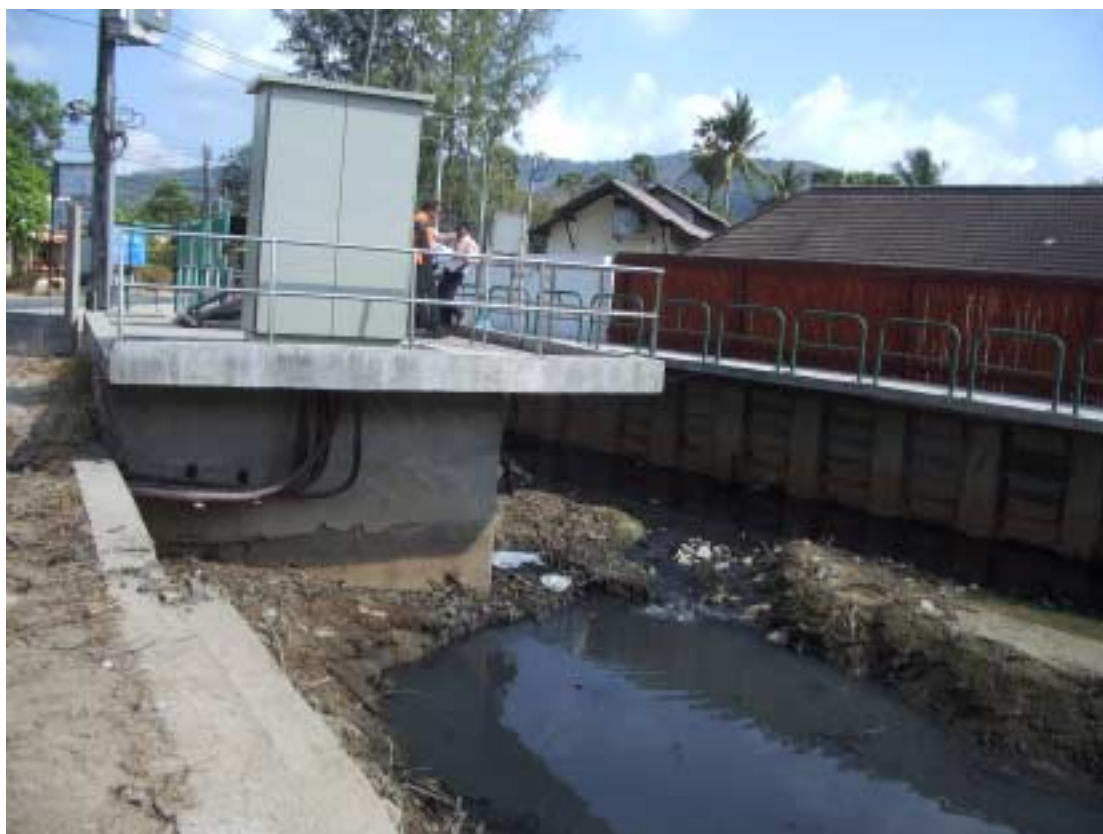
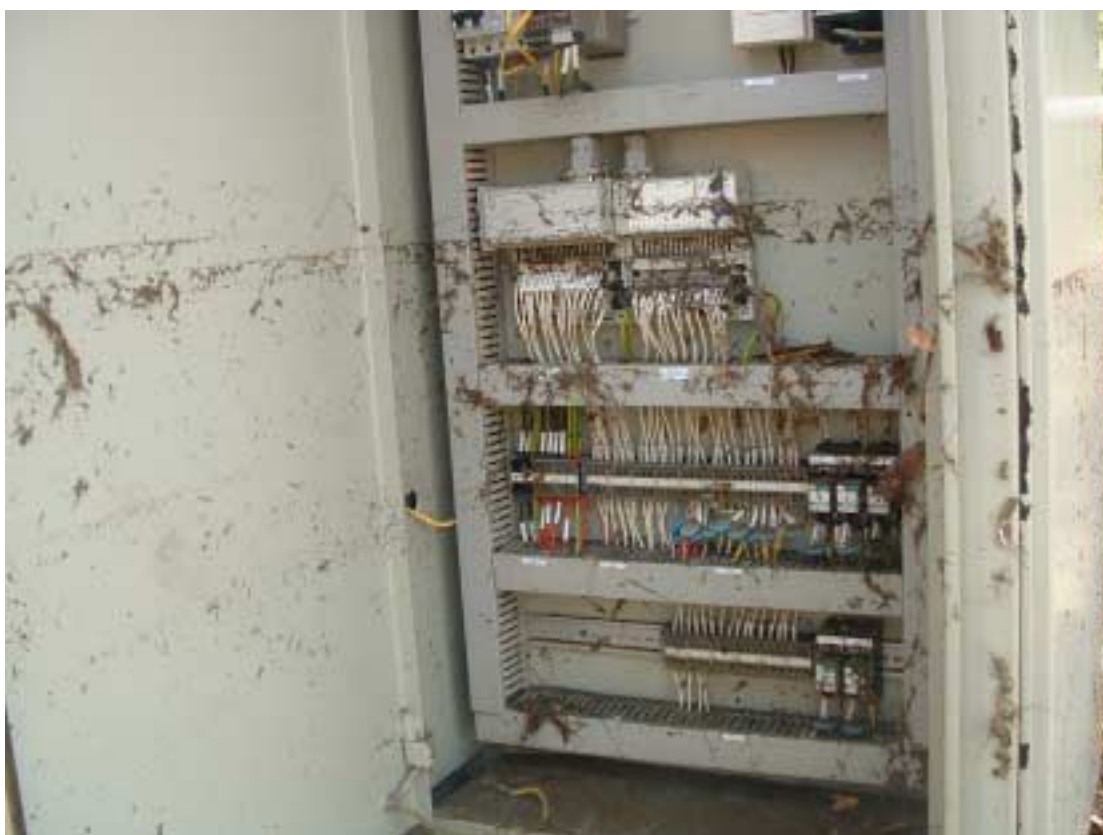
This was repeated at the many affected resort areas along the Thai coast. In some cases even though the plant (e.g. pumping stations) was not physically damaged, it was rendered inoperable by the tsunami having inundated the control electrics and mechanisms at various collection points (Figure 9a and 9b).

Figure 9a and 9b. *Inspecting damage to a sewerage pumping station at Kata Beach, Phuket Island. Electrical control systems were damaged beyond repair, causing sewer overflows into the adjacent stream, and discharge onto the nearby beach (Photos RB and HC).*

A month after the tsunami, minor sewer overflow discharges were still continuing at some beaches while authorities were waiting for repairs and replacement components. They were very aware of the need for speedy repairs to preserve the pristine image for the numerous resorts.

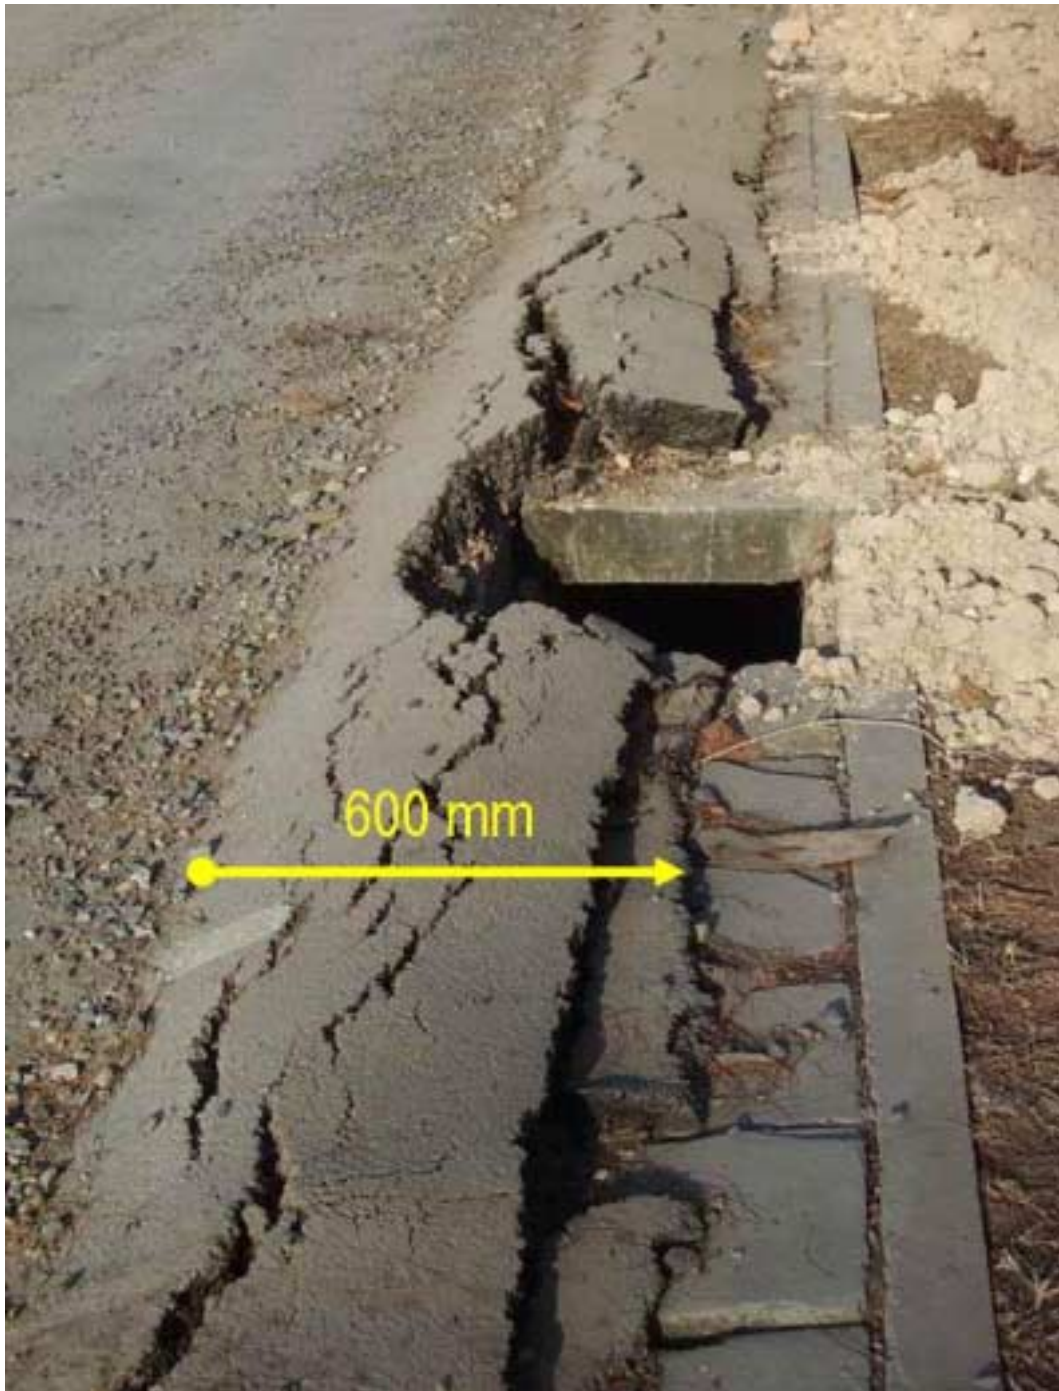
One road bordering the coast at Kamala Beach (Phuket Island) suffered extensive damage. Here the impact of the tsunami destroyed the protecting seawall and bodily shunted the asphalt of a section laterally by about 600 mm so that it was forced over the concrete roadside stormwater drain cover (Figure 10).

Figure 10. *Damage to roads was locally severe due to scouring. At Kamala Beach, Phuket Island, where the torrent depth was 3-4 m, the beach-front road pavement was shifted landward 600 mm onto the adjacent stormwater drain cover.*

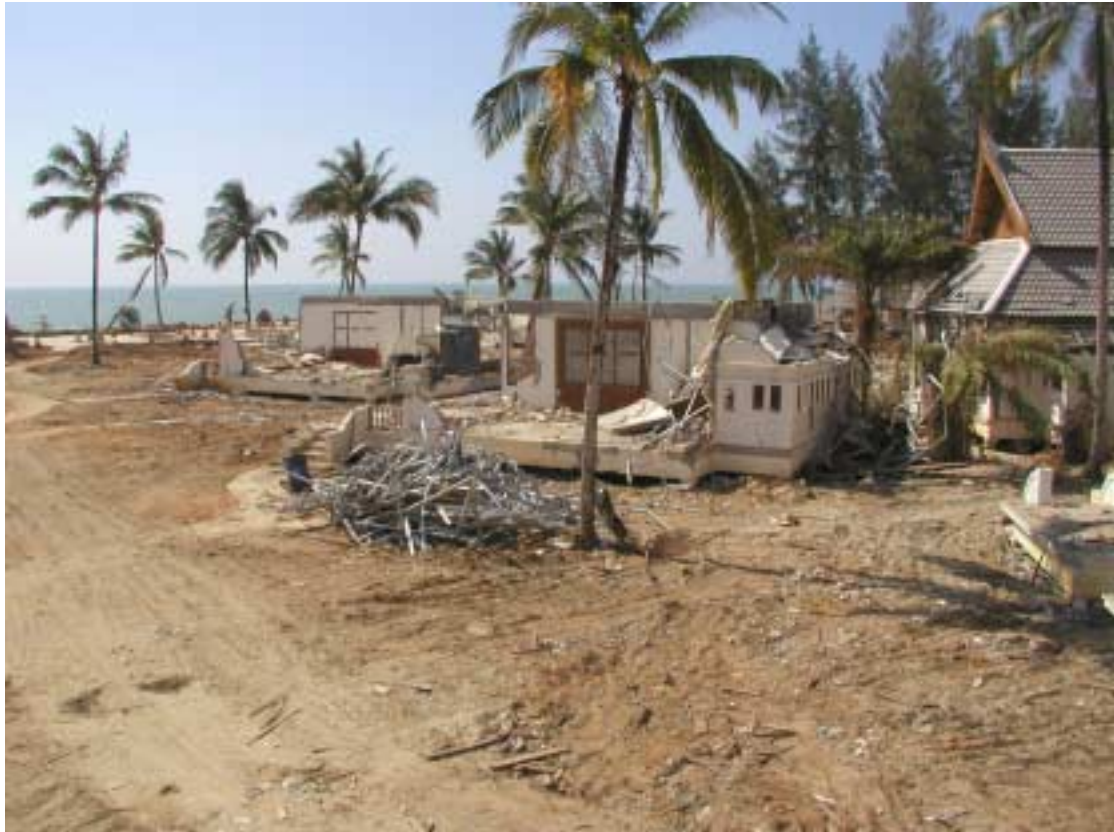
Most of the damaged and collapsed single storey buildings had been cleared by the time of the visit. The extensive areas of cleared sand gave an indication of the large number of buildings that had been destroyed. These buildings included detached bungalows, bars, restaurants and those associated with the resorts. Those that remained standing through the torrent appeared to have been either well sheltered by buildings in front or were very well tied at foundation and eaves levels, with numerous partition walls (Figure 11).

Figure 11. View to seaward at one of the coastal resorts in Khao Lak. Foundations are all that remains of the single-storey buildings closest to the beach. A gradation in the severity of damage owed more to the protection afforded by adjacent structures than to the absolute distance inland (Photo HC).

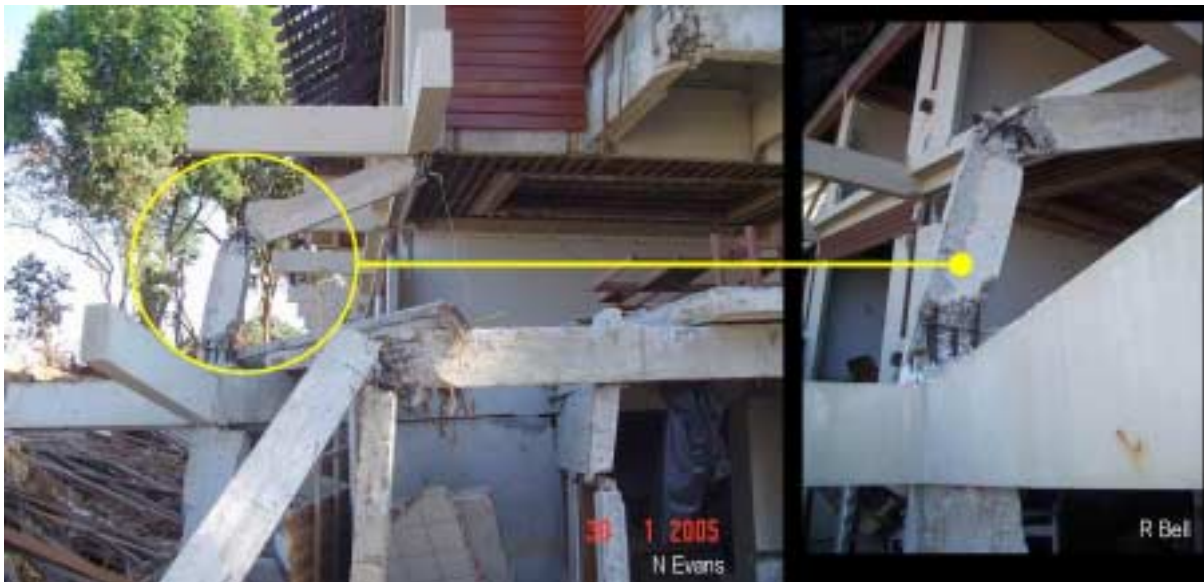
The remaining damaged single-storey buildings that we observed demonstrated a wide variety of failure mechanisms associated with inadequate detailing of reinforced concrete to sustain high lateral loads. For many the basic structure was a simple mechanism with little lateral bracing and inadequate jointing (Figure 12).

Figure 12. Damage to reinforced concrete frame structures was only locally severe, where exposed structural elements were impacted by entrained debris (Photos NE and RB).

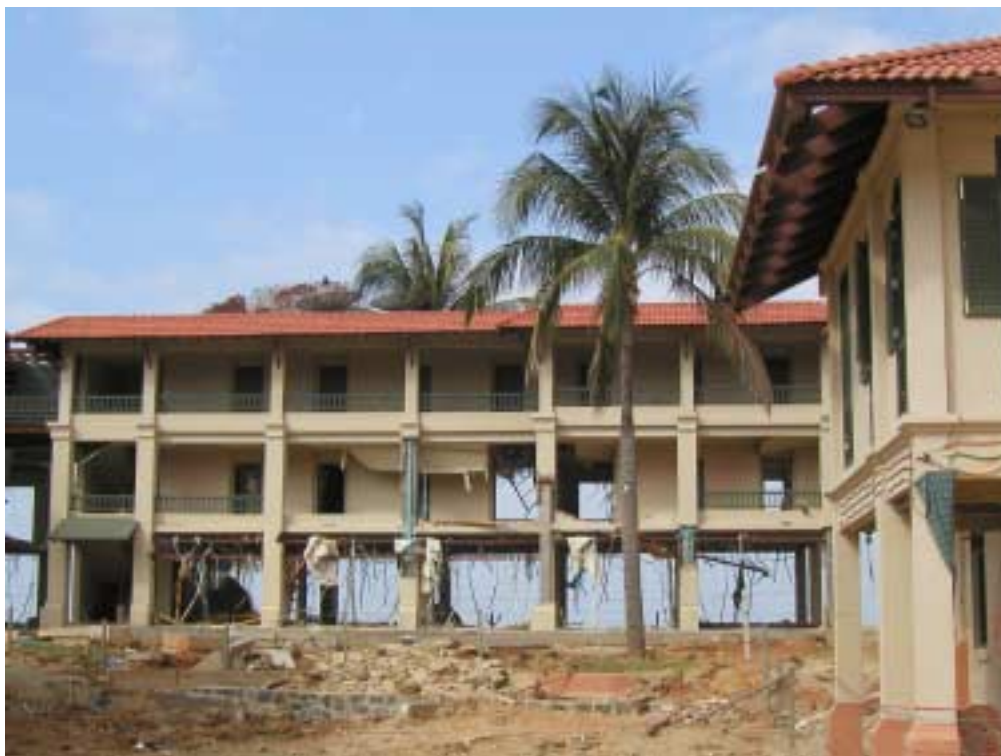
The multi-storey buildings were extensively damaged in the ground floors with walls facing the torrent blasted through (Figure 13). Once the tsunami was able to flow through the lower storeys the loadings on the building would have been significantly reduced and the remaining walls, generally in the direction of flow, were able to provide in-plane resistance. An extreme example of the difference of impact forces occurred at Kamala Beach School, Phuket where a new school two-storey block under construction with no ground storey infill walls survived while two completed similar buildings were destroyed.

Figure 13. *One of resorts at Khao Lak located a few hundred metres from the shoreline, where the highest tsunami run-up (12 m) occurred. Water entered rooms even on the third floor, and in-fill block walls and windows on the first and second floors were punched out (Photo ED).*

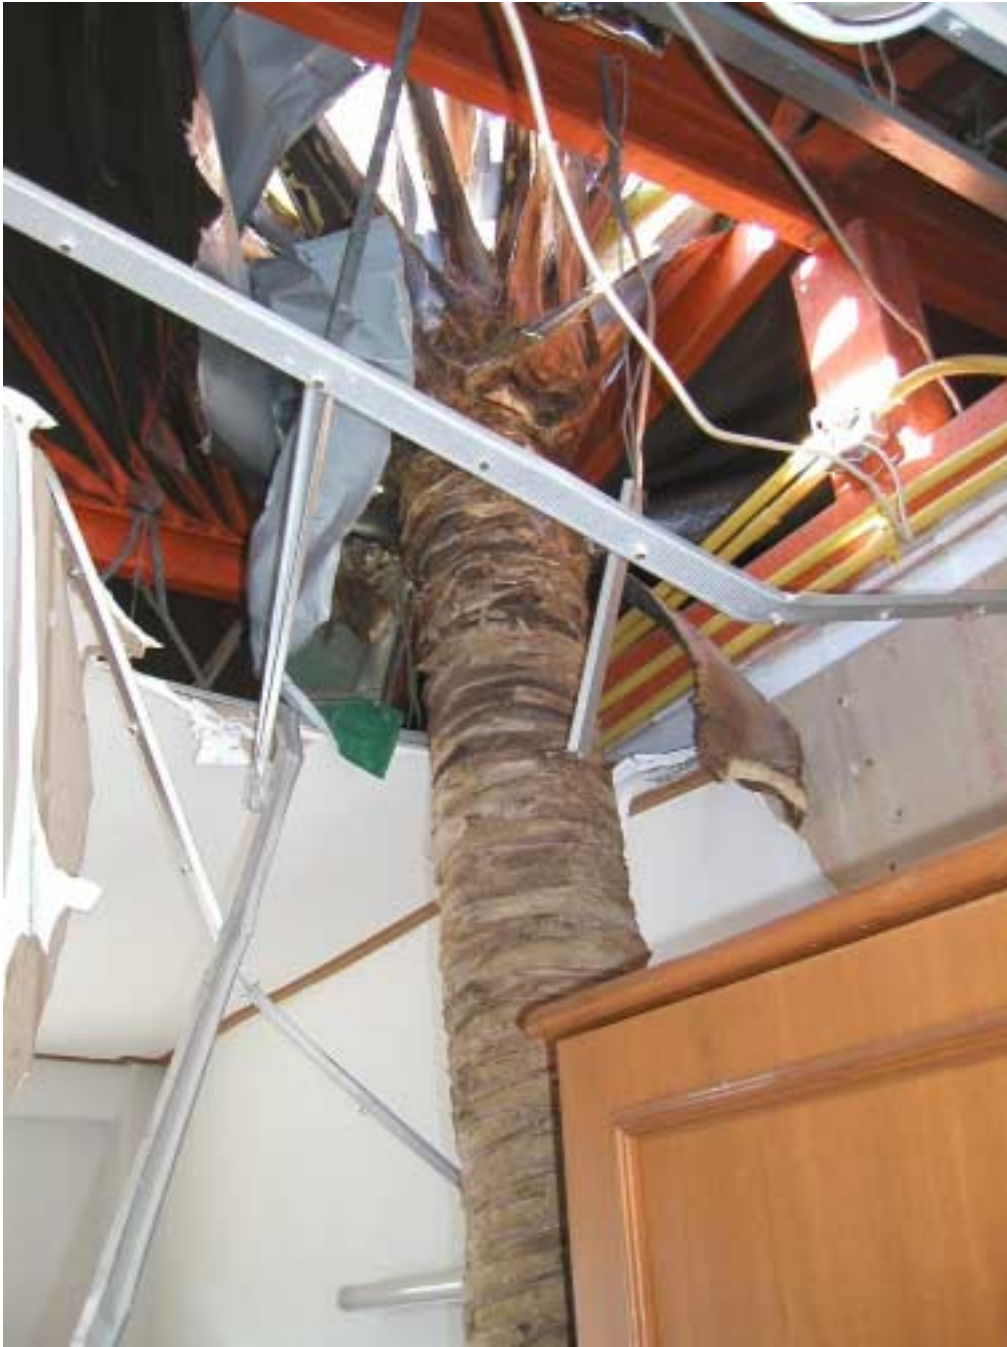
Ten to twelve metre run up heights in Khao Lak meant that for many buildings the inundation extended to the second, and locally the third, storey. While the damage to partition walls was significantly less in the higher storeys, ceilings and furniture and fittings were caught up in the torrent and damage was frequently initiated by the impact of projectile logs and other debris (Figure 14).

Figure 14. Extraordinary volumes of debris were entrained by the tsunami and contributed to its destructive impact. This coconut palm trunk penetrated the roof and internal ceiling of a hotel on Koh Phi Phi (Photo ED).

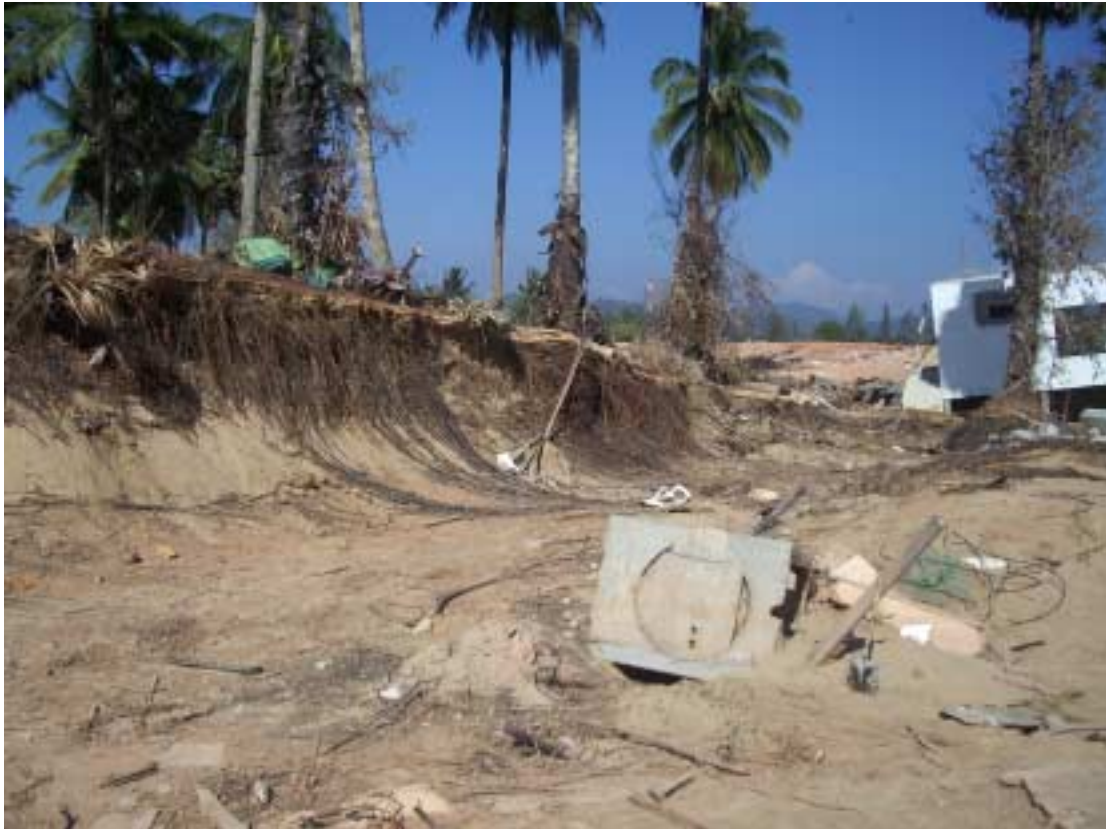
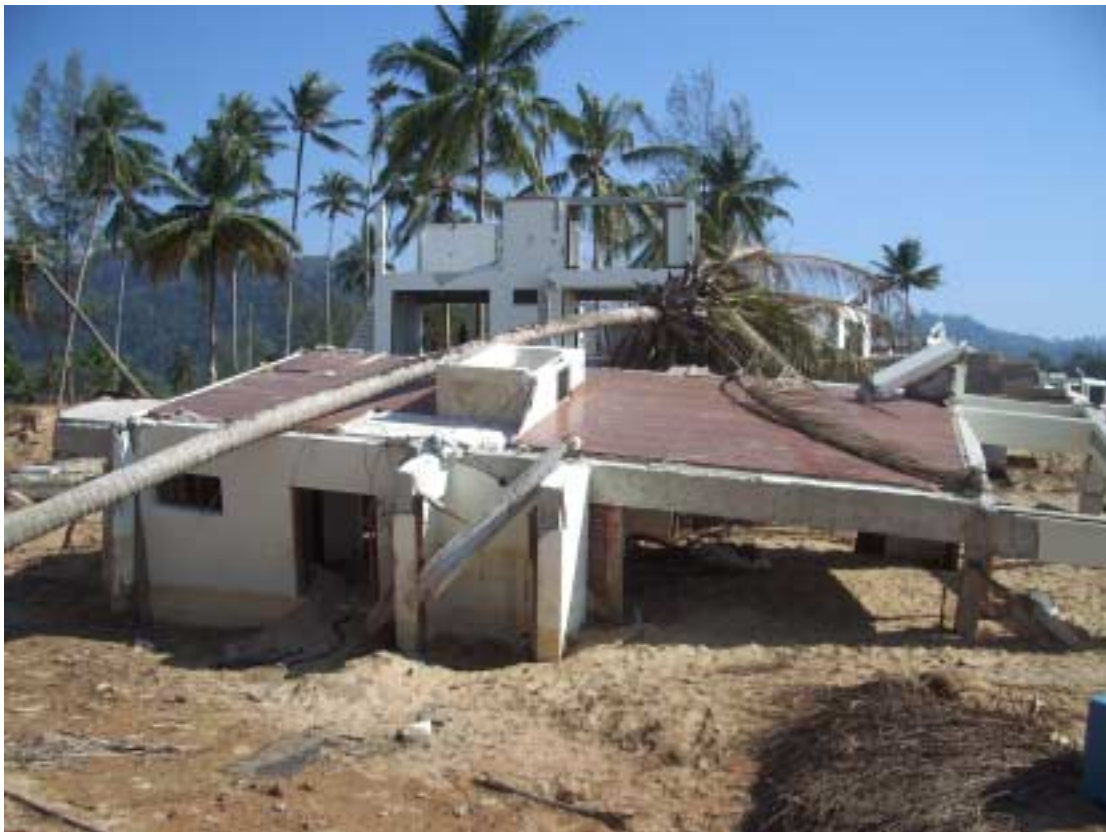
At a number of Khao Lak coastal resorts the outgoing sea waters (following each wave inundation) caused extensive and deep outwash scour channels causing numerous coastal side-road dropouts. Since these resorts were far from re-establishing at the time of our visit, these dropouts had yet to be repaired.

Figure 15a and 15b. The receding waters after each wave caused substantial scouring of small streams and low-lying depressions, as shown here at Khao Lak. The scoured “channel” (15a) is 50 m wide and up to 3 m deep, completely undermining the resort buildings (15b) nearby (Photos RB).

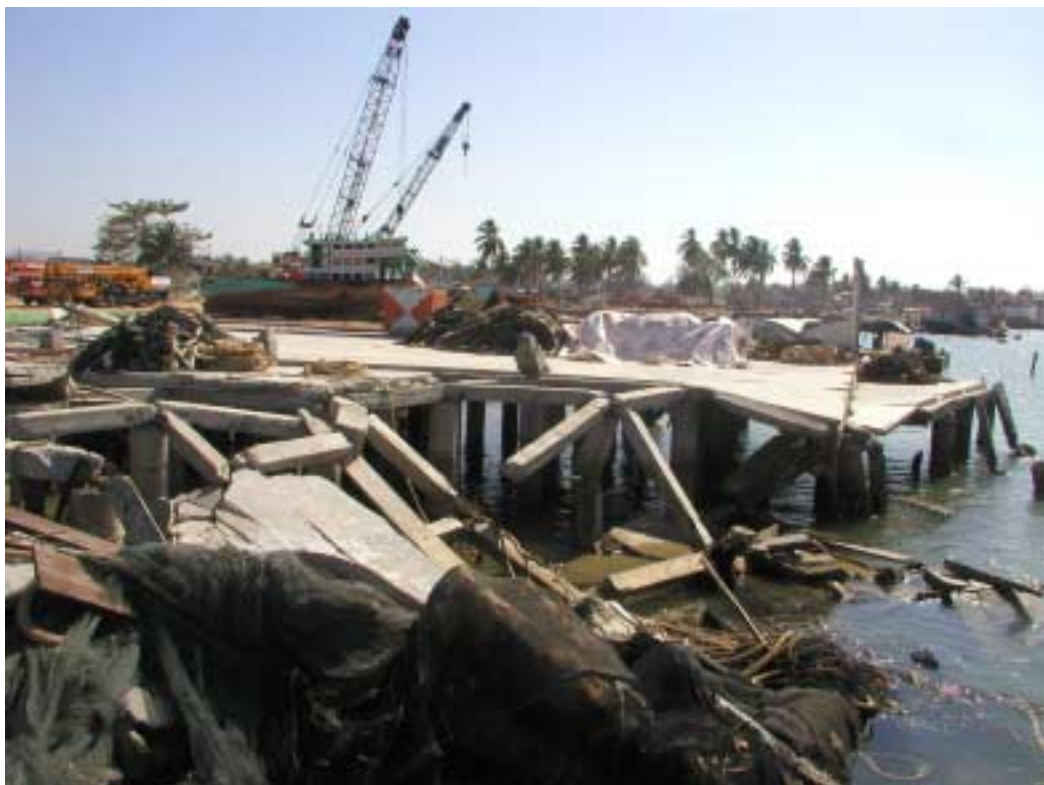
Figure 17. Severe damage to the wharf piles and topping at Ban Nam Kem, a fishing port north of Khao Lak, where the tsunami height reached nine metres (Photo HC).

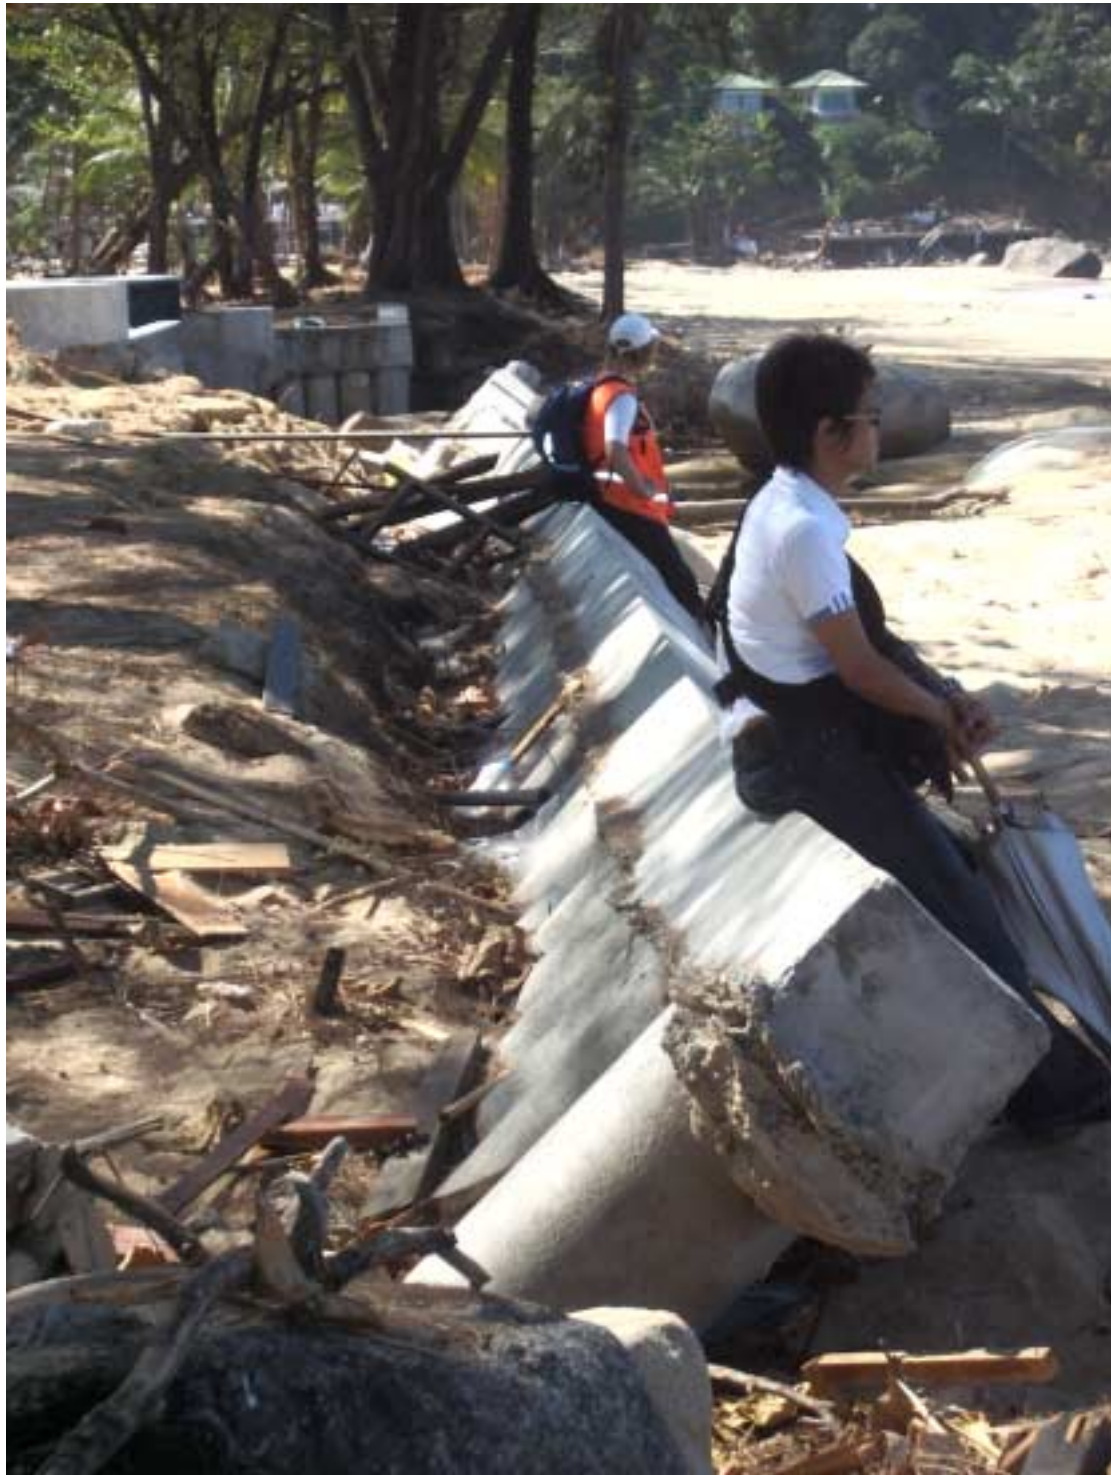
Figure 18. Receding waters (out-rush) caused collapse of most seawall defences from behind due to scouring (Photo RB).

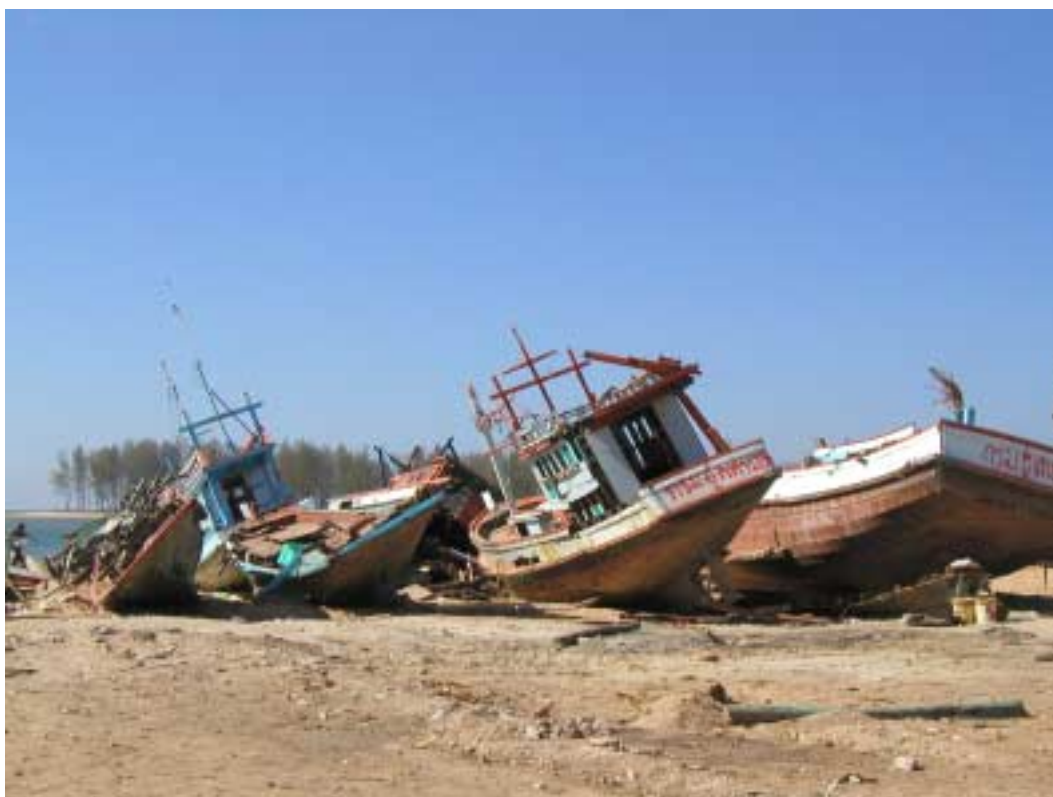
The tsunami also caused significant damage to the local fishing industry (Figure 19), with around 20% of officially registered boats suffering damage (EIU, 2005). The Department of Fisheries estimates that a total of 7,446 fishing boats were lost (UNDP, 2005a).

Figure 19. *At Ban Nam Kem, fishing and port facilities were destroyed, many lives were lost and the ecology of coastal fishing grounds altered. The economic recovery from the tsunami poses a significant challenge to this community and others like it along the Andaman coast (Photo ED).*
