**Impacts and management of recent volcanic  
eruptions in Ecuador: lessons for New Zealand**

Science Report

2005/20

**June  
2005**

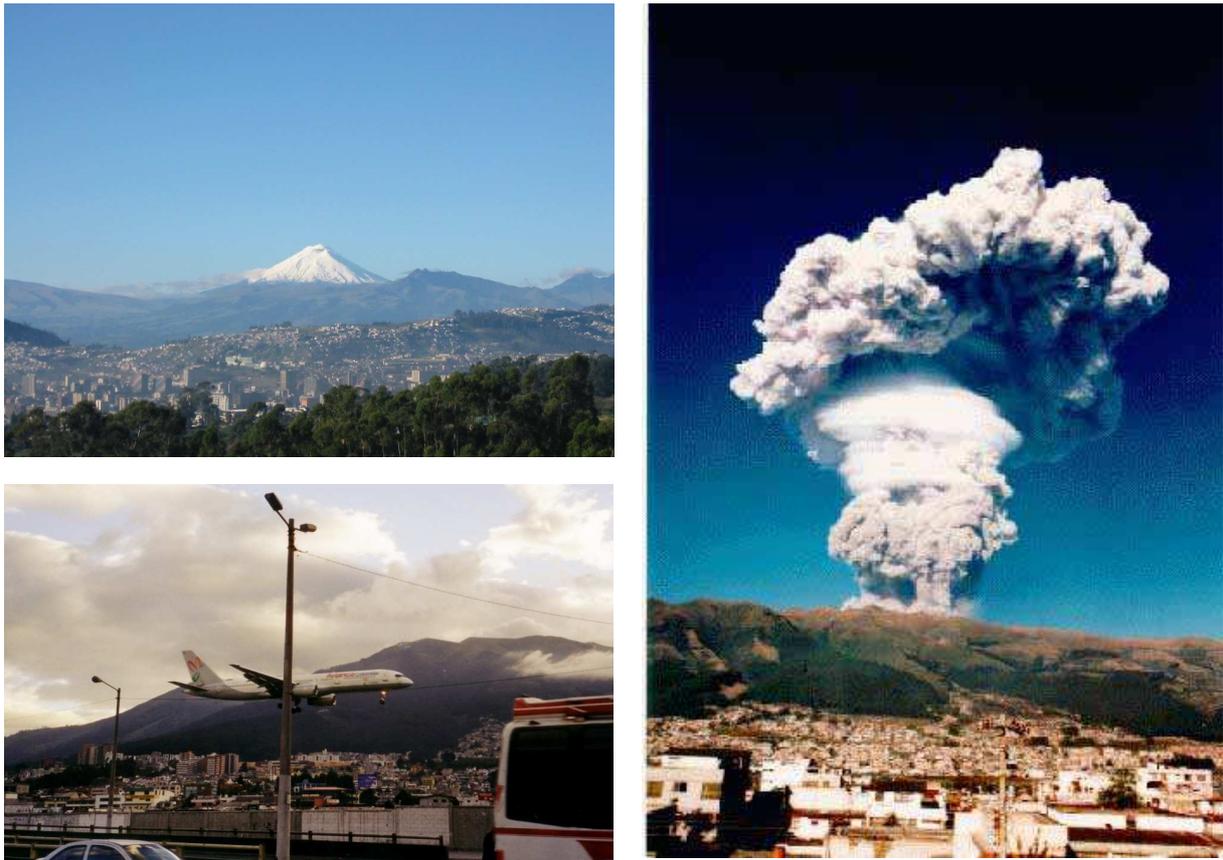
**Figure 3** Two volcanoes close to Quito have been active in the last 200 years. Above: Cotopaxi viewed southeast over Quito's southern 'valley' district; below left: Guagua Pichincha viewed east over Quito's airport. Quito sits directly at the base of the latter volcano (left-hand photos from wikipedia.org); below right: Guagua Pichincha erupting in 1999, viewed to the west over the suburbs of Quito (Photo courtesy of IGEPN).

All of Quito city can expect ash fall from neighbouring volcanoes from time to time. As mentioned above, the 1999 eruption of Guagua Pichincha and 2002 eruption of Reventador have most recently supplied millimetre-thicknesses of ash to the whole of Quito city (Figure 3). The “valley” suburbs to the south, home to at least 0.2 million people, are also subject to lahar hazards from Cotopaxi volcano.

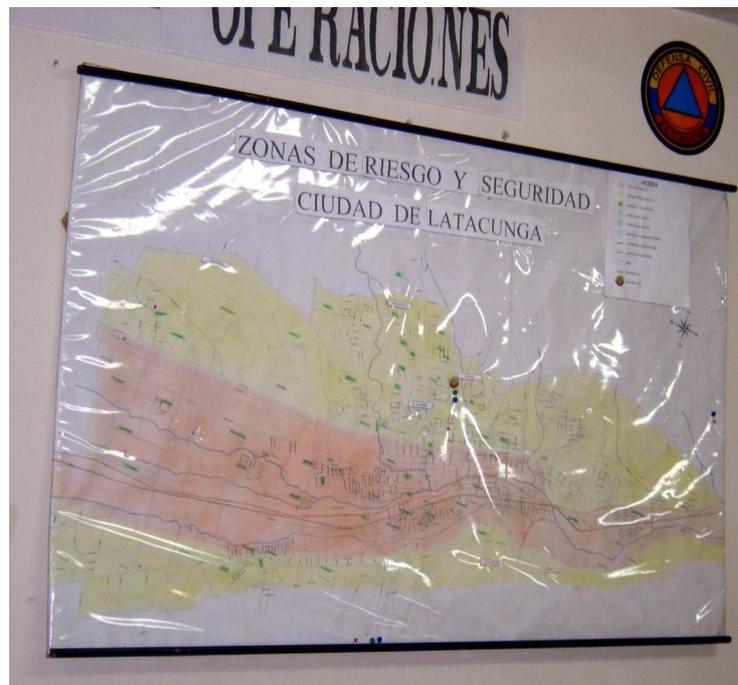
**Figure 4** Civil Defence lahar hazard map of Latacunga, showing the high and moderate lahar danger zones (orange and yellow, respectively) over the street layout; much of the city is at risk.

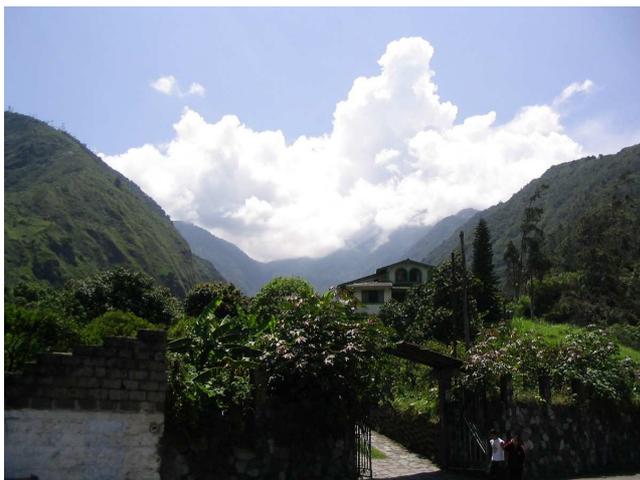
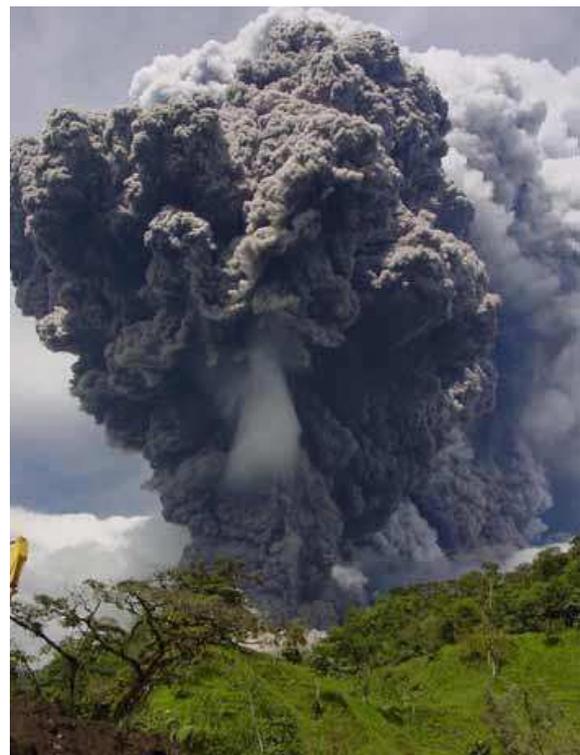
Baños lies on a terrace of pyroclastic flow and lahar deposits formed from Tungurahua eruptions (Fig. 5), with additional lahar material contributed from Cotopaxi volcano. The western part of the town lies within a valley in a steep catchment feeding pyroclastic flows and lahars directly from the summit of Tungurahua. Pyroclastic flows travelling down this valley could easily spread out to engulf most or all of the town. Lahars from this valley may also affect an area of the town more significant than the valley area itself. Baños has in total received centimetres of ash from the 1999 to present eruption of Tungurahua, and continues to get dustings as often as weekly. Local doctors have anecdotally reported greater than normal incidences of some cancer types in the town, up to four times the expected rate, but the cause has not been determined.

**Figure 5** Above: the path of lahar and pyroclastic flows from Tungurahua summit (in cloud) that could potentially devastate western Baños (foreground and out of frame to left) at some future time.. Right: Tungurahua erupting in 2003, as seen from the slopes of the volcano. The town of Baños lies at the northern edge of these slopes. (Photo IGEPN)

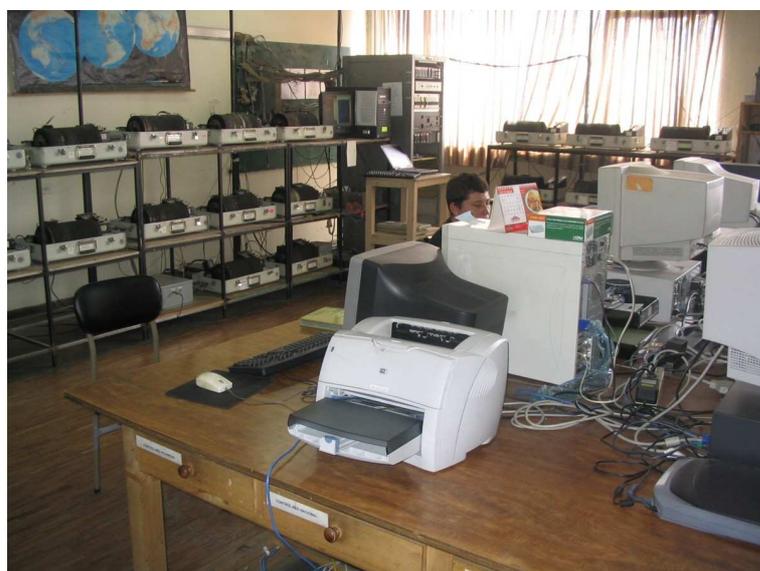
Monitoring involves the use of seismographs, pressure sensors, ground deformation, geochemical, thermal and visual data (Fig. 6). They also have direct international contacts to warn and receive warnings of ash fall from eruptions in neighbouring countries. For example, Peru contacted IGEPN in Quito directly in the last Gallarez eruption (2004).

**Figure 6** Computer and smoker-drum monitoring and recording of radio-telemetered seismograph data at Instituto Geofisico in Quito. Earthquake locations are calculated here and Civil Defence is alerted to those indicating eruptions. Staff and students are rostered to provide a constant monitoring presence.

Seismograph data is telemetered in near-real-time via radio to Quito, and in the case of Tungurahua, also to the IGEPN's local observatory, just off the northern flanks of the volcano. Earthquake locations are fixed on computer by staff and graduate students rostered as round-the-clock staff at the Quito office. Seismograph data, as well as being stored on computer, is plotted on smoker drums as it arrives, for easy visual monitoring of earthquake activity.

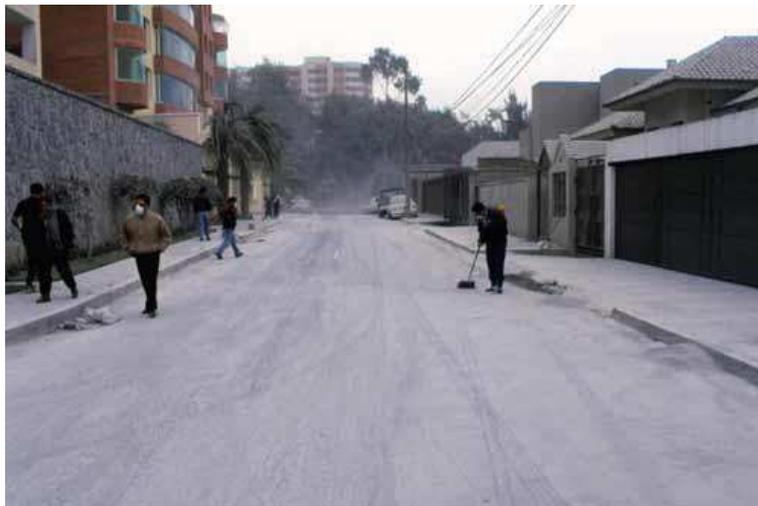
Much of the ash that fell in urban areas in both eruptions was prevented from entering storm water drainage systems, partly due to rapid clean-up by residents and the military, but also because of light rain that stabilised the ash rather than washing it into drains. Those drains that were blocked were cleaned using high pressure water and brooms (where access permitted). No damage was reported to pumps, but increased maintenance was required. There were a few barrios (street blocks) where enough ash moved into storm water systems to cause localised flooding after the eruption (PAHO, 2003). Local calculations suggest that about 300,000 tonnes of ash was shovelled from drains in Quito after the 2002 Reventador eruption (Fig. 7).

**Figure 7** Streets are swept by hand in Quito, and ash enters storm water drains causing some blockage, but no damage to storm water pumps has been recorded. Ash is removed by trucks, so only a small proportion enters drains.

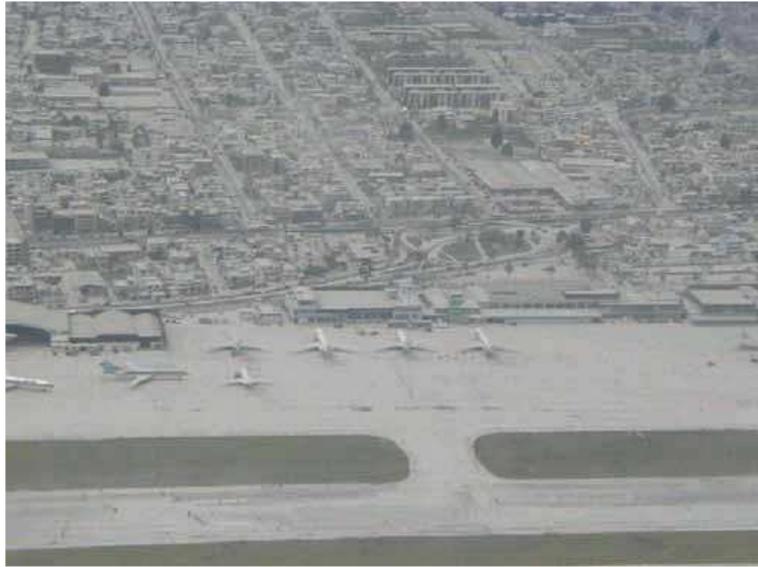
During the Guagua Pichincha eruption in 1999, 2 to 3mm of ash was twice deposited on Quito airport; the 2002 Reventador eruption resulted in a 4mm covering of ash. In all cases grounded aircraft were covered by ash (Fig. 10). In 2002, the airport was given 5 hours of warning (9am warning from IGEPN), but no mitigation was initiated at that time. The airport was closed one hour before ash began to fall. Rapid response was required to protect vulnerable parts of the aircraft parked on the taxiways and aprons of the airport. Aircraft nose-cones and windshields were covered by tarpaulins. Landing gear, engines and pitot tubes were also covered (all plane baggage compartments contain engine covers). Wings were not covered, but all flaps/spoilers etc. were fully closed/retracted.

**Figure 9** Two to four millimetres of ash has fallen on Quito airport twice in the last 6 years

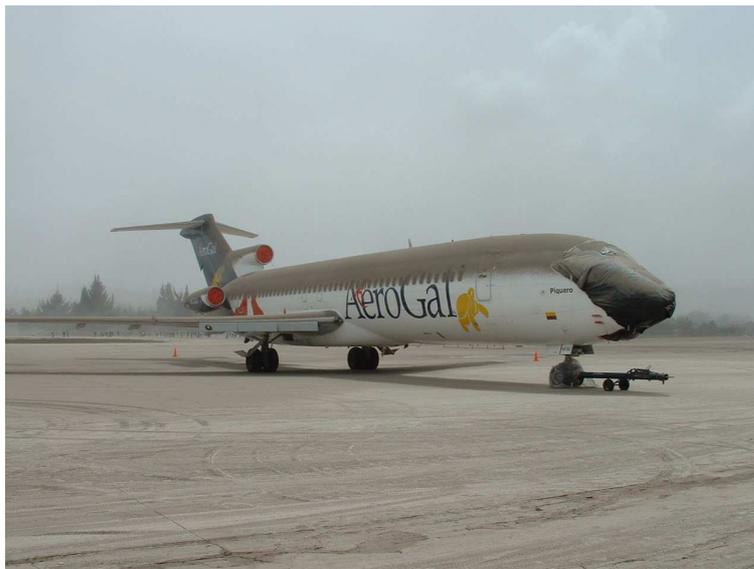
**Figure 10** Average jet airliners were able to be cleaned by high-pressure water blasting from standard fire appliances in 10 to 15 minutes. No water ingress was detected, and no leachate or abrasion damage was noted. Aircraft maintenance experts were on hand to monitor effects. Note the covering of engines and nose cone prior to ash fall.

Ash adhered to the aircraft, but was dry enough to be removed by a person blowing on it. The ash remained on the aircraft from 12 to 48 hours, depending on when crews cleaned each aeroplane. Aircraft were moved with tow vehicles rather than starting jet engines or auxiliary power units in the presence of ash. Cleaning was performed using high pressure water from

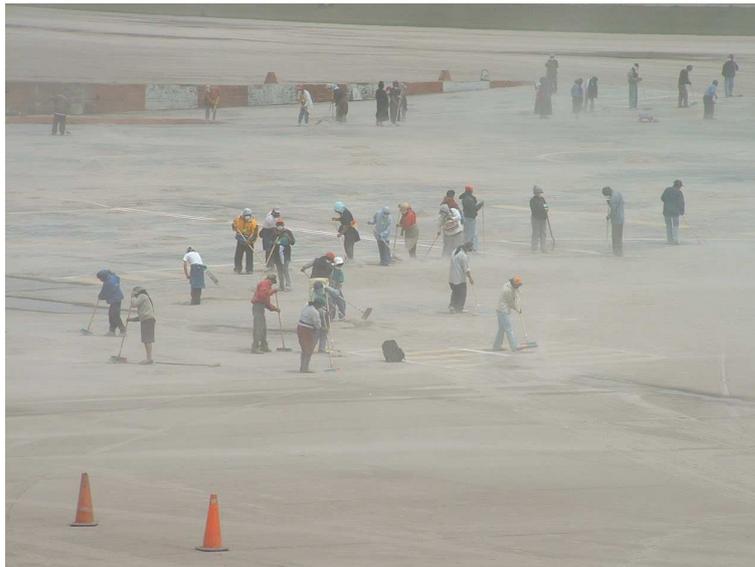
**Figure 11** Five hundred workers took at least seven days to clear the runways with brooms, working for 15-hour shifts.

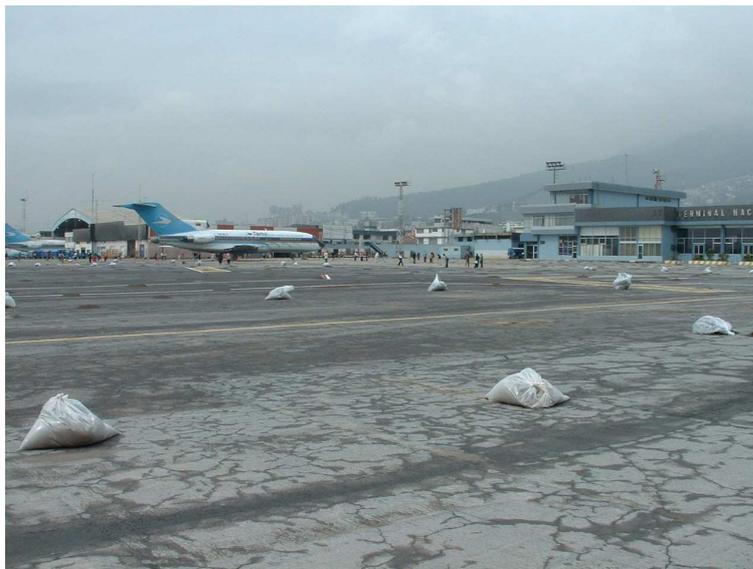
**Figure 12** Ash was bagged in place then removed by truck.

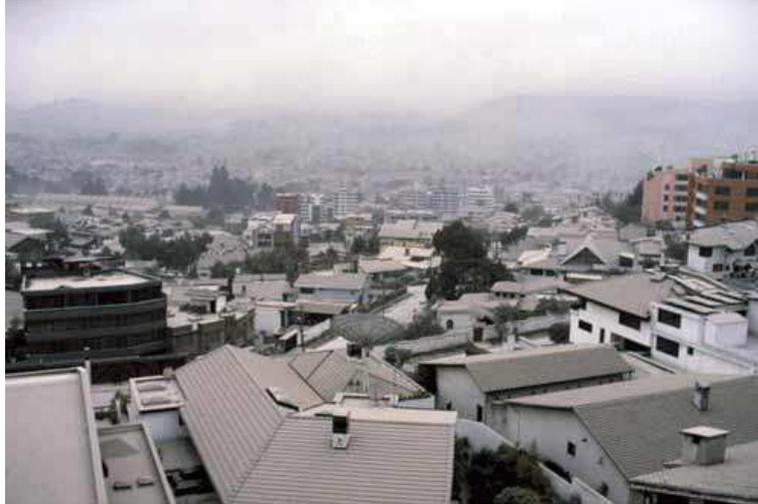
**Figure 13** Ash covered roofs in Quito

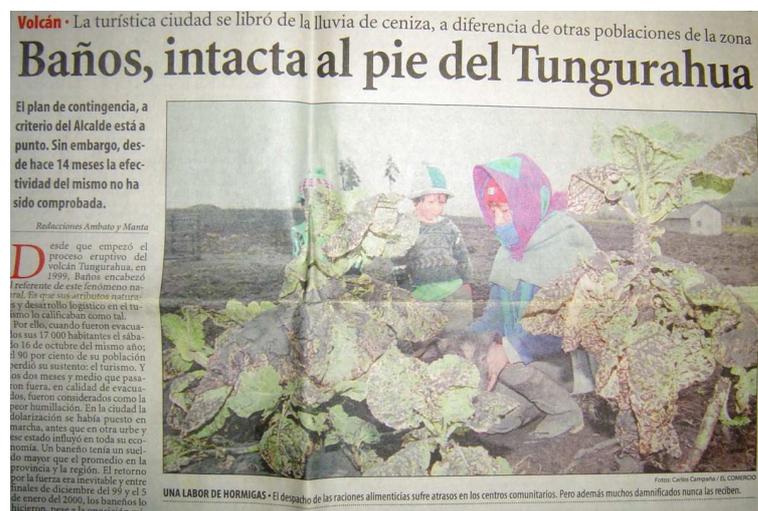
Different crops react differently to ash. Plants with larger leaves tend to be affected more, as there is a larger surface area for the ash to accumulate on (Fig. 14). How exposed they are is also a factor, as wind and rain may wash ash off leaves. Leaves closer to the ground will usually be affected more by ash, as these are more sheltered from the wind, and any accumulation of ash therefore remains on the plant for longer. Similarly ash fall at night, when wind is less, tends to adhere to crops of all heights more. With deeper ash fall plants are likely to be killed outright. A local farmer reported that some agricultural areas adjacent to Tungurahua received up to ~20cm of ash (partly remobilised/wind blown ash) during volcanic activity in early 2004. These depths reportedly killed all crops, while a few centimetres or less of ash caused about 50% losses in and around Baños. Crops were quickly burned, reportedly by the ‘heat’ of the ash (although leachate burns can not be ruled out), with some farms losing 100% of their crops. Even farms with superficial depths of ash lost ~5% of crops due to hot ash burning foliage (Roberto Castillio pers comm., 2004).

**Figure 14** Crop damage in 1999 in Baños from Tungurahua volcano

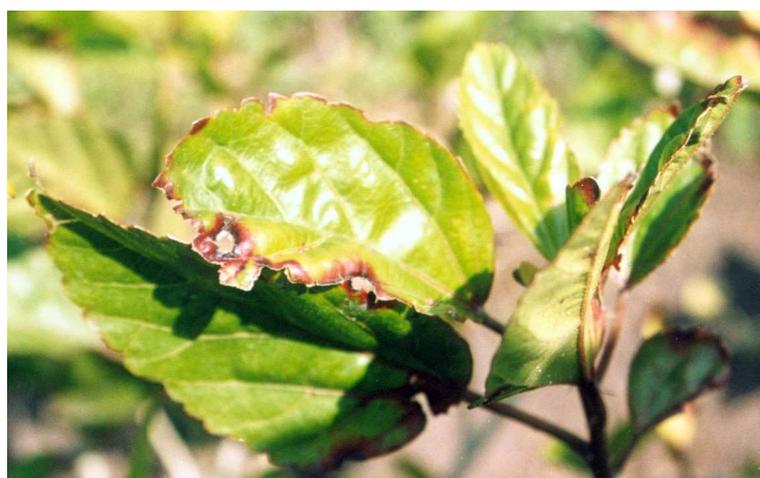
Irregular ongoing eruptions have a greater cumulative effect than a single isolated fall. Light dustings of ash in 2004 were still damaging leaves (Fig. 15). Farmers sometimes face several cycles of ash fall – plant loss – new plantings – ash fall – plant loss and so on. This may lead to eventual economic failure of a farm which might have coped with a single ash fall and crop loss.

**Figure 15** Crop damage in Baños in 2004 from occasional dustings of ash only

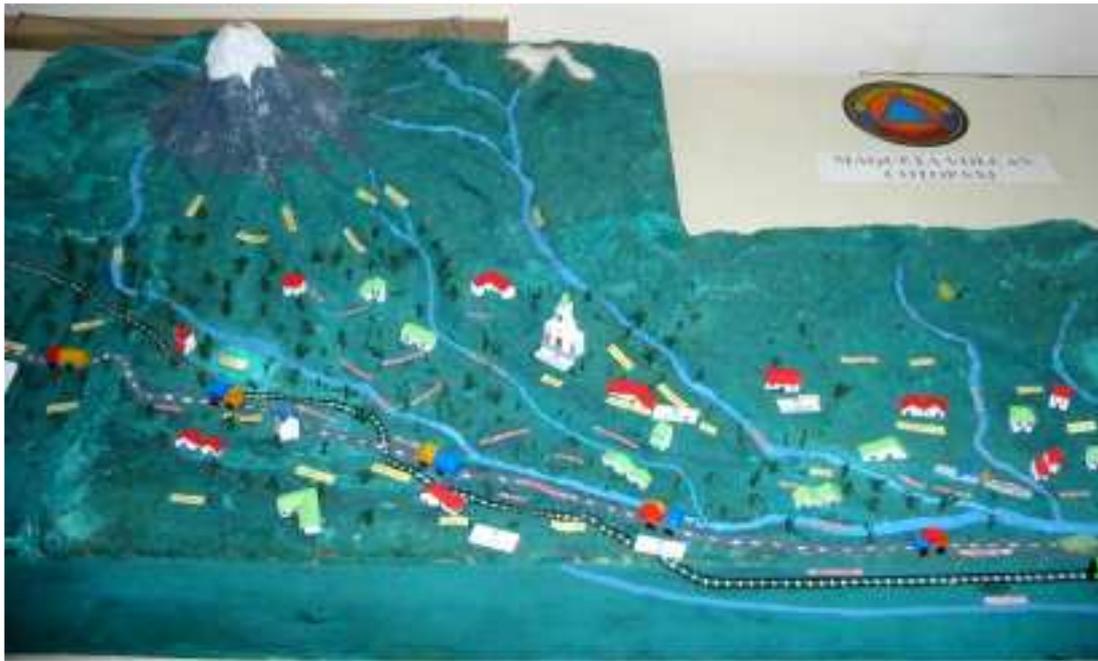
**Figure 20** Table-top relief model of Latacunga Valley used as an education tool by Cotopaxi Civil Defence.

Civil Defence in the Latacunga area (Cotopaxi Province), have also been heavily involved with educating the southern flank at-risk communities. Figure 20 presents a table-top model used in their face-to-face education. In Latacunga, CD has jurisdiction over a much larger area than just the city itself, incorporating the majority of the populations at high risk from lahars along the Rio Cutuchi. Approximately 130,000 people are believed to live in high-risk zones in the Latacunga Valley, and as historical evidence shows that over 60% of Cotopaxi's lahars travel down this valley it is important that preparedness and evacuation education reaches these people. Civil Defence estimates that over 80% of residents in the high risk zone have received preparedness/evacuation education; however, around a quarter are thought not to believe, or take notice of the information until Cotopaxi erupts. Demographics of this area have a significant influence, with indigenous peoples comprising a higher proportion of the population, especially in the sierra region (leading to belief and language barriers in hazard education), as well as a generally lower level of education than in urban areas.

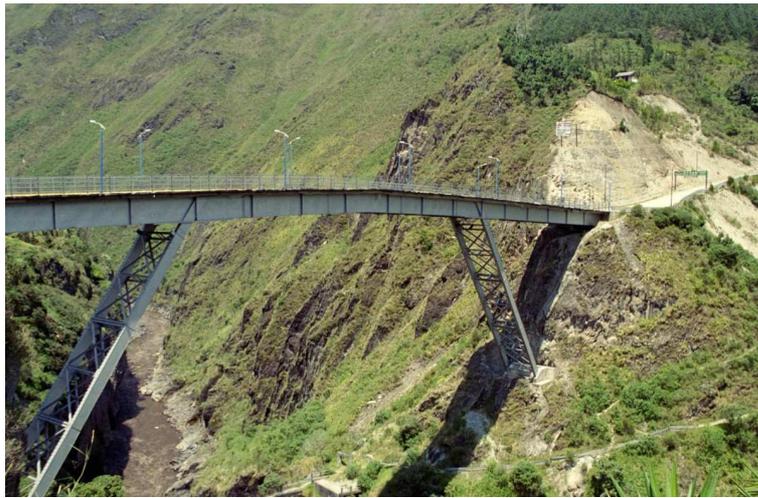
**Figure 25** Bridge to safety: Installed since the 1999 reawakening of Tungurahua, this bridge provides an evacuation route from Baños (at left) but there is concern that it crosses the major lahar and pyroclastic flow valley, and connects to a part of Baños also likely to be in the path of a pyroclastic flow.
