**Effects on Motor Vehicle Behavior of Color and Width of Bicycle Facilities at
Signalized Intersections**

Glen Koorey, MIPENZ

Elizabeth Mangundu

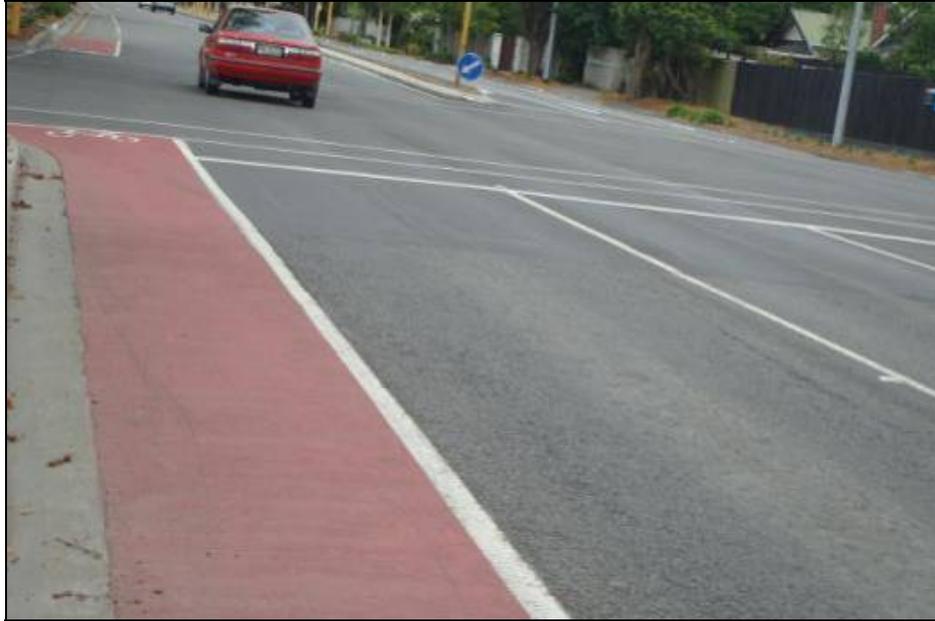
FIGURE 1 Typical Advanced Stop Line (ASL) in Christchurch, NZ

- Advanced Stop Lines (ASL), whereby the bicycle lane is extended slightly in front of the traffic lane limit lines (see Figure 1), to improve bicyclist visibility particularly for turning motorists.
- Advanced Stop Boxes (ASB), whereby an area is located directly in front of the traffic lane (see Figure 2), to provide more queuing space and assist with right-turning.

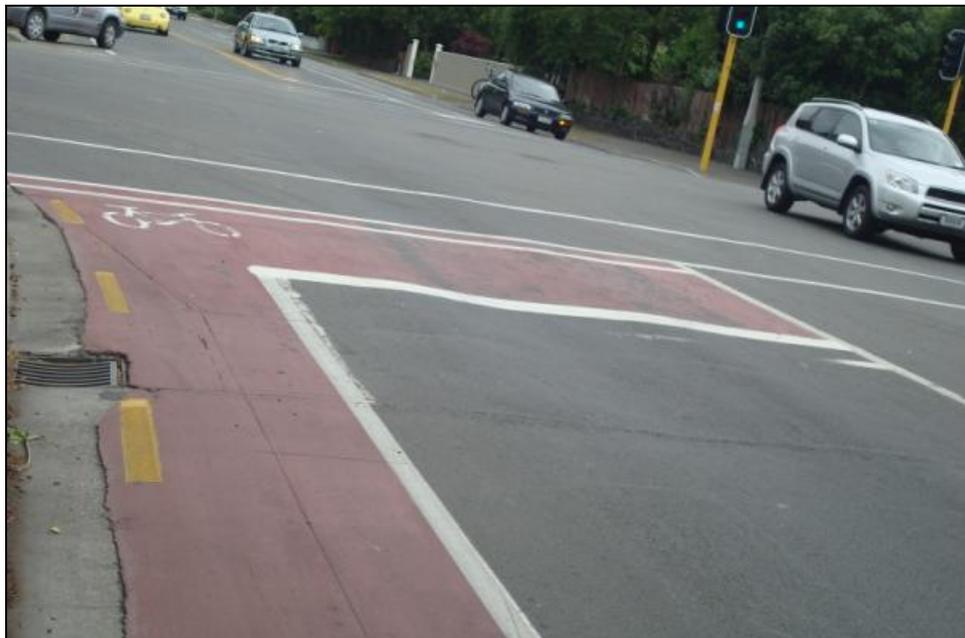
FIGURE 2 Typical Advanced Stop Box (ASB) in Christchurch, NZ

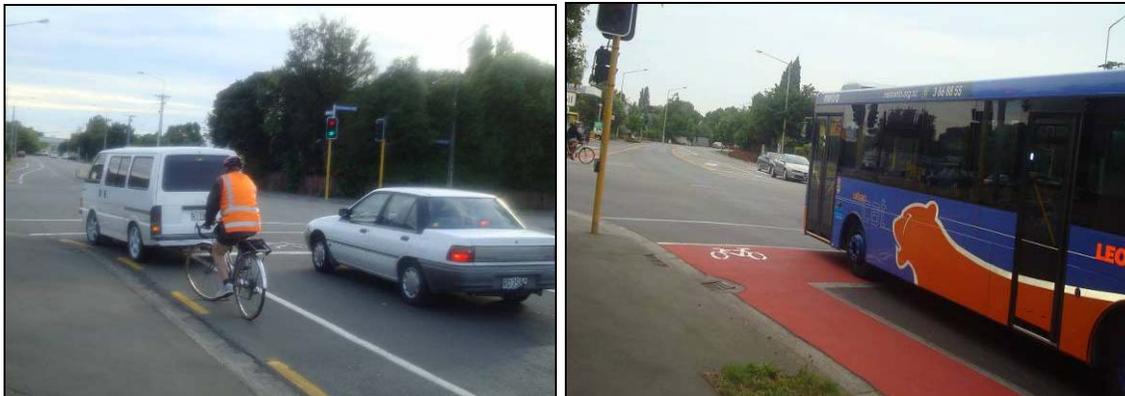
FIGURE 6 Examples of Full Encroachment on ASLs and ASBs

“Full encroachment” is where a motor vehicle stops or drives whilst covering the whole bicycle space and a bicyclist has to find an alternative route or waiting position (Figure 6). Too many full encroachments on a site with an ASL mean that the queuing space is not accessible to approaching bicycles. Similarly, a full encroachment on the bicycle lane side of the ASB is more hazardous than those on the advance box.
