SEISMIC PERFORMANCE OF AN UNREINFORCED MASONRY BUILDING: AN EXPERIMENTAL INVESTIGATION

Jitendra K Bothara¹, Rajesh P Dhakal², John B Mander³

Abstract

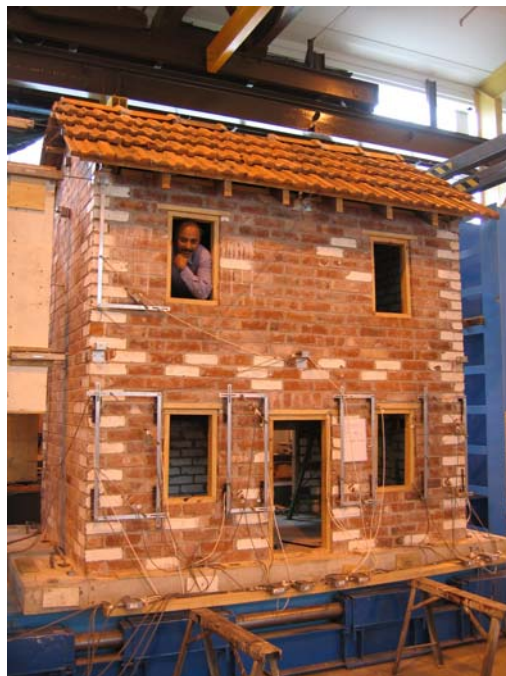
Figure 2: Model building on the shake table during testing in the longitudinal (E-W) direction

unidirectional accelerometers were used during the two test series. The locations of accelerometers used during the shaking table test in the longitudinal direction are also indicated in Figure 1. Similarly, 48 and 28 linear potentiometers were attached to the model building during the tests in the longitudinal and transverse directions, respectively. These potentiometers were employed to measure crack opening at the rocking base, shear deformations in the piers, sliding between the floor/roof and the walls, and movement of the model base slab in the direction of shaking. Apart from those used inside the building to measure the sliding between the floor/roof and walls, most of these potentiometers can be seen in Figure 2.

The testing program was basically aimed at two objectives: i) identification of dynamic characteristics; and ii) investigation of seismic behaviour of URM buildings. For identification of dynamic properties, the model building was subjected to several white-noise excitations. To investigate the model building's response to strong shaking, it was subjected to frequency-scaled earthquake ground motions in the longitudinal and transverse directions. A view of the model building on the shaking table is shown in Figure 2.

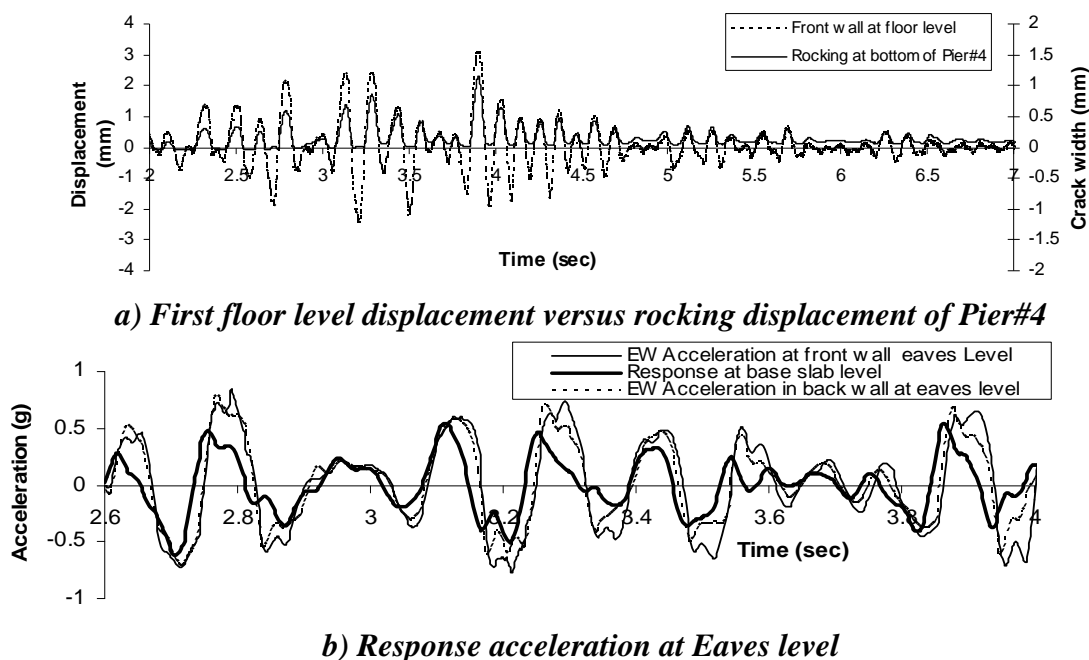
Figure 4: Seismic response of the model to RA01168 (0.5g) excitation (longitudinal shaking)

nothing significant was observed in the back wall. The transient acceleration responses of the model building to the RA01168 (0.5g) excitation measured at the base and eaves of the front and back walls are compared in Figure 4b. A phase shift between the input acceleration and the response acceleration can be seen in the figure, which indicates softening of the model.

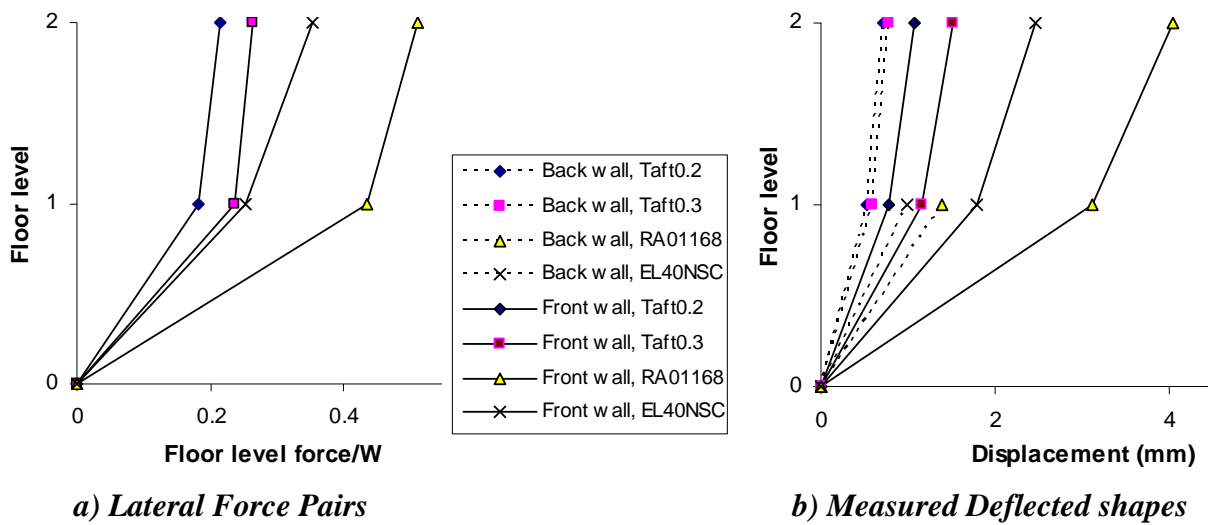
Figure 5: Deflection and forces at the floor levels during the longitudinal shakings

Figure 5a presents the normalized forces at the two floor levels during the four excitations in the longitudinal direction. The floor level forces were computed by multiplying the measured acceleration by the tributary mass at that level, and the plotted coefficients are the normalized values with respect to the effective seismic mass of the model building. In uncracked state, the force pairs (at the two floors) are nearly equal. It contradicts with the code-recommended provision of triangular distribution of the floor level forces. However, with increasing damage in the bottom storey, a change in the lateral load distribution is evident in the figure.

Figure 5b presents deflected shapes of the model during the four seismic excitations. Deflections measured at both the front and back walls are plotted in the figure. A rapid increase in deflection in the first storey front wall can be observed compared to the second storey. It is because most of the damage was concentrated in the first storey front wall. Moreover, throughout all excitations, the front wall deflected significantly more than the back wall and the rate of increase of deflection in the front wall also exceeded that in the back wall. These can be attributed to: (i) visibly more damage in the front wall (than in the back wall); and (ii) rocking of the front wall, which must have contributed to additional deflection.

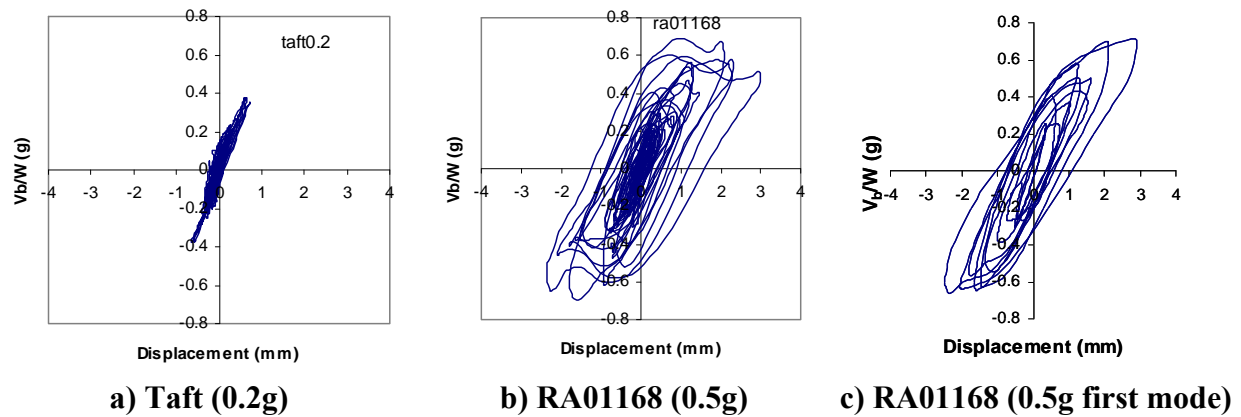
Figure 6: Displacement versus average acceleration plots at the first floor level front wall (Longitudinal shaking)

Figures 6a and 6b present average response acceleration-displacement curves for the Taft (0.2g) and RA01168 (0.5g) excitations. A consistent increase in strength can be noticed after the first cracking if the two figures are compared. After initiation of cracking at the average response acceleration of 0.384g, the average response acceleration increased to 0.7g during the RA01168 (0.5g) excitation. The maximum displacement observed at the first floor level was about 3 mm and that at the eaves level was 3.9 mm during this shaking. The figures show an increasing level of non-linearity and decreasing stiffness in the response of the model building with increasing excitation severity. After significant cracking during the RA01168 (0.5g) excitation, the acceleration-displacement plot is bilinear with the acceleration (i.e. capacity) degrading almost linearly because of the P- Δ effect. In order to see the response of the degrading system due to the first mode of vibration, the response data within the time window including the most intense shakings was narrowly filtered around the identified frequencies of the first mode [11, 19]. Moving average smoothing of the

acceleration and displacement time history data was carried out to improve clarity of Figure 6b. The resulting plot of displacement versus the restoring force pertaining to the first mode is presented in Figure 6c for the same excitation. It is evident from the figure that with an increasing displacement, the stiffness (i.e. slope of the curve) decreases and the energy (i.e. area covered by the loop) increases; thereby indicating accumulation of damage.

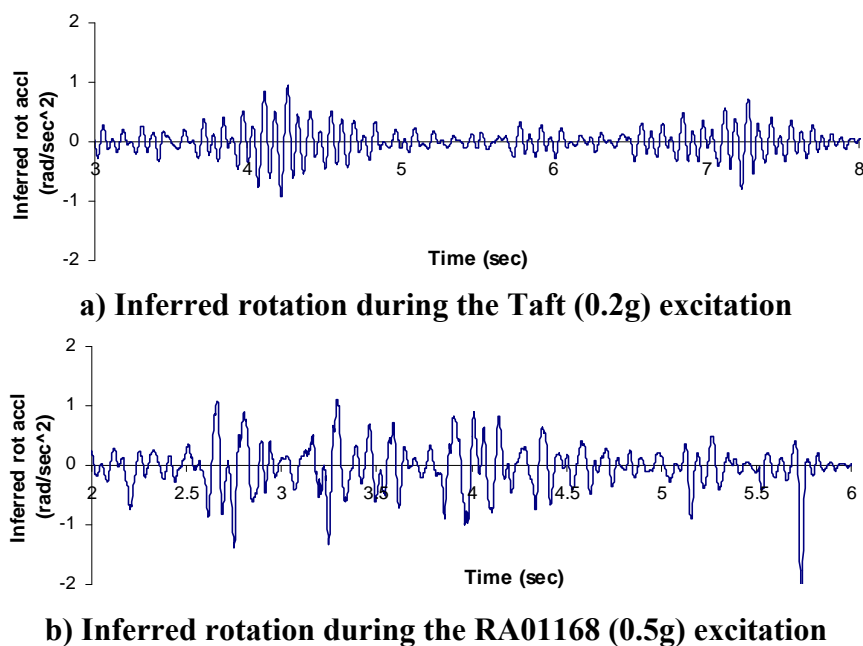
Figure 7: Inferred rotational acceleration of the model (Longitudinal shaking)

The transverse acceleration response histories measured at the two side walls were compared during the different longitudinal excitations. It was found that a phase difference existed in the response acceleration time histories of the two walls, which suggests that the model was torsionally active. Based on the transverse acceleration measurements, the torsional response of the model was approximated. The inferred rotational acceleration histories of the model during the Taft (0.2g) and RA01168 (0.5g) excitations are plotted in Figures 7a and 7b, respectively. Although the normalized maximum acceleration decreased with increasing intensity of shaking, the rotational accelerations increased.

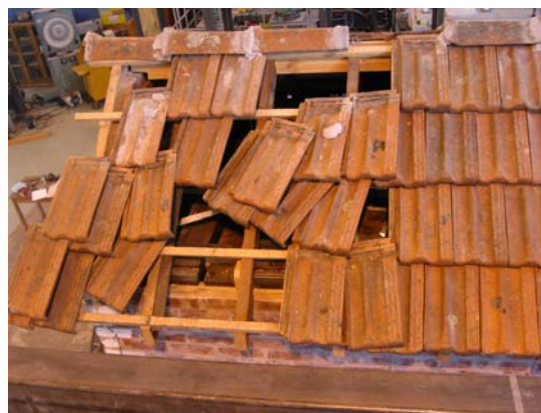
Figure 9: Scattering and falling of unsecured tiles (tied up tiles did not slide)

It is noteworthy that some of the unsecured roof tiles scattered badly and few of them slid off the roof slope during the RA01168 (0.5g) excitation. As shown in Figure 9, these tiles slid off catastrophically during the RA01168 (0.7g) and larger excitations. It is interesting to note the tile sliding started from the roof edge. However, tiles which were tied down with the roof structure did not move much and did not slide off the roof. These were in serviceable condition even at the end of the test, as can be seen in the figure.

8. **Roof tiles behaviour:** It is noteworthy that the roof tiles which were not tied up with the roof structure, scattered badly and few of them slid off the roof slope during the RA01168 (0.5g) excitation. However, in real event these have been seen sliding off at much lower shaking. It could be because of a combination of the following probable reasons: (i) the tiles were not tied down (common in many parts of the world); (ii) the wires could have been corroded; (iii) roof could be more flexible; and (iv) the tiles were not laid well.

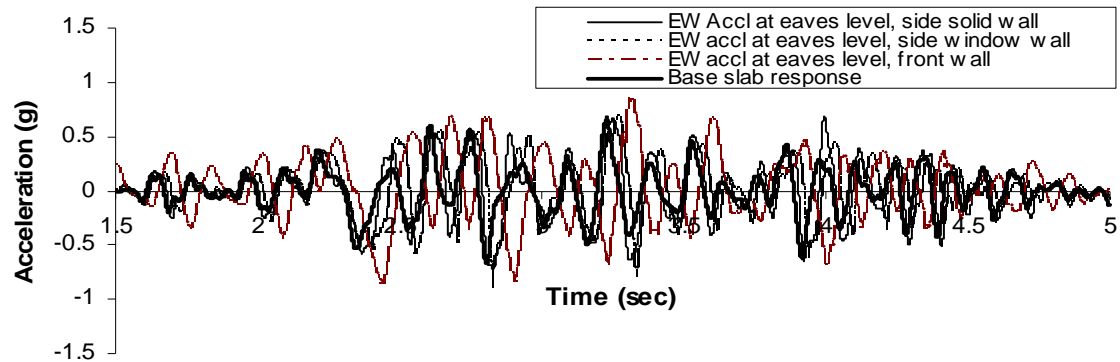
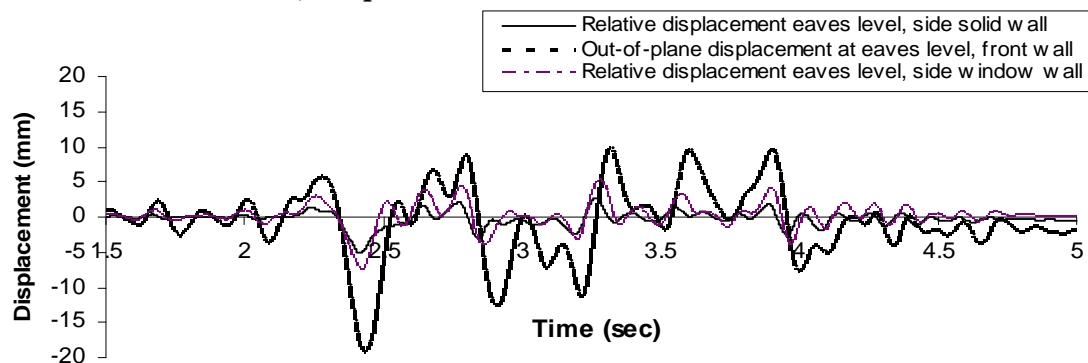
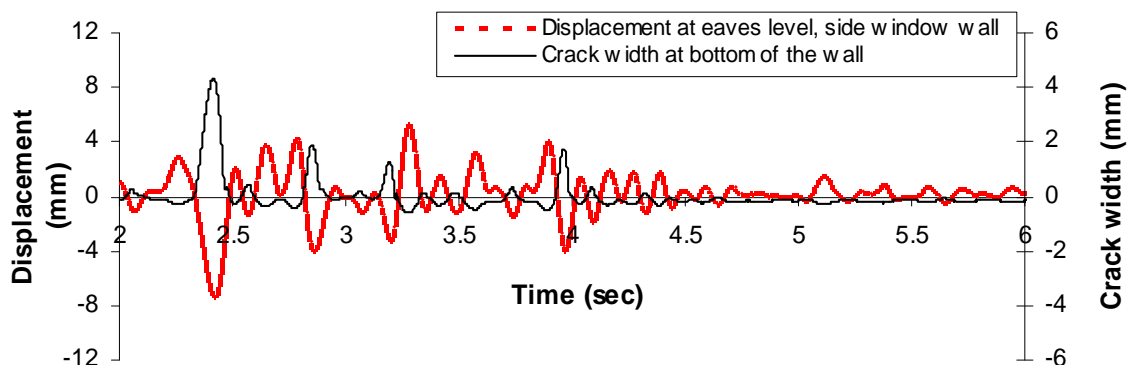
a) Response acceleration at Eaves level

b) Displacement at Eaves level

c) Eaves level deflection and crack opening at the bottom of the side window wall

Figure 11: Seismic response of the model to RA01168 (0.7g) excitation (transverse shaking)

The instrumental data shows that the front wall cracked at the base of the second storey at an early stage of Taft (0.2g) excitation. To explain the general features of the model response to different transverse excitations, the transient response of the model to the RA01168 (0.7g) excitation is presented in Figure 11. A significant phase shift between the input base acceleration and response accelerations of different walls can be seen in Figure 11a. It indicates softening of the model and consequently different dynamic characteristics of the building components. The same is evident in Figure 11b. In this excitation, maximum out-of-plane displacement of the front wall was observed to be about 19 mm. Figure 11c shows that the cracks at the bottom of the side window walls opened up to 4.2 mm which is consistent with the rocking displacement at the eaves level of the wall.

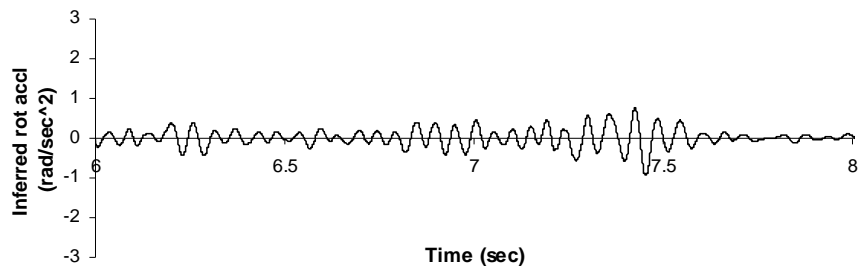
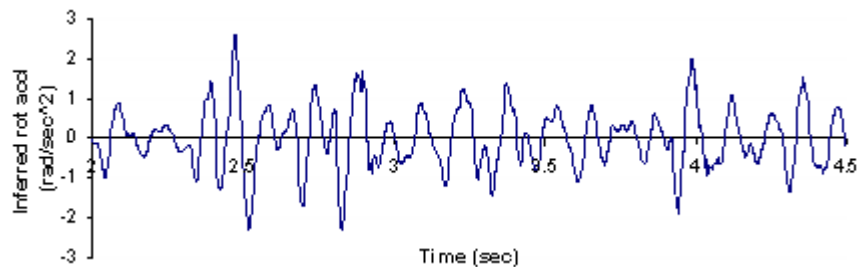
a) Inferred rotation during the Taft (0.2g) excitation

b) Inferred rotation during the RA01168 (0.5g) excitation

Figure 12: Inferred rotational acceleration of the model (Transverse shaking)

As in the longitudinal shaking tests, a phase difference existed between the orthogonal acceleration responses of the front and back walls during the transverse shaking tests as well, which indicate that the model building was torsionally active. Figures 12a and 12b plot the inferred rotational acceleration calculated from the in-plane response of the front and back walls for the Taft (0.2g) and RA01168 (0.5g) excitations. As can be seen in these figures, the rotational acceleration increased with increasing intensity of shaking.

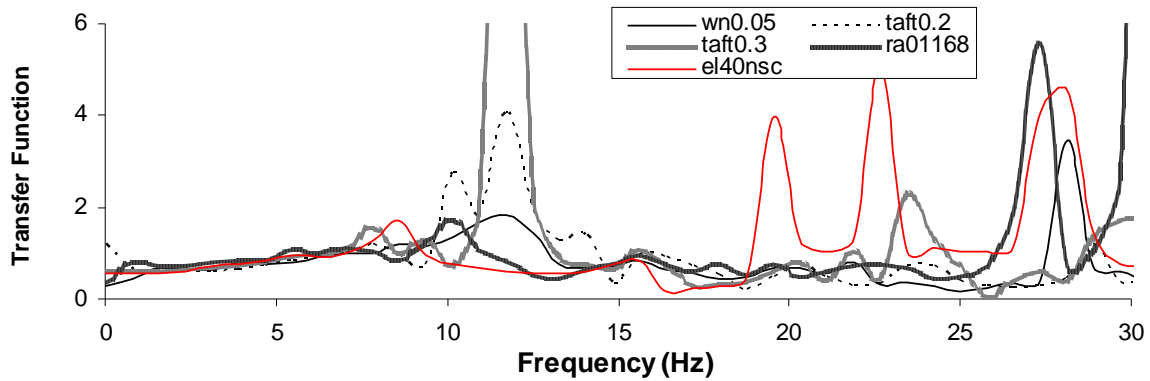
a) Longitudinal shaking

b) Transverse shaking

Figure 13: Transfer functions for the eaves level response acceleration

Figure 13 shows the results of frequency analysis conducted for the most significant period of all longitudinal excitations and the white noise excitations applied in the transverse direction. Table 5 presents damping and other dynamic characteristics of the model calculated from the measured responses during different excitations in the longitudinal direction. Both Table 5 and Figure 13a show a clear shift in frequency from 11.7 to 8.6 HZ during the shakings in the longitudinal direction. This shift in frequency is not only because

of decreased stiffness (due to cracking) but also due to inelastic rocking behavior of the piers. However, the frequency appears constant during the Wn (0.05), Taft (0.2g) and Taft (0.3g) excitations. This is in contrast with the damage and softening indicated by the time domain responses during these excitations. During the white noise test at the beginning, the damping was estimated to be 4.7% which increased to 10.3% with increasing level of damage during the following excitations.

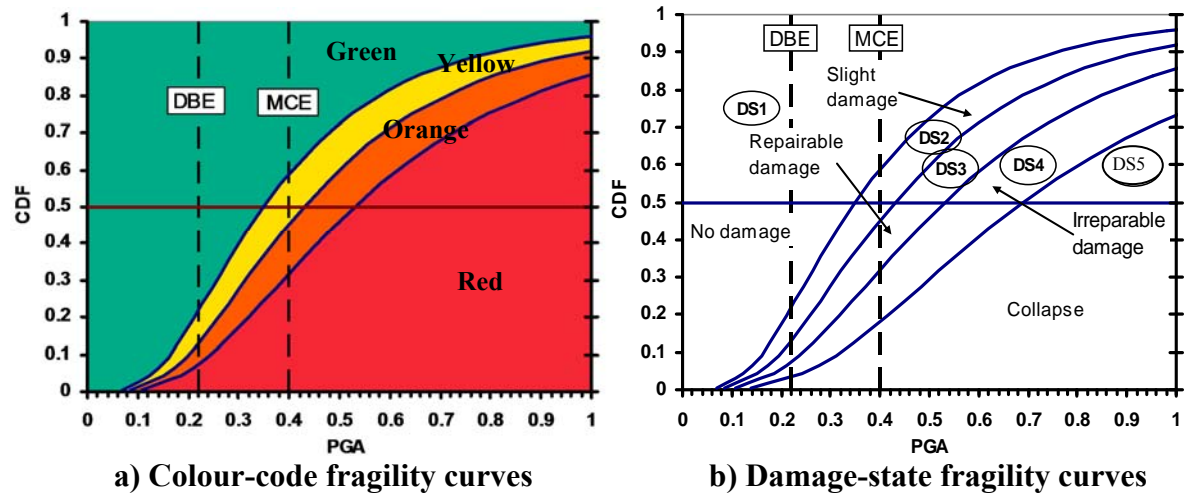
Figure 14: Fragility curves for quantifying performance of two-storey URM buildings

The PGA calculated using Equation (2) and listed in Table 8 are the median values of the PGA corresponding to the boundaries between different damage levels; and these values are likely to vary due to the randomness in ground motion, uncertainty associated with the material properties, uncertainty in modelling and subjectivity in interpretation of the test results. It is common for the different randomness and uncertainties to be combined into a single parameter; i.e. the standard deviation [24]. It has been proved that the variation of

demand (in fragility curves) normally confirms to a lognormal distribution [25]. The standard deviation of the log-normally distributed fragility curves (also called the dispersion factor) have been estimated as 0.5 for reinforced concrete [25] and 0.64 for masonry [26]. In this study, the lognormal standard deviation of the PGA functions for different damage states and colour tags is taken as 0.6, which combined with the median PGA values shown in Table 8 are then used to develop fragility curves following a lognormal distribution.

Thus generated fragility curves for a typical URM house where damage states are classified according to the post-earthquake inspection-based colour-coding format as well as the damage-state format are presented in Figure 14. In the graph, MCE (Maximum Considered Earthquake) is the 2475 year return period event (i.e. 2% in 50 years) with $PGA = 0.4g$ and DBE (Design Basis Earthquake) is the 475 year return period event (i.e. 10% in 50 years) with $PGA = 0.22g$ on rock for Christchurch. It can be interpreted from the plot that if a DBE strikes Christchurch area, some 7% of the URM houses might be red tagged, 6% orange tagged, another 9% yellow tagged and the remaining 78% would be still inhabitable. However, if an MCE was to strike the city, some 31% of the URM houses would be red tagged, 14% orange tagged, other 14% yellow tagged and only 31% would be inhabitable. Based on the damage-state considerations, if a DBE was to strike Christchurch, some 7% of the URM houses can be expected to suffer irreparable damage or collapse, while up to 93% may suffer damage that would be either slight or repairable. However, if an MCE was to strike, then some 32% URM houses might suffer irreparable damage or collapse with the remaining 68% suffering minor or repairable damage. Alarmingly, there is only about 68% chance that a URM building will maintain life-safety (i.e. by not exceeding Damage State 3) in an MCE. Note that the current fragility functions are generated based on the experiment of a URM building model with a strong reinforced foundation slab and the outcomes might be more alarming for URM buildings with loose and flexible foundation system.
