# Potential impacts from tephra fall to electric power systems: a review and mitigation strategies

J. B. Wardman · T. M. Wilson · P. S. Bodger ·  
J. W. Cole · C. Stewart

**Abstract** Modern society is highly dependent on a reliable electricity supply. During explosive volcanic eruptions, tephra contamination of power networks (systems) can compromise the reliability of supply. Outages can have significant cascading impacts for other critical infrastructure sectors and for society as a whole. This paper summarises known impacts to power systems following tephra falls since 1980. The main impacts are (1) supply outages from insulator flashover caused by tephra contamination, (2) disruption of generation facilities, (3) controlled outages during tephra cleaning, (4) abrasion and corrosion of exposed equipment and (5) line (conductor) breakage due to tephra loading. Of these impacts, insulator flashover is the most common disruption. The review highlights multiple instances of electric power systems exhibiting tolerance to tephra falls, suggesting that failure thresholds exist and should be

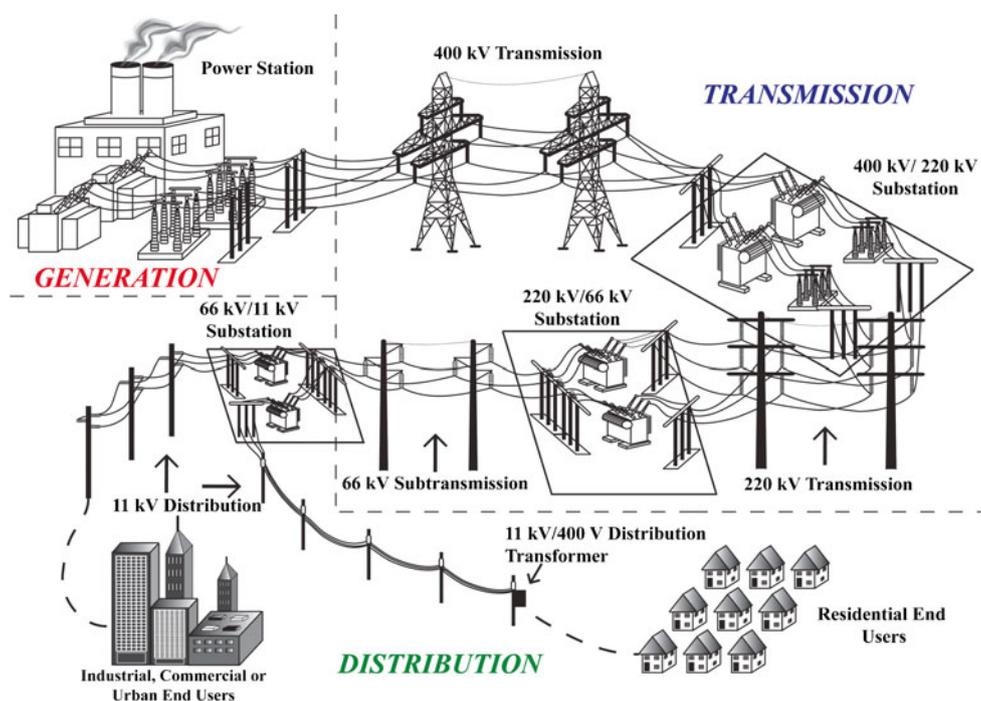
**Fig. 2** An example of a modern electric power system. Electric energy is generated at a power station (e.g. 13 kV). From here, the voltage is increased (current decreased) and the energy transmitted at 400 kV via extra-high voltage (EHV) transmission lines to a 400/220 kV EHV substation. The energy is then transmitted to a HV substation where the voltage is reduced to 66 kV. Sub-transmission lines connect the HV substations to many distribution substations located within cities,

where the voltage is reduced to 11 kV and the energy finally distributed either directly to industrial plants or factories or to local residential and commercial zones. Distribution lines from 11 kV to ~400/220 V (depending on the system used) for use in homes, shopping centres and other local loads (adapted from Karady 2007)

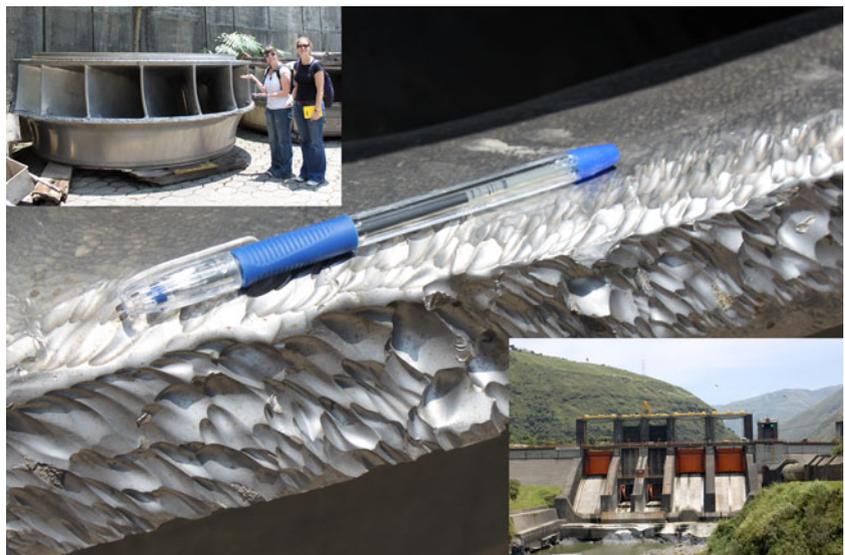
**Fig. 3** A severely abraded turbine that was removed from service at the Agoyan hydroelectric power plant, which is sited 5 km east of Tungurahua volcano. Tephra-laden water filtering through the turbines has necessitated the replacement of four turbines in 21 years. *Bottom inset:* The Agoyan Dam and its (orange) floodgates are designed to let highly turbid water bypass the turbines so as to avoid accelerated wear of generation components

However, while the dam turbines, generators and control house are located in a zone of low-frequency tephra fallout, the Pastaza catchment of the dam is often exposed to significant tephra fall, leading to significant suspended solids in the water and occasionally lahar hazards, which are more threatening to the Agoyan HEP than direct tephra fall (Sword-Daniels et al. 2011). Intake mechanisms such as wicket gates, turbine covers and blades are particularly at risk of abrasion from the tephra-laden water. Severe pitting and scouring of the metallic components (Fig. 3) have accelerated their degradation, and four turbines have been replaced in the last 21 years.

To reduce the impacts from the intake of highly turbid water, Agoyan has a specially designed floodgate system in place so that the intake flow can be diverted away from generation components and directly flushed out into the river (Fig. 3, inset). When there is heavy rain, causing an increased risk of tephra-laden floodwaters and lahars, the dam operators monitor water levels and turbidity, and activate the protective bypass system as required.

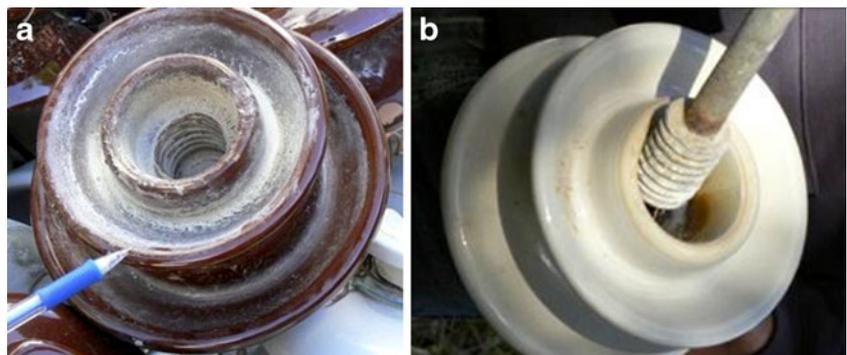
**Fig. 4** **a** Fine-grained tephra adhered to the underside of a 33 kV porcelain insulator in Futaleufu, Chile following the 2008 Chaitén eruption. **b** Underside of a 3 kV porcelain insulator that suffered tephra-induced flashover following the 2008 Chaitén eruption. Note the brown burn mark (centre right) from the high intensity arc during flashover

Following the May 2008 Chaitén eruption, a 68-km stretch of 33 kV line to Futaleufu township, Chile (75 km from the volcano) was coated with fine-grained (<0.1 mm particle diameter) rhyolitic tephra of 20 to >300 mm in depth in some areas between 2 and 8 May 2008. Local linesmen reported that 10–20 % of the ceramic insulators suffered flashovers after light misty rain between 6 and 9 May 2008. Following inspections, the lines company decided to replace all insulators on the affected stretch of line, as it was too laborious to clean or assess damage to each insulator. Many of the insulators that had suffered flashover were cracked and exhibited burn marks at the base where it screwed onto the supporting metal pin (Fig. 4). Distribution transformers on the circuit were also reported to have suffered flashover damage.

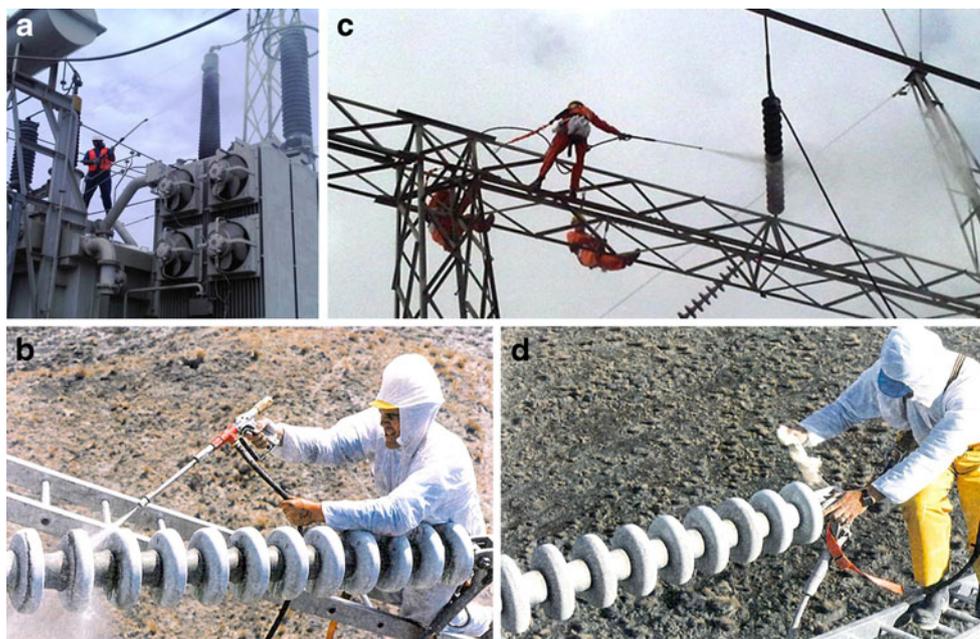
**Fig. 5** **a** High-pressure de-energised washing of a power transformer bushing at a substation in Ecuador following the 2010 eruption of Tungurahua. **b** A linesman cleans tephra from a de-energised 220 kV strain (horizontally strung) insulator located ~15 km from Ruapehu, New Zealand. **c** Linesmen cleaning de-energised insulators at a Guayaquil, Ecuador substation after 1–2 mm of fine-grained tephra fell following the 2010 Tungurahua eruption. **d** Hand-cleaning tephra from a de-energised 220 kV strain insulator after the 25 September 1995 Ruapehu eruption. Photo credits: **a** Transelectric, **b** Transpower, **c** Transelectric, **d** Transpower

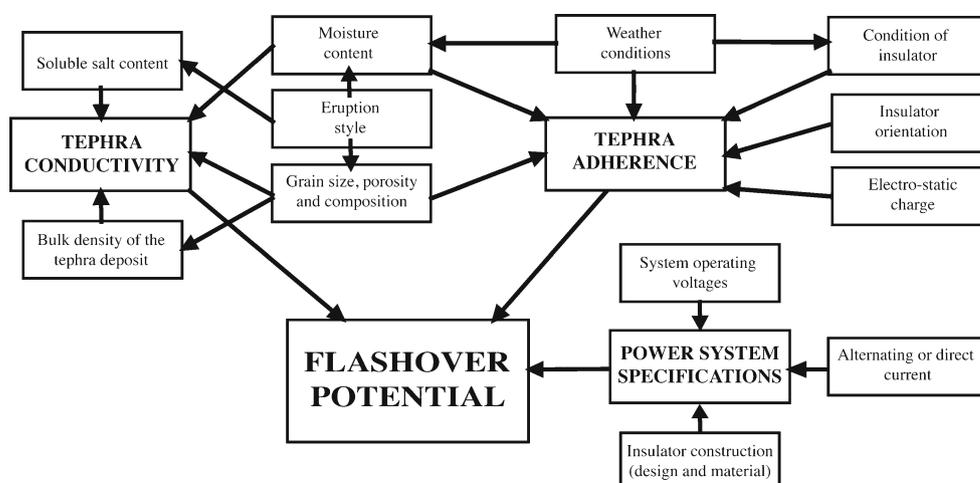
**Fig. 7** Flow chart illustrating the many variables influencing tephra-induced insulator flashover (adapted from Johnston 1997b)

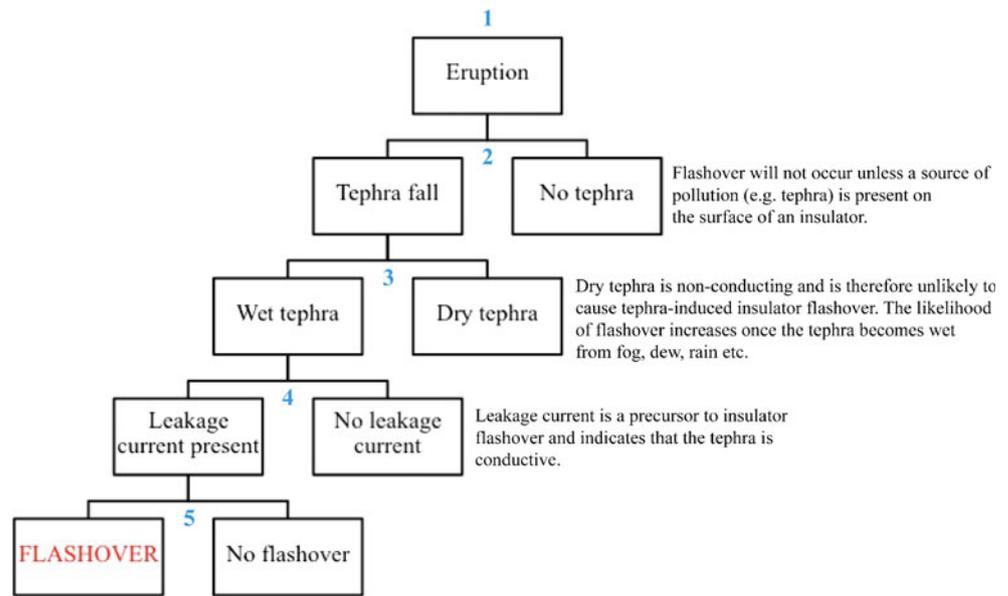
**Fig. 8** Event tree showing the sequence leading up to tephra-induced flashover. At present, values for the likelihood of each event occurring at each node are not available to hazard managers or power system operators. The development of fragility functions will help to populate event trees such as this one with more robust data for interpretation

flashover to occur (Fig. 8). Each branch of the tree leads from a necessary prior event to a more specific outcome (e.g. from an eruption to a tephra fall). Several of the events are controlled by external factors, such as conditions at the volcano (eruption style), environmental conditions (wind direction and precipitation), design of the power system, prior contamination of system components, etc. Such information requires input at the time of risk assessment for a particular scenario. However, considering the lack of quantified data for events 3–5 (Fig. 8), our compiled review dataset of flashovers and tolerances allows us to create a fragility function that estimates the conditional probability of a flashover occurring for different tephra thicknesses. This simple, first-order approach is designed to aid system operators in assessing the allowable accumulations of tephra before initiating mitigation strategies.

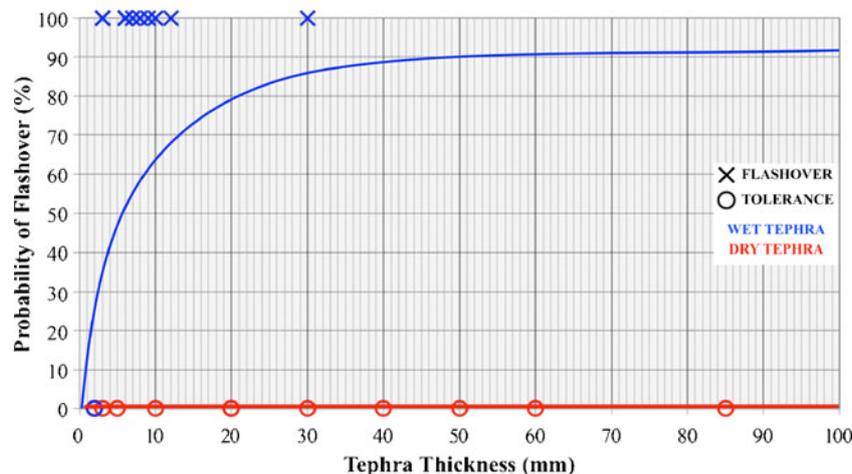
**Fig. 9** Logarithmic fragility curves showing the probability of tephra induced flashover as a function of wet or dry tephra thicknesses. Data are derived from systems that have either experienced flashover or exhibited tolerance to tephra fall, or both. Insulator flashover is considered a 100 % failure in performance while instances of tolerance signify 0 % failure. However, these data have only been added to this

figure as a guide (i.e. they are not plotted); rather, the blue and red fragility curves (wet and dry tephra, respectively) estimate the probability of flashover based on the discrete end member data points. Two anomalous wet samples at 2 and 300 mm (not shown) represent the only two recorded instances where wet tephra did not cause insulator flashover

We can assume that because insulator flashover is a mutually exclusive event and HV insulators are designed to prevent the transfer of electricity from transmission and distribution equipment to earthed (bonded with the ground) apparatus, insulator flashover can be considered a 100 % failure in performance. Conversely, instances of tolerance signify 0 % failure (Fig. 9).

As this is the first study of its kind to create a fragility function for HV insulation exposed to tephra fall, and given our limited binary dataset, we have selected a logarithmic function to provide an estimate for the probability of flashover across a single cylindrical insulator or insulator string at different thicknesses of either wet or dry tephra. After plotting the data, a line of best fit was applied and the

resulting curves are presented in Fig. 9. Results suggest that dry tephra will not cause flashover but increasing thicknesses of wet tephra on insulators will increase the likelihood of flashover. The generated curves and data trends agree with our observations from existing literature and experiences in the field.
