**LONG-TERM PERFORMANCE OF
POST-TENSIONED LVL FRAMES AND WALLS**

Report no: STIC- 2012-XX

August 2012

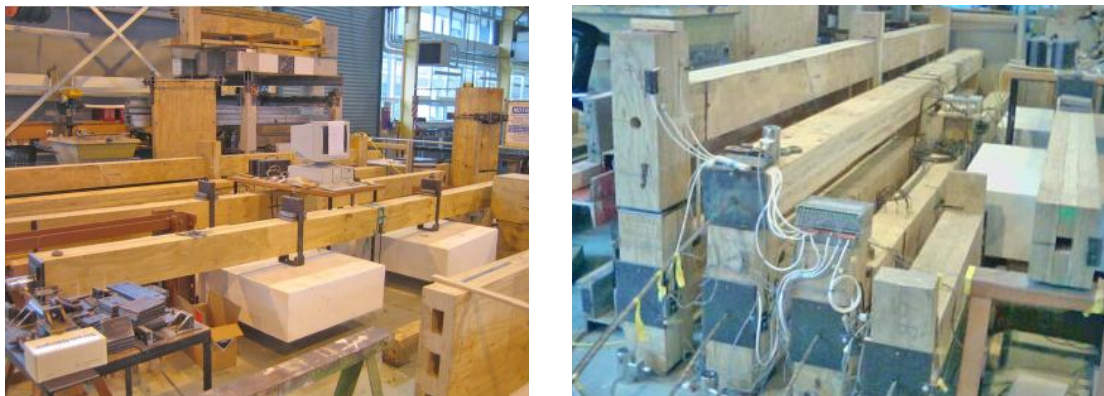
Figure 1.1 Post-tensioned LVL beams tested under bending (left) and post-tensioned LVL frame specimens (right) in an uncontrolled heated indoor environment.

Test specimens had a box-shaped cross section and the stressing was applied through the centre of the section. Large scale specimens were loaded in bending with, and without applied pre-stress. Other large specimens and some smaller specimens were assembled to replicate the layout of a two-bay, moment-resisting frame. These specimens were pre-stressed with the tendon running through the beams and continuing through the columns; thus, loading the LVL both perpendicular and parallel to the grain. Creep tests were performed on small blocks of LVL subject to compression parallel or perpendicular to the grain.

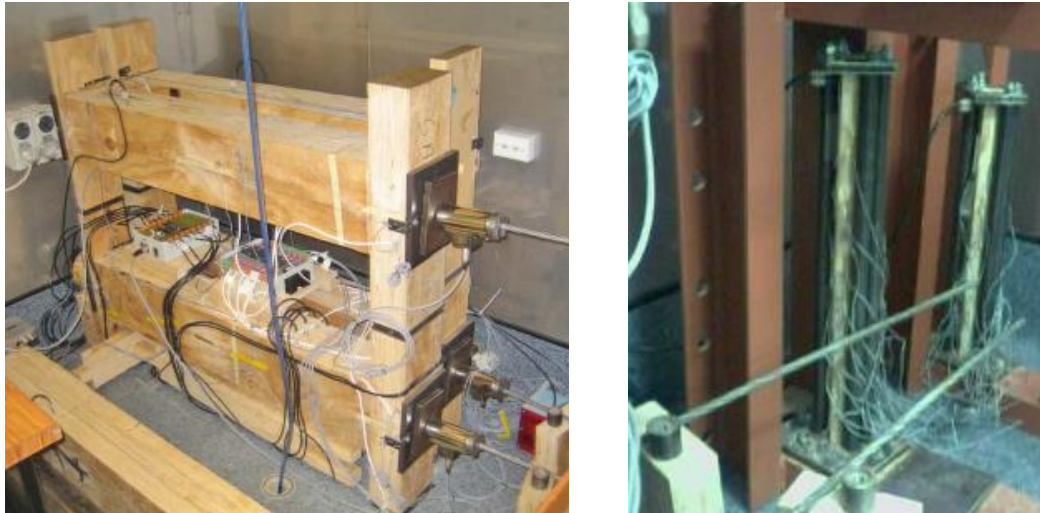
Figure 1.2 Post-tensioned frame specimens in a controlled environment (left) and small LVL specimens loaded under compression (right).

Two sets of tests ran in parallel, with one set subject to an uncontrolled, heated, indoor environment and the other subject to heated, controlled, indoor environmental conditions (constant RH 50 % and temperature 20 °C). The test programme included full-scale specimens, reduced scale specimens and small blocks of laminated veneer lumber (LVL) (Figures 1.1 and 1.2). The specimens were loaded for one year. All relevant parameters (strain, deflection, tendon load, timber moisture content, environmental temperature and relative humidity) were monitored throughout the time under load. In order to measure the recovery, monitoring continued for a further three months following unloading of specimens.

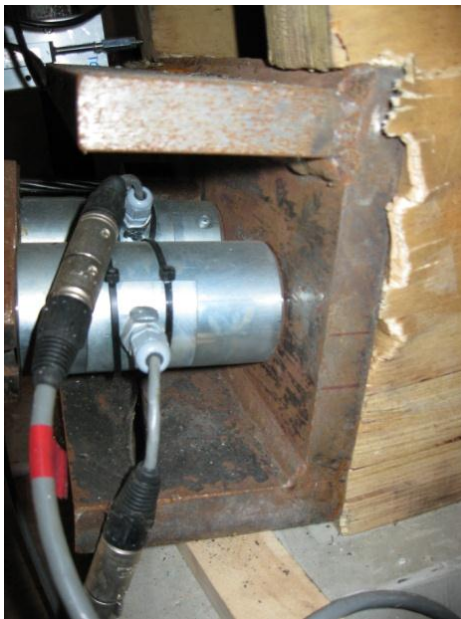
Figure 2.1 Crushing failure due to eccentric loading and insufficient bearing area between the steel anchorage block and LVL.

The progress of this long term test was interrupted by the 2010 and 2011 Christchurch earthquakes and continued aftershocks. The beams also encountered crushing parallel to the grain failure due to LVL crushing at the anchorages, and this failure was more severe for the ends of the beams closer to the partially open end of the building in which they were located (Figure 2.1). Such failure was likely due to the severe environmental conditions in the shed corresponding to Service Class 3, which was not considered or expected in the initial design of the end blocks. This failure was remedied by cutting off the ends of each beam and gluing and screwing in LVL blocks to more effectively distribute loads from the steel anchorage plates onto the ends of the beams and to avoid the effects of eccentric loading of the plates. Approximately 400 mm were cut off from the large beams and 250 mm from the small beams following removal of loading blocks and de-stressing and removal of the steel tendons. In each beam an LVL block was glued in using resorcinol adhesive mixed on-site and screws were installed at 45° to provide additional strength and also clamping pressure for the glue. Once the adhesive was cured the beam ends were flattened and the beams were re-stressed and then loaded (Figure 2.2). A chronology of the events that happened throughout this experiment is summarised in Table 2.1.

Local stress at failure (only webs) = 59 N/mm²

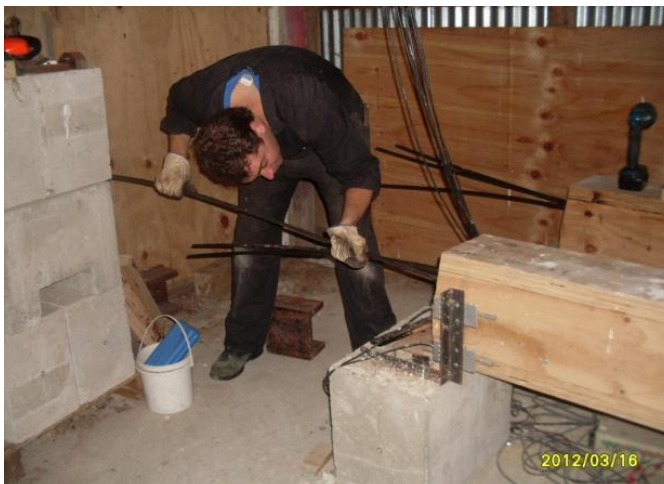
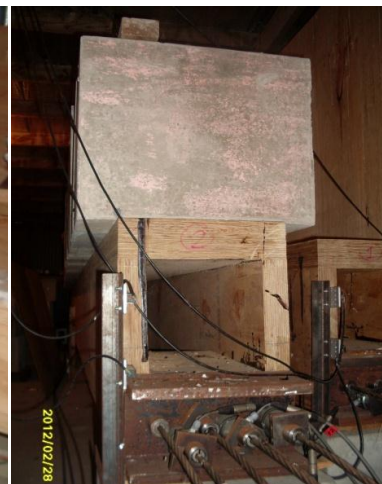
Fig 2.2 Setting up of Beams 2 (left) and Beams 1 after repair of the anchorage block (right).

The ends of the beams were cut off. A mid height LVL member were glued at each end of all the beams and reinforced with 3 to 4 screws (SFS screws in Beams 1 and Type 17 screws in Beams 2) installed at 45° to the longitudinal axis so the beams on each side. These additional members were positioned such that they lined up with the top edge of the steel plate in order to increase the bearing area.
January 2012	Completed repair on Beams 1. Set up again, stressed and loaded. Monitoring resumed.
Mar - Apr 2012	Completed repair on Beams 2. Set up again, stressed and loaded. Monitoring resumed.
Apr 2012 - present	Monitoring continues

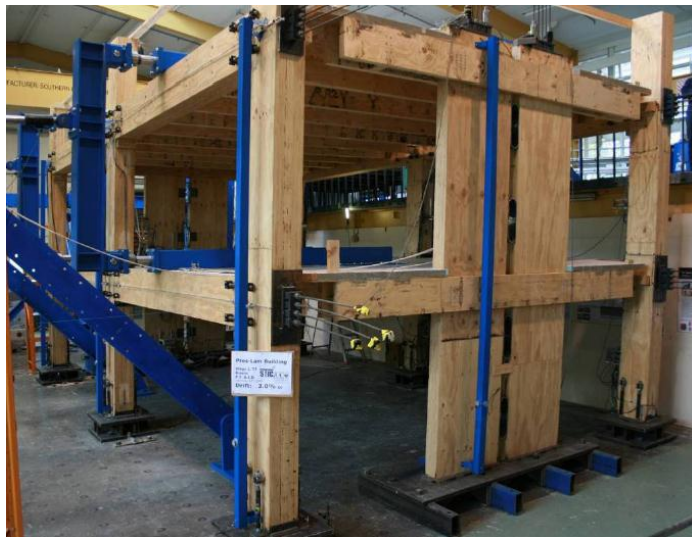
Figure 3.1 A 2/3rd scale 2 storey post-tensioned laminated veneer lumber (LVL) building built in the Structures Laboratory of the University of Canterbury

The test specimen was a 2/3rd scale 2 storey post-tensioned laminated veneer lumber (LVL) building built in the laboratory of University of Canterbury and subjected to an extensive quasi-static seismic testing programme (Figure 3.1). The building comprised of post-tensioned moment resisting frames in one direction and post-tensioned shear walls in the other direction, and the floors were timber-concrete composite. Concerns about crushing in the column due to compression perpendicular to the grain at the beam-column interface and the post-tensioning losses in the tendons were the motivations behind this experiment.

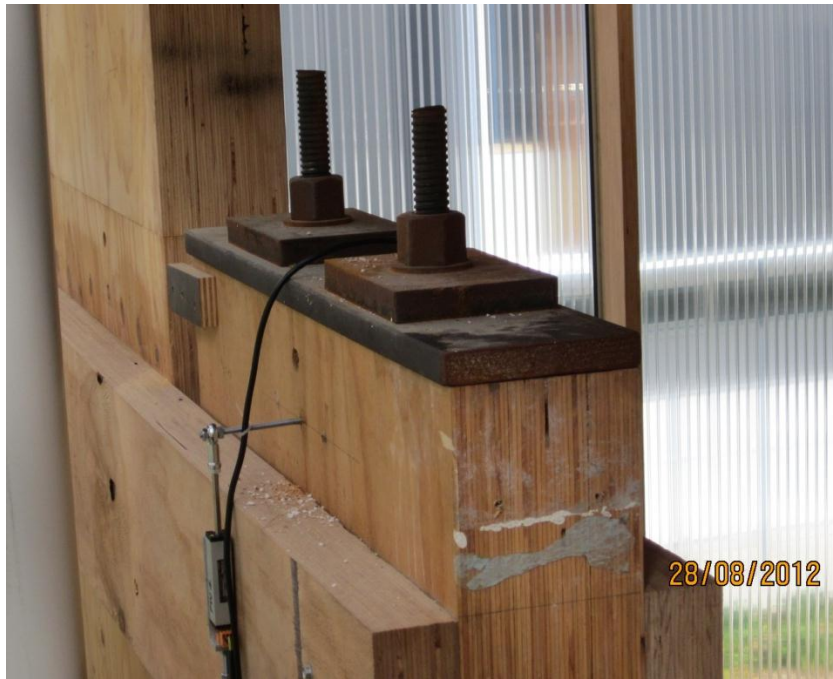
Figure 4.2 LVL shear wall with small (top) and large (bottom) bearing plate

During the construction of the building, the LVL shear wall with a cross-section of $150(w) \times 400(l)$ mm was post-tensioned to a design force of 300 kN per bar. The post-tensioning operation had to be stopped due to severe crushing of the LVL at the top of the wall. Bearing plates were sized $130(w) \times 195(l) \times 25(t)$ mm, which did not cover the full section of the wall. This caused instant crushing as loads were applied. Subsequently, a plate of size $150(w) \times 400(l) \times 25(t)$ mm which covered the full wall section was used (Figure 4.2) for all four walls.

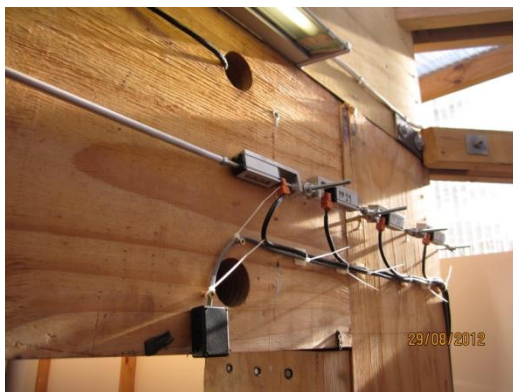
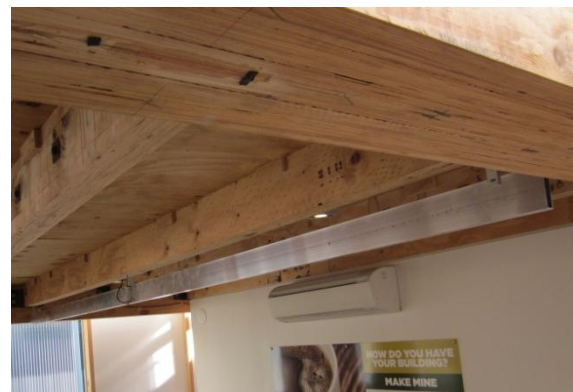
Figure 4.3 Long-term instrumentation of the EXPAN Building for frame (left) and floor (right)

At this date (August 2012), efforts are under way to instrument the walls, frames and floors in the building to monitor future long-term deformations and losses in post-tensioning elements (Figure 4.3). To date, some crushing due to compression perpendicular to the grain in the columns at the Level 2 unreinforced beam-column joints were found (Figure 4.4).

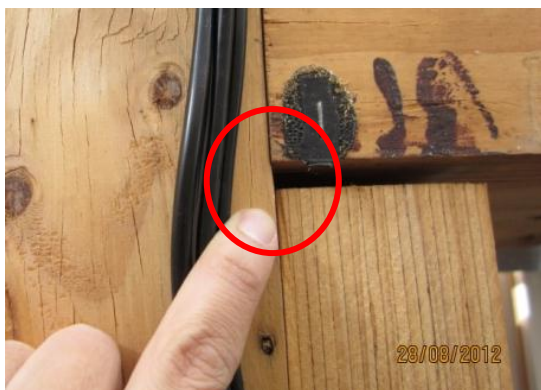
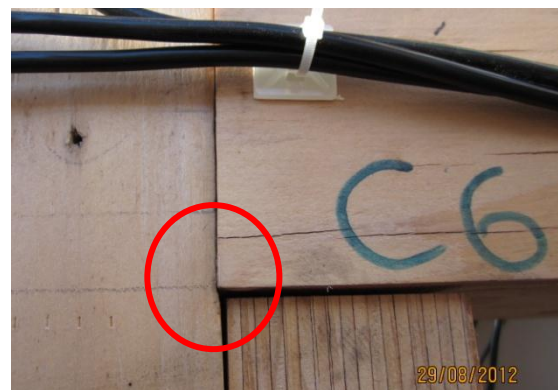
Figure 4.4 Perpendicular to the grain crushing at the bottom of the beam-column interface located at Level 2 Column 2 (left) and Level 2 Column 6 (right)

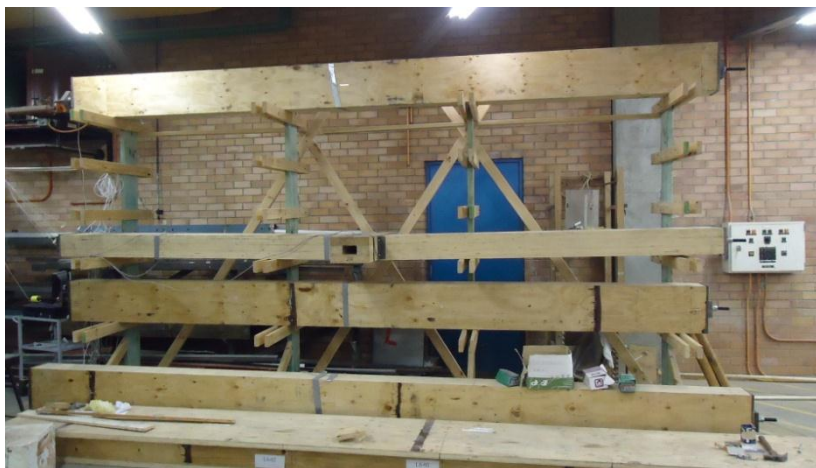
Figure 6.1 Post-tensioned LVL beam and frame specimens under uncontrolled non-cyclic environment

Specimens include post-tensioned LVL beams for study on parallel to grain effects and post-tensioned LVL frame sub-assemblies comprised of two beams and a column segment for study on perpendicular to grain effects. Screws were introduced as reinforcement into some of the columns to minimise perpendicular to grain crushing, but no steel bearing plate was provided to distribute the load from the screw heads to the ends of the beams. Two sets of each specimen type were made. The first set was tested under ambient environmental conditions in the laboratory and the second set was subjected to cyclic environmental conditions in a climate chamber where for the first 3 months, they were monitored under the ambient environment of the laboratory and later subjected to severe four to six weeks of environmental cycling of up to 100 % relative humidity with temperatures maintained at 20 °C (Figures 6.1 and 6.2).

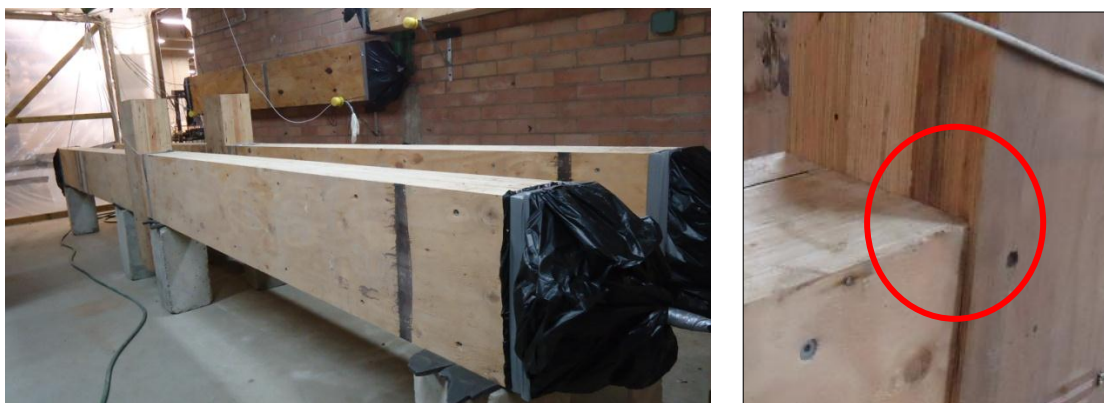
Figure 6.2 Post-tensioned LVL beam and frame specimens under controlled cyclic environment (left) and compressive perpendicular to grain failure in the column at the beam-column interface (right).
