Steel Shim Hardness Effects on Asymmetric Friction Connection Performance

ABSTRACT

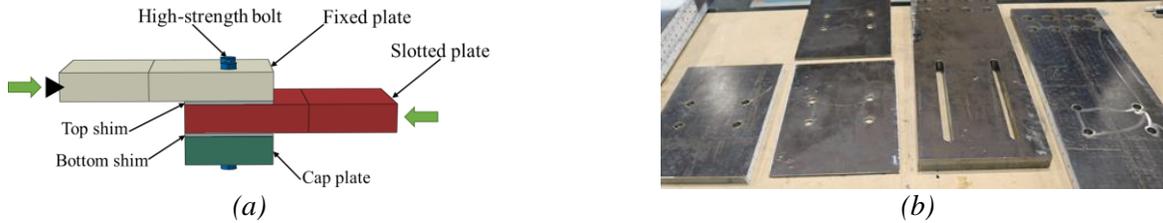
aluminum and high-strength Bisalloy with different grades for AFC [7-9]. The AFC in the bracing system is assembled by the fixed plate (here the brace section, the column and beam section at the base and beam-column connections), the slotted plate (gusset plate), the cap plate (outer plate) and two thin steel shims as shown in Figure.1. The plates are usually clamped together using high-strength structural bolts (usually grade 8.8), are tightened to their proof load level. Structural washers or Belleville washers are also used.

Figure 1. AFC. (a) assembled specimen (b) component; left to right: cap plate, shims, slotted and fixed plate

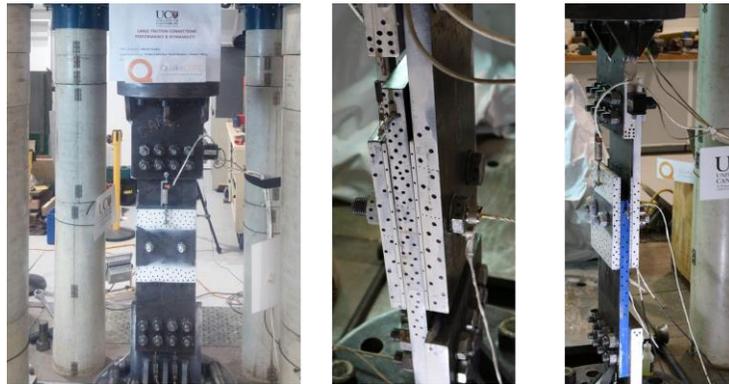
All surfaces were cleaned by acetone and a light wire brushing to remove any lubricant, dust, rust, corrosion and particles owing to cut and drilling holes. The bolts are delivered from suppliers or manufacturers without appropriate protection in the face of environmental conditions. These bolts had variable lubrication level. This lubricant material also absorbed dust and particles in a period of storage or transformation. Preliminary studies had indicated that this resulted in different friction coefficients between the bolt threads and the nut which affect the bolt tension force as well as the bolt loosening both after tightening, and during the sliding tests. As a result, all bolts were brushed, cleaned with acetone and lubricated with a thin layer of Opal Hi-Load as a high-quality multipurpose grease containing molybdenum disulfide. This was done by placing the lubricant in the threaded nut and then running the nut up and down of the bolt threaded length. The amount of the lubricant was determined such that it should cover the whole thread with none left over after removing the nut. The AFC specimens were tested on a Dartec universal machine with a capacity of 10 MN. The test setup comprised a fixed bracket at the top of Dartec and a moving bracket at the bottom side, both Grade 350 mild steel. Figure 2.

Figure 2. AFC specimen and test setup under the DARTEC machine
