Waterway Barrier Design for Protection of Native Aquatic Values

Report prepared by University of Canterbury

for Department of Conservation

October 2013

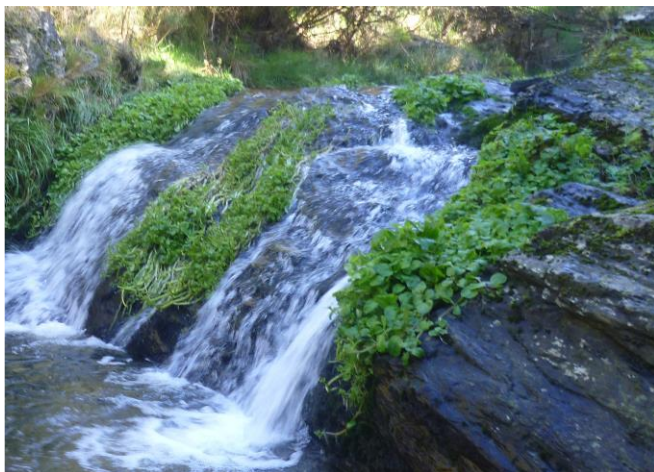
Figure 6-4: Akatore Creek Waterfall Barrier (pre-weir)

- High flows may have coincided with spawning trout
- High flows may have coincided with increased deposition of gravel in the pool immediately below the waterfall, reducing the barrier height
- A small depression up the waterfall face may have provided a 'stepping stone' for trout to use in scaling the barrier, reducing the height of each jump required to breach the barrier

The galaxiid population was observed to recover well following several trout removal operations, and therefore the site was selected for installation of a built barrier to prevent reinvasion of the trout (Campbell et al., 2013).

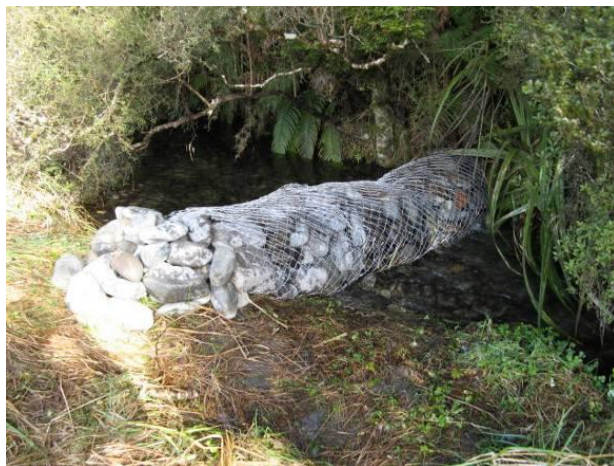
Figure 7-1: Maruia River Tributary gabion barrier, soon after installation

A gabion barrier was installed prior to 2007 at one of the tributaries of the Maruia River (at the Lake Daniells carpark; average stream width of 2-3 m) ([Figure 7-1](#)). Routine monitoring had shown this tributary to be a key habitat for dwarf galaxias (Collis, 2008). As of 2007, annual monitoring had shown that the barrier was successful at preventing further introduced species from gaining access to upstream of the barrier. The barrier is comprised of large rocks, up to 250 mm in diameter, held with gabion wire mesh. The intention of the design is to prevent access for introduced species while allowing dwarf galaxias to migrate past the barrier via the spaces between the rocks within the barrier. Trout were in low to moderate numbers upstream of the gabion barrier as they have not been removed. Unfortunately, due to lack of maintenance and the location at which the barrier was installed, flood flows have breached the barrier and repeated flooding has washed away the barrier (Gavin Collis, pers. comm.).

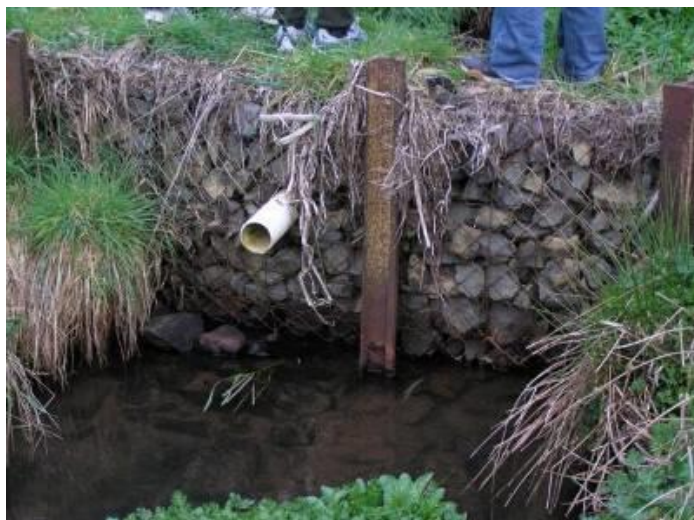
Figure 7-2: Orokonui Creek "permeable" Gabion Barrier

Several diadromous native fish species have been found in this catchment, and the only species of concern is brown trout. The gabion basket was therefore intended to work by allowing juvenile native fish to move upstream through the interstitial spaces within the gabion, while brown trout would be unable to pass through these small spaces. A perched culvert was installed within the gabion to allow adult migratory fish passage out to sea, while preventing brown trout from being able to jump upstream past the gabion ([Figure 7-2](#)).

However, the subsequent monitoring results show that the overall abundance of native fishes above the gabion basket is declining. This is an indication that the barrier does not allow sufficient numbers of juvenile fish to pass through. The loss of two species of bully and the apparent decline of banded kokopu provides further indication that the gabion basket does not effectively allow for migration of juveniles. In addition to not providing access to fish, the gabion weir needed regular maintenance to clear it of debris that would build up in higher flows. The plant, Monkey Musk (*Mimulus guttatus*), also established on the weir such that the interstitial spaces in the gabion became clogged (Pete Ravenscroft, pers. comm.).

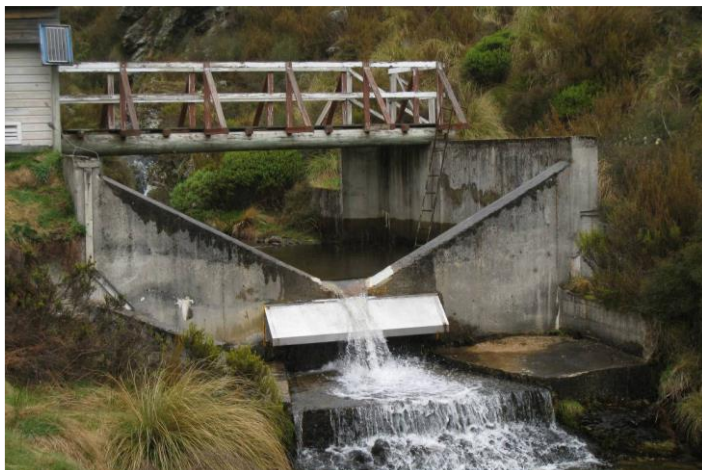
Figure 7-3: Upper Waipori River gauging weir with added stainless steel barrier apron

A v-notch weir on the Upper Waipori River ([Figure 7-3](#)) has been modified to create a barrier to exclude kōaro as they were thought to be adversely impacting the upstream population of dusky galaxias. As of 2012, the effectiveness of this barrier was uncertain (Bowie and West, 2012), both in terms of whether total exclusion of kōaro is achieved and whether this barrier enhances the dusky galaxias population as monitoring was not showing a response in the dusky galaxias population to the removal of kōaro and installation of the barrier.

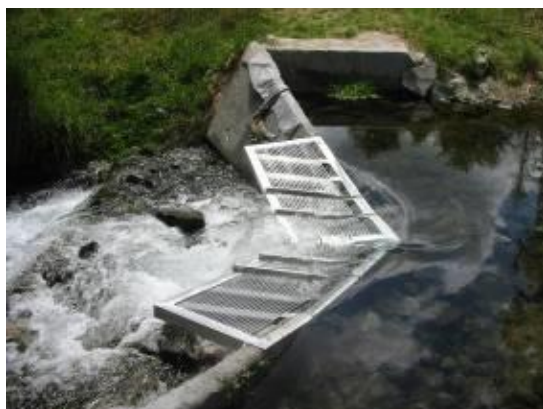
Figure 7-5: Haumurana Stream Tributary weir and grate barrier

- 1) Concrete apron on downstream side
- 2) Wingwalls cut into bank and protected with gabion baskets
- 3) V-notch weir profile to ensure concentrated, fast water flow over the crest under varying flow conditions, and allows climbing species to negotiate the weir
- 4) A metal grate extends out over the weir crest to inhibit trout from jumping
- 5) The presence of the weir will raise upstream water depth by 100-120 mm, however, this is not considered a flooding issue as the stream banks at the proposed barrier location are high, the inset wingwalls will protect against side scour and the spring source means flows are generally stable.

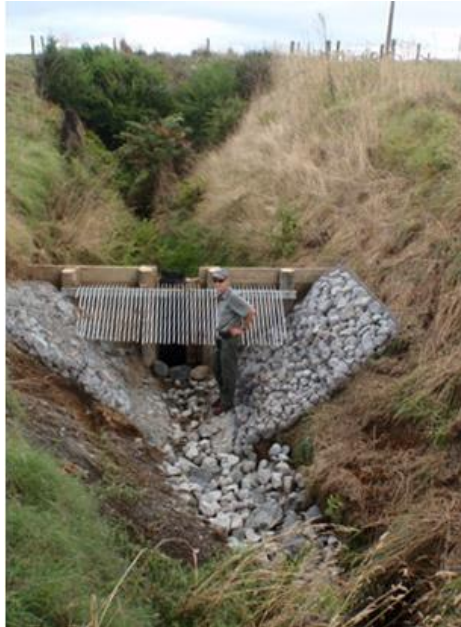
Figure 7-7: Lake Rotopiko outlet barrier, immediately after installation

7. A facing of nylon bristles is set against the downstream side of the timber boards to create a climbing eel passage.
8. The weir foundations (i.e. the full-round posts) are set in concrete to a minimum depth of 2 m below surface.

Figure 7-7 shows the completed installation, however, no data on the effectiveness of this barrier is available yet.

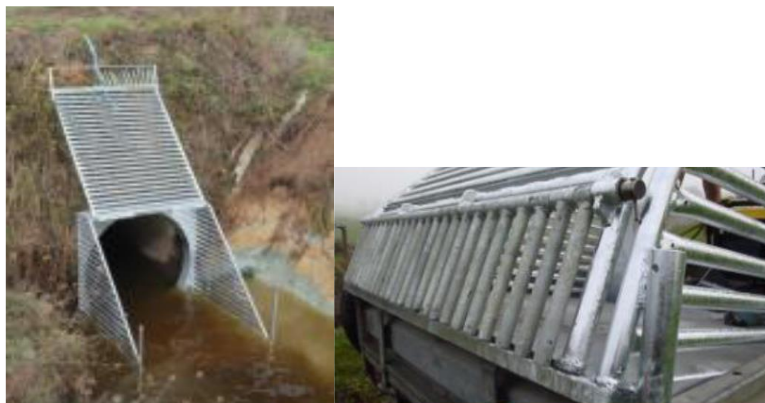
Figure 7-8: Left: One way barrier installed on outlet of Lake Ohinewai, Waikato River. Right: Close up of one-way hinged grate through which large fish can pass in one direction only.
(Photo credits: Adam Daniels)

Coarse screens have been installed over drain entrances at Lake Ohinewai to prevent koi carp entering the drains from the lake (Bowie and West, 2012). These barriers have proven to be effective at controlling the spread of carp and are low cost. This type of barrier may be suitable in environments where little debris is expected from the piped drains, and only large spawning fish need to be excluded.

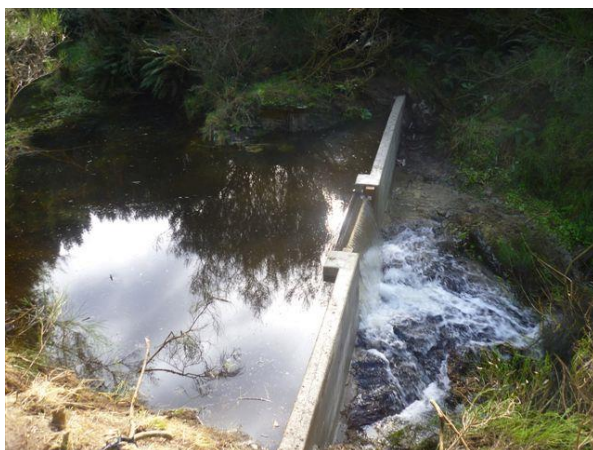
Figure 7-9: Akatore Creek Built Barrier

As detailed in Section 6.1.3, the Akatore Creek natural waterfall barrier was breached by brown trout and as a result a concrete and wood slat weir was installed in 2013. Subsequent surveys suggest there are no brown trout remaining above the barrier, and observations suggest a positive response by Taieri flathead galaxias to the removal of brown trout (Campbell et al., 2013).

The key design features of the enhanced barrier are:

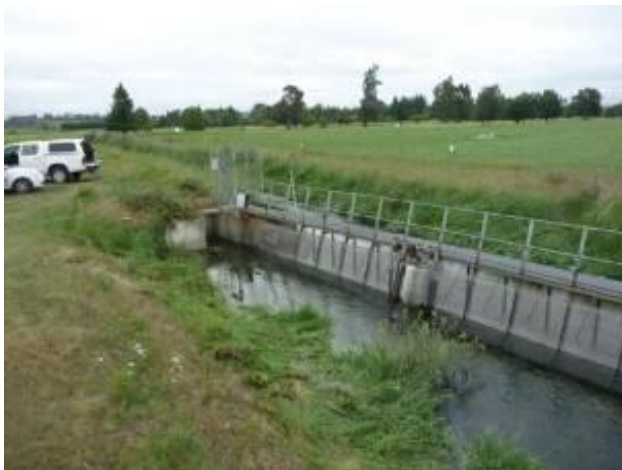
Figure 7-10: Fish screen at intake to irrigation water race

6. Screening material on the screen needs to have openings small enough to exclude fish and a surface smooth enough to prevent any damage to fish (**2-3 mm** optimal for exclusion of NZ fish species)

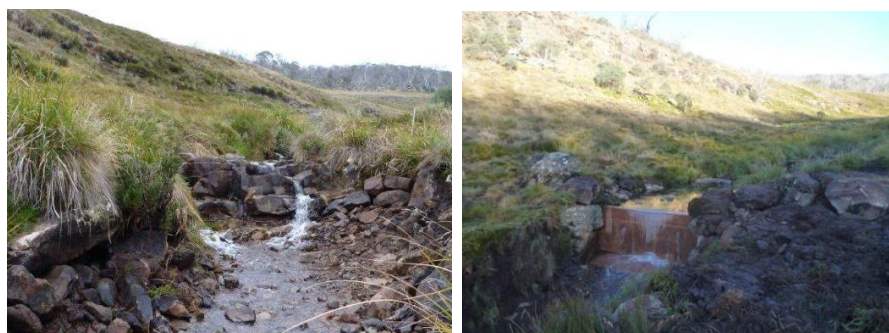
Figure 7-11: Shaw Creek Barrier, before and after installation in 2012 (Source: Raadik, 2012)

The permanent weir is a 1.3 m high cast-in-situ concrete weir with a shallow v-notch crest profile, as shown in [Figure 7-11](#). It includes a downstream concrete apron and pools both directly upstream and downstream of the weir have been infilled as part of the construction.

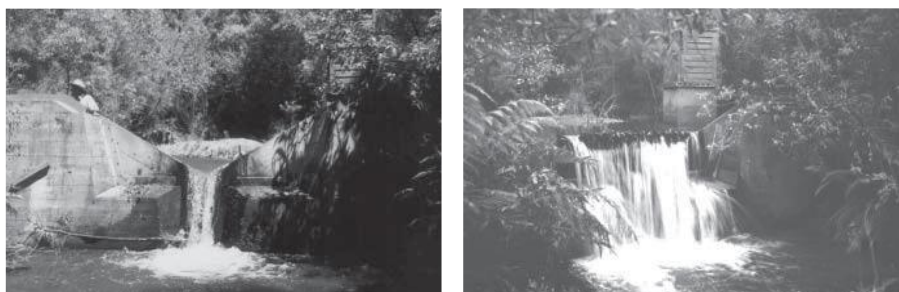
Figure 7-12: Lees Creek Weir Barrier, before and after augmentation

An existing v-notch weir in Lees Creek, ACT, Australia has been augmented to prevent re-invasion of rainbow trout (*Oncorhynchus mykiss*) into *Galaxias olidus* habitat (Figure 7-12). Lees Creek is a perennial stream with a stream width of 1-2 m and average water depth of 100-300 mm (Thomas et al, 1989, in Lintermans and Raadik (2001)).

The weir was augmented by addition of a metal grill to provide a vertical drop of 1.75 m. Rotenone treatment, a type of ichthyocide (fish poison), was then undertaken to eradicate trout upstream of the barrier. Prior to the augmentation of the weir, a road crossing culvert 2.4 km upstream of the weir was found to have successfully prevented upstream movement of trout, due to its 15 m length of relatively fast, unbroken flow with no cover available to provide respite from the current for trout.

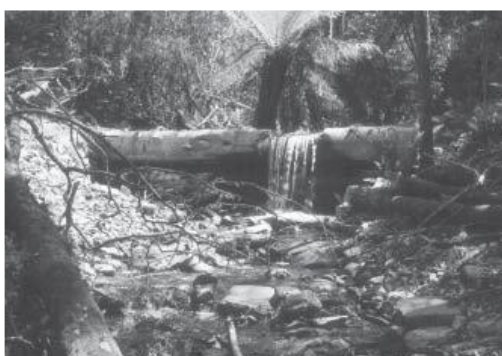
Figure 7-13: Godfrey Creek constructed trout barrier

- 1) Vertical drops ranging from 1.5 m to 1.8 m (the design criteria was a minimum of 1.5 m) were achieved by creating each barrier out of two hardwood logs stacked on top of each other, keyed into each bank by 1.5 m (Figure 7-13).

- 2) In higher flows, flow is directed towards the centre of the stream channel, via a notch cut into the upper log at stream centre
- 3) Slower overland flow and erosion around the sides is prevented by crushed rock placed along the stream edges
- 4) Any pooling below the barrier was filled in to help prevent trout from jumping past barrier
- 5) The upstream weir faced was infilled with crushed rock to reduce the hydraulic pressure on the face and eliminate any upstream pool. Initially there was flow through the crushed rock and seepage out the gaps between the logs, but migration of fines plugged these gaps up over time. The water now consistently flows over the top of the log weir structure.

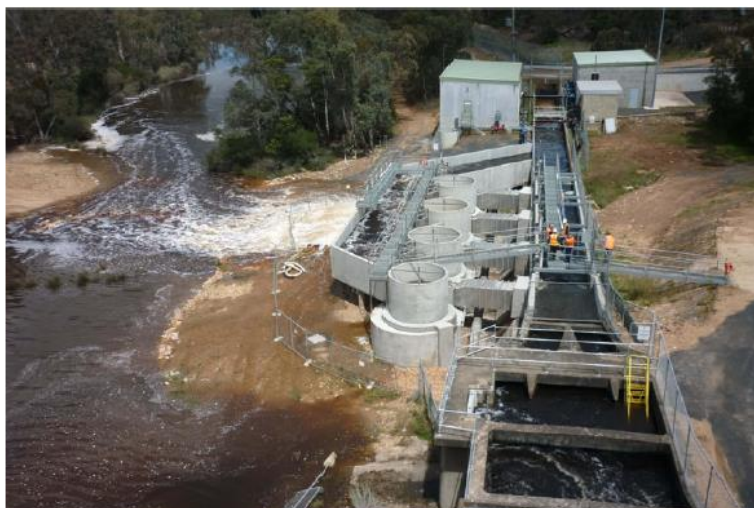
Figure 7-15: Prototype Carp Extraction System in operation (Source: Keller, 2012)

A CDS barrier was installed at the outlet of a reservoir in the Glenelg River system (Keller, 2012) (Figure 7-15). The objective of preventing carp from moving downstream from the carp-infested reservoir waters into the river. The barrier needed to be able to pass high flows at all times. A model study, followed by a prototype field trial, was conducted with carp eggs and hatchlings to record the success rate of the CDS in preventing their passage back into the stream. The model studies demonstrated 99.7% effectiveness at removing carp eggs and hatchlings, while five years of field monitoring has shown no evidence of establishment of carp populations in the river beyond the barrier.

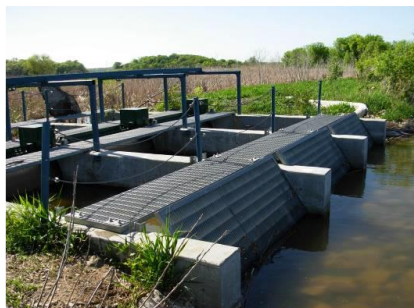
(a) Electric rotating drum barrier

Figure 7-17: Minnesota Shallow Lakes Barriers (Source: West, 2009)

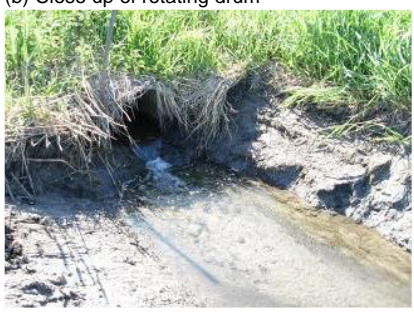
(d) High velocity culvert outlet

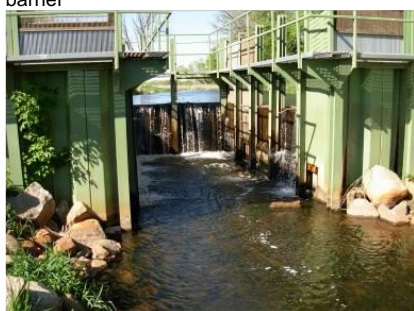
(f) Vertical weir barrier (overflow weir)

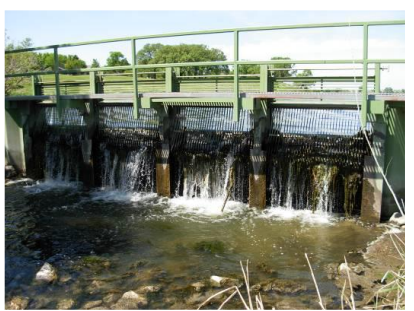
(g) Grated weir

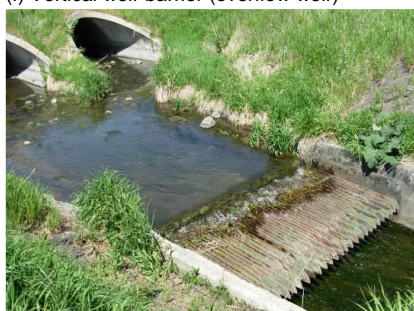
(h) Low head weir with grated overhang and downstream apron

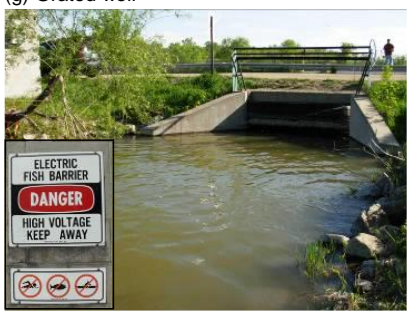
(j) Electric barrier (switchboard building to back left). Inset: warning sign on switchboard building.

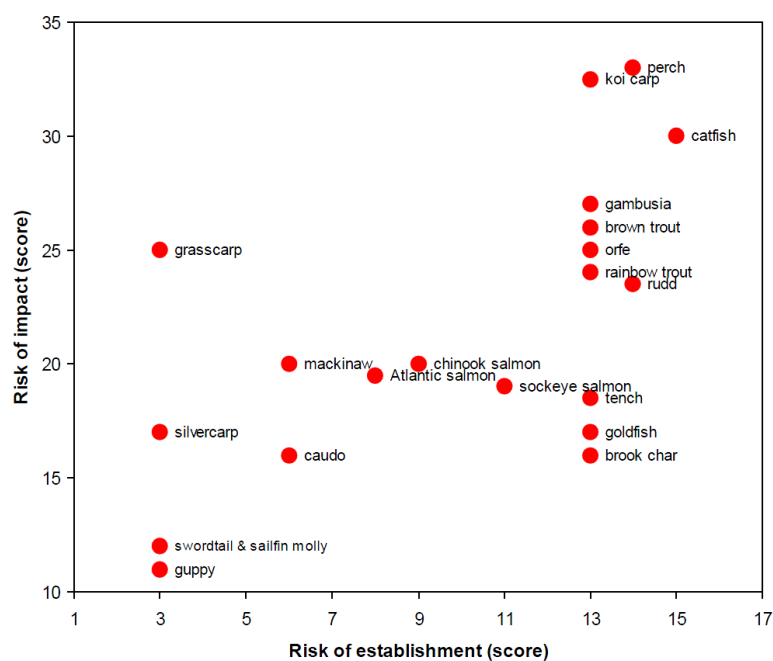
Figure B 1: Relationship between the risk of establishment and the risk of causing an ecological impact for alien freshwater fish species in New Zealand

The Fish Risk Assessment Model was developed by Wilding and Rowe (2008) to provide a measure of the potential ecological risk of introducing a new species to New Zealand. It is divided into two parts – risk of establishment and risk of causing ecological impact. The risk scores for each part are developed from a series of questions with weighted values for each yes/no/unsure response.
