Geotechnical Damage due to the 2011 Christchurch, New Zealand

Suguru Yamada, Assistant Professor, University of Tokyo
Rolando Orense, Senior Lecturer, University of Auckland
Misko Cubrinovski, Associate Professor, University of Canterbury

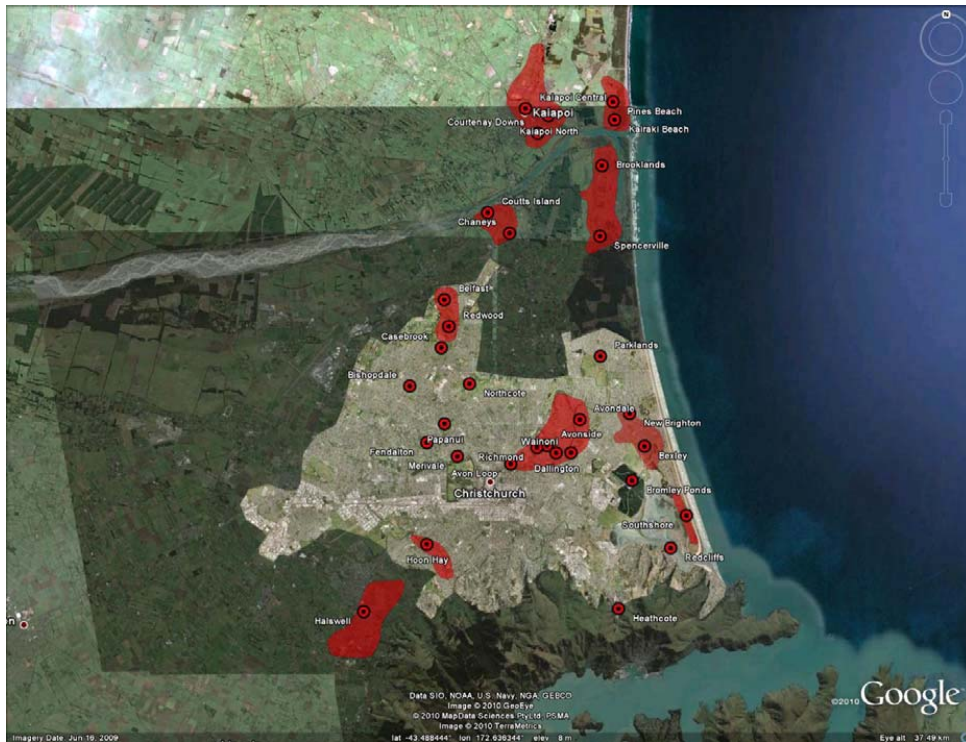
Figure 7. Areas of liquefaction (red shaded regions and red points) in Christchurch and Kaiapoi caused by the 2010 Darfield Earthquake (Cubrinovski et al, 2010).

The earthquake caused widespread liquefaction in the eastern suburbs of Christchurch city as well as in Central Business District (CBD). The liquefaction-affected area in Christchurch during this earthquake was much wider than the one in September 2010. While major liquefied sites in the September 2010 earthquake were distributed along the Avon River (northeast of CBD), liquefaction was observed in the 2011 earthquake across a wide areas in suburbs north to south of Christchurch city. Figures 7 and 8 show the areas of observed liquefaction in urban area of Christchurch after the 2010 Darfield earthquake and 2011 Christchurch earthquake, respectively. These two maps were based on surface manifestation of liquefaction visible in aerial photographs and initial observations from ground surveying. The survey to understand areas of liquefaction caused by each quake was conducted immediately after the earthquake occurrence by a reconnaissance team of the University of Canterbury.

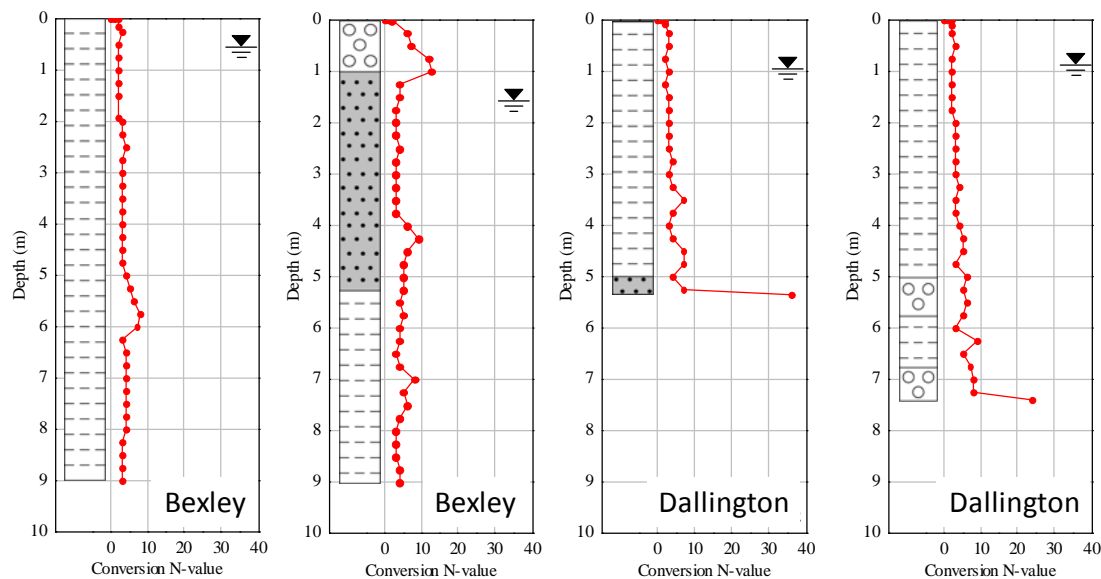
Figure 9. Converted N-Value profile in Bexley and Dallington. Ground survey was conducted by University of Canterbury and JGS Reconnaissance teams in September 2010 (JGS, 2010).

Typical results of SWS tests in Christchurch are shown in Figure 9. It can be understood from the figures that there are strata of very loose ($N < 5$) silt/sand, at about 5 m or deeper below the ground water table.

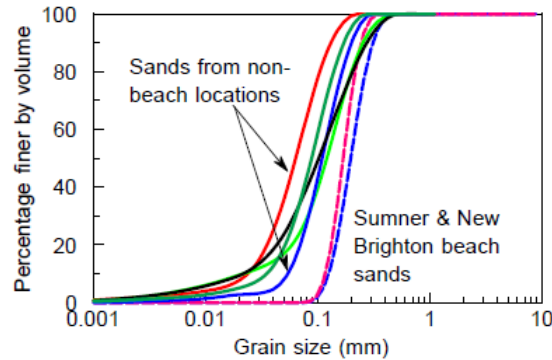
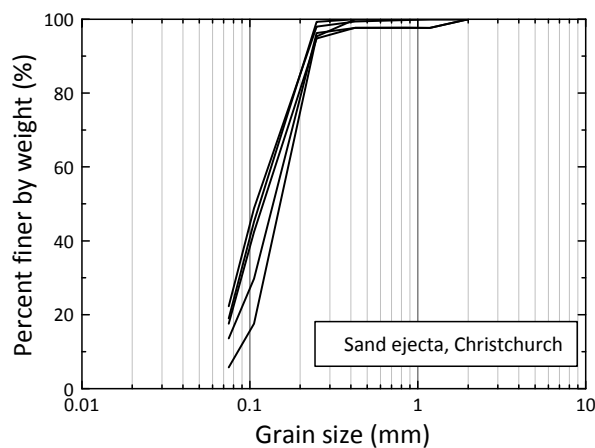
Figure 10. Grain size distribution curves of sand ejecta collected in Christchurch city.

The ejecta from sand boils found at liquefied areas in Christchurch were generally similar and had distinctive features, like presence of non-plastic fine sand and silty sand with grey/blue color. Figures 10 (a) and (b) show the grain size distribution curves of sand ejecta collected at several sites in Christchurch after 2010 Darfield earthquake and 2011 Christchurch earthquake, respectively. In general, the sand ejected in both earthquakes had very similar grain size distributions.

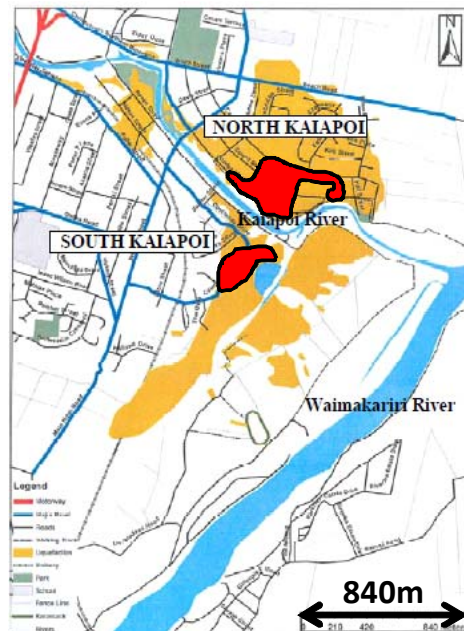
Figure 24. Comparison of liquefied area in Kaiapoi between 2010 Darfield and 2011 Christchurch earthquakes (Modified from Cubrinovski et al., 2010).

As mentioned above, liquefaction-induced damage comparable to September 2010 was observed at few residential properties in North Kaiapoi. However, the areas affected by liquefaction in this earthquake were more localized than during the previous one. The areas where evidence of liquefaction were observed during the 2011 earthquake are indicated as red colored areas in the liquefaction map of 2010 Darfield earthquake (Figure 24; Cubrinovski et al., 2010). Note that liquefied area shown in the figure is based on the view observation conducted on 27 February and 4 March 2011. The indicated area may be extended as a result of further investigations.

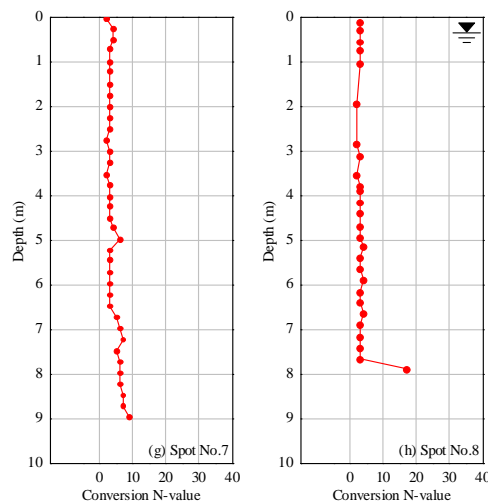
Figure 25. Converted SPT N-value profile in North Kaiapoi. Ground survey was conducted by University of Canterbury and JGS Reconnaissance team on September 2010 (JGS, 2010).

After the 2010 Darfield earthquake, SWS tests were conducted at a residential property shown in Figure 23 (Cubrinovski et al., 2010 and JGS, 2010). The profiles of converted N-value from SWS tests are shown in Figure 25. The upper portion of the ground consists of very loose sand, with depth more than 7 m and the ground water table was very shallow. Figure 26 shows the grain size distribution curves of sand ejecta collected in Kaiapoi. The solid curve with red color in the figure indicates the grain size distribution of soil collected after this earthquake, while the other dashed curves correspond to soils taken after the 2010 Darfield earthquake. The sands ejected in both earthquakes have generally similar grain size distribution. Moreover, they have similar grain size distributions as the sand ejecta in Christchurch, which are shown in Figure 10.
