Geotechnical Aspects of the M_w 6.2 2011 Christchurch, New Zealand Earthquake

ABSTRACT

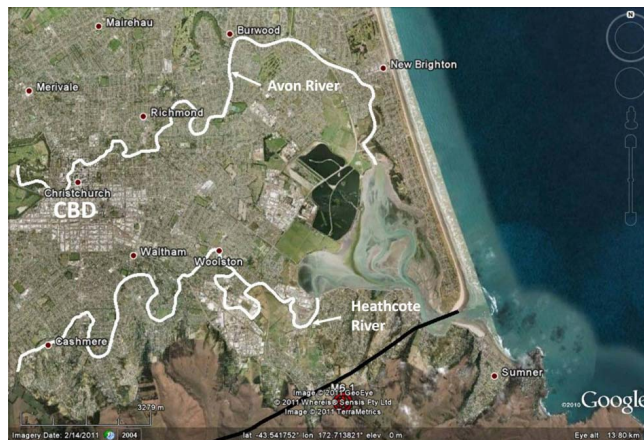
spreading, compression or slight slumping of approach material, and minor cracking in abutments. All bridges were single span and all were passable to recovery vehicles soon after the event. Compared to the Avon River bridges, those crossing the Heathcote River (Figure 4) suffered much less damage. Apart from the Ferrymead Bridge at the mouth of the Heathcote, all bridges were either undamaged or experienced only minor damage. Typical damage was approach settlement, with little impact on the bridge abutments and superstructure.

Figure 4. Aerial image of Christchurch with the Avon and Heathcote Rivers.
