Residual strength assessment and destructive testing of decommissioned concrete bridge beams with corroded pretensioned reinforcement

Rhys A. Rogers, Liam Wotherspoon, Allan Scott, and Jason M. Ingham

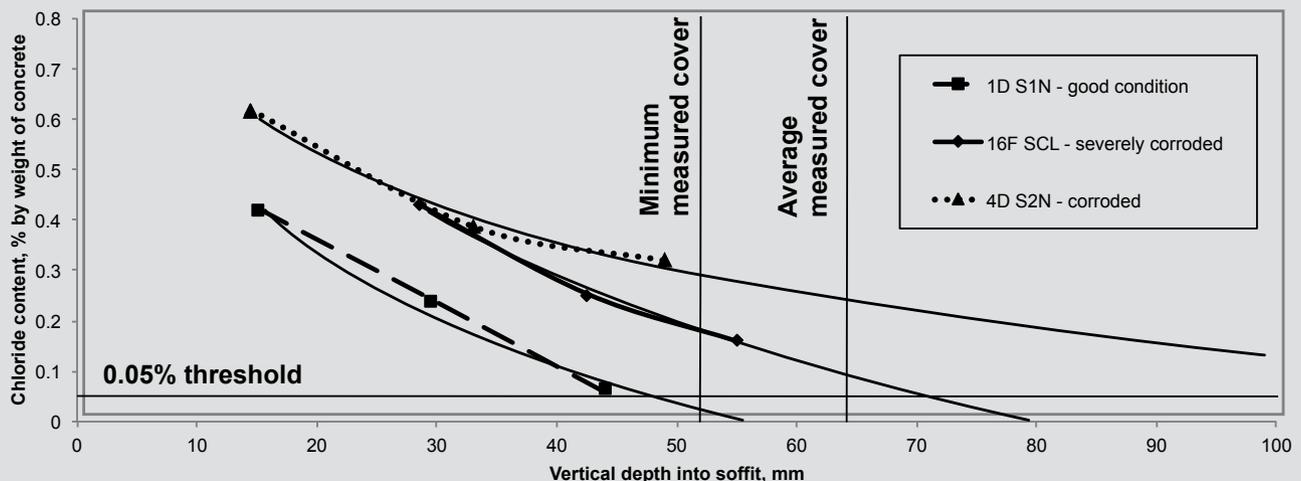
Figure 5 gives an example of chloride ingress in the soffit of three beams. A considerable difference in chloride con-

Figure 5. Preliminary chloride ingress results for three Tiwai Point Bridge beams of varying conditions. Note: 1 mm = 0.0394 in.

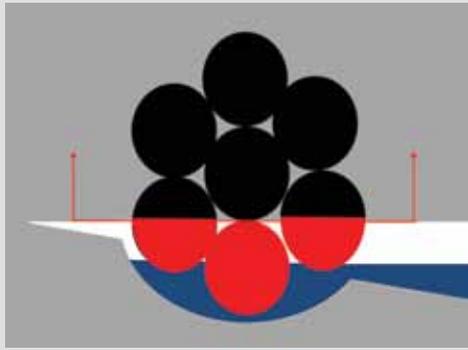
After longitudinal cracking of the concrete has occurred, seawater and oxygen are more readily available to the corroding steel and the process accelerates. The cracking usually causes debonding of the lower part of the strand because the concrete is less stiff in the direction of the soffit. This debonding forms a void below the strand where seawater collects (**Fig. 7**). The presence of seawater around the bottom of the strand causes the strand to corrode uniformly upward toward the top of the strand. This type of corrosion was widespread in cracked regions of the corroded test beams (right part of **Fig. 7**). Because each strand

Corrosion progression of wires in a single strand

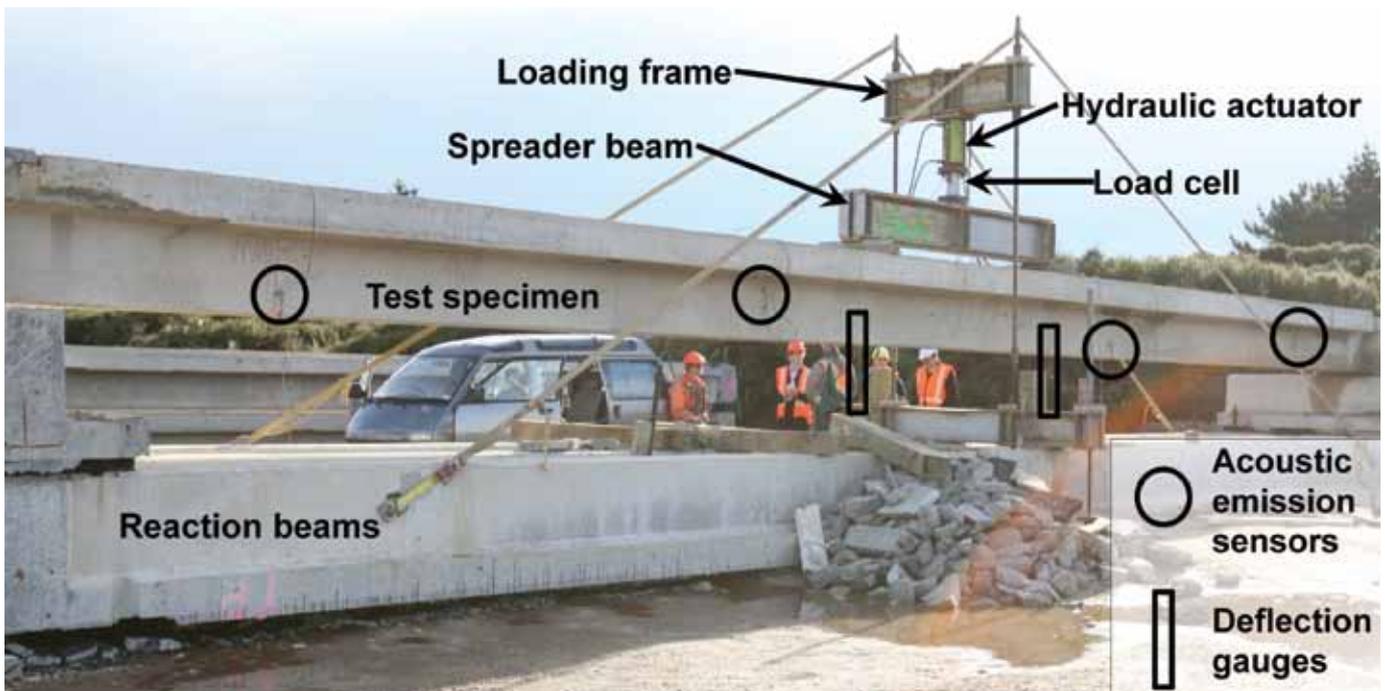
Load was applied to the asphalt surfacing on the test beams through two 100 mm wide (4 in.) line loads oriented across the width of the flange. The line loads were located 1.5 m (4.9 ft) either side of midspan and were applied through a simply supported spreader beam by a single 1000 kN (225 kip) hydraulic ram at midspan. Load was measured using a load cell on the ram, and deflections were measured relative to the ground below each of the line loads. Deflection of the end supports was also measured relative to the ground, and the beam deflections were adjusted to account for this support deflection. Load readings did not take into account the self-weight of the beams.

Figure 10. Self-reacting loading frame and instrumentation for destructive testing.

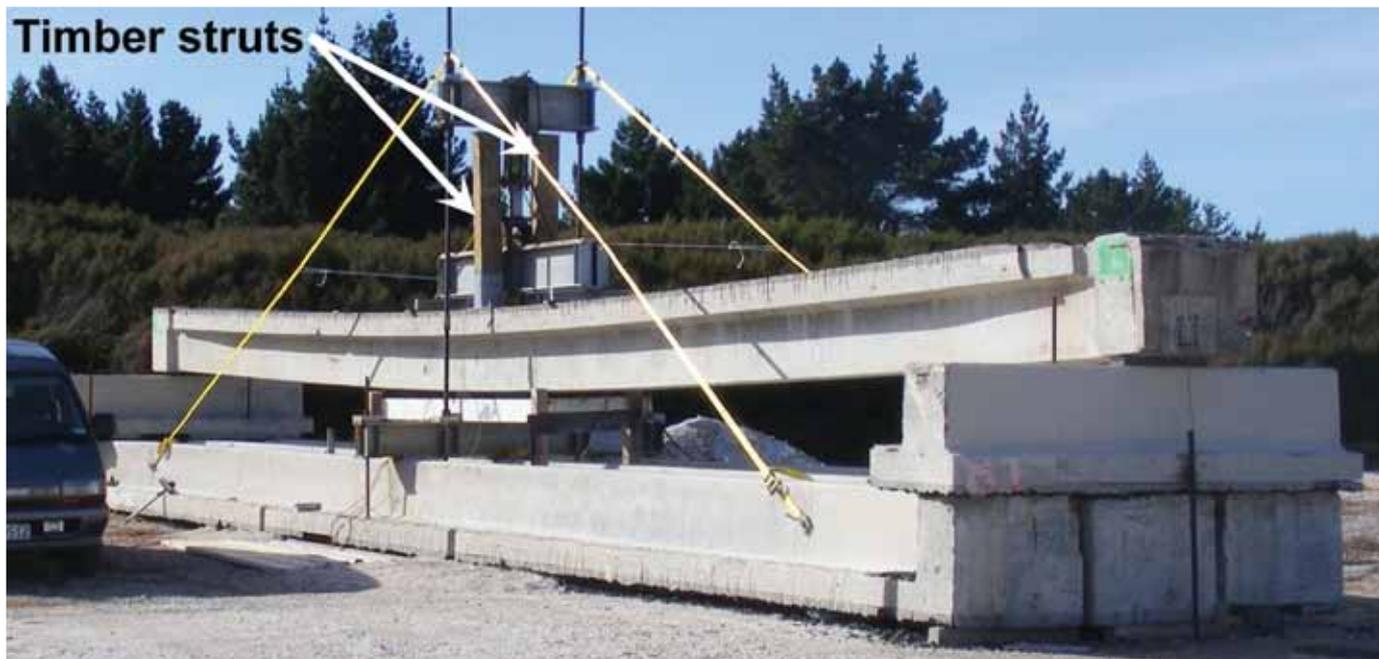
Figure 11. Test rig and deflected good-condition beam.

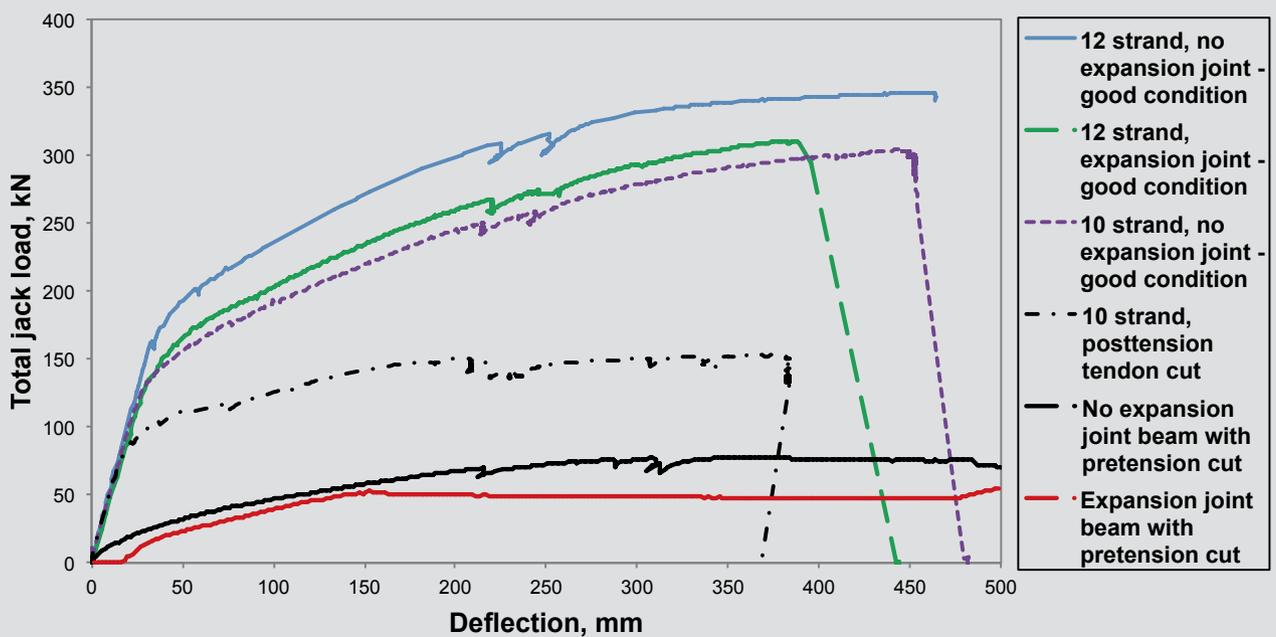
Three control tests were also conducted to isolate the two differing posttensioned tendon drapes and the pretensioned reinforcement. The control tests were performed by cutting all of either the pretensioned or the posttensioned reinforcement to isolate the other. The reinforcement was cut as close as possible to the failure locations displayed by full-strength beams. **Figure 14** gives load-deflection plots from the control tests, showing that the strength contribution from the pretensioned strand is considerably greater than that from the posttensioned tendon and that the two different drapes resulted in a small difference in strength.

Figure 14. Control test results and prestressing arrangement comparison. Note: 1 mm = 0.0394 in.; 1 kN = 0.225 kip.

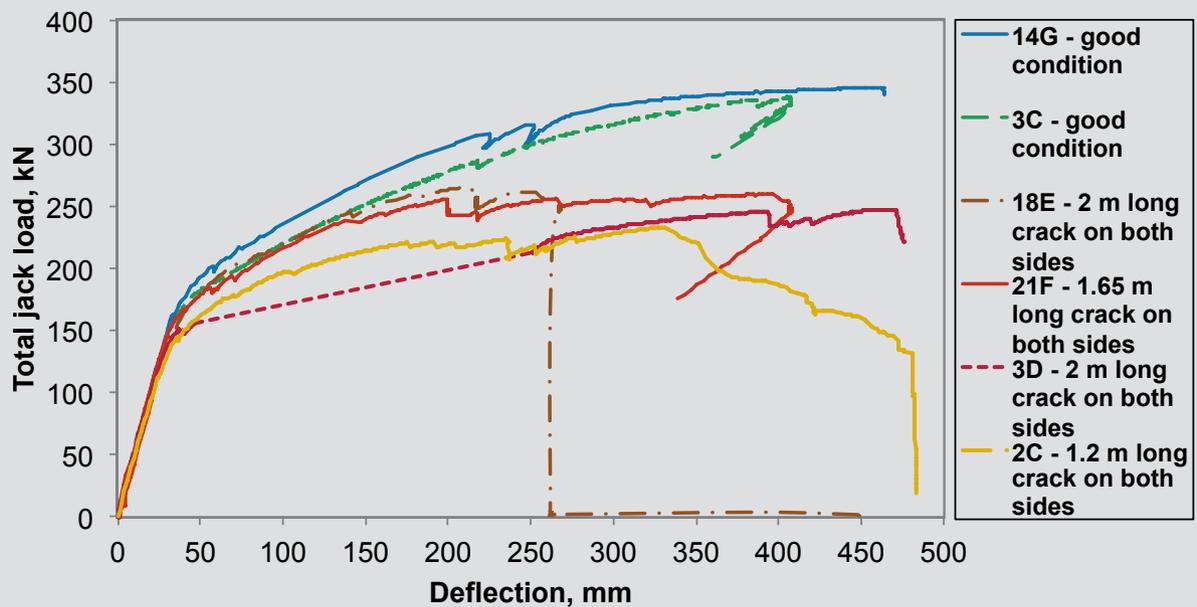
Six tests were performed on beams with 12 pretensioned strands and no expansion joint, with two tests on good-condition beams and four tests on beams displaying corrosion damage to the pretensioned reinforcement. **Figure 15** displays the six load-deflection plots. The average ultimate strength of the beams in good condition was 342.5 kN (77.00 kip), whereas the weakest of the corroded beams supported only 68% of this load. Posttest inspection revealed that the weakest beam (2C) had corrosion damage to all four strands in the bottom layer of pretensioned reinforcement, evidenced by a 1200 mm (47 in.) crack 1.5 m (4.9 ft) from midspan that was visible on both sides of the web. As stated in Table 1, beams 18E and 3D also had corrosion damage to all four bottom strands, while 21F had corrosion damage to three.

Figure 15. Load versus deflection for 12 pretensioned strands with no expansion joint. Note: 1 mm = 0.0394 in.; 1 m = 3.28 ft; 1 kN = 0.225 kip.

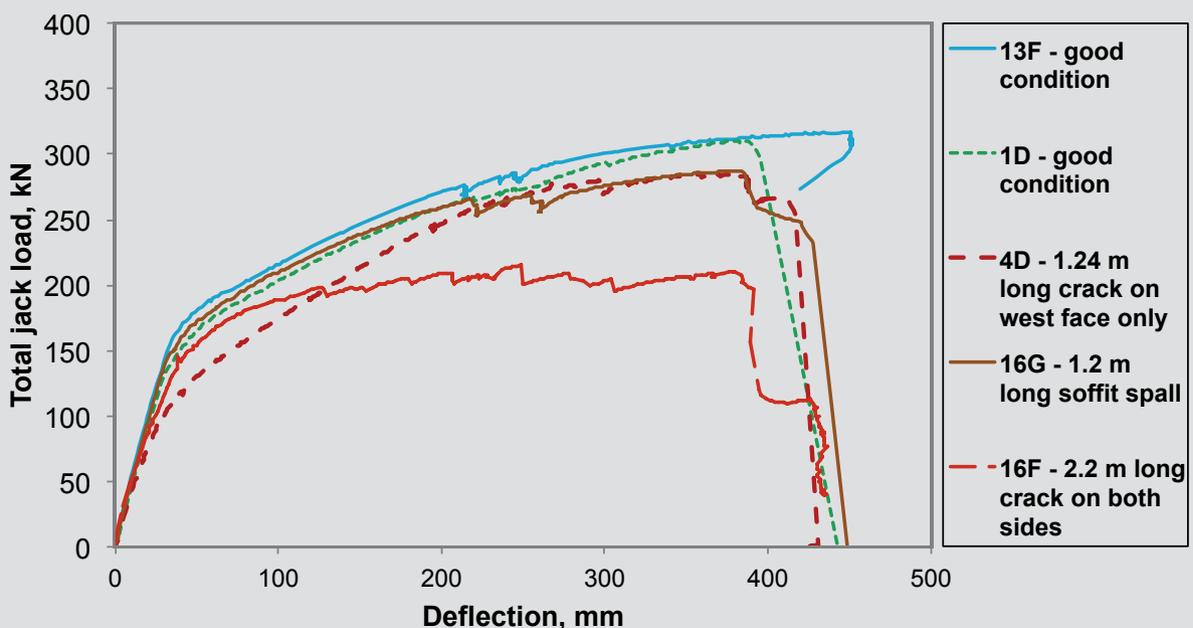
Five tests were performed on beams with 12 pretensioned strands and an expansion joint. Two tests were on beams in good condition and three tests were on beams displaying corrosion damage to the pretensioned reinforcement. **Figure 16** displays load-deflection plots from these five. The average ultimate strength of the beams in good condition was 313.5 kN (70.48 kip), whereas the weakest of the

corroded beams supported only 69% of its good condition counterpart. Posttest inspection revealed that the weakest beam (16F) had corrosion damage to all four strands in the bottom layer of pretensioned reinforcement, which was evidenced by cracking and spalling of the lower part of the web and soffit over a length of 2.2 m (7.3 ft) extending outward from near to midspan. The other corroded beams (4D and 16G) had corrosion damage to three of the four strands in the bottom layer.

Figure 16. Load versus deflection for 12 pretensioned strands with expansion joint. Note: 1 mm = 0.0394 in.; 1 m = 3.28 ft; 1 kN = 0.225 kip.

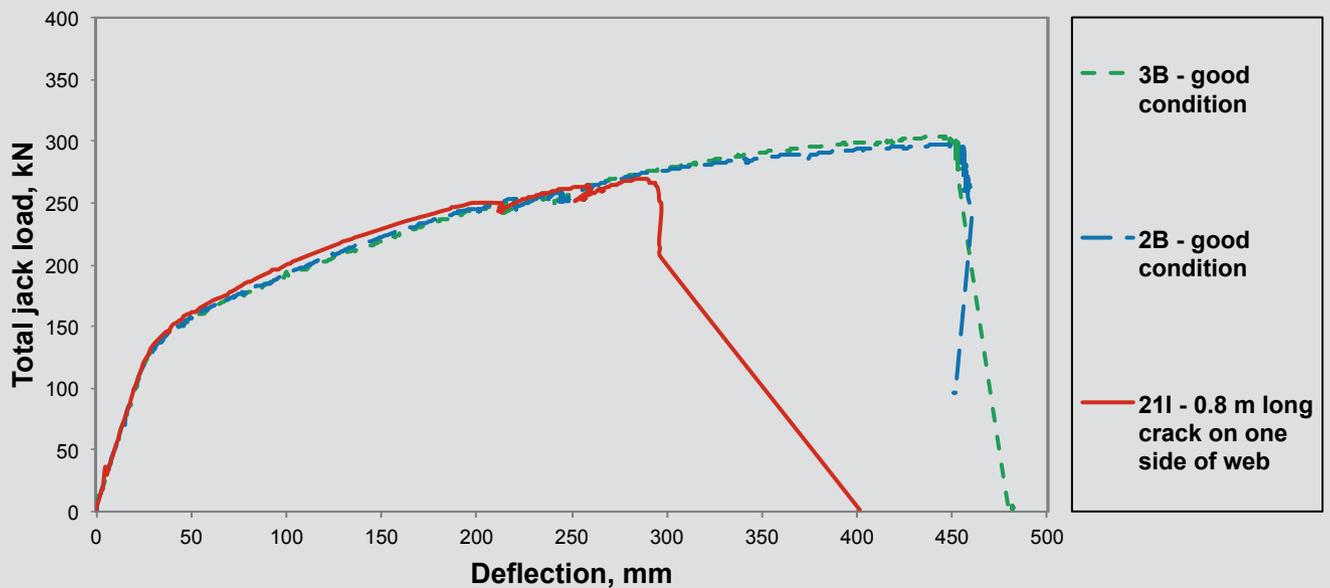
Figure 17. Load versus deflection for 10 pretensioned strands with no expansion joint. Note: 1 mm = 0.0394 in.; 1 m = 3.28 ft; 1 kN = 0.225 kip.

Figure 17 displays load-deflection plots of these three tests. The average ultimate strength of the beams in good condition was 301 kN (67.7 kip), whereas the corroded beam sustained 90% of its good-condition counterpart. This weaker beam (21I) had corrosion damage to one of the two pretensioned strands in the bottom layer of reinforcement, which was evidenced by an 800 mm long (31.5 in.) crack visible on only one side of the web.
