Guidelines for the use of expanded foam polystyrene panel systems in industrial buildings so as to minimise the risk of fire

Fire Engineering Research Report 06/1 2006

A project submitted in partial fulfilment of the requirements for the degree of Master of Engineering in Fire Engineering

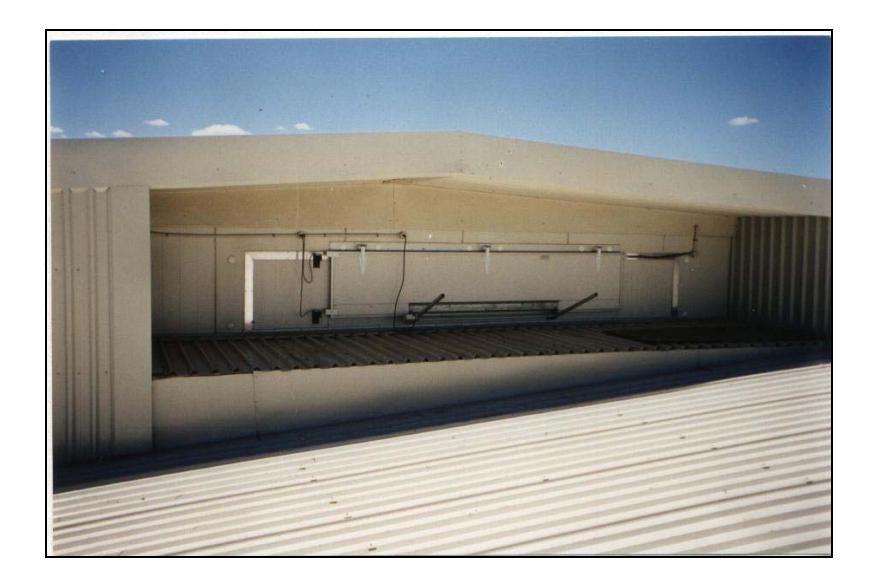
A problem with sealing around the EPS doors, had been solved by adding large hinged 150mm thick EPS flaps that opened up the evaporators to the outside of the building during the defrost cycle. These flaps had been in daily service for about five months before the fire. The flaps were actuated by an electrical window opener, and prevented from icing up by electrical trace heat wiring around the perimeter. (Fig.7.10). The trace heating was of a similar type and construction to that described in Case Study No.1.

Fig. 7.10 Evaporator room on roof with defrost flap in closed position

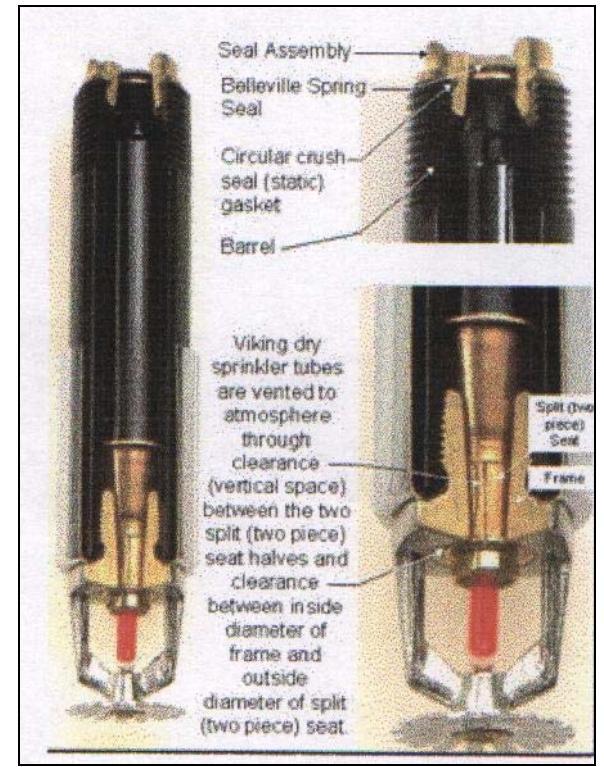
The pallet-racked cold store operating at minus 24°C was put into service in August 2003 **before** sprinkler pipe work was fully commissioned and charged with water. Dry pendant sprinklers, as their name implies, do not contain fluid in the last 500mm or so of pipe and no water is in proximity with the cold temperature of the refrigerated space. The dry section contains a Belleville spring seal at the water end, and is held in place by an inner tube under compression from the glass bulb at the sprinkler head.(Fig.7.15).Fork hoist masts caused unnoticed damage to at least two sprinkler heads. The moisture naturally present in the installed but uncharged sprinkler pipes was drawn thermodynamically towards the open heads in the room allowing condensation and freezing to form an ice-plug in the sprinkler droppers where they penetrated through the EPS ceiling.

Fig. 7.15 Viking dry pendant sprinkler used in cold stores.

The store sprinkler system was subsequently charged with water in December 2003 with the ice plugs which by now were about 100mm in length, maintaining the pressure despite the damaged heads. Inspectors missed the damage because the heads were obscured by pallets of frozen product immediately below them. As is standard practice, dropper penetrations are cut oversized and the annulus around the dropper foamed in place once the escutcheon is fitted. Thus when a head is knocked, there is no noticeable damage visible from the outside of the store. Outstanding maintenance items meant that the connection to AFA (Automatic Fire Alarm) monitoring had not been made at the time of the incident.

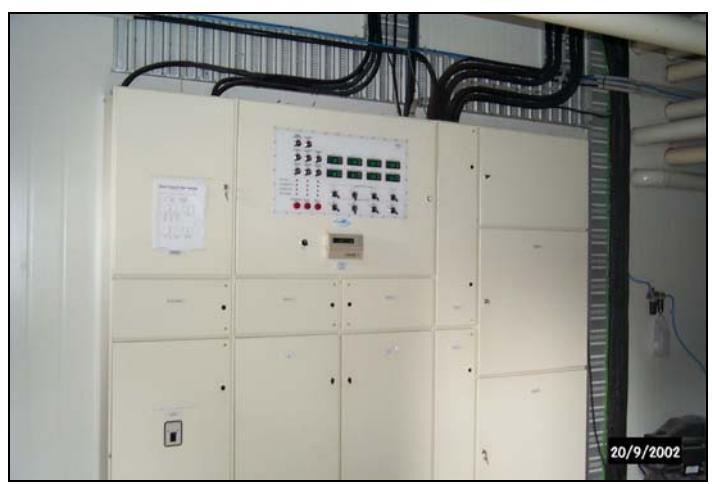
Fig. 8.1 Modern switchboard with wiring surface mounted on ladder rack.

Pay particular attention to the detail and method of sealing and fire rating all penetrations through EPS regardless of their physical size and number. Bunch services to minimise penetrations and provide plugs for future changes particularly in electrical conduit or trunking.

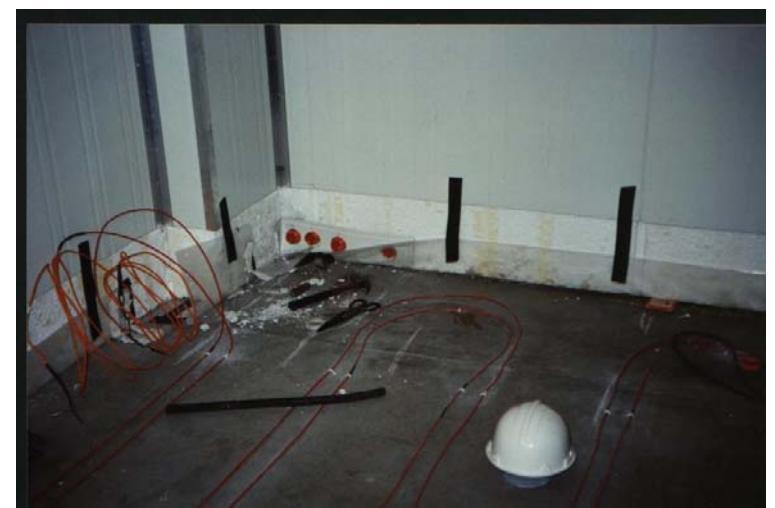
Fig. 8.2 Cold store being built on existing warehouse floor using electrical heating cables

When EPS is used to create a new lining inside an existing compartment, check that no fire hazard exists in the cavity behind the new wall or ceiling. If a hazard is to be concealed, place a detector (heat or smoke) or sprinkler in the cavity with a means of access to it for servicing.

Alternatively, remove the hazard or fire load, or apply a form of passive protection if it is necessary to retain it. (An example is timber structural roof trusses in the ceiling space of a production area requiring a cleanable surface.) Line trusses with gypsum plaster board.

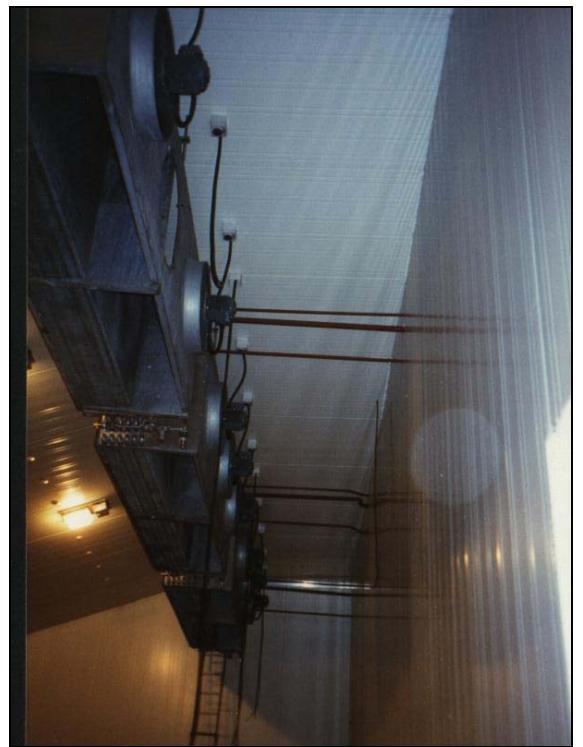
Fig. 8.4 Row of evaporators suspended from EPS panel ceiling.

Consider the behaviour of panel used to support plant items such as evaporators under fire conditions as being at best a secondary element with no F rating. (F rating is a Building Code Fire Safety measure usually in minutes, of the time that an element is expected to withstand a fire on one or both sides, and considers structural adequacy, integrity and insulation.) Consider the option of supporting plant items from the floor. Require installers of replacement equipment to cap and seal <u>both sides</u> of old, redundant penetrations through EPS as part of their scope of work.

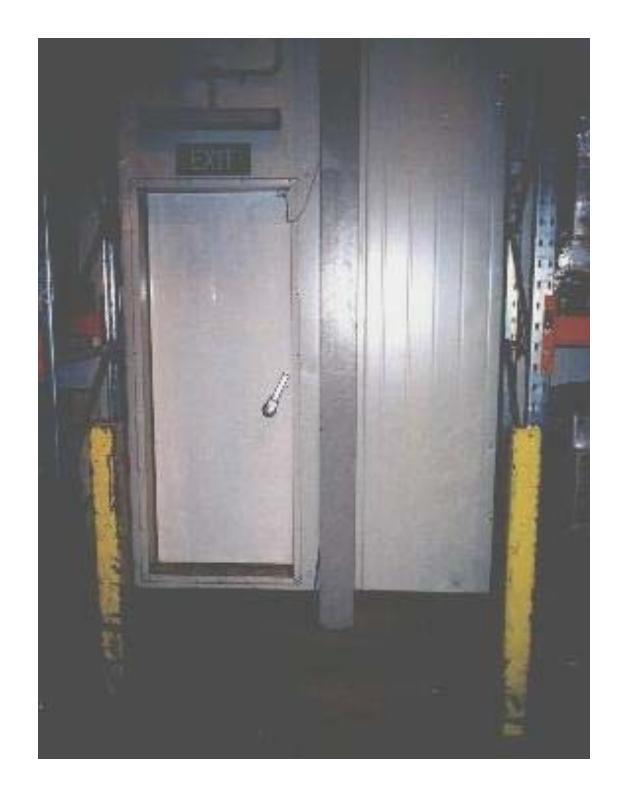
Photograph 8.6 Typical cold store door showing (yellow) protective bollards.

Ensure new doorways are protected from fork hoist damage by a combination of posts, nibs and crossbars. Fit rails to protect walls in high traffic areas.
