# Power Quality Observations at a Light Industrial Site

Hamish Laird, *Student Member, IEEE*, Simon Round, *Member, IEEE*, Richard Duke, *Member, IEEE*  
Alister Gardiner.

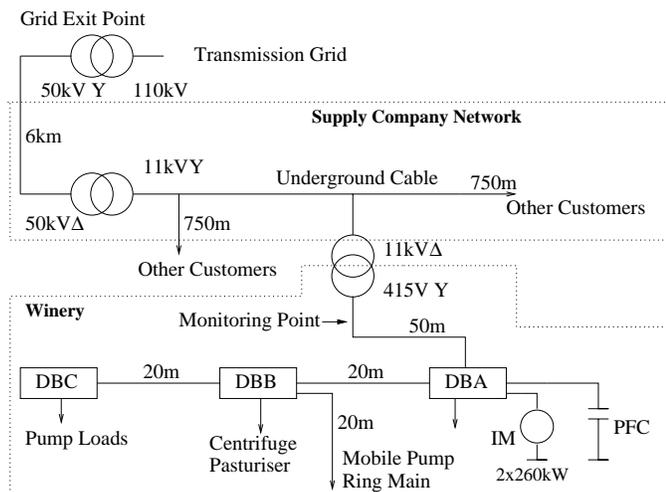
Figure 1. Winery Site and AC Supply System

The site is supplied with electricity through a 1MVA, 11kV to 415V, transformer and the power quality recording equipment monitors the incoming current and voltage at the 415V entry point to the site. The transmission network connection is a 110kV single line spur from the transmission grid. The grid exit point is into a 50kV overhead line sub-transmission network that supplies the 50kV to 11kV transformer. The 11kV is reticulated with underground cables to sites in a light industrial area. Although the system is not physically radial it is configured that way electrically as no ring connections are made at the 50kV or 11kV level. The winery transformer is connected approximately 750m from the 50kV to 11kV transformer and a cable feeds the 415V to the main distribution board, DBA. There are two other distribution boards. DBB supplies the Programmable Logic Controller (PLC) controlled pasteuriser, the 22kW centrifuge, the mobile pump ring main and two vacuum filters, while DBC connects the grape bag presses and four 5kW slurry pumps for moving pressed grapes. Residual current devices (RCD), that protect both equipment and staff, are installed on the mobile pump ring main. The main distribution board, DBA, feeds two refrigeration compressors that are powered by 260kW induction motors. Power factor correction capacitors and their associated controller are also connected at this point. The winery is open to the elements, having no roof except the building containing the compressors. A large amount of water is used in cleaning the site. A particular problem is water ingress into the induction motors that drive the mobile pumps. Water ingress has also been a problem in the compressor motors. Two motor heating units are connected at DBA to ensure that the compressor motor operating temperature is maintained. This prevents water lowering the insulation level to a point where it will break down.

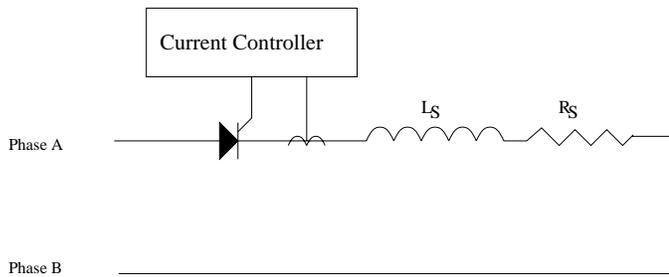
Figure 3. Induction Motor Heating Unit Circuit Diagram

The principal harmonic current producing loads on the site are the two induction motor heating units. One unit is connected to each refrigeration compressor motor. These units half-wave rectify the AC to produce a DC current that keeps the motor at operating temperature. The units are connected line to line and are switched out with a contactor when the motor runs. The electrical circuit of the heaters is shown in Figure 3. Two phases of the induction motor stator winding are used as a resistive heating element and the stator inductance,  $L_s$ , limits the rate of rise of current. The current control system controls the thyristor firing angle to maintain a relatively constant heating current. This can be seen in Figure 4 (which shows the typical AC side current and line to line voltage) where the thyristor is fired just before the voltage zero crossing. The total current (for two heater units) has a peak current of 600 Amps and an RMS value of 170 Amps. The two units are connected to the same phases (line to line) and conduct

concurrently. This means each unit carries half the total current shown in Figure 4.

The units are half-wave controlled rectifiers having only one thyristor and they produce DC, odd and even harmonics in the AC current. The lack of half-wave symmetry indicates that there are even harmonics and a DC component present.

The DC current has impact on transformer operation as it produces a DC MMF that will offset the magnetising hysteresis of the transformer core. If the offset is large enough to drive the core sufficiently into saturation the magnetising current will increase and this could cause transformer overheating and possibly failure. As the rectifiers are connected line to line, the current has non-zero sequence triplen harmonic components that propagate through a star-delta supply transformer. Such harmonic currents may cause resonance that would not be excited by zero sequence triplen harmonics (produced by balanced harmonic loads) which are blocked by a star-delta transformer. The impact of the motor

The induction motor heater unit current harmonics are large and the presence of even harmonics is unusual. The apparent lack of problems that the DC component of the heater current causes is perhaps fortuitous as the resulting transformer MMF offset could cause transformer damage through saturation. No such damage has occurred and the transformer operating temperature during the site survey was 38 C. The fact that the heater units operate only when the site load is low means any adverse transformer heating from saturation is offset by reduced heating due to the low load. Configuring the rectifiers to produce a half wave symmetric current waveform would eliminate the DC current produced by the induction motor heaters. One way to do this is to reverse the phase connection of one of the induction motor heaters. The two heater units would then conduct in opposite half cycles and together would produce a half-wave symmetric waveform. This would decrease the peak current and remove the even harmonic currents. The current waveform would however not be half-wave symmetric at all times as the heating units are on occasion operated separately. However the maximum level of DC current flowing in the transformer would be lowered as DC current would flow only when one heater was operating.
