COST-EFFECTIVE CONSIDERATION OF NON-STRUCTURAL ELEMENTS: LESSONS FROM THE CANTERBURY EARTHQUAKES

ABSTRACT

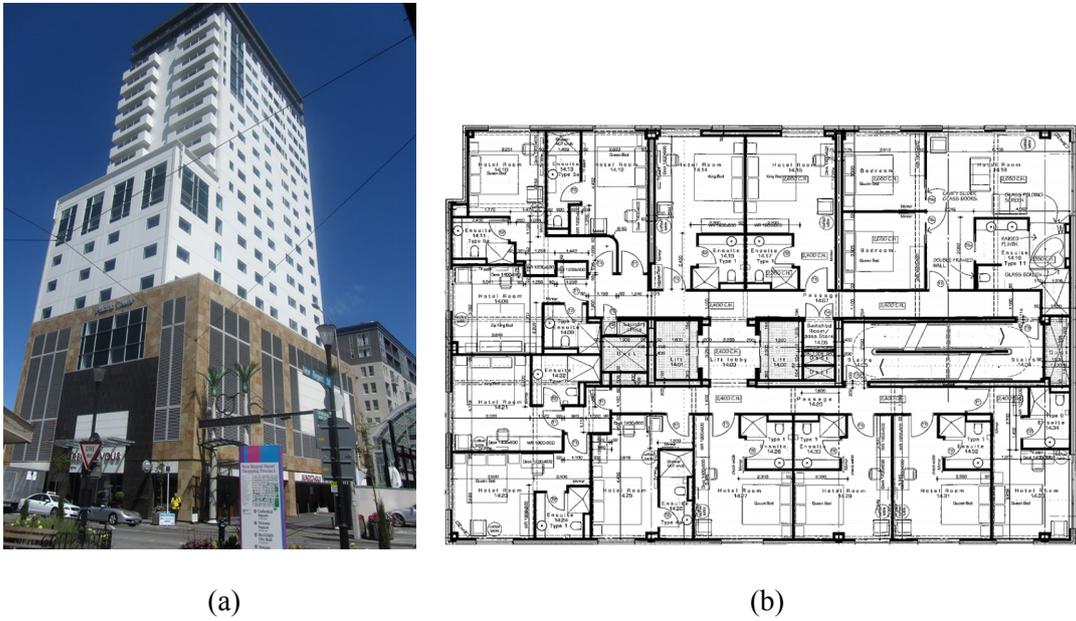
A photo of the 22-storey case-study building, built in 2010 and located in the central business district of Christchurch, is shown in Figure 1(a) and an architectural layout of a typical floor (14th floor) is shown in Figure 1(b). The building is mixed-use, with carparking over lower storeys and hotel/residential use over upper storeys.

Figure 1. (a) Photo of 22-storey case study building from street level, (b) architectural plan from level 14.

The non-structural elements present are those that would be typically expected for this use and type of building. Internal partitioning is provided via lightweight metal framed plasterboard walls and suspended ceilings are present. As can be seen in Figure 1, the building is clad principally with perforated precast concrete panels.

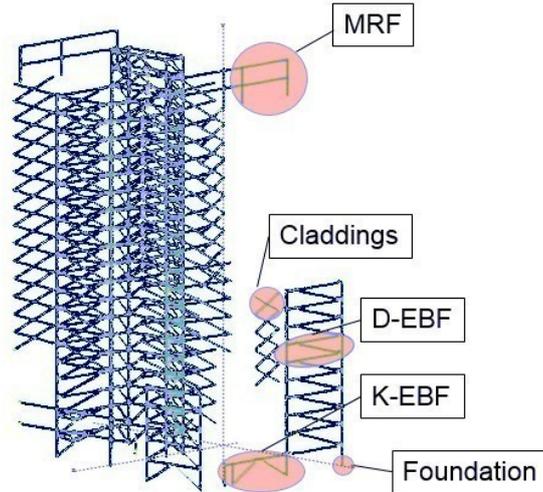
The building incorporates a structural steel system, with a number of eccentrically-braced frames resisting providing the main lateral resistance. The flooring is realised with composite reinforced concrete slabs on metal decks and composite steel beams. Figure 2 illustrates a 3D structural analysis model (described further in Section 3) in which it can be seen that the distribution of EBF links is not completely regular with height (in order to match architectural requirements) and some moment resisting frames (MRFs) are provided at the top levels. The building is sitting on concrete piled foundations. Cladding is also identified within Figure 2 for reasons that will be explained in Section 3.

Figure 2. Perspective view of 3D structural analysis model developed in Ruaumoko (Carr, 2017).

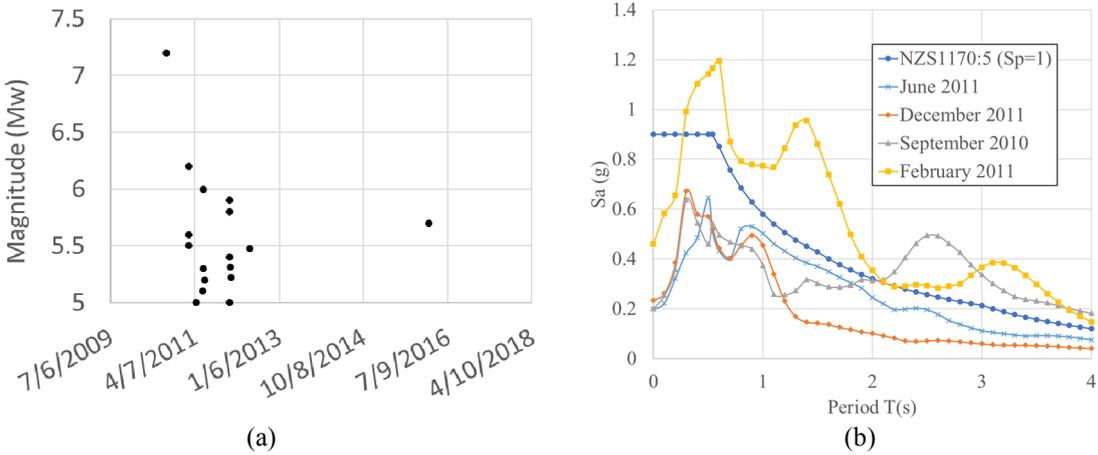
The Canterbury region has undergone a period of intense seismic activity over the past seven years. Figure 4(a) shows the earthquakes of magnitude greater than or equal to 5.0 that occurred within a 60km radius of the Christchurch central business district (CBD) since 2010. The main earthquake, referred to as the Darfield earthquake, was magnitude 7.1 and occurred around 40km from the Christchurch CBD. Damage to Christchurch from the main shock was significant but relatively minor compared to the damage caused by the magnitude 6.2 aftershock that occurred on February 22nd 2011. This is because the February aftershock, being located closer to the CBD, was more intense, as can be seen from Figure 4(b) which plots N-S response spectra recorded in the CBD near the case study building for the main earthquake and a number of significant aftershocks. Note that the aftershock sequence has been particularly long, with a magnitude 5.7 aftershock occurring as recently as February 2016. The stated design level shaking in NZS1170.5 for the ultimate limit state (500 year intensity level) is given in Figure 4(b). Note that the soil class for Christchurch was identified as Class D and that design of ductile EBF structures in New Zealand is commonly undertaken using a seismic performance factor, S_p , of 0.7 together with a ductility factor of 3.0, to arrive at an equivalent force reduction factor (also known as behaviour factor in Europe) of 4.3.

Figure 4. (a) Record of earthquakes of magnitude $M_w > 5.0$ within a 60km radius of the Christchurch CBD since 2010, (b) N-S response spectra, averaged across 3 sites (CHHC, CBGS and CCCC) in the CBD close to the case study building, from the most intense events.
